NASA/TM-2017-219599

Simulating the Impact Response of Three Full-Scale Crash Tests of Cessna 172 Aircraft

Karen E. Jackson
Langley Research Center, Hampton, Virginia

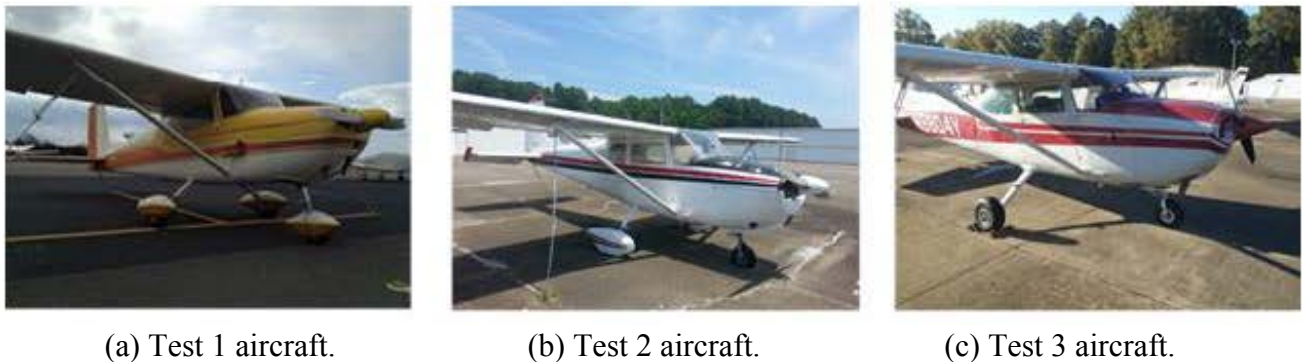
Figure 1. Photographs of the three C-172 aircraft obtained for crash testing.

Photographs of the three aircraft that were obtained for crash testing are shown in Figure 1. Test article one was a 1958 C-172, which was current on its annual inspection. Test article two was a 1958 C-175, which is the C-172 airframe, but contains a different engine and gearbox. The third test article was a 1974 C-172M, which was also current on its annual inspection. Test articles 1 and 3 were flying as late as the winter of 2014, before being transported to NASA LaRC for use as crash test articles.

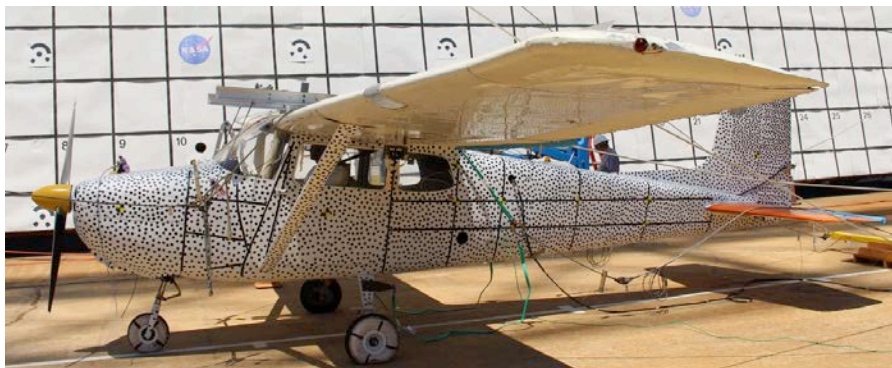
Figure 2. Pre-test photograph of C-172 crash Test 1.

The first full-scale crash test of a C-172 aircraft (Test 1) was performed on July 1, 2015. A pre-test photograph of the C-172 aircraft used in Test 1 is shown in Figure 2. The aircraft contained two crew seats, two Hybrid II 50th percentile Anthropomorphic Test Devices (ATDs), an onboard data acquisition system (DAS) box, four ELTs that were mounted throughout the cabin and tail of the aircraft, and ballast weights to represent fuel loading in the wings. The locations of the ELTs installed onboard the Test 1 aircraft are shown in Figure 3. The total weight of the aircraft was approximately 2,000-lb. The left side of the aircraft was painted white and 1-in.-diameter black dots were added to provide a stochastic speckle pattern for the purpose of collecting three-dimensional (3-D) photogrammetry data during the test [6]. Sixty-four channels of data were collected at 10,000 samples per second using the onboard DAS. The DAS was located behind the pilot and co-pilot seats in the location where luggage would normally be stored, or passenger seats could be added. Thus, the DAS provided ballast to the airframe. Additional lead weight was added over the wing to simulate fuel weight. The lead, along with the main swing hardware accounted for approximately 100 lb of weight over each wing, which simulated fuel tanks above 75% full. Finally, onboard and external high-speed video coverage was obtained from internal and exterior cameras.

The LandIR facility is used to conduct full-scale crash tests of aircraft using either a single (which introduces a pitch rate) or parallel (which removes the pitch rate) swing cabling system. For Test 1, a single set of swing cables was connected to the west end of the LandIR facility and was attached to hard points on the aircraft. Pullback cables were connected on one end to a movable overhead bridge located on the east side of the LandIR facility and on the other end to the test article. As the pullback cables are retracted using the bridge winch system, the aircraft is lifted into the air to a pre-determined drop height. Following a countdown, a pyrotechnic cutter severs the pullback cables, causing the test article to swing along a pendulum-like flight path from east to west onto a pre-determined impact location on the ground. Just prior to impact, the swing cables are pyrotechnically separated allowing the aircraft to impact the surface in a free (unconstrained) condition. Various combinations of swing cable length, impact location, drop height, impact surface conditions (rigid, soil or water) along with a test article's attitude can be prescribed, creating a wide

variety of impact conditions. Measured impact conditions for Test 1 were: forward velocity was 722.4-in/s (60.2-ft/s), vertical velocity was 276-in/s (23.0-ft/s), pitch rate was +16.5-degrees/s, and pitch attitude was 1.48° (nose up).

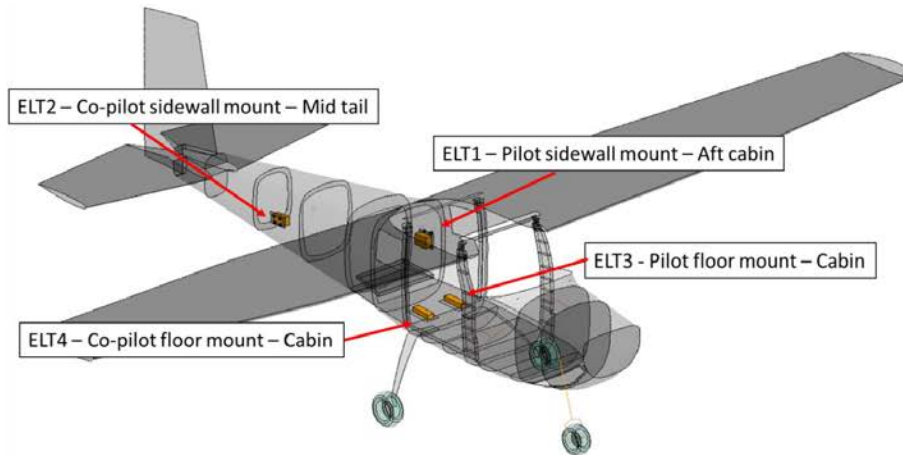
Figure 3. Test 1 ELT configuration.

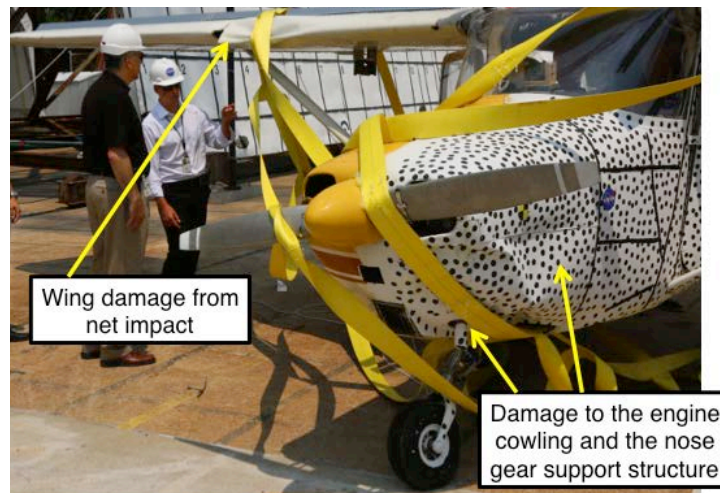
Figure 4. Post-test photograph.

Test 1 essentially represented a “hard” landing. Initially the nose gear tire impacted the concrete, followed closely by impact of the main gear tires. The main landing gear spread outward, as the nose gear stroked vertically. The only fuselage contact with the concrete surface was a slight impact of the rearmost portion of the lower tail. After this impact, the airframe rebounded upward. At 0.5-s following initial impact, the aircraft hit a net that was setup to limit forward travel of the aircraft. Some damage to the engine cowling and nose gear support structure was evident. Likely the engine cowling damage was caused by contact with the net straps. Damage to the nose gear support structure occurred during initial impact. However, following the test, the aircraft was rolled back to the storage facility using the nose and main landing gear tires, which were still inflated. A post-test photograph of the test article is shown in Figure 4. Evidence of damage to the wing caused by contact with the net can also be observed. It became apparent following Test 1 that capturing the behavior of the nose and main landing gear was essential to achieving accurate prediction of the airframe dynamic response. Consequently, landing gear component tests were conducted, as described in a later section of the paper.

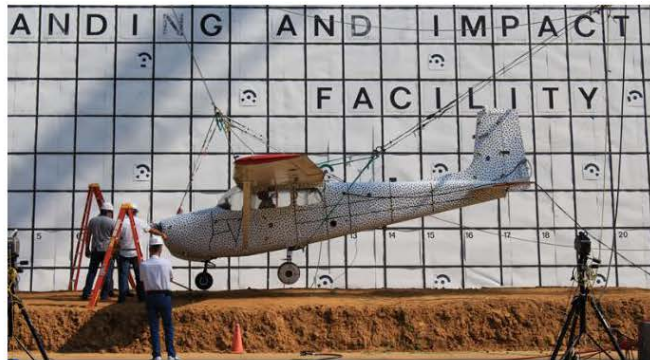
Figure 5. Pre-test photograph of C-172 crash Test 2 aircraft at impact attitude.

Prior to the impact test, the nose gear oleo-pneumatic strut was found to leak. Following unsuccessful attempts to repair the strut, the gear was locked into place at the innermost, fully deflected position. Finally, a 2-ft. high soil bed was spread above the concrete surface. The soil was a sand/clay mixture that was wetted one hour before the test. Details of the swing-cable methodology used for the crash test are provided in Reference 3. As in many high-wing crash tests into soft soil, the airplane flipped over and landed upside down at the end of the impact event, as shown in the test sequence of Figure 7. Also, the tail of the fuselage buckled early in the crash. Buckling initiated behind the bulkhead at the end of the floor, and by 0.240-s the buckle was fully formed.

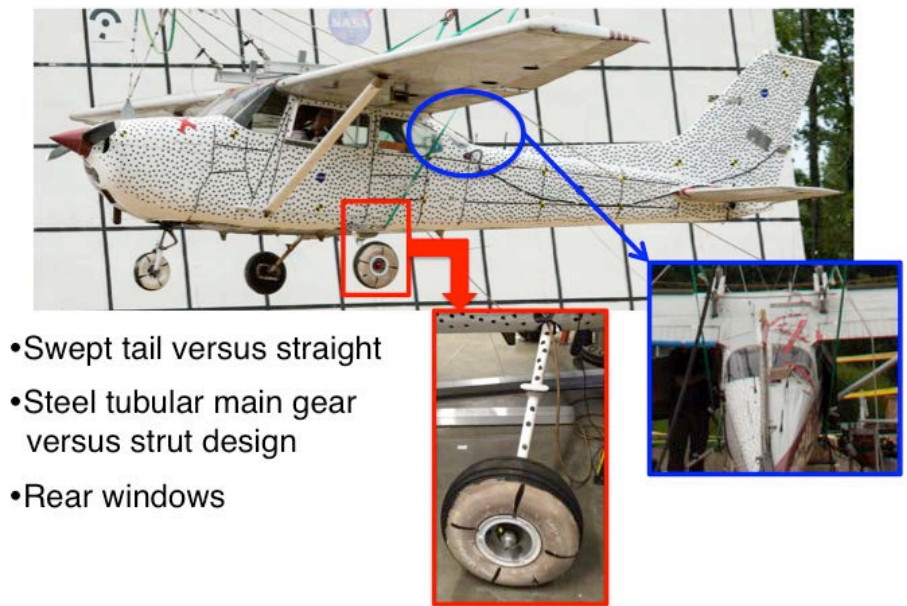
Figure 8. Photo showing the Test 3 aircraft and highlighting configuration changes.

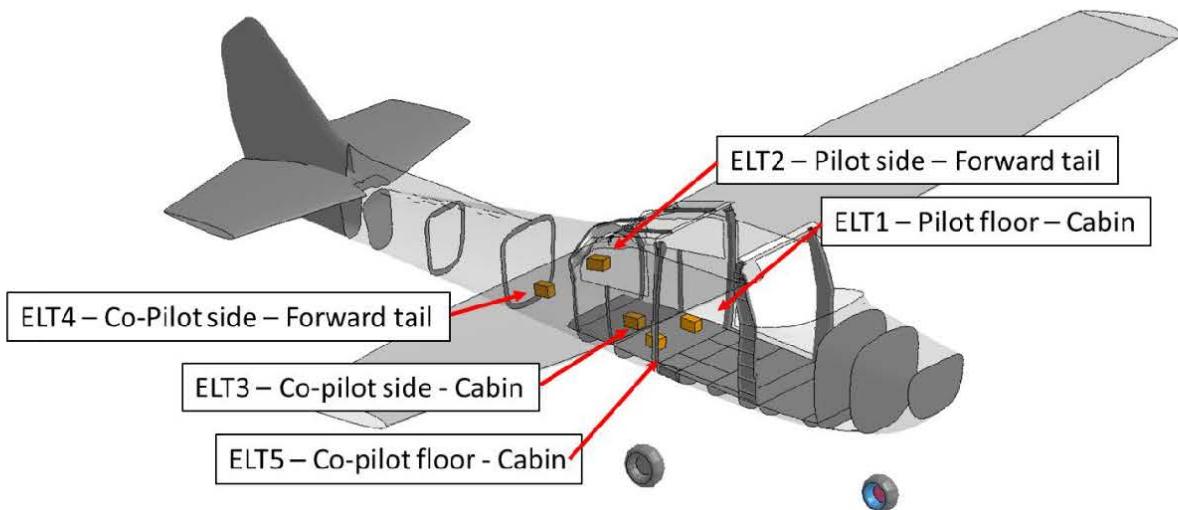
Figure 9. ELT configuration for Test 3.

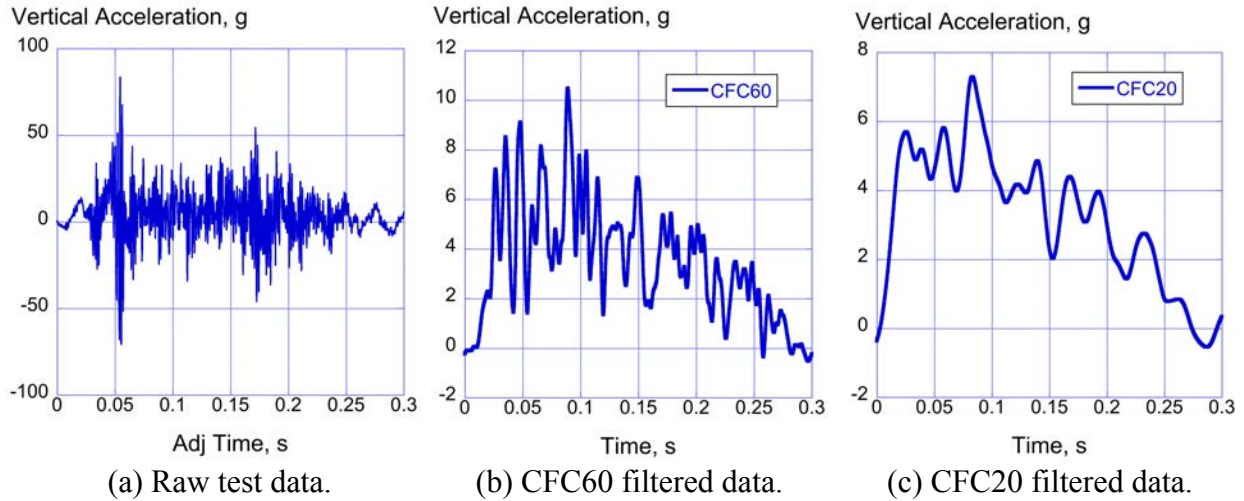
Figure 11. Pilot floor acceleration time histories from Test 1.

Following each of the three full-scale crash tests, the test data were evaluated for quality using the procedures described in the Appendix of Reference 14. Prior to generating time-history response plots, both the experimental and analytical acceleration data had to be filtered. As an example, three plots of the pilot floor acceleration time-history responses from Test 1 are shown in Figure 11. The data were collected at 10,000 samples per second. It is obvious that the raw test data, plotted in Figure 11(a), contains high-frequency oscillations that obscure the underlying crash pulse. Next, the raw test data is filtered using a Society of Automotive Engineers (SAE) Channel Filter Class (CFC) 60-Hz low-pass filter [15], which is commonly used to filter crash test data. The underlying crash pulse is now visible, as shown in Figure 11(b); however, many oscillations still exist in the data. For this reason, the raw acceleration data were filtered using an SAE CFC20 low-pass filter. Now, the fundamental acceleration pulse is evident, without distracting oscillations, as shown in Figure 11(c).

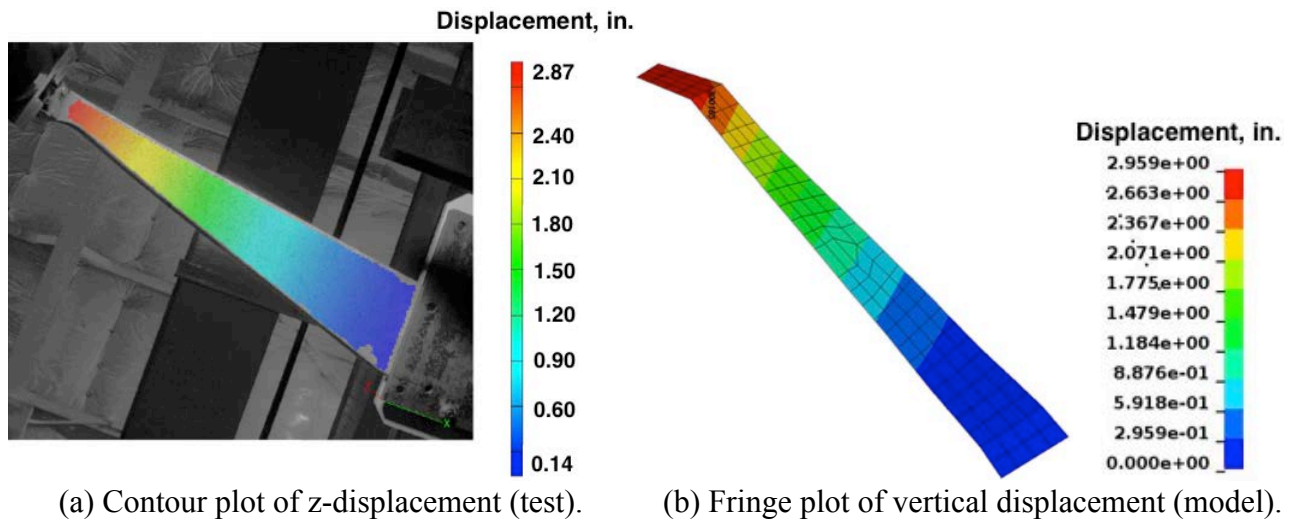
Figure 14. Results of quasi-static test and simulation of the main gear strut.

In the model, the nodes forming the upper end of the strut were fixed and the bottom nodes were free to move horizontally. The block attached to the bottom of the strut was given a defined vertical load ranging from 0- to 2500-lb over a 2-s time duration. Results of the quasi-static test are shown in Figure 14. A contour plot of vertical displacement at a load of 2500-lb is shown in Figure 14(a). A fringe plot of predicted vertical displacement at a load of 2500-lb is shown in Figure 14(b). These two plots are similar and indicate a maximum vertical displacement of 2.87-in. for the test and a maximum of 2.96-in. for the model. These results verify that the elastic modulus of the material model representing spring steel is correct at 3.0E07-psi. Unfortunately, the testing did not continue into the plastic regime allowing determination of the yield stress, strain hardening modulus, or failure strain. As a result, handbook values for these parameters were used in the model.

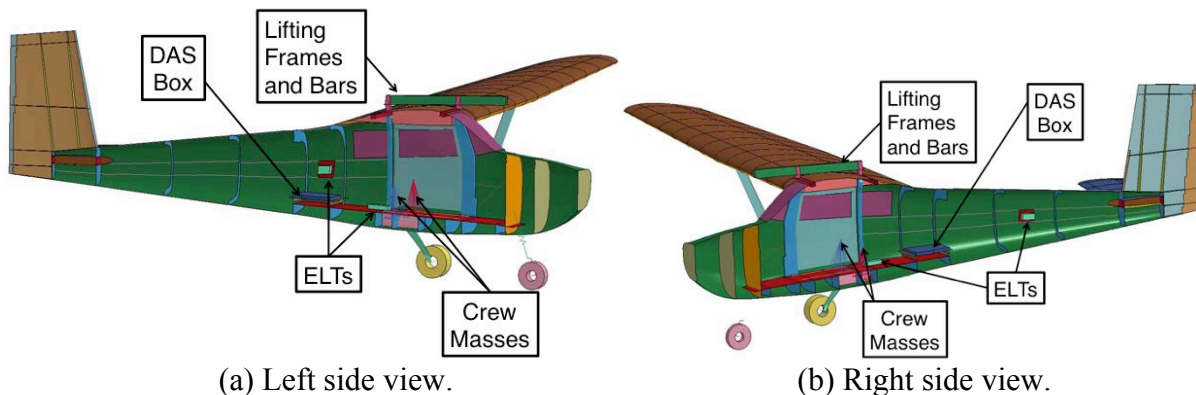
Figure 16. Cutaway views of the Test 1 model.

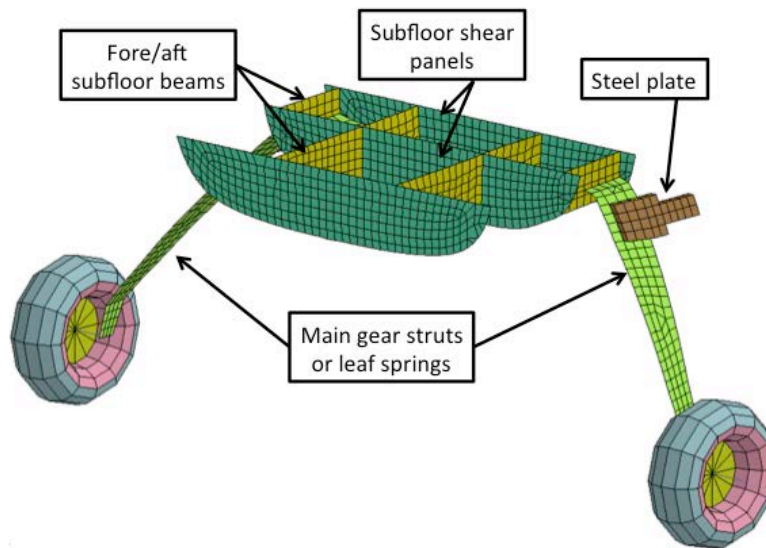
Figure 18. Main gear model.

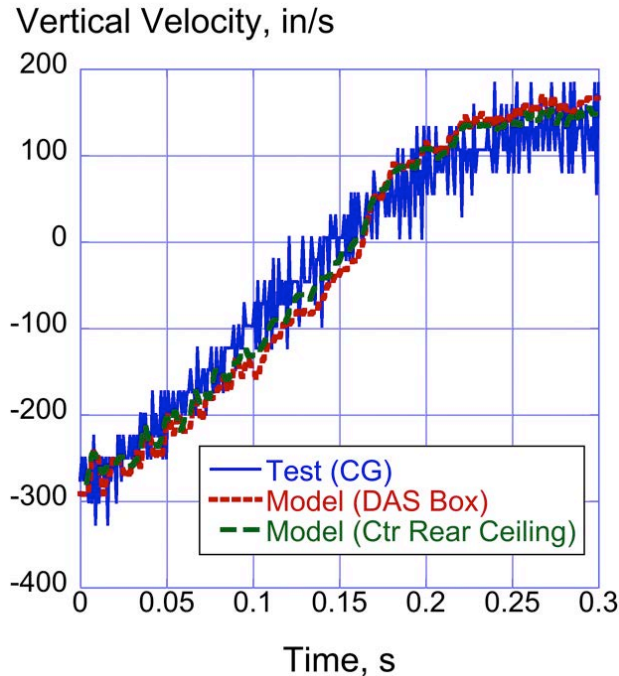
Figure 30. Test velocity response of the CG, as measured by photogrammetry, compared with the predicted velocity responses of the DAS box and the rear center ceiling support beam.

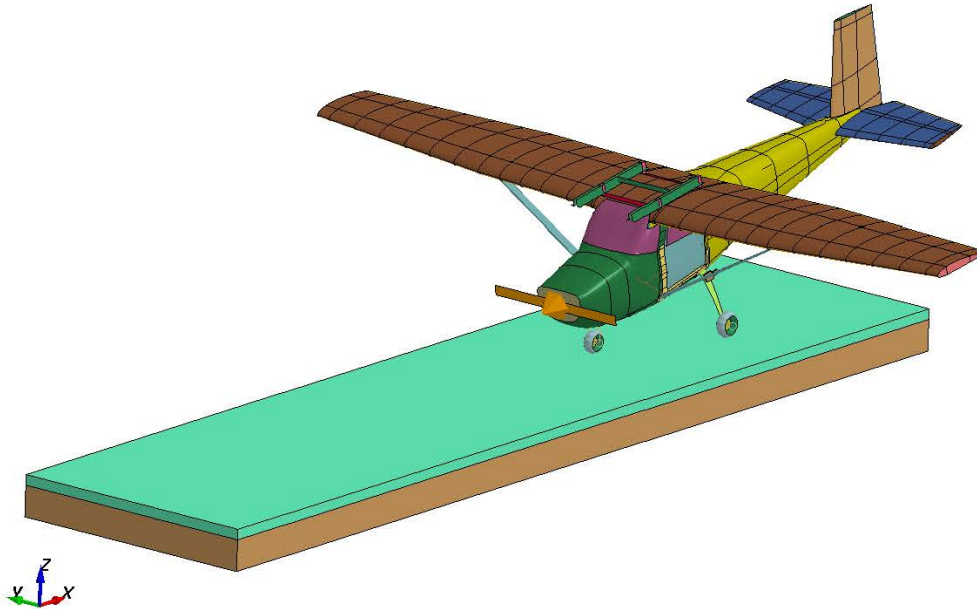
Figure 31. LS-DYNA model representing the Test 2 configuration.

A spinner and propeller were added to the Test 2 model as these structures were noted to penetrate into the soil, as shown in Figure 31. Other changes included more detailed material models of the airplane structure that included plasticity and failure. The *MAT_PLASTIC_KINEMATIC representation, which allows for the full regime of properties from elastic through yielding and plasticity to failure was used for most of the metallic parts in the model. The occupant masses, represented by CNRBs attached to the seat tracks, were moved forward by 10-in. to match the test

condition. Also, an 8-in. x 12-in. hole was created on one side of the tail section to represent the hole produced by a pre-existing access panel that popped off upon first impact. Other changes made to the model included the addition of a fifth ELT, and the addition of an automatic single surface contact. Finally, prior to Test 2, the actual nose gear was essentially locked into place due to leakage problems. Consequently, the nose gear in the model was fixed using CNRBs. This oversimplification likely caused the predicted initial vertical accelerations to be higher than those measured. Also, the wing failure that occurred at 0.111-s after impact in Test 2 was not simulated due to time constraints.

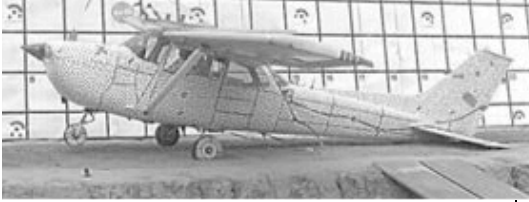
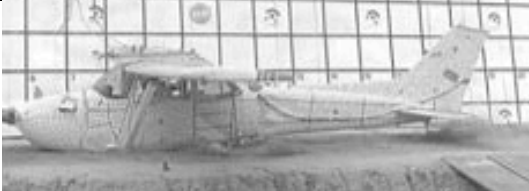
Time of initial tail impact, s	0.030-s	0.063-s

Time of nose impact	0.116-s	0.120-s

Time of initial tail separation	0.138-s	0.135-s

Figure 47. Comparison of time sequence of events for Test 3.

The time sequence of events, shown in Figure 47, includes four major events: time of initial tail impact, time of nose impact, time of initiation of tail separation, and tail separation at 0.25-s. The model does a good job of matching the times that these events occur, with the exception of the tail impact. In the test, tail impact occurs at 0.03-s; however, in the model it occurs at 0.063-s. The reason for this difference is unknown; however, it is useful to point out that the observed time delay is not evident in the following two events.

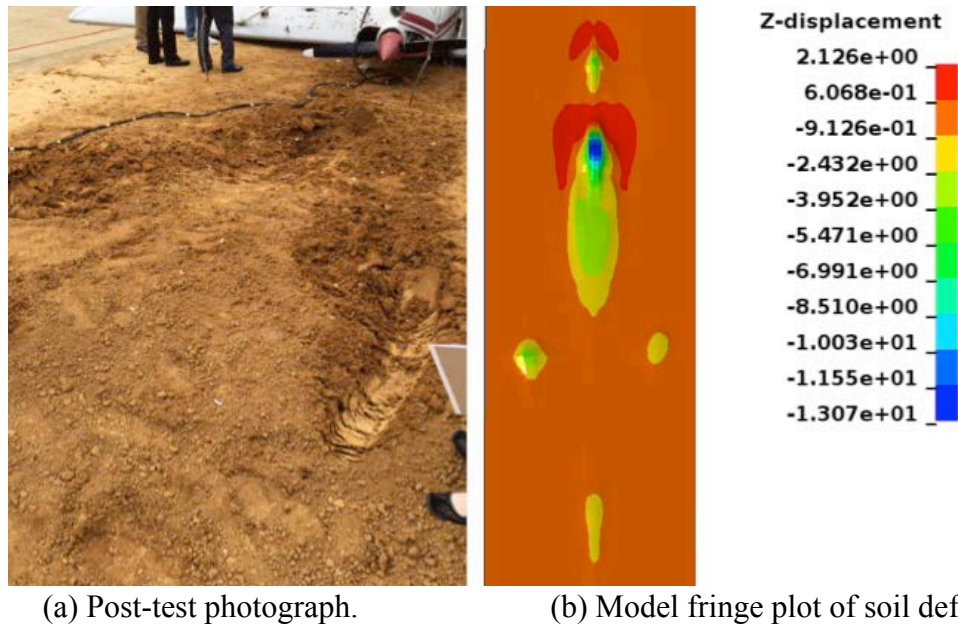
Figure 48. Soil deformation pattern for Test 3.

A photograph is shown in Figure 48(a) depicting the soil deformation pattern post-test. For comparison, a fringe plot of soil deformation in the vertical direction is shown in Figure 48(b) for the model at a time of 0.258-s, which is the time of maximum nose gear deflection. The deepest crater is measured at the point the nose gear digs into the soil. Table 8 shows a comparison of test and analysis soil depth measurements and track distances. In general, the model did a reasonable job of matching the test soil deformation.

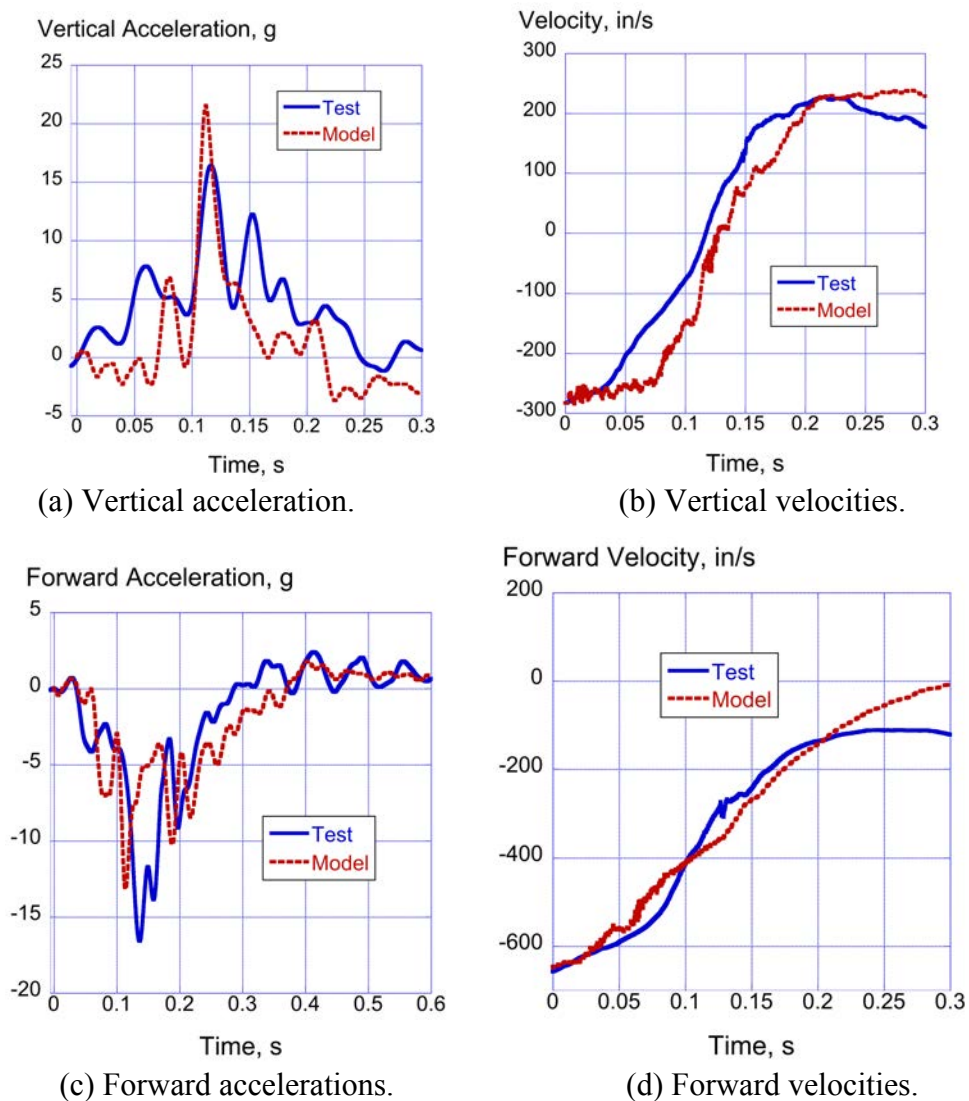
Figure 49. Comparison of vertical and forward acceleration and velocity responses of the pilot floor.

Comparisons of vertical and forward acceleration and velocity time-histories are shown in Figures 49-54 for six selected accelerometer locations within the airframe. It should be noted that the experimental and analytical acceleration curves were filtered using an SAE CFC 20-Hz low-pass filter [15]. Experimental velocity data were obtained by integrating the raw acceleration. Analytical velocity data were output directly from the simulation. Analytical accelerations were output in the local coordinate systems defined at each accelerometer location. However, the analytical velocities were output in the global coordinate system. Of the six structural accelerometer locations, the

measured forward velocities, shown in Figures 49(d) through 54(d), do not cross zero velocity, since the plane is still moving forward. Instead, velocity is reduced initially, then at a certain time the forward velocity begins increasing due to rotations of the airframe. The point in time in which the forward velocity starts increasing is different at each location and is most pronounced at the rear of the aircraft as it begins to flip over. For example, it is useful to compare the forward velocity of the DAS box (Figure 51(d)) with the pilot floor location (Figure 49(d)). Likewise, the analytical forward velocity responses approach zero, but do not cross it. Consequently, values of forward pulse duration were estimated based on the forward acceleration and velocity plots. Note that vertical pulse durations were determined using the method shown in Figure 12. Table 9 summarizes the test-analysis data including average acceleration, pulse duration, and delta-V for Test 3. In general, the level of agreement between test and analysis predictions is good for the six structural locations.

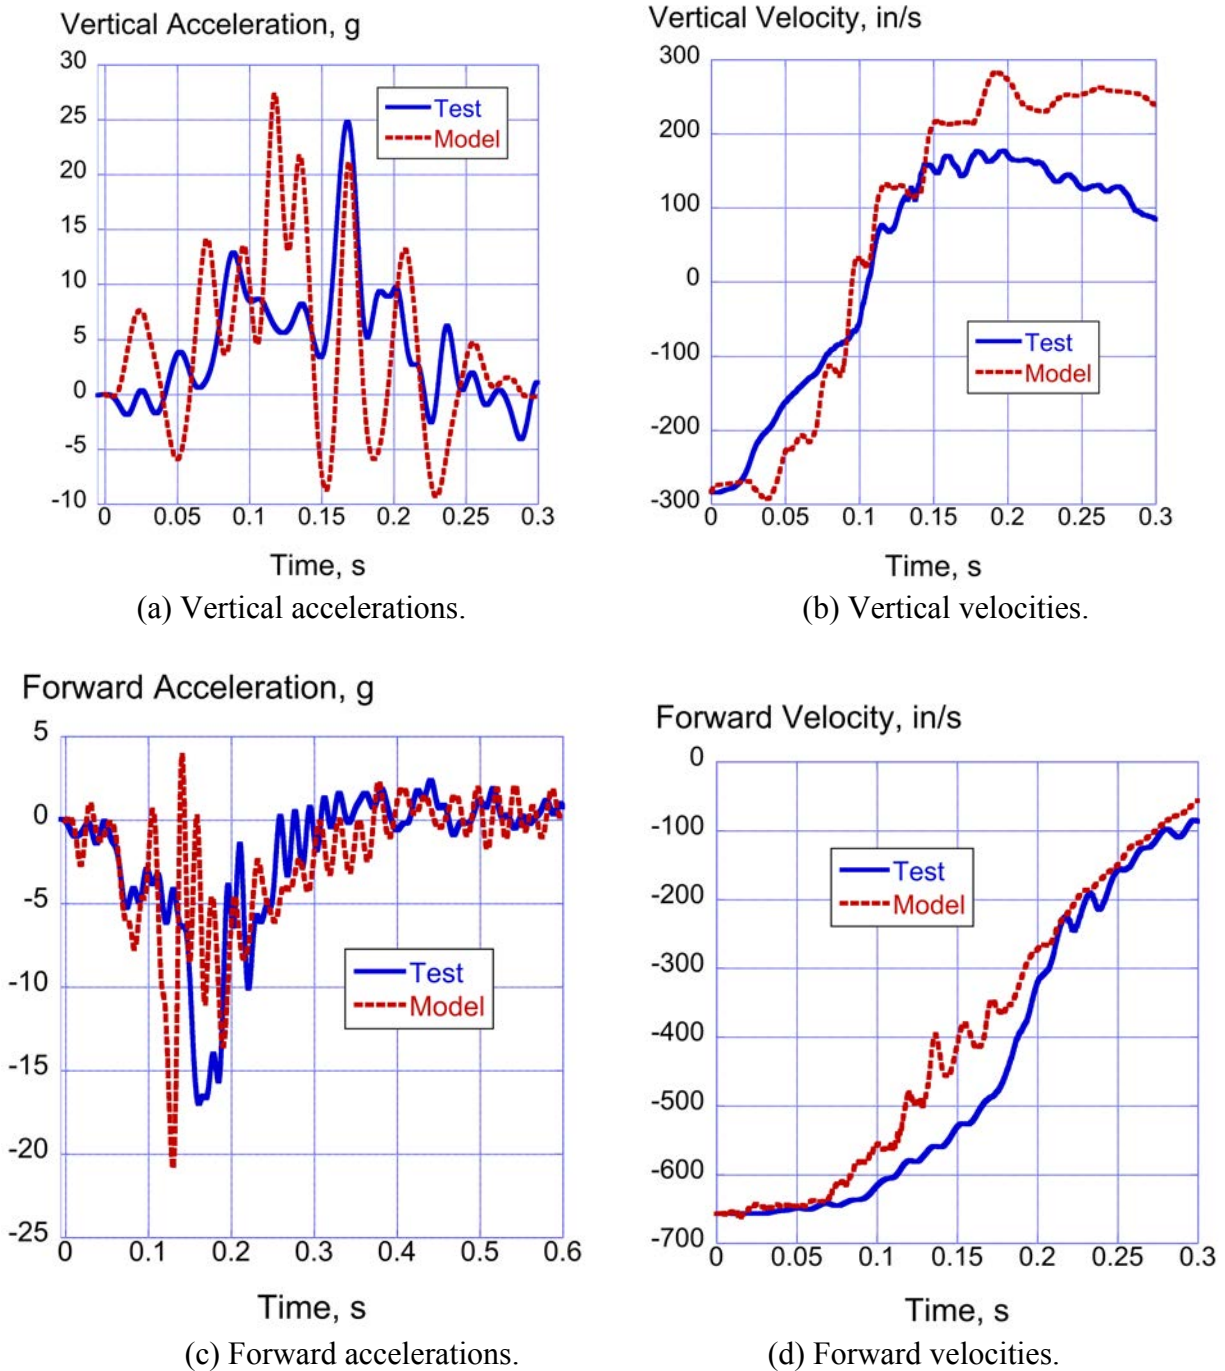
Figure 55. Comparison of vertical and forward acceleration and velocity responses of the left floor ELT1 in Test 3.

than for the floor mounted ELTs; however, overall the predicted responses match the test behavior reasonably well. Note that average accelerations, pulse durations, and delta-V values for both the experimental and analytical velocity responses are included in Table 9. As mentioned previously, forward pulse durations were estimated based on forward acceleration and velocity plots.

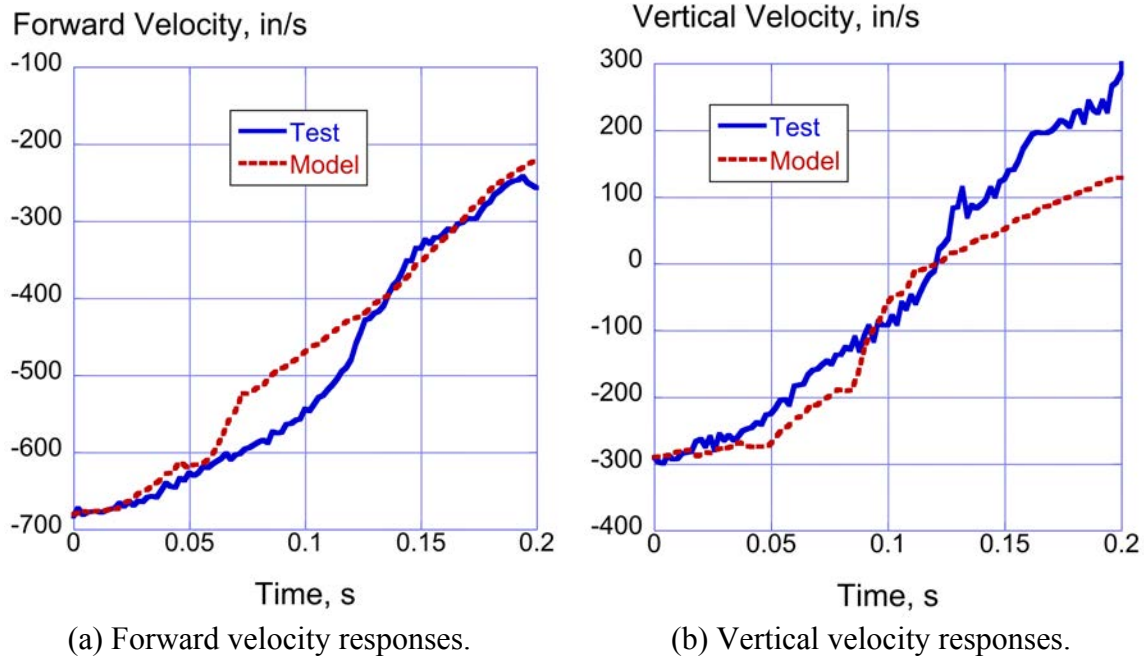
Figure 61. Test-analysis comparisons of forward and vertical velocity responses of the doorframe.

Test-analysis comparison plots of forward and vertical velocity responses for the doorframe and the tail are shown in Figures 61 and 62, respectively. For these plots, the test velocity responses were obtained from 3-D photogrammetry and the model responses were obtained in the global coordinate system by following the responses of nodes in the model whose locations approximately matched the locations shown in Figure 60. Note that the doorframe location, as shown in Figure 60, is close to the CG of the aircraft.

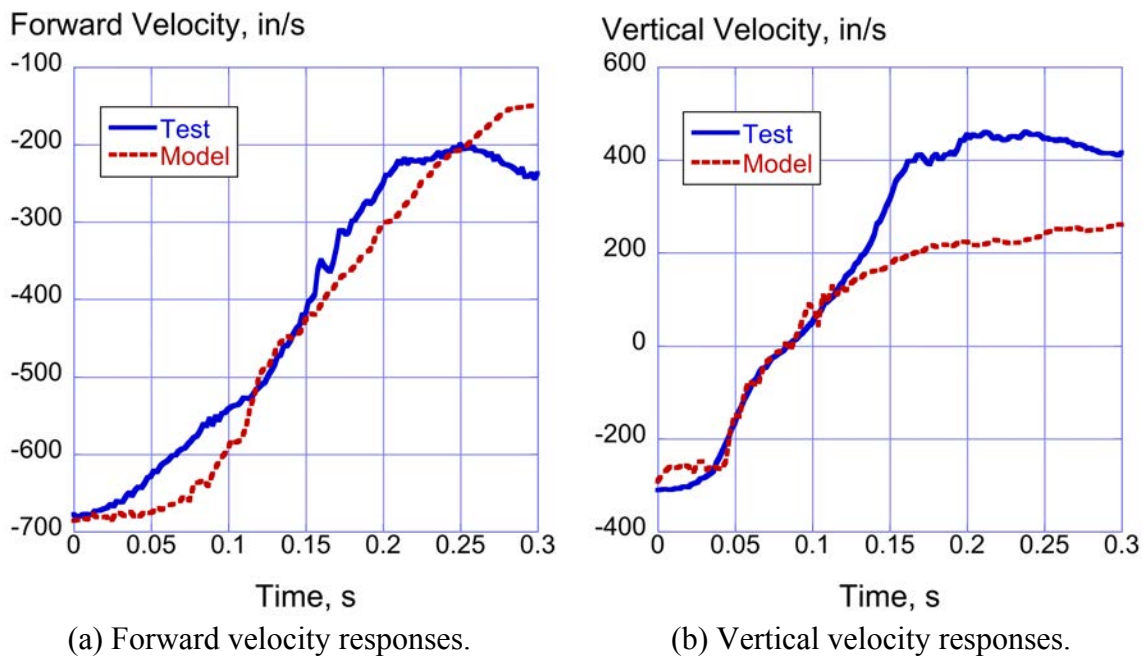
Figure 62. Test-analysis comparisons of forward and vertical velocity responses of the tail.

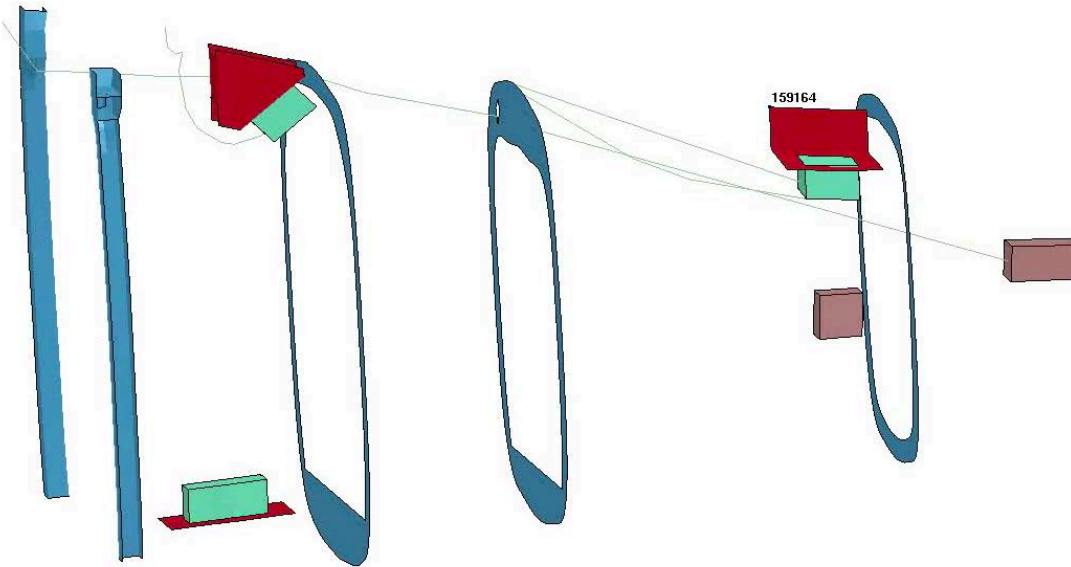
Figure A1. Note various coaxial cables modeled for Test 2 including cable running through a hole in the middle frame. Also, note some of the cables have considerable slack built in.

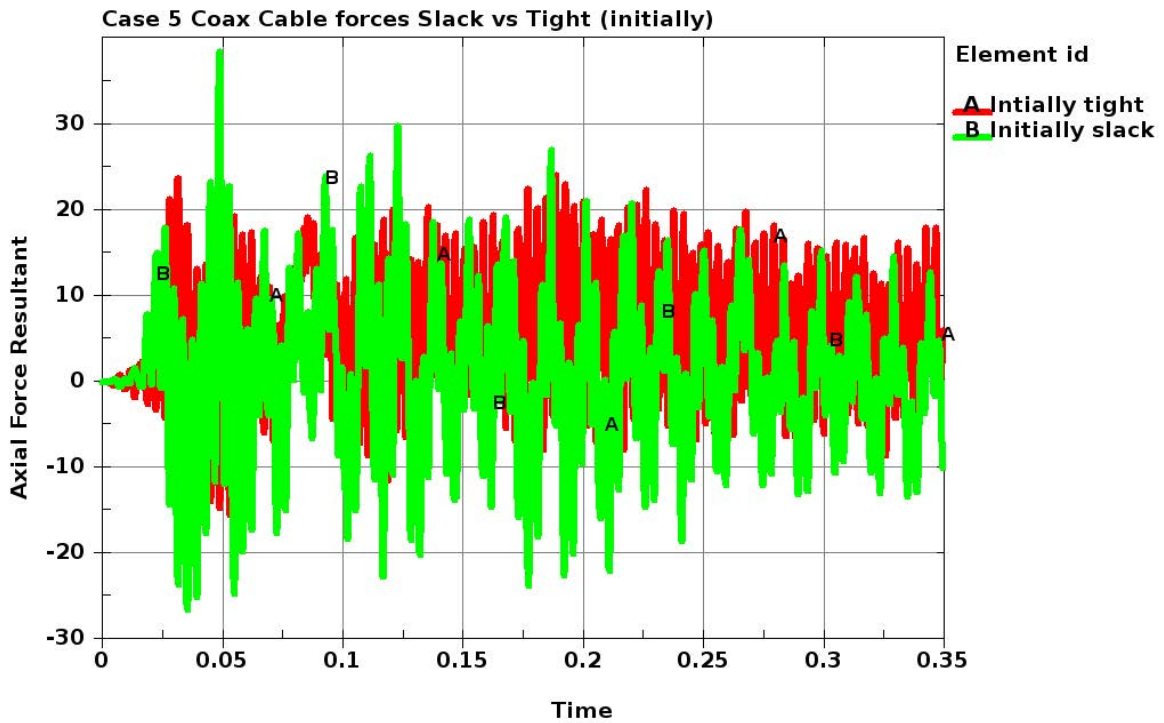
Figure A2. Dynamic force and frequency response, taut coax vs slack.

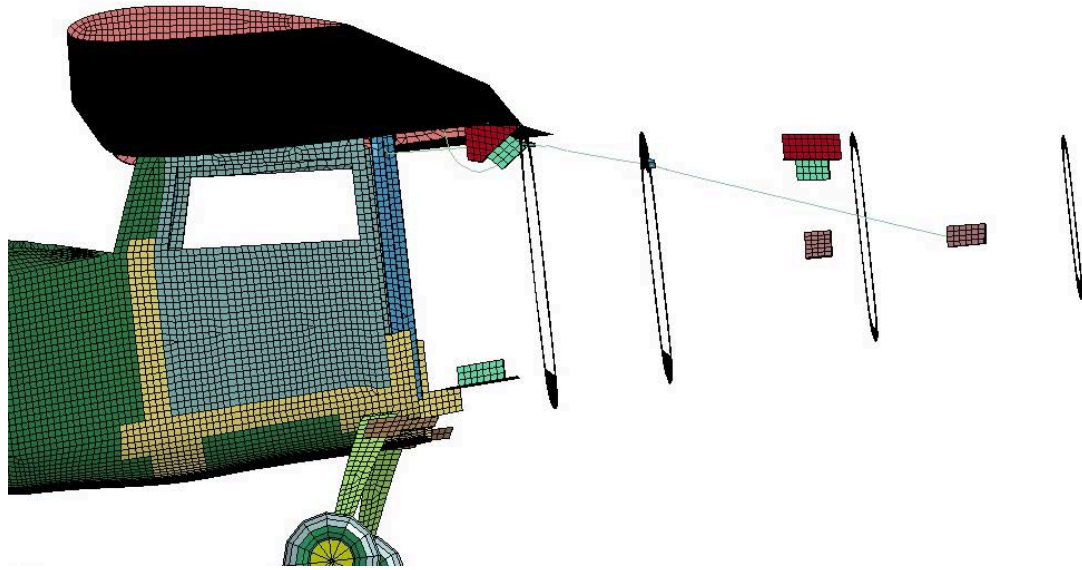
Figure A3. Test 2 with coaxial cables modeled between the ELT and antenna. Note the long cable that lies between the ELT in the rear tail and the antenna in the cockpit area is taut at time 0.021-s.

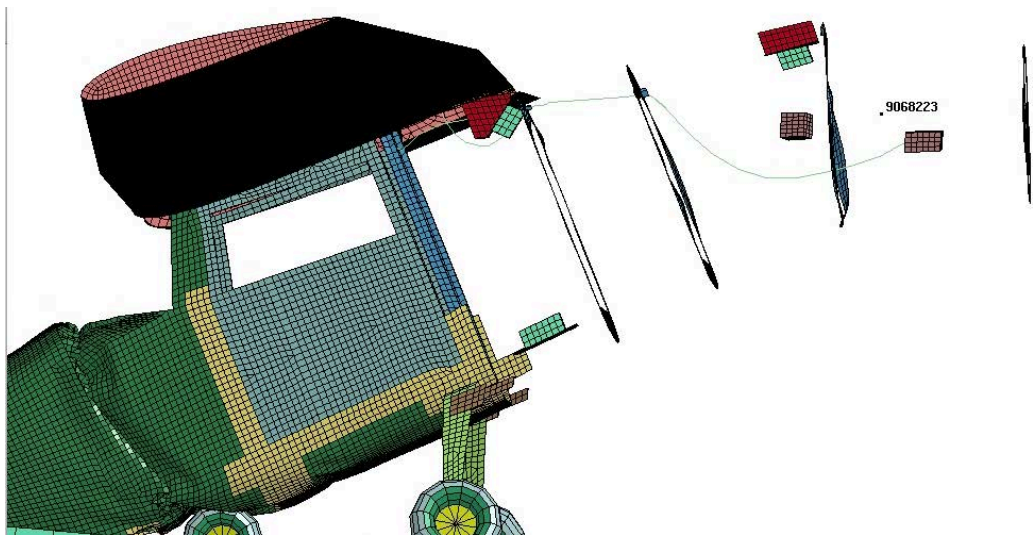
Figure A4. Test 2 showing the long cable going slack at time 0.156 seconds after the tail buckled.

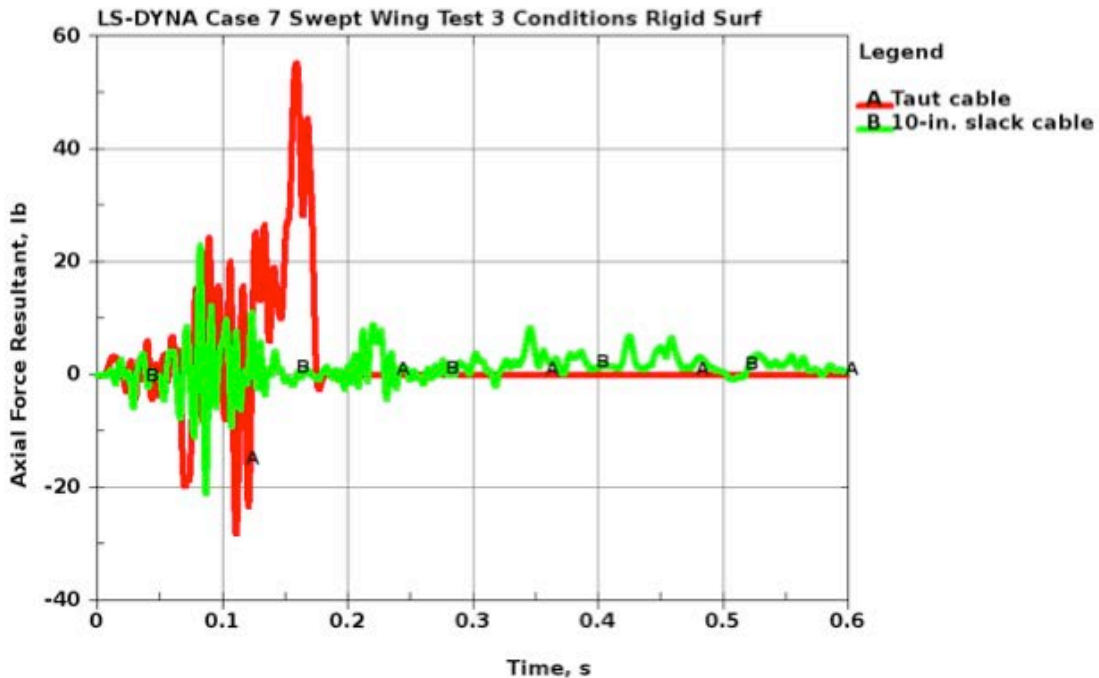
Figure A6. Resultant axial forces for taut and 10-in. slack cables for Case 7 onto a rigid surface.

Resultant axial forces in the cables are plotted in Figure A6 for Case 7. As can be seen, the taut cable exhibits a peak force of 55-lb and fails at 0.175-s. In contrast, the cable with 10-in. of slack exhibits oscillations and survives. Next, the Case 8 model was simulated onto layered soil with a taut cable and a 13-in. slack cable. Resultant axial forces are plotted in Figure A7 for Case 8. For this case, the taut cable exhibits a nearly identical load behavior as it does in Case 7. A peak load of 60-lb is achieved and the taut cable fails at 0.165-s. For Case 8, the cable with 13-in. of slack also fails, due to tail separation. The peak load is again 60-lb and failure occurs at 0.4-s. Thus, the addition of slackness in the cable provided an extra 0.2-s of time in this scenario, during which signals might be propagated.

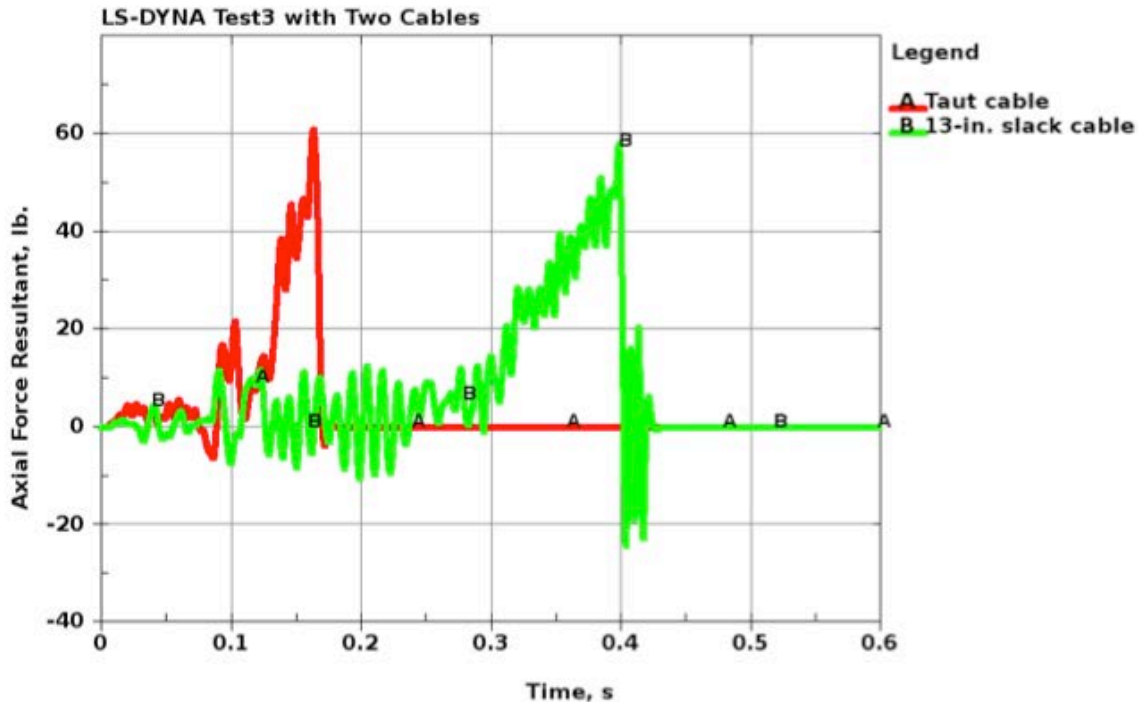
Figure A7. Resultant axial forces for taut and 13-in. slack cables for Case 8 onto soil.

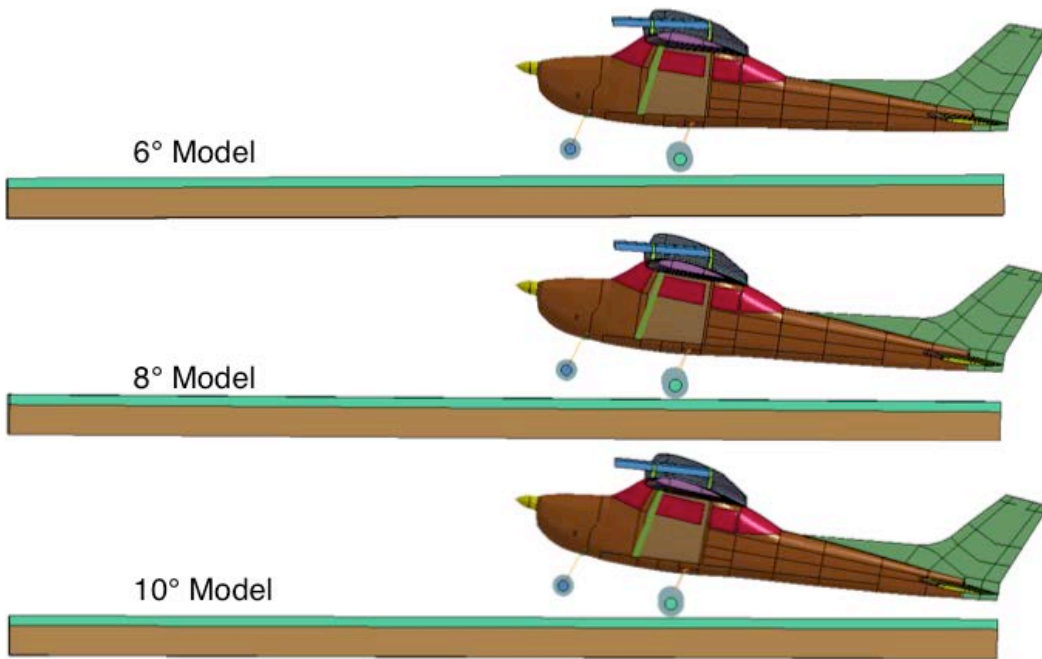
Figure A8. Influence of pitch angle using Case 8.

A series of simulations were executed to determine the influence of pitch attitude. The Test 3 model (Case 8) was executed for three pitch angles: 6° , 8° , and 10° , as shown in Figure A8. Each model contained two cables, one taut and the other with 13-in. of slack. Resultant axial forces are plotted versus time for each simulation, as shown in Figures A9, A10, and A11. For the 6° pitch model, the taut cable failed, but the 13-in. slack cable did not. For the 8° pitch model, both cables failed with failure of the 13-in. slack cable occurring approximately 0.2-s later in time. However, with the 10° pitch model, the slack cable did not fail, but the taut cable did. Thus, findings from this study are: the taut cable failed in each simulation, whereas the slack cable did not fail at 6° and 10° pitch, but did fail at 8° pitch. Therefore, it can be stated that cable slackness will not always protect the ELTs and their connectors such that the dynamic forces and cable strain remain below the failure limit. However, it does show the benefit of including a reasonable amount of slack in that the probability of cable survival is increased.

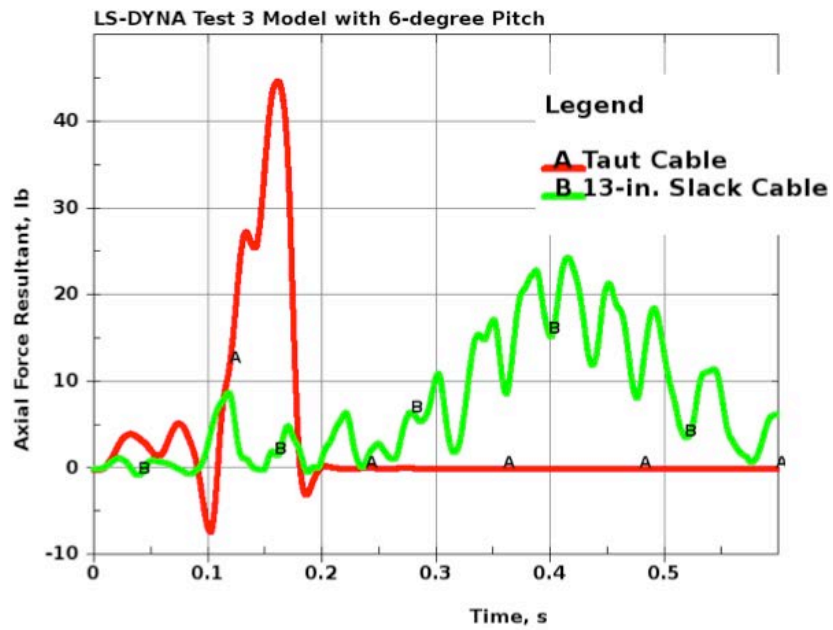
Figure A9. Resultant axial force versus time for the Case 8 model with 6° pitch.

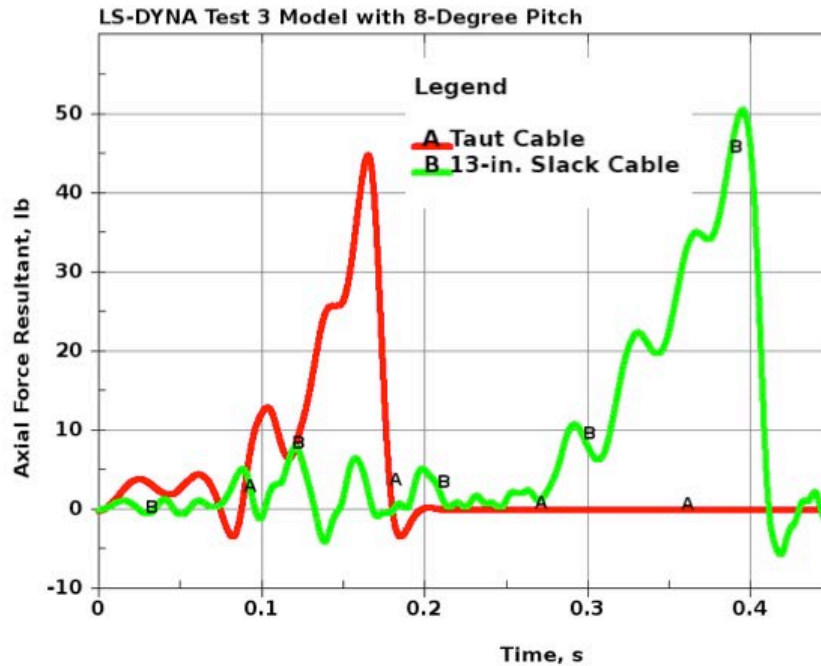
Figure A10. Resultant axial force versus time for the Case 8 model with 8° pitch.

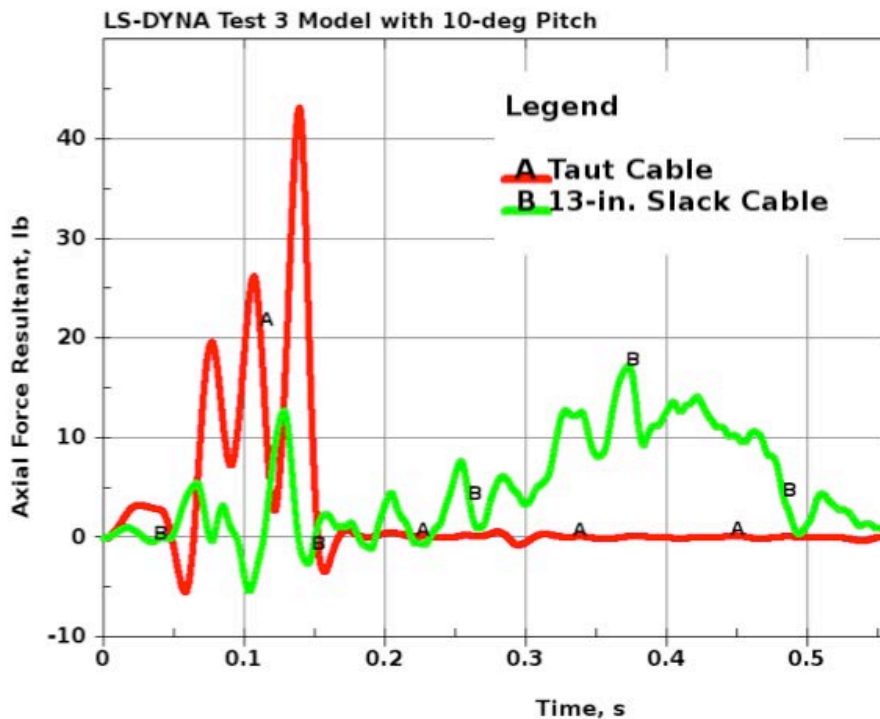
Figure A11. Resultant axial force versus time for the Case 8 model with 10° pitch.
