NASA/TM-2017-219599

Simulating the Impact Response of Three Full-Scale Crash Tests of Cessna 172 Aircraft

Karen E. Jackson
Langley Research Center, Hampton, Virginia

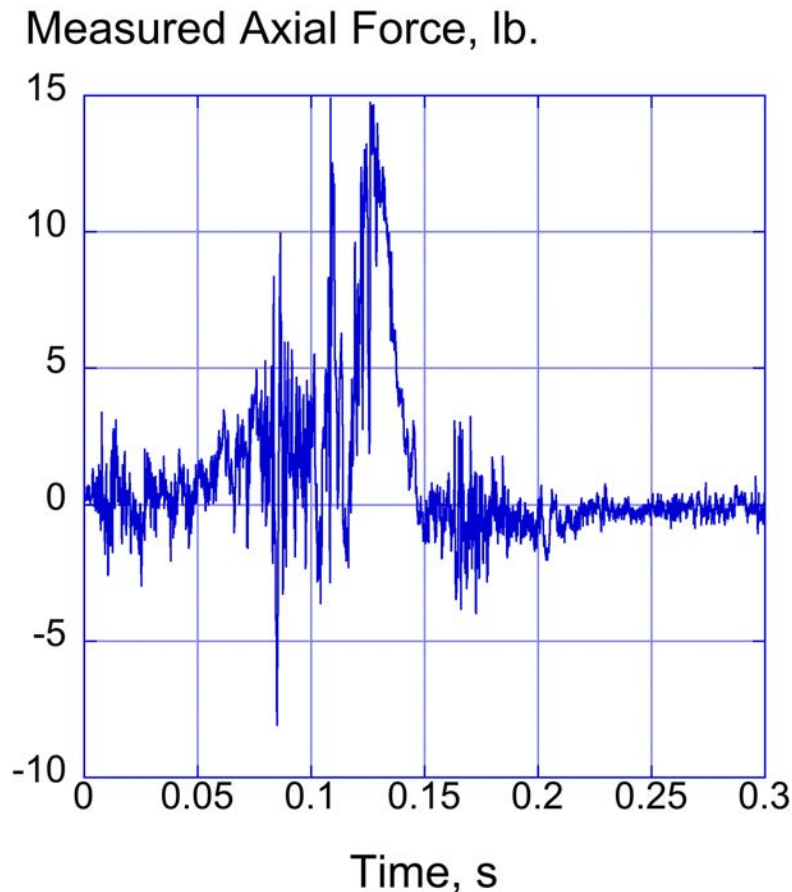
Figure A12. Plot of measured axial force versus time of the Dummy Cable 1 in Test 2.

For comparison purposes only, the measured axial force in Dummy cable 1 from Test 2 is plotted in Figure A12. The force response, which is quite “noisy” is similar in appearance to the responses predicted by the models in Figures A9, A10 and A11, though the magnitude of the test response is lower (15-lb compared with 42-lb). It should be noted that the dummy cable did not fail during the test [4].

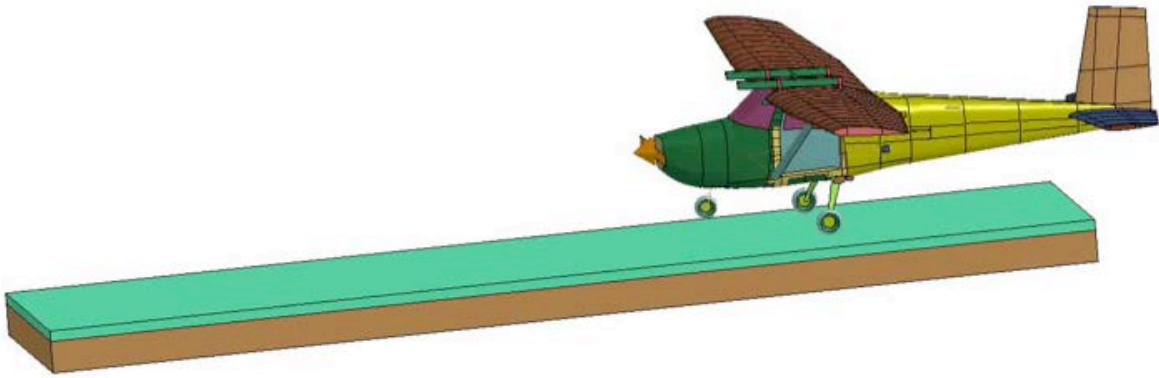
Figure A13. Case 2 simulation representing Test 1 crash impact onto soil.

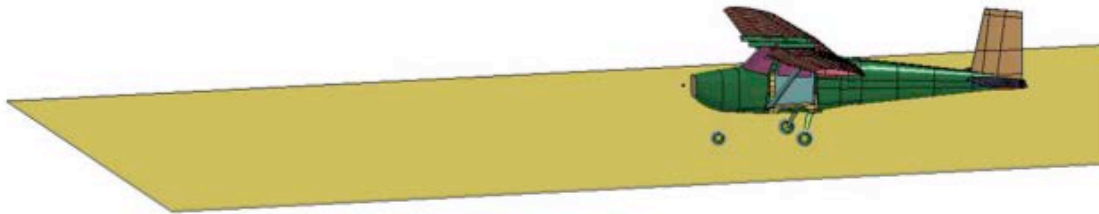
Figure A17. Case 3 model, straight tail aircraft impacting rigid surface at cruise velocity.

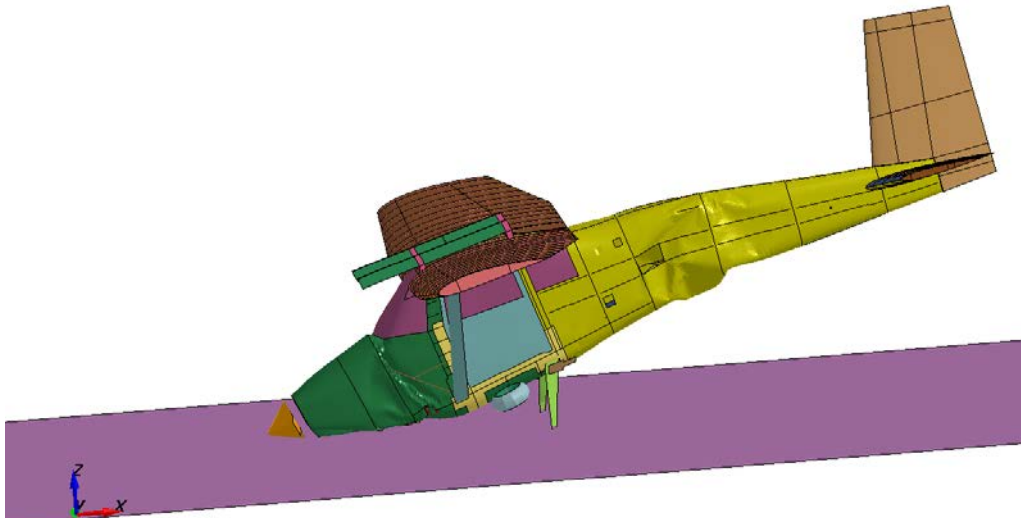
Figure A25. Buckle in tail and wheel axel failure occurring at approximately 0.2 seconds.

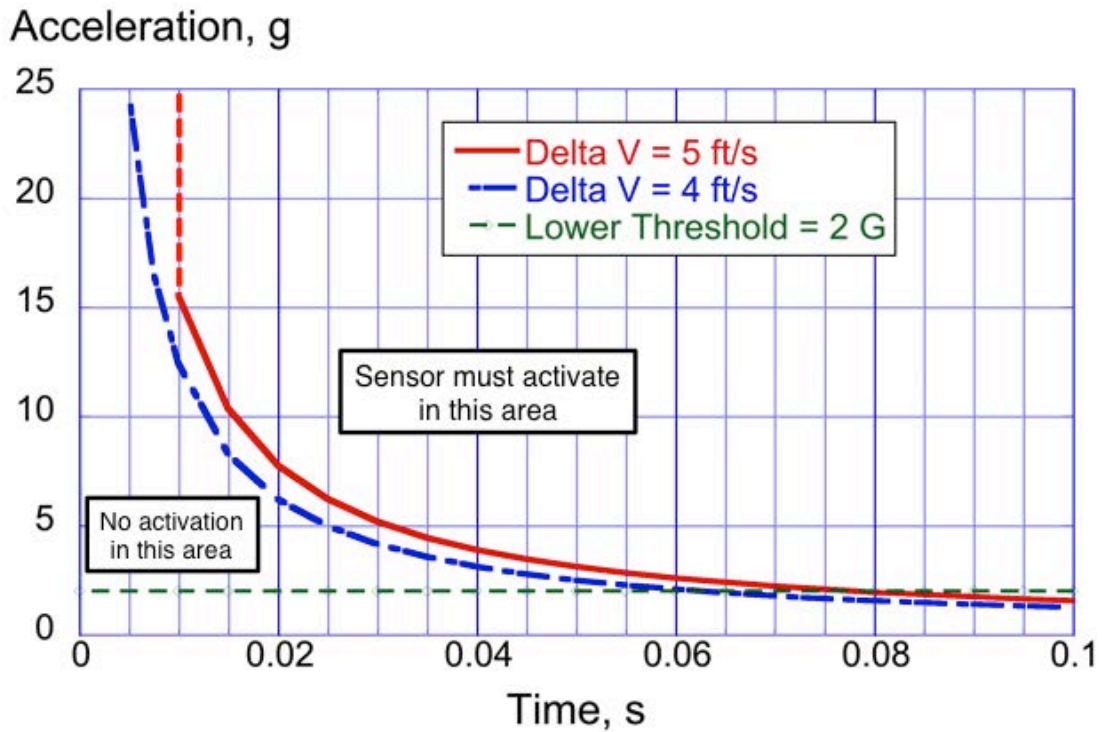
Figure A45. ELT acceleration threshold chart for activation.
