## **Characterizing GEO Titan IIIC Transtage Fragmentations using Ground-based and Telescopic Measurements**

### **Abstract**

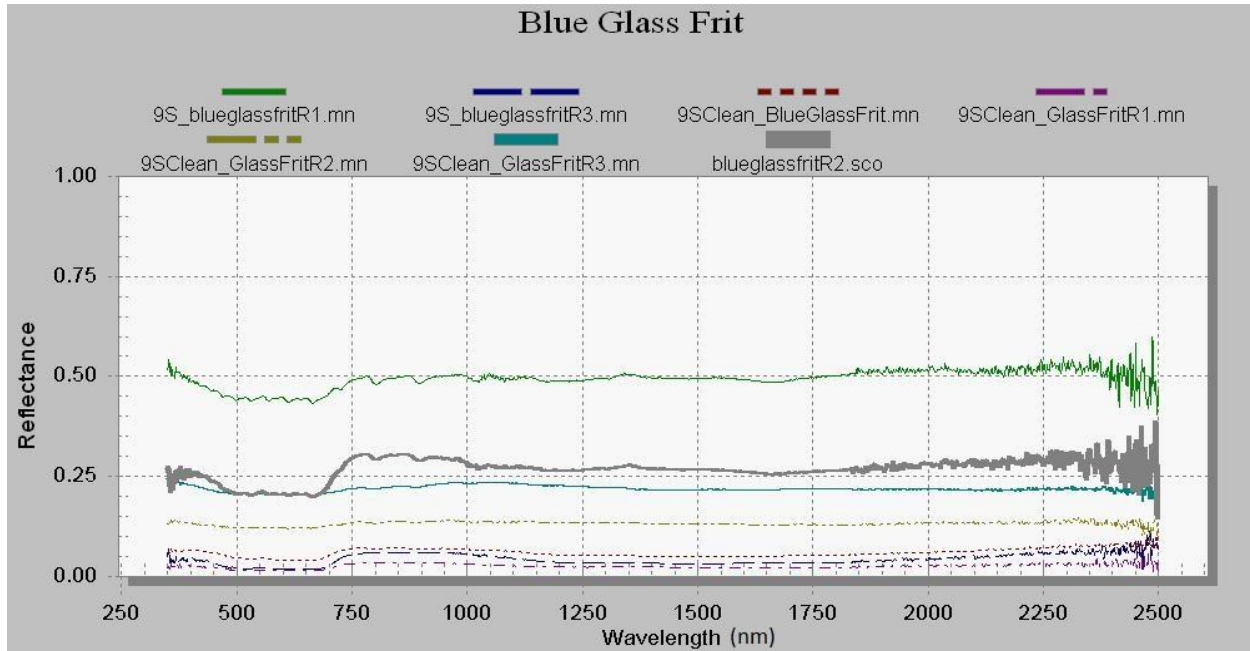
Fig. 8. Reflectance spectra of blue glass frit specimens superimposed with similar glass frit materials taken from unclean and clean test article surfaces. The data labeled “blueglassfritR2.sco” belongs to an unclean surface spectral reading.

The first set of analyzed spectral data to be presented focuses on blue glass frit located on the test article’s engine bell, shown in Fig. 8. Spectral readings obtained from the test article’s glass frit surfaces were all acquired after transport to NASA JSC’s B9S. The data acquired during the initial measurement campaign exhibit greater evidence of blue

color absorption features than their cleaned counterparts did. The data labeled “blueglassfritR2.sco” is the only spectra data that was taken where a mean statistic was unable to be acquired. This single measurement shows a deep (wide) absorption feature starting near 300 nm and ending close to 750 nm. Reflectance curves exhibit relatively flat spectral curves past the visible region (~800 nm), best correlated to the presence of metallic elements within the composition, due to a moly-disilicide coating integrated with the glass frit on the test article. No indication of organic presence resulted from the two data collects involved with glass frit materials taken in B9S.

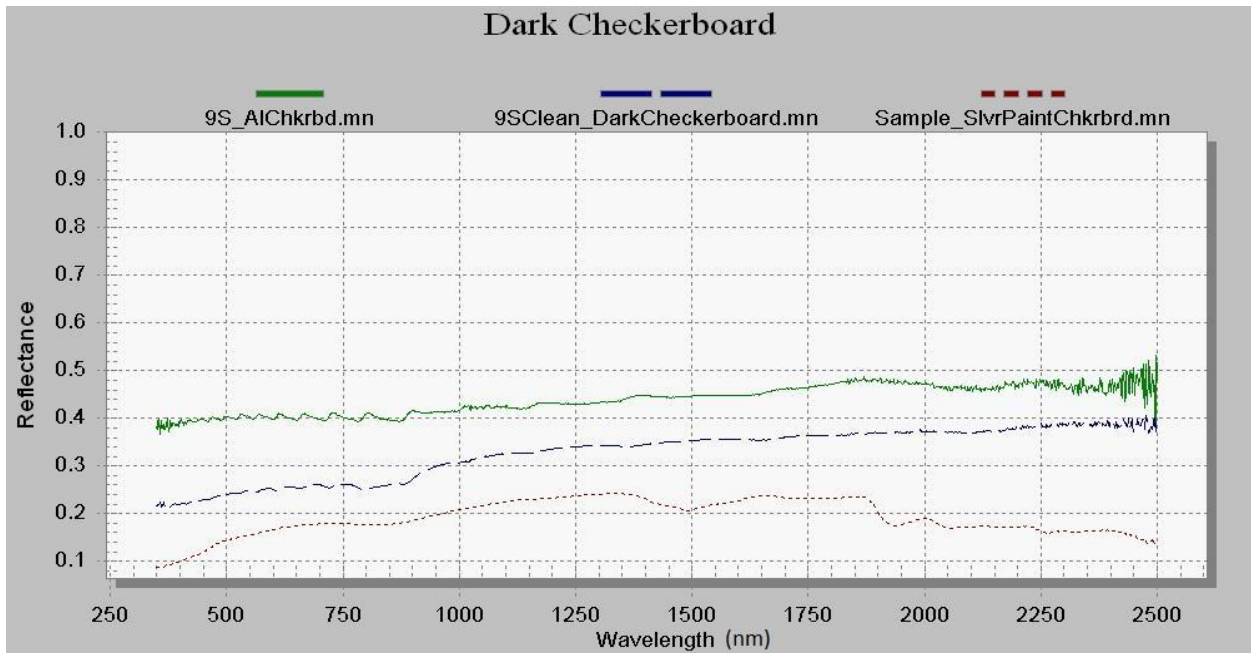
Fig. 9. Reflectance spectra for dark regions located on checkerboard pattern on test article's exterior.

The next set of spectral measurements targeted the unique checkerboard pattern on the test article’s barrel section (refer to Fig. 1). Although the schematic shows 35% iridized aluminum and 63% aluminum silicon paint, the exact material used for the “dark” and “light” checkerboard regions are not well known. Future work may include using inductive coupled plasma mass spectrometry analysis (ICP-MS) to verify the actual composition of checkerboard patterns. The darker checkerboard regions on the test article exhibit a slight aluminum feature at 850 nm common between all three data collects, referred to as “Dark Checkerboard” (Fig. 9). The silver paint checkerboard sample, “Sample\_SlvrPaintChkrbrd.mn” retrieved from AMARG, demonstrates prominent organic features at 1500 nm and ~1930 nm wavelengths that could be due to water (H<sub>2</sub>O) and carbon-hydrogen (C-H) bonds often present in organic material. Counterparts to its dark regions, the test article’s light checkerboard regions, referred to as “Light Checkerboard,” are shown in Fig. 10. The data acquired on the white paint checkerboard sample recovered from the AMARG initial inspection titled “Sample\_WhitePaintChkrbrd.mn” exhibits slight organic features, similar to the dark checkerboard sample titled “Sample\_SlvrPaintChkrbrd.mn” shown in Fig. 9.

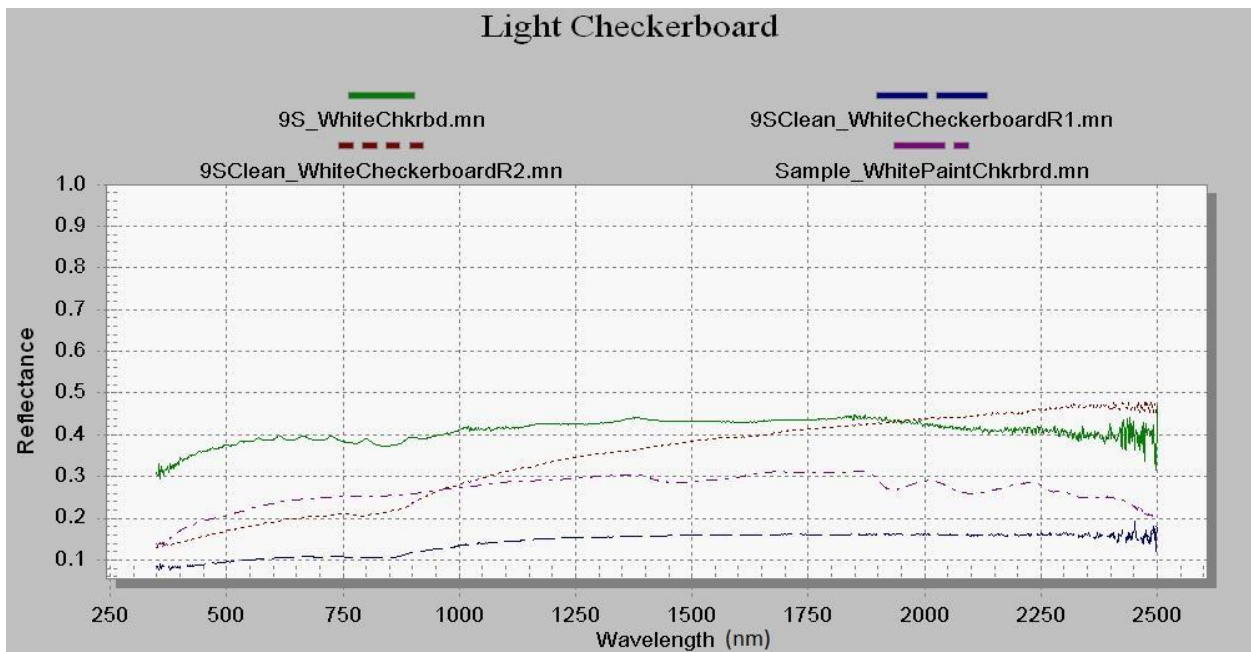
Fig. 10. Reflectance spectra for light regions located on checkerboard pattern on test article's exterior.

The checkerboard barrel section samples of the test article retrieved from AMARG, both dark and light checkerboard regions, were removed through the use of standard sandpaper. The analysts did remove the bias from the sandpaper spectra response; however, organic features existing on the retrieved samples' curves could be a result of contamination from the sandpaper utilized, whereas these organic results are unseen on spectra obtained from the clean and unclean test article (Fig. 9 and Fig. 10). Therefore, surfaces on the test article in both the "as received" and cleaned conditions display aluminum features while showing no indication of organics present for their respective spectra.

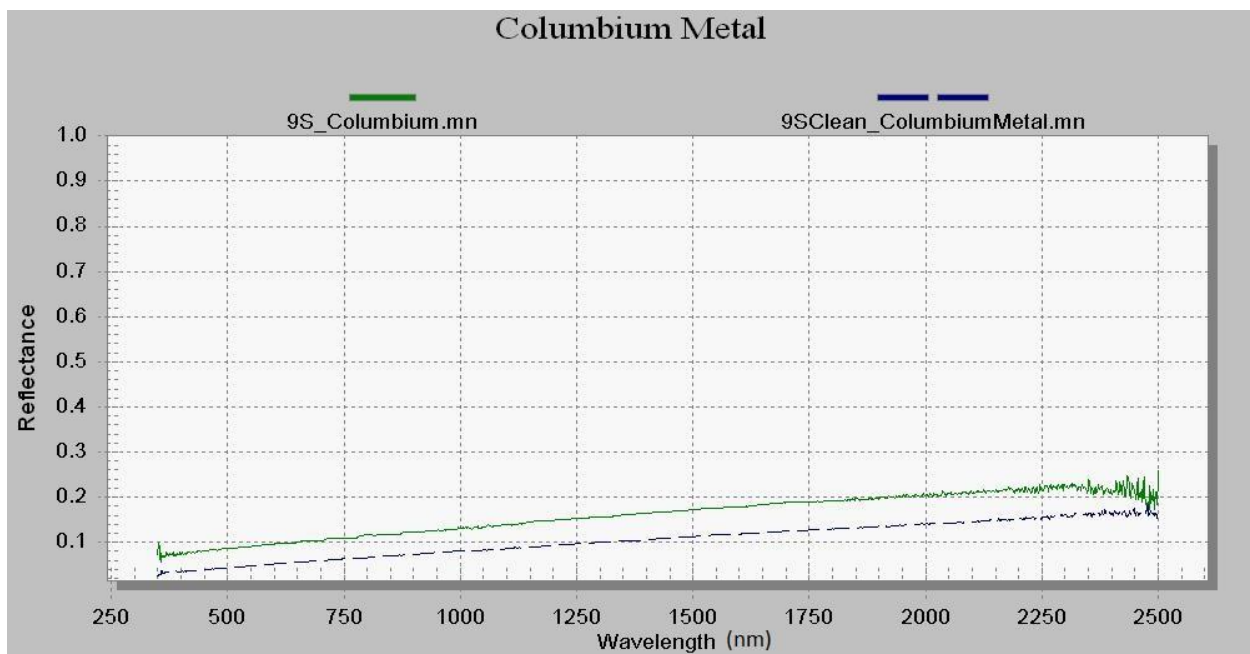
Fig. 11. Reflectance spectra taken on “as received” and clean surfaces of Cb-related metal on the test article in B9S.

Fig. 11 represents spectra taken from the test article's engine bells with focus on the exposed Columbium (Cb) that would be underlying the blue glass frit. No samples could be removed during the AMARG visit, thus data presented will be only for measurements acquired post-transport to NASA JSC. The spectra in Fig. 11 are representative of metallic materials (non-organic), noting the increase in slope into the short wave infrared wavelengths (> 1100 nm). The uncleaned and cleaned test article surface data sets are consistent with each other, presenting curves low in reflectance (<10% or 0.1) with a continuous increase in slope (near 20% or 0.2). The absence of any organic or aluminum absorption features in the obtained spectra is consistent with our knowledge of Cb. A literature review into reflectance properties for pure Cb, also known as Niobium (Nb), showed an evident absorption feature present at approximately 350 nm with an increasing slope, as noted in the test article spectral data [Error! Reference source not found.]. The lack of this feature near 350 nm is presumably because the material used for the test article was C103 Cb alloy [7, 8]. Similar to the above-mentioned checkerboard pattern materials, future work may include using ICP-MS to verify the true composition of the Cb alloy.

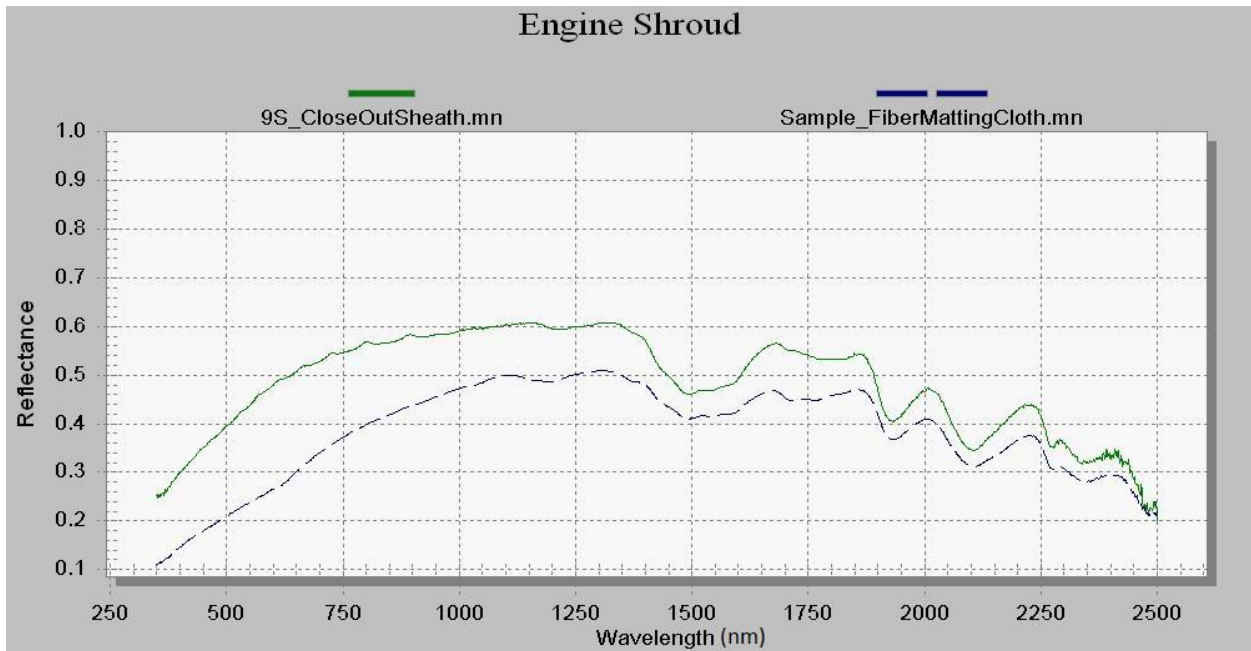
Fig. 12. Reflectance spectra of engine shroud found aft of the test article barrel section.

Spectra taken on the various materials shown in Fig. 12 are in reference to the test article's engine shroud. This test article material was not cleaned during the post-cleaning campaign because of its fragile state after exposure to harsh environments during storage at AMARG. The fiber matting cloth sample from AMARG and the uncleaned test article close out panel/thermal shield readings demonstrate curves most comparable to one another; however, all three spectra data collects show a presence of organic elements within these materials. The absorption features near 1400 and 1900 nm indicates an H<sub>2</sub>O feature and the absorption features centered at 2100 and 2300 nm indicate a C-H bond. The wide bandgap at 1500 nm likely is due to the close out/shield cloth material.

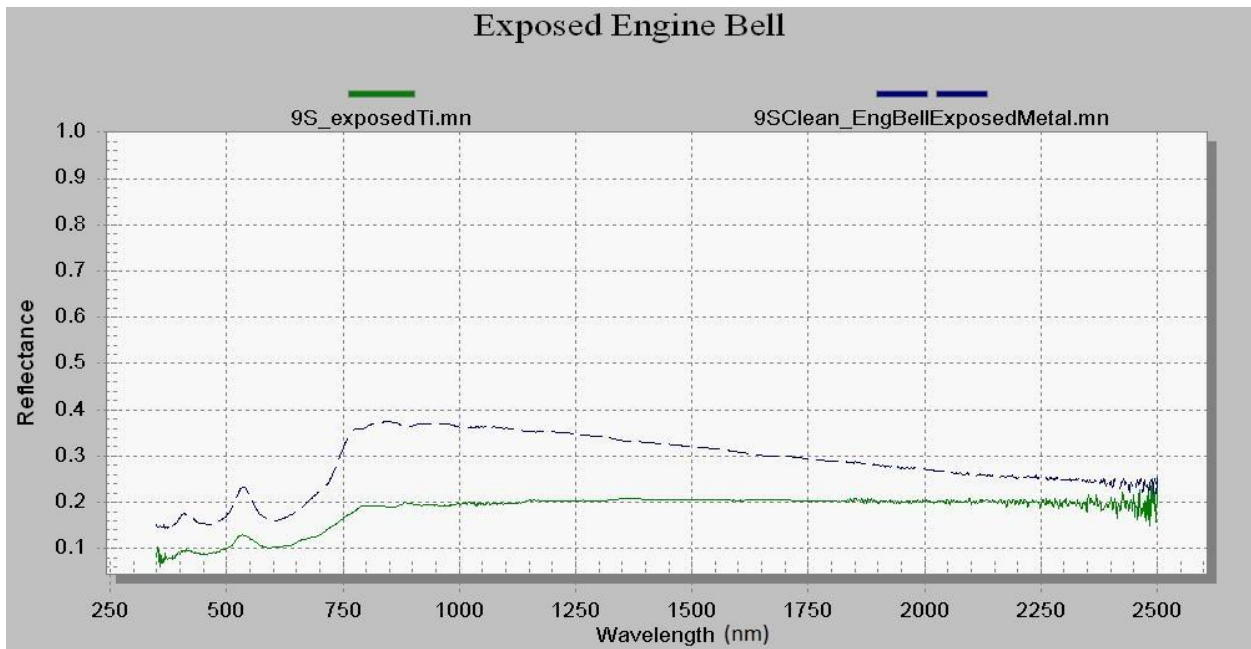
Fig. 13. Reflectance spectra corresponding to exposed engine bell on the test article in B9S.  
No sample data acquired.

Spectral readings obtained on the unclean and cleaned exposed engine bell surfaces of the test article, shown in Fig. 13, indicate color absorption features (perhaps due to green paint and the yellow, non-flight primer paint) that were used on the aft extension of the engine bell. Also noted is the lack of an aluminum feature and a flat reflectivity response from 750 -2500 nm indicative of a metal, probably titanium. The exact composition of this material can be analyzed with further research as mentioned previously with the checkerboard pattern surface materials and Cb.

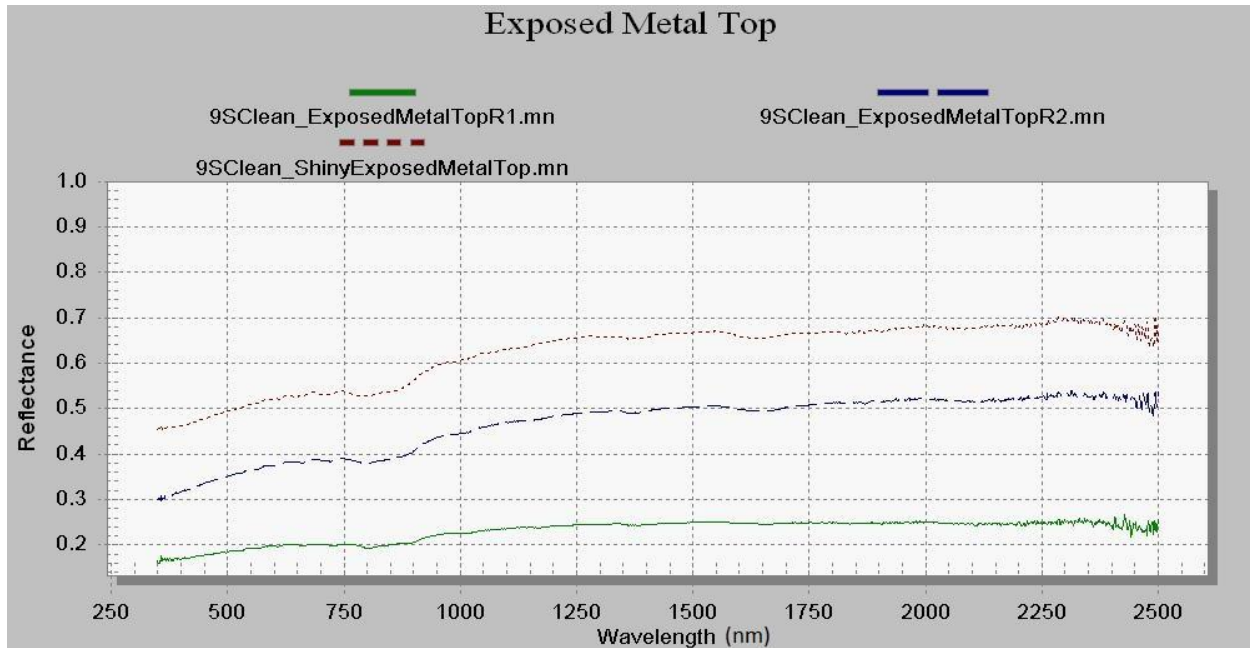
Fig. 14. Reflectance spectra taken from cleaned test article in B9S for material characterization of bare barrel surface.

In Fig. 14, reflectance spectra from the test article's exposed metal on the top of the barrel (as seen from the ground in B9S) were only collected post-transport to NASA JSC, but the prior data collects taken during the pre-clean measurement campaign at NASA JSC offered insufficient results for a comparison standpoint. Although reflectance varies between the spectral data analysis for the bare metal top, it can be determined that the material mainly consists of aluminum with common occurrences in absorption at 850 nm.

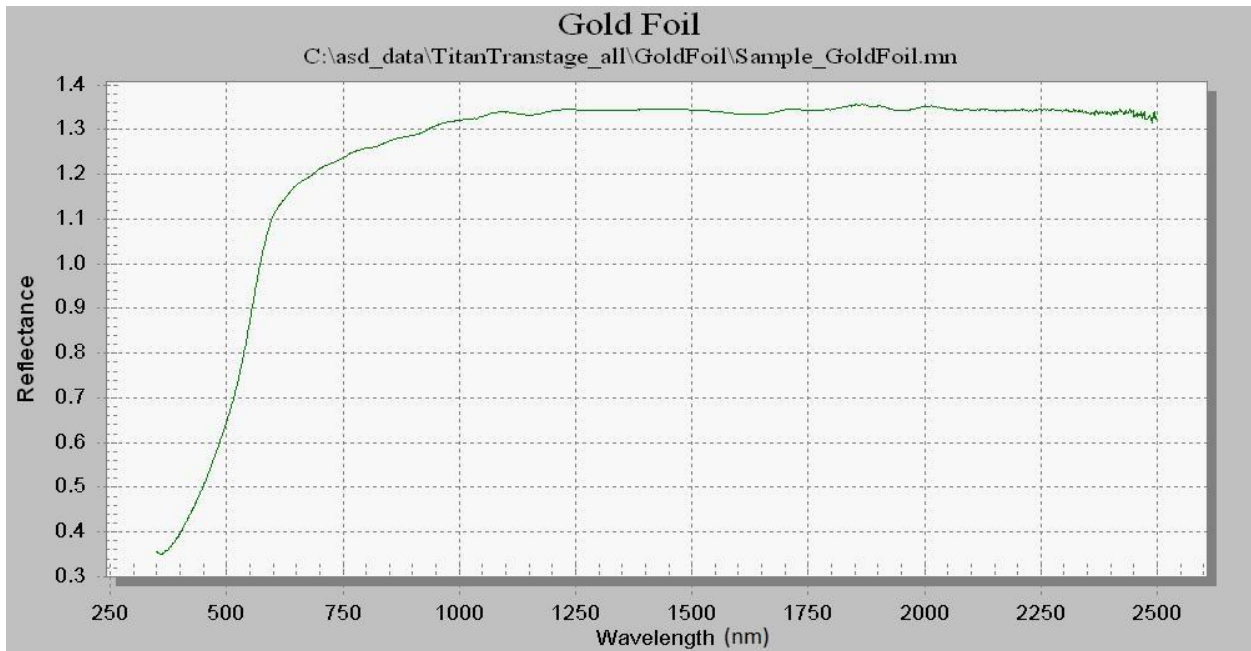
Fig. 15. Reflectance spectrum for gold foil samples taken from the test article at AMARG.

Similar to the circumstances with the engine shroud material, measurements and analysis of the gold foil located on the test article's oxidizer tank were conducted only on the samples retrieved from AMARG; however, it still has features of interest to evaluate. In Fig. 15, the spectra plot depicts a clearly evident gold/yellow color band gap between 350-600 nm with minor organic traits present at 1150 nm and 1950 nm wavelengths. Often, foil is composed of aluminum coated in oxides to enhance corrosion resistance [9]. If the test article's gold foil has these typical properties, then it can be inferred that this is responsible for the organic spectral results. The spectrum pertaining to the gold foil reaches above 100% reflectance, suggesting that the laboratory instrument was saturating due to its inability to accept such increased specular reflections.

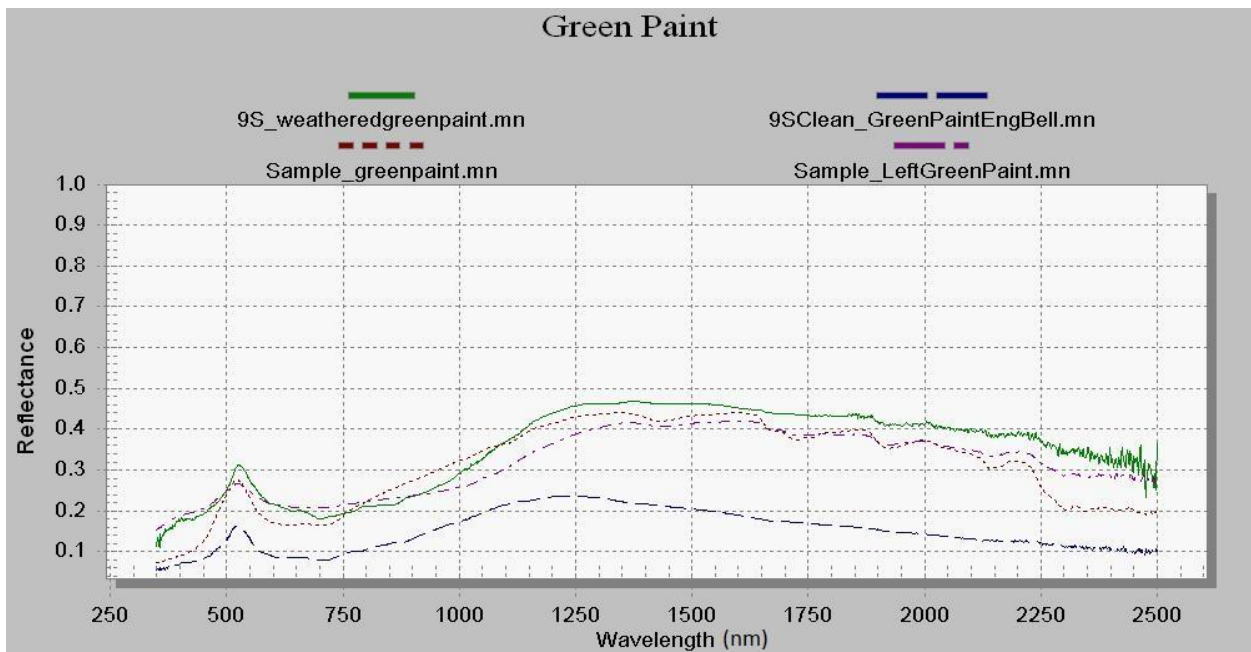
Fig. 16. Reflectance spectra for various green paint regions present on the test article's exterior engine bell.

Spectral readings acquired from all three data collects involving green paint on the engine bell of the test article demonstrate prominent green color band gap traits in existence at approximately 500 nm (Fig. 16) and slight organic features revealed in all materials, excluding the green paint taken from the cleaned surface designated as "9SClean\_GreenPaintEngineBell.mn." The green paint overlays the engine bell as a coating, raising the possibility that the cleaning removed some paint oxidation remnant, thus minimizing the organic features from the engine bell's spectrum and making it inconsistent with previous spectral results.

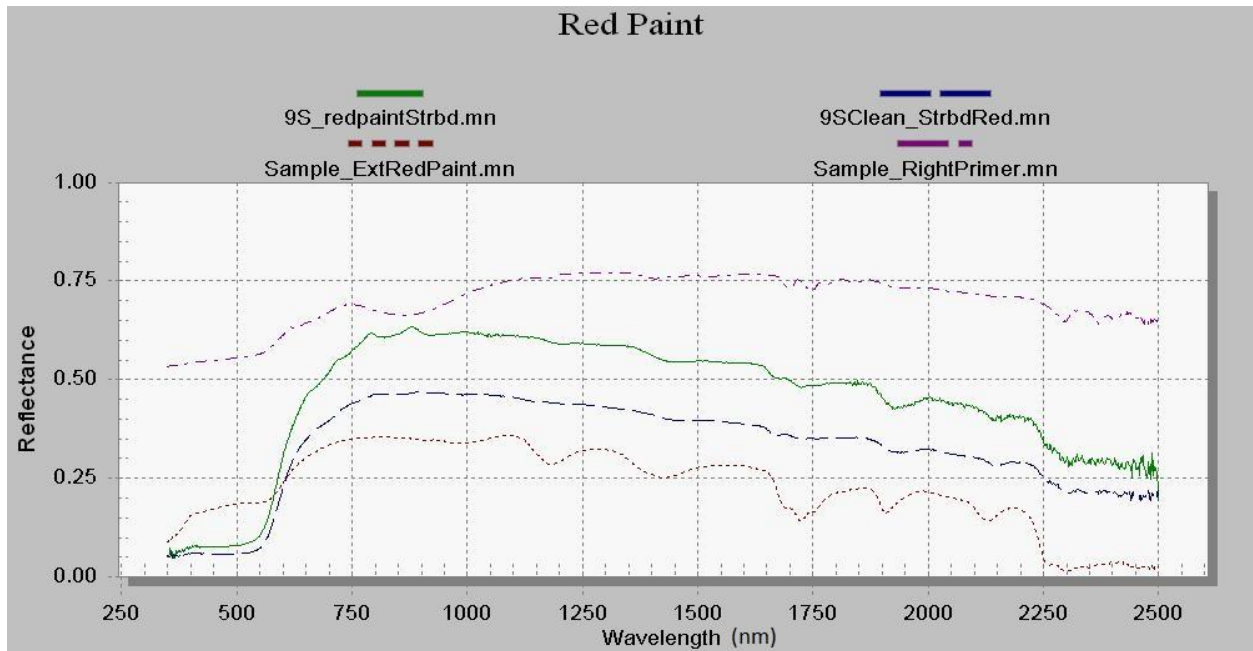
Fig. 17. Reflectance spectra for red paint on various exterior regions of the test article.

The spectral measurements acquired on the red-pigmented paint located at various locations (internal and external) on the test article were examined, as shown in Fig. 17. The red colored paint bandgap is present near 550-600 nm for all material readings, with the right primer sample, "Sample\_RightPrimer.mn," recovered from the test article at AMARG showing the highest reflectivity (>50%) in comparison to all other red paint measurements. Again, the right primer sample is unlike its associates due to its exhibition of aluminum presence with an absorption occurrence at 850 nm. The measurements acquired on the red paint from the exterior surfaces suggest the same primer probably was not used for the exterior and interior surfaces of the test article.

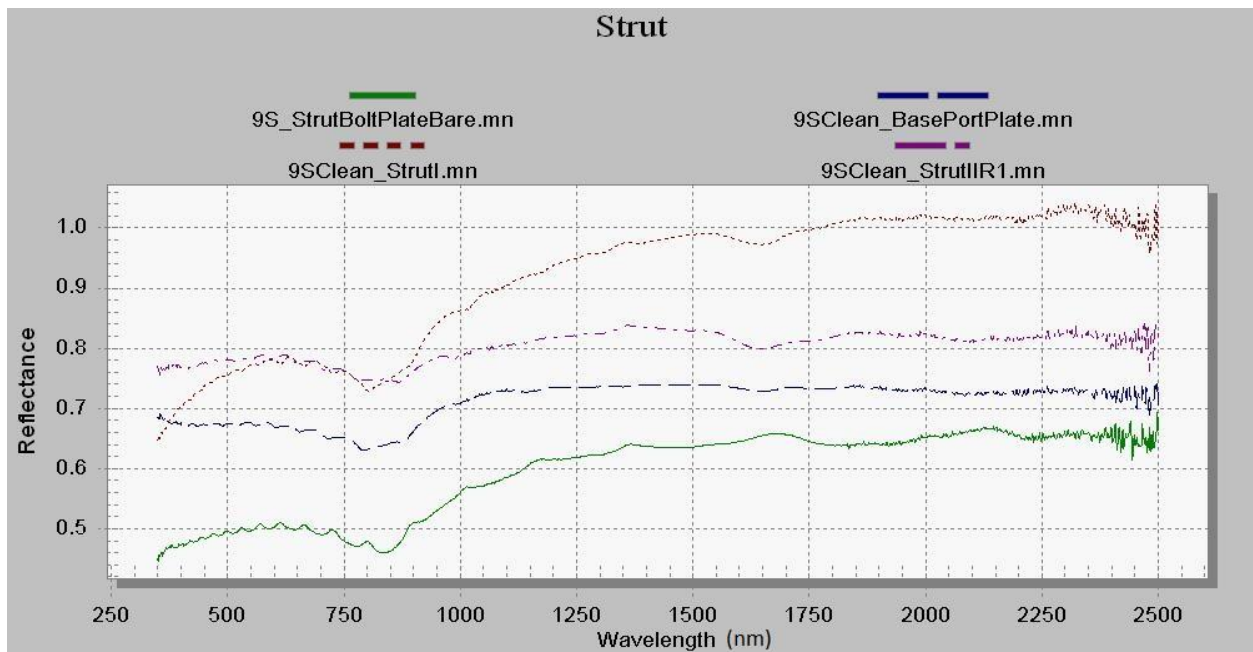
Fig. 18. Reflectance spectra taken on “as received” and clean surfaces of the test article in B9S.

Reflectance spectra data taken on the struts, located at the aft of the test article’s barrel within the fuel tank and engine bell volume, were only done post-transport to NASA JSC; thus, the cleaned and uncleaned surfaces are presented in (Fig. 18). The spectra data acquired from all measurements shows the presence of aluminum near 850 nm. The feature near 1650 nm is similar to absorption features found on spacecraft metals that use a specific coating for the harsh environment of space.

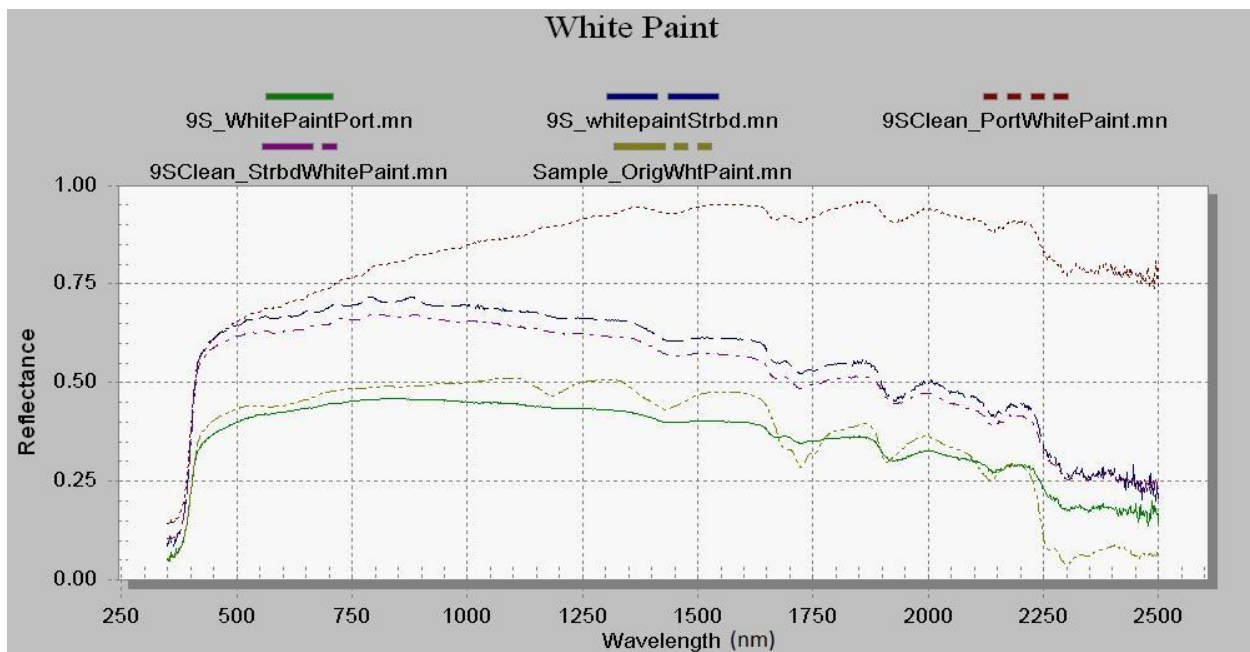
Fig.19. Reflectance spectra corresponding to various regions of white paint present on surfaces of the test article.

In Fig.19 spectral data of white paint found on the exterior of the test article is shown. The consistency between the multiple white paint spectral readings is sufficient, presenting apparent white band gaps at approximately 400 nm followed by organic features beyond 1100 nm, most likely due to the test article's respective paint properties. The white paint sample, "Sample\_OrigWhtPaint.mn," showed equal reflectivity measurements as that of the "9S\_WhitePaintPort.mn" data. The cleaning process significantly increased the reflectance properties for the "9SClean\_PortWhitePaint.mn" sample, although minimal effects were seen with the white paint samples taken from the starboard side. Paints often utilize H<sub>2</sub>O as a solvent, and O-H\C-H bonds are found in paint binders, which are used to secure pigment and therefore take on polymeric properties [10]. These molecular bonds, or any additional organics discovered within their respective paint compositions, presumably could be responsible for the absorption features beyond 1000 nm for blue, green, red, and white paints. These, as discussed previously, were examined for further material characterization of the test article. Preliminary analysis indicated the paint sampled from the port and starboard sides was not consistent, and the sample acquired from AMARG is consistent with the starboard side of the test article.

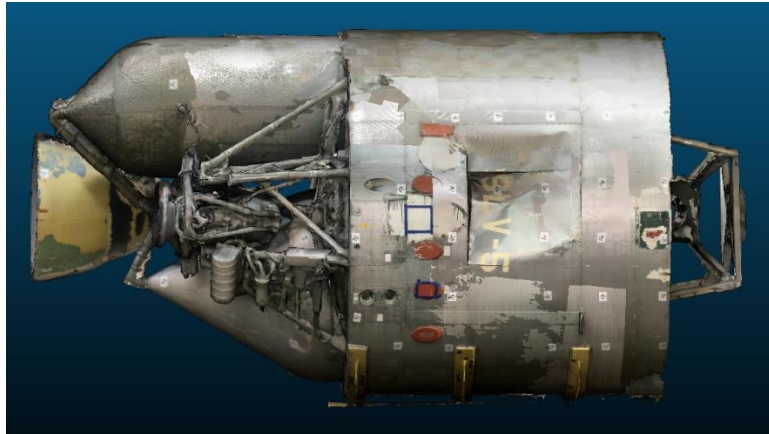
Fig. 20. LIDAR digital overlay of the test article

To better characterize the test article for future research, a scale model will be made in a size that will be used for OMC lightcurve signature analysis. A secondary goal is to generate a 3-D point cloud from a scan of the entire test article and then use software codes to test theoretical explosion/fragmentation events based on hydrocode analysis of known targets. To meet these requirements, the Image Science and Analysis Group (ISAG) at NASA JSC provided support via a handheld LIDAR system mounted on an iPad Air 2 [11, 12]. Because the test article was much larger than the LIDAR's intended use, the team collected approximately 60 scans and images, which they ordered topologically to ensure completeness in the scanning collection. The instrumentation created a 3-D point cloud with a digital overlay as shown in Fig. 20 and Fig. 21.

The LIDAR data presented in this document is only part of Phase I of this project. Phase II will include removing artifacts (such as the damaged side of the barrel shown in Fig. 20 and Fig. 21), as well as incorporating authentic components of the Titan IIIC Transtage that were not found on the test article. The LIDAR data from Phase II will be used to create 3-D printed articles for analysis at the NASA JSC OMC. The scaled Titan IIIC Transtage will be mounted on a 6-degree-of-freedom robotic arm to characterize the reflective properties from an intact Transtage using bidirectional reflectance distribution measurements. Using the OMC measurements and analysis of an intact Transtage can provide insight into observed properties-specifically determining the uniqueness of the fragmentation events alongside an historical survey of orbital information data to characterize the fragmentation events. Secondly, the LIDAR data will provide a surface overlap 3-D point cloud that can be used for hydrocode analysis, providing a complex, non-asymmetric rocket body, to better understand potential causes of failure for the Titan IIIC Transtage breakup events.

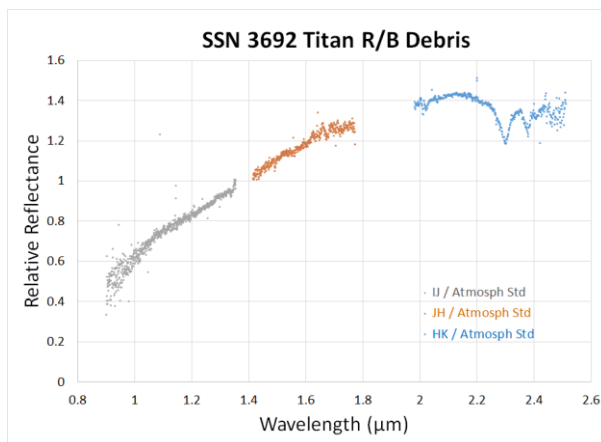
Fig. 23. UKIRT spectra of SSN 3692

The United Kingdom Infrared Telescope (UKIRT) was also used to collect spectral measurements of fragmentation debris associated with the Titan IIC Transtage breakups. A subset of spectral data on focused targets, generally the fragments with the larger radar cross sections, is presented below. International Designator 1969-013B, SSN #3692 is a rocket body from a Titan IIC Transtage 2014 fragmentation event; see Fig. 23 [14]. International Designator 1976-023J, SSN #8832 is mission-related debris, an apparently intact object (not fragmented debris) associated with the deployment of the mission’s payload in GEO, shown in Fig. 24 [14]. The increase in slope shown in both spectral plots is consistent with silicon features found in spacecraft paints and silicon-based solar cells; noting that because no solar cells are associated with the Titan Transtage IIC target, the most likely correlation is paint. A more diverse collection of ground-based measurements, including visible and infrared, with multiple observations of the same target would be required to provide better insight into the surface material(s) observed in respect to Titan Transtage fragments and associated debris (rocket bodies and mission related).
