Failure Simulation Testing of the Z-1 Spacesuit Titanium Bearing Assemblies

Richard C de Baca¹ and Alfredo Juarez²
*NASA Test and Evaluation Contract, NASA Johnson Space Center
White Sands Test Facility, Las Cruces, NM 88004*

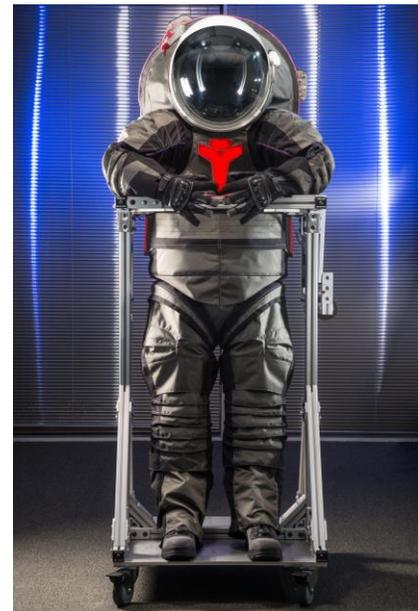
Figure 1. Z-2 Space Suit

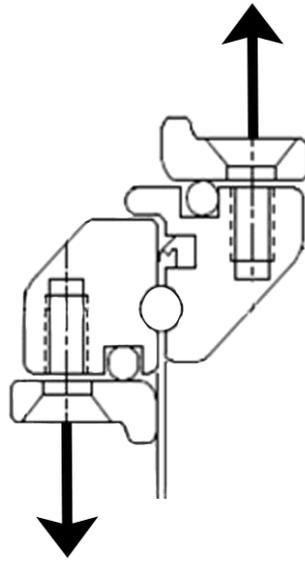
Figure 2. Hip Bearing Cross Section with Load Indication Arrows

Three titanium bearing assemblies representing the hip bearing, the scye (shoulder) bearing, and the waist bearing were tested. Each of the bearings' ring and race elements were fabricated using titanium alloy Ti-6AL-4V, the same alloy used in the bearing materials from the previous tests conducted in the 1990s. As a comparison these early tests did not utilize actual bearings for most of these tests but rather a gothic arch with a sliding pin assembly to simulate non-rolling ball bearings. Cross sections for each bearing assembly used in the tests described in this paper are shown in Figures 2 through 4. Note that while the figures show the lip and environmental seals, the actual bearing assemblies tested did not have them installed. This simulated a compromised seal(s) and the whole assembly was placed in the enriched oxygen environment during test.

The ball bearings were in an alternating configuration between 440C stainless steel balls and Vespel[®] balls to reduce friction. The balls and race were lubricated with Braycote[®] 814Z during use and would be protected from external particulate by two environmental seals. However, environmental seals and lip seals were removed for this test series to simulate the worst-case seal leak. All three bearings were of similar construction, each using identical materials, with dimensional variations to accommodate the unique load case based on the anatomical placement of the bearings in the suit. All bearings tested have been used for manned suit testing in atmospheric conditions.⁶ Prior to test the bearings were cleaned, lubricated, and the condition of the bearings documented.

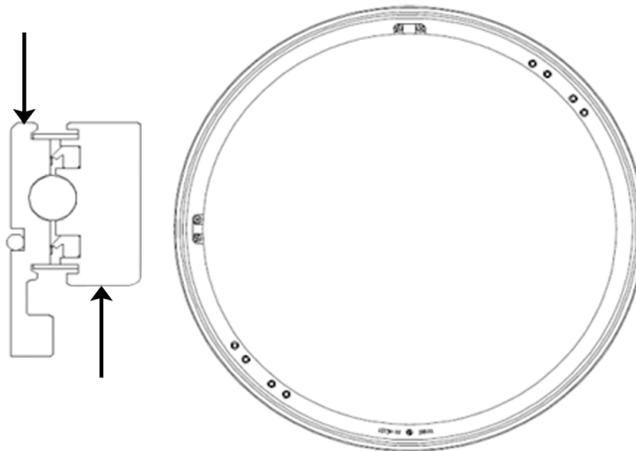
Figure 3. Scye Bearing Cross Section with Load Indication Arrows

The scye bearing used a detailed mounting configuration at specified locations to better simulate actual load conditions applied by the spacesuit. The configuration also needed to place the bearing inside a “scye carrier” which contacts the bearing on its shoulder (where upper load arrow is shown in figure 3) and is held in place by pressure when installed in the actual suit. Thus, the loading directions are different than those in the hip and waist bearings. This also allowed for adequate attachment points to the test apparatus while being robust enough to sustain the test-specified thrust load. The inner race was attached to a stationary load plate via two spacers 180 degrees apart. The outer race was rotated in this configuration and is held via scye carrier and attached by four brackets spaced 90 degrees apart. Insulators were installed between the bearing and the fixture to slow thermal soak to the test apparatus. A diagram of this test setup is shown in Figure 8. Figure 9 shows the pretest installation.

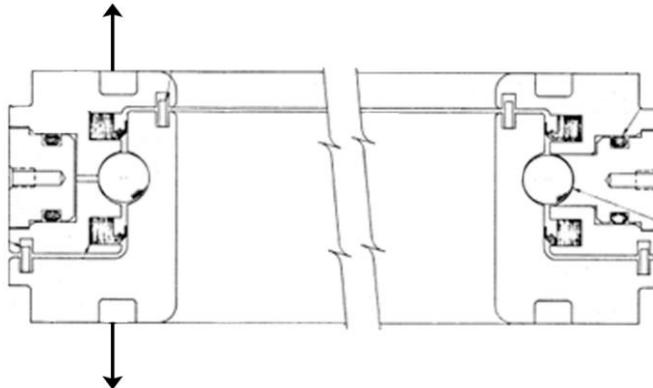
Figure 4. Waist Bearing Cross Section with Load Indication Arrows

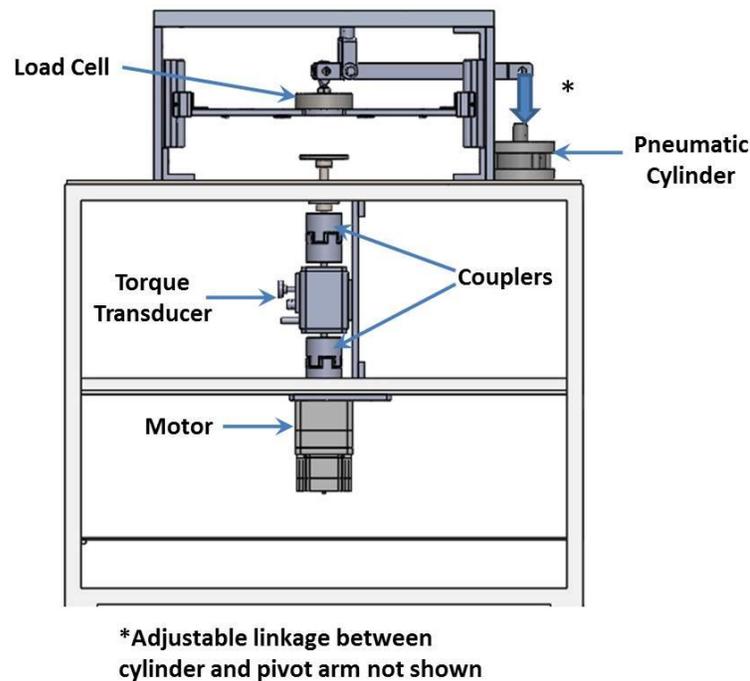
The test apparatus was installed in the 287 ft³ (8.1 m³) flammability chamber located in the WSTF oxygen test area (Figure 5). The chamber was filled with +99 percent oxygen, at 12.4 psia (85.5 kPa), as the test atmosphere.

Figure 5. Test Apparatus

A test apparatus was developed to rotate the bearing while simultaneously applying the tensile load. An electric, brushless, direct current (DC) stepper motor was used to rotate one race of the test bearing assembly; the other race of the bearing assembly attached to the load cell plate located above the bearing assembly. A pneumatic cylinder was used to apply a tensile load normal to the bearing assembly plane of rotation. The pressure was supplied to the cylinder by a nitrogen k-bottle connected to a regulator. The load was applied through a pivot arm attached to the cylinder; the pivot lifts a ball end rod attached directly to the Omega LCHD-4K load cell. The load cell was mounted to a plate that attaches to the inner or outer race of the bearing assembly. The GSE 2220 torque transducer was coupled to the motor on one side and flanged shaft on the other. A mounting plate attached the bearing assembly to the flanged shaft. Five thermocouples, mounted on the inner diameter of the bearings, provided temperature data. By the design of the test, the load applied to the test articles could not exceed 150 ±20 percent of the maximum test load. To prevent overload, a nitrogen bottle with the pressure equivalent to exert 150 percent maximum load with the air cylinder and linkage was used for each test. Three fixture configurations were used for this test to simulate load cases specific to each bearing assembly.

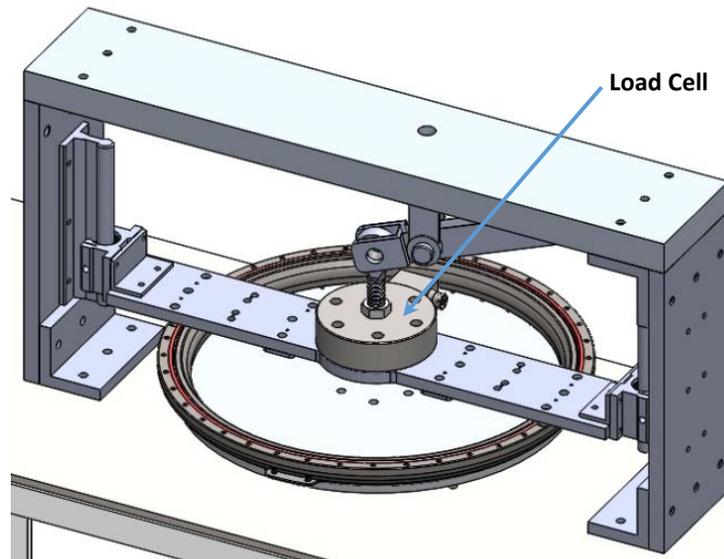
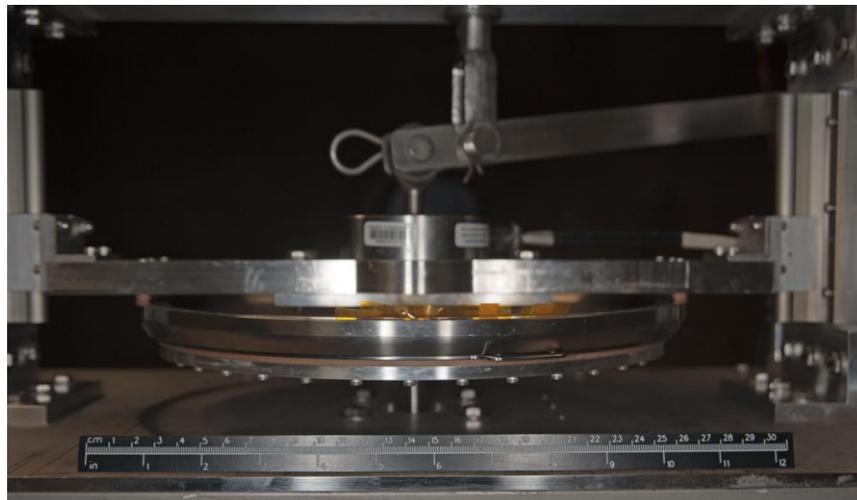
The hip bearing was mounted to a plate to distribute the load evenly across the entire brief side of the bearing and from two points 180 degrees apart (utilizing three screws per side) on the leg side of the bearing. The load path for the bearing when installed in the suit is across all screws fairly equally on the brief side of the bearing, but through only the axial brackets on the hip side. This best simulates the end use configuration of the bearing. Insulators were installed between the bearing and test fixture to slow thermal soak to the test apparatus. The inner race was rotated in this configuration. The hip bearing fixture is shown in Figures 6 and 7.

Figure 6. Hip Test Configuration

Figure 7. Hip Posttest Photo

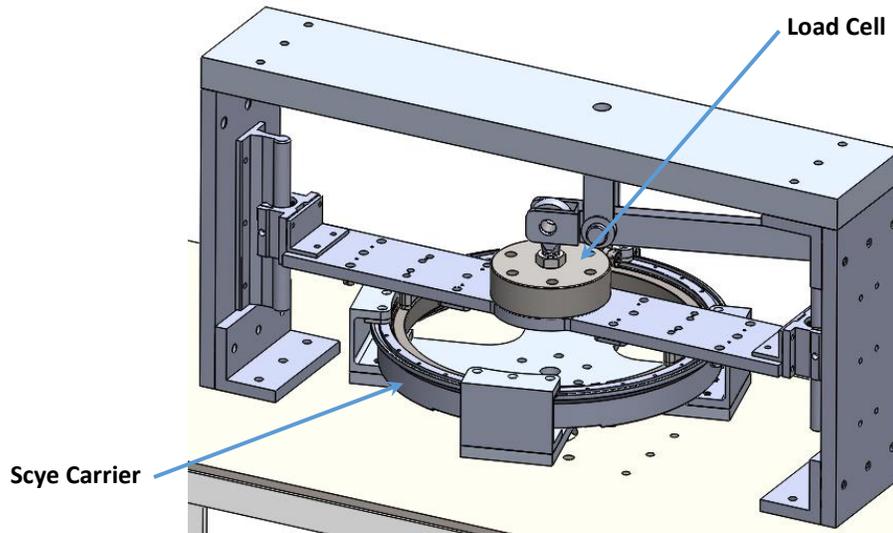
Figure 8. Scye Test Configuration

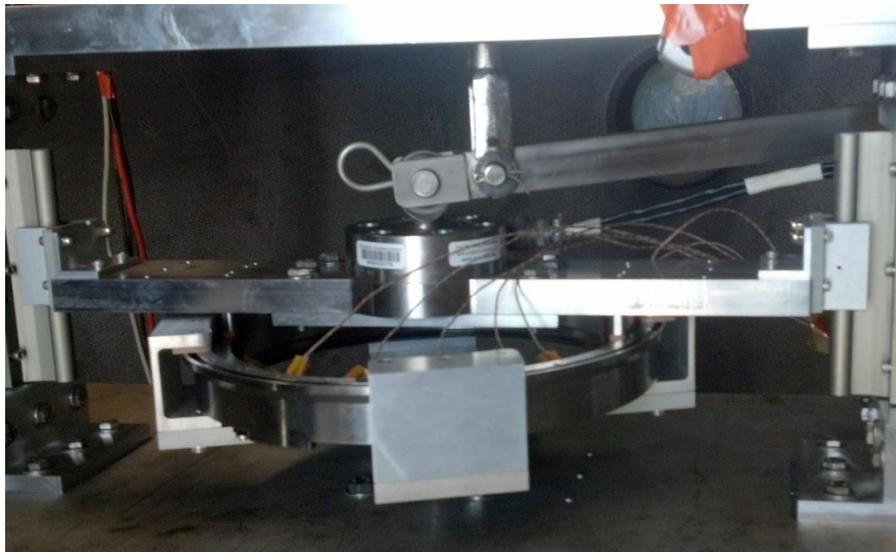
Figure 9. Scye Test Pretest Installation

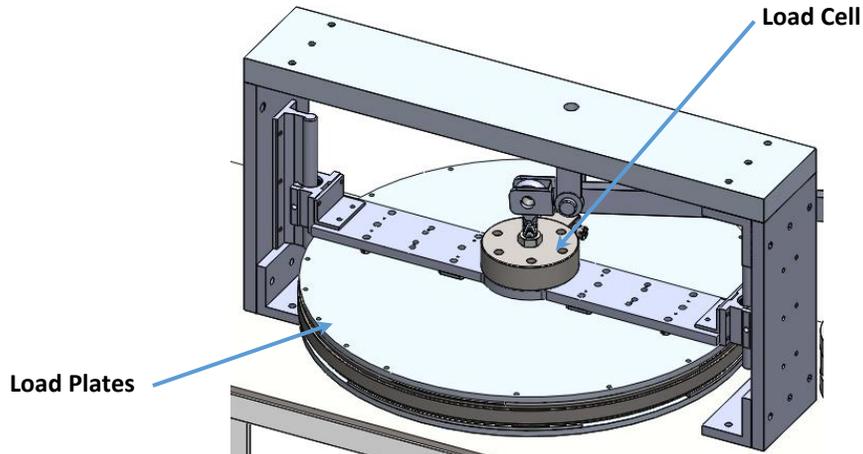
The waist bearing was mounted to plates to distribute the load evenly across both sides of the bearing. When the bearing is installed in an actual suit this load case is consistent with the load path in the suit as the bearing is expected to be bolted to a hard upper torso and sizing elements below it. Insulators were installed between the bearing and test fixture to slow thermal soak to the test apparatus. Figure 10 shows the waist bearing test configuration.

Figure 10. Waist Test Configuration

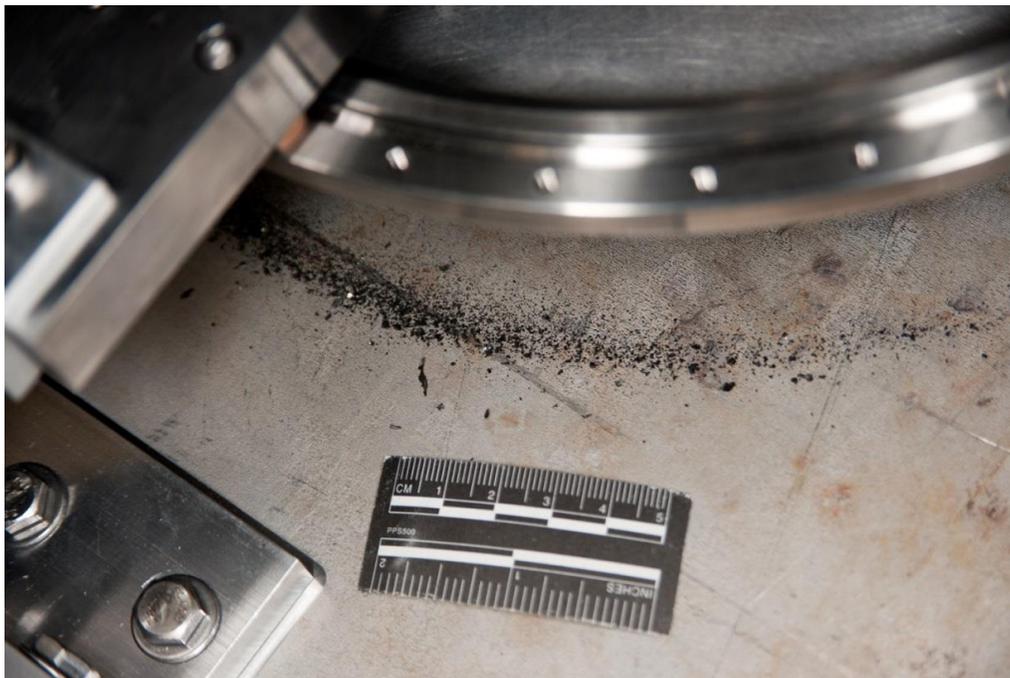
No visual indications of sparking occurred over the 96-h (193,920 cycles) test duration; however, the bearing's actuation torque increased significantly and decreasing of the mechanical performance was observed. An audible "ratcheting" sound was noted by the test team near conclusion of the test, and rotational resistance was observed. The initial torque reading was 50 inch-pounds (in-lb) (5.649 Newton-meters (N·m)) and remained steady until ~45 h, then began to increase. The final torque reading was ~200 in-lb (22.59 N·m) for Phase I. Maximum bearing/ambient temperature differences of up to ~12 °F (6.7 °C) were observed and the bearing temperature remained above ambient temperature throughout the entire test. Phase II ran immediately following Phase I testing. Torque readings resumed at about 200 in-lb (22.59 N·m) for Phase II. Posttest inspection revealed debris on the fixture table resulting from the frictional wear of the bearings (Figure 11). Raw data plots for hip bearing Phases I and II are in Figure 12.

Figure 11. Debris on Table Posttest

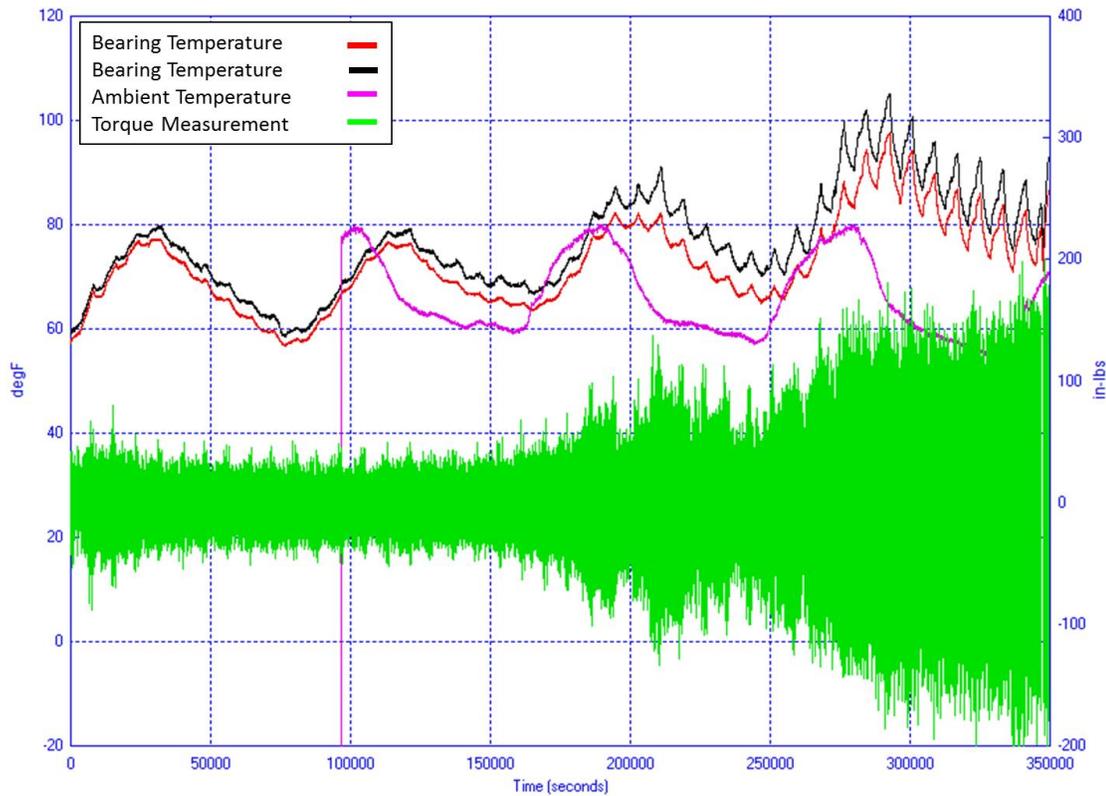
Figure 12. Hip Bearing Phase I and II

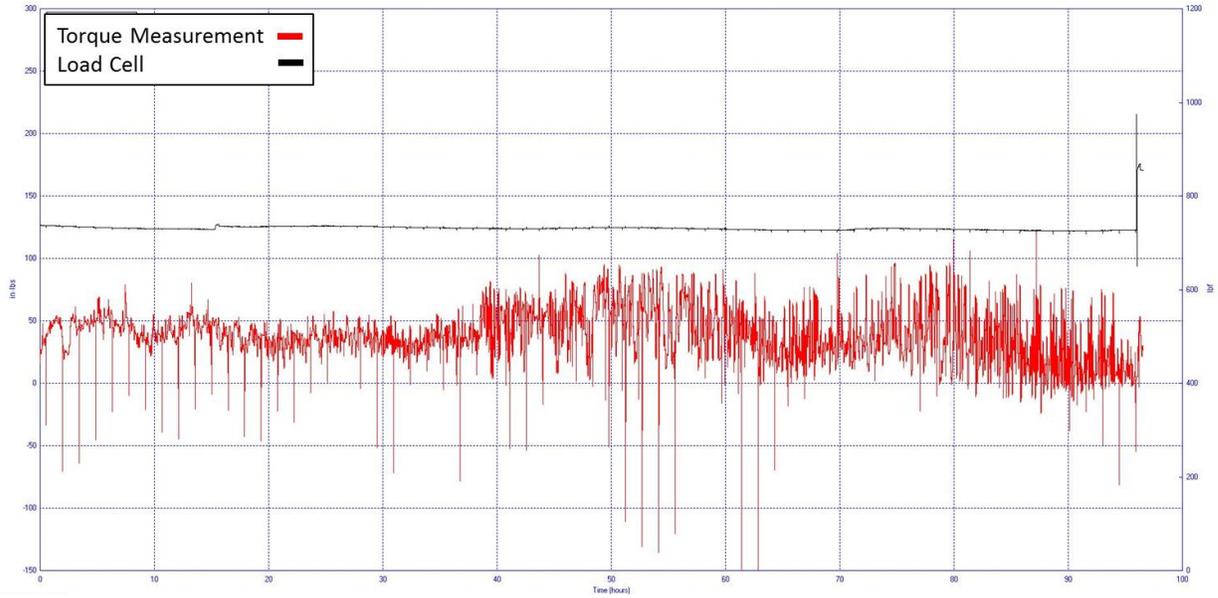
No visual indications of sparking, in the form of burning metal particulate ejecta, occurred over the 96-h (1920 cycles) test duration. Phase II was performed immediately following Phase I testing. Temperature increases were not significant and remained steady throughout the test. Torque readings, however, were found to be inconsistent (Figure 13). The torque data exhibited hysteresis during the 3-min pauses between cycles and held the last value measured instead of returning to zero as expected. It was also suspected that the sample rate was not fast enough to fully characterize the 135 degrees/second rotation event. Posttest the torque transducer was removed and calibration was validated. The results revealed the torque transducer was operating correctly and no significant change in performance was noted when compared to the previous calibration. One possibility for the torque anomaly could be that when the bearing was loaded into the test fixture a slight axial load was applied through the torque transducer, which skewed the resting torque reading. This was determined to be a reasonable scenario after review of the installed bearing and test fixture interfaces. Special care would be taken in subsequent tests to load the bearing before couplers were tightened.

Due to the abrupt stop and change in direction during cycling, a mechanical ringing sound was observed and oscillations were recorded in the torque data. No debris was present on the test fixture table posttest.

Figure 13. Scye Bearing Phase I and II

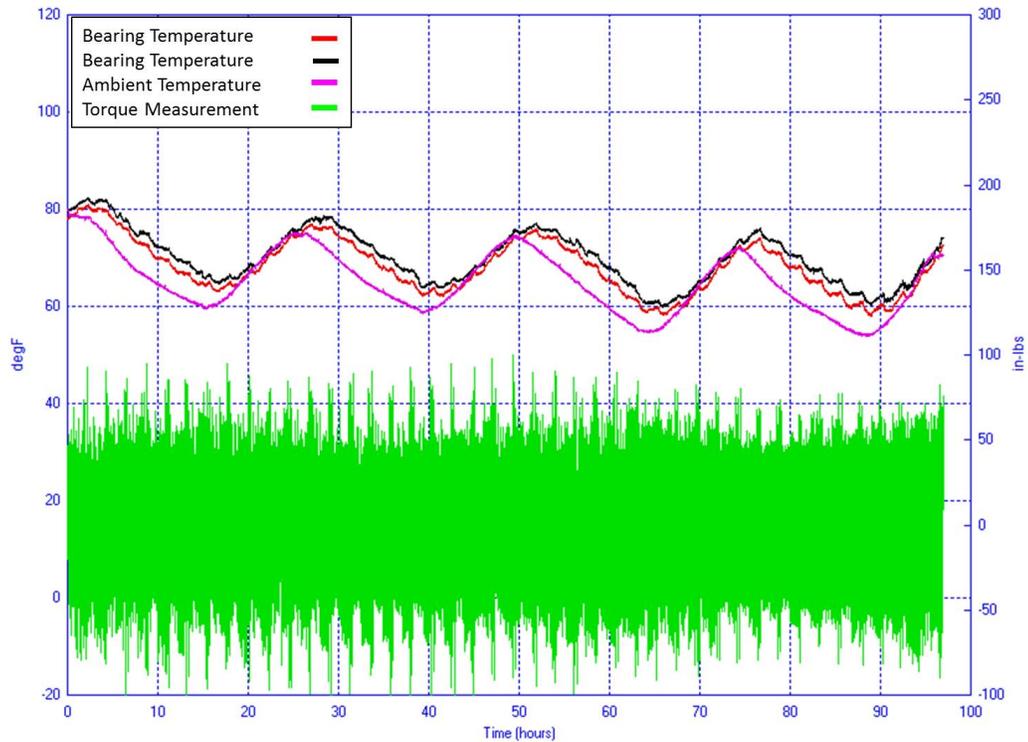
Due to the configuration of the test bearing design (unlike the scye and hip), the bearing balls are not visible; however, video of the outer race was still observed during the test with no indication of spark being observed over the 96-h (193,920 cycles) test duration. An increase in torque was observed over the duration of the test.

Initial torque reading was between 60 to 70 in-lb (6.78 to 7.91 N·m) while running the 20-cycles/min and 40-cycles/min profiles. While running the 52 cycle/min profile, the measured torque was around 100 in-lb (11.3 N·m). The torque values remained consistent throughout the test. Phase II ran immediately following Phase I testing and torque values measured around 90 in-lb (10.16 N·m). No debris indicating mechanical breakdown due to friction was found posttest. Raw data plots for waist bearing Phases I and II can be seen in Figure 14.

Figure 14. Waist Bearing Phase I and II
