NASA/CR-2017-219668

# Hybrid Wing Body Multi-Bay Test Article Analysis and Assembly Final Report

*Alexander Velicki, Krishna Hoffman, Kim A. Linton, Jaime Baraja,  
Hsi-Yung T. Wu and Patrick Thrash  
The Boeing Company, Huntington Beach, California*

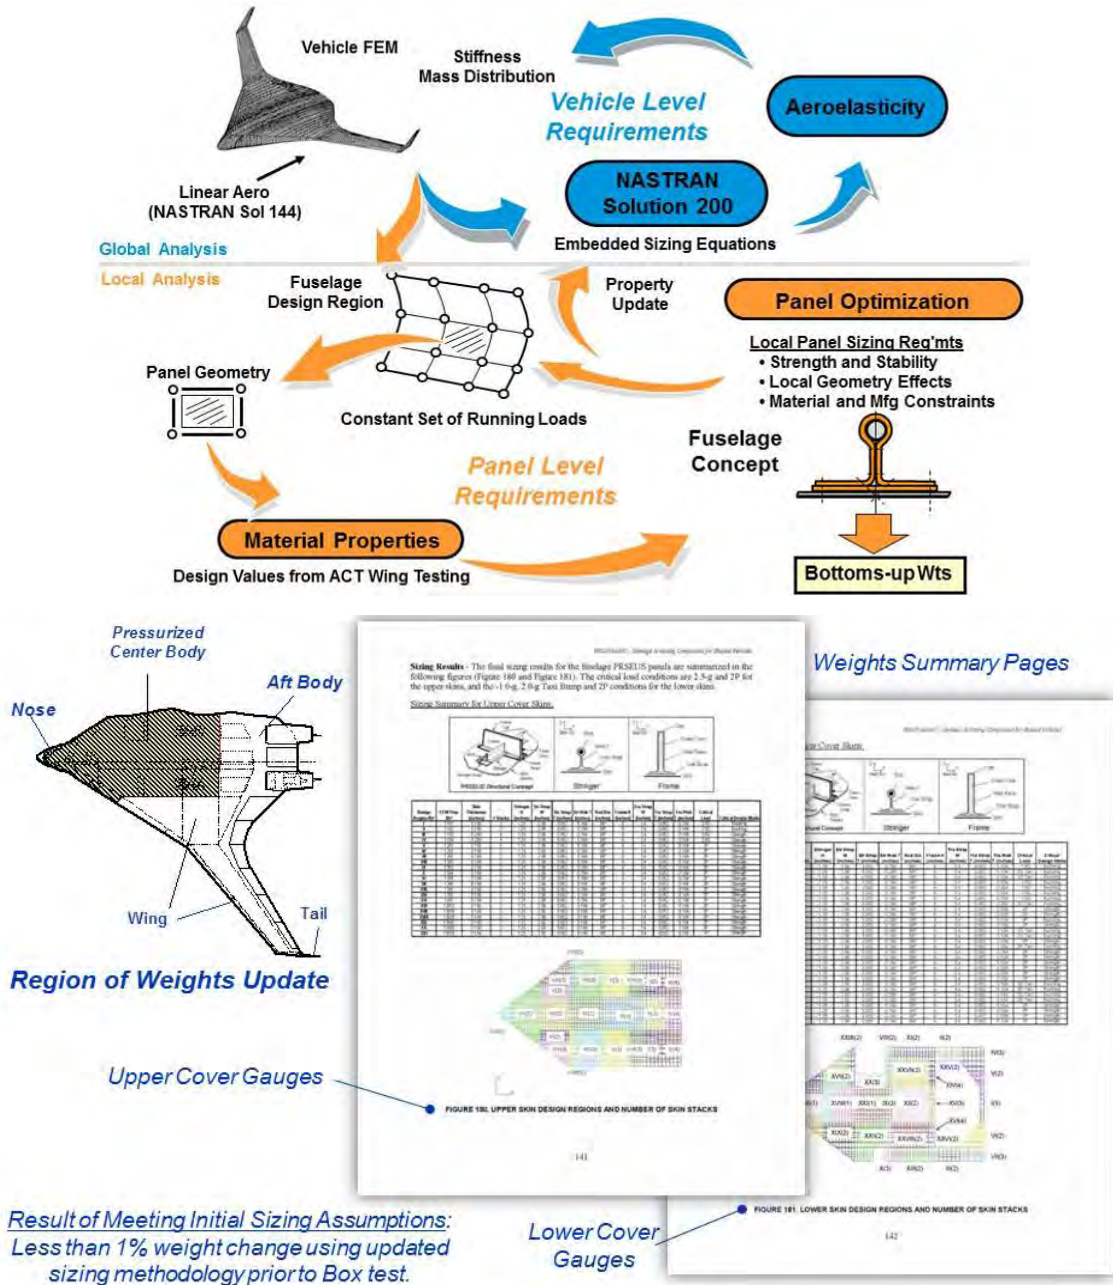
Figure 2-11. Summary of FEM-based Trade Study Structural Weights

In conjunction with the detail design for the MBB, results of the vehicle-level trade studies (Figure 2-11) (Ref. 2-1) were used to establish the critical load cases as well as calculate the running loads that would be imparted on the MBB Finite Element Model (FEM). It was important to preserve the analytical linkage between the vehicle and MBB FEMs so that the eventual test results could be correlated back to an airframe weight or sizing assumption that would quantify the relative success of the testing.

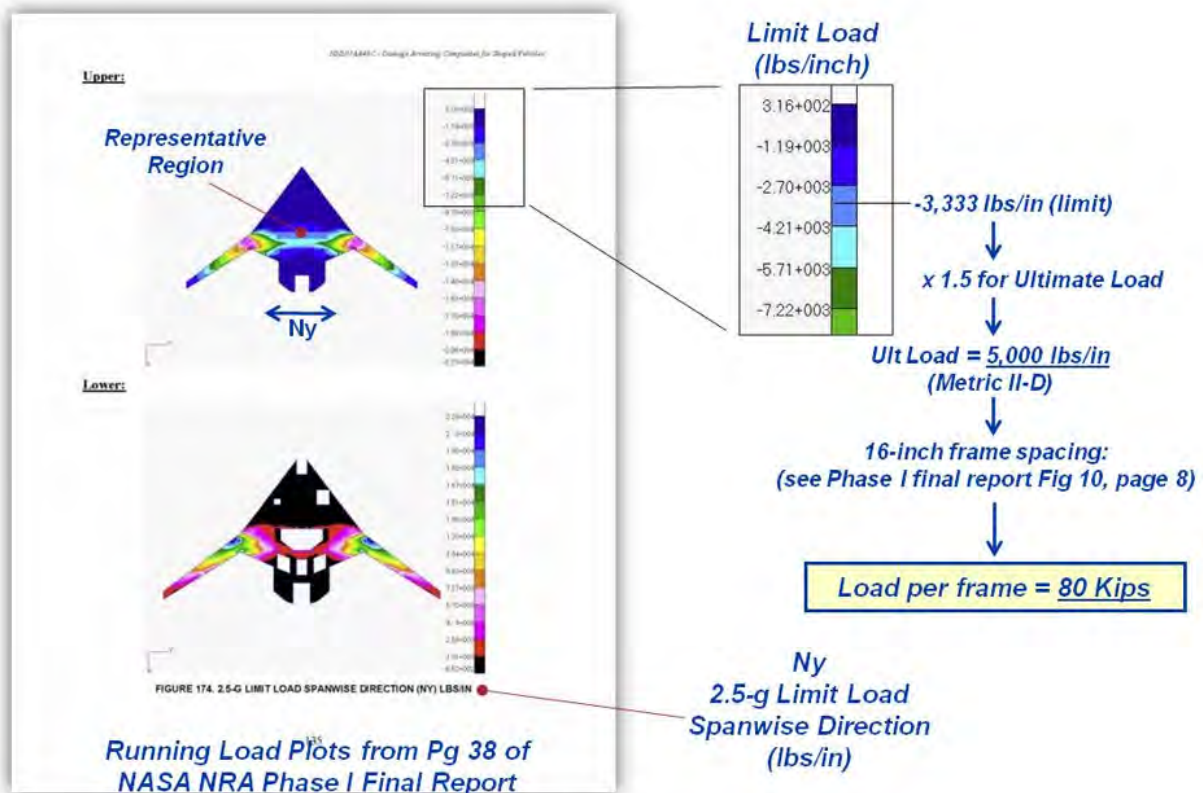
**Figure 4-13. HWB Design Ultimate Running Load Calculation Was Based on 2.5-g Load Case**

Load cases for the MBB analysis were determined by the optimization and sizing performed under contract NNL07AA48C (Refs. 2-1, 2-2). Of the 14 load cases used in the vehicle sizing trades, the most critical five were used in this study. These cases were the 2P pressure condition, the 2.5-g and -1.0-g maneuver conditions, and the 2.5-g + 1P and -1.0-g + 1P combined loading conditions. Among the five, the 2.5-g load case was shown to be critical on the upper cover of the aft end of the HWB, whereas the -1.0-g load case was critical on the lower cover of the aft end, where the wing bending loads are introduced into the fuselage. The 2P pressure condition was critical for the forward section of the HWB. Demonstrating the effects of the combined loading conditions was of particular interest because high stresses were expected on the metallic fittings joining composite panels together. The 2.5-g load case was used to determine the applied running load and the maximum load through the frame, as shown in Figure 4-13. The HWB design ultimate load was 80,000 lb per frame based on the calculation of the 2.5-g load case. Each of these load cases was assessed to determine the critical load case and the final test sequence.

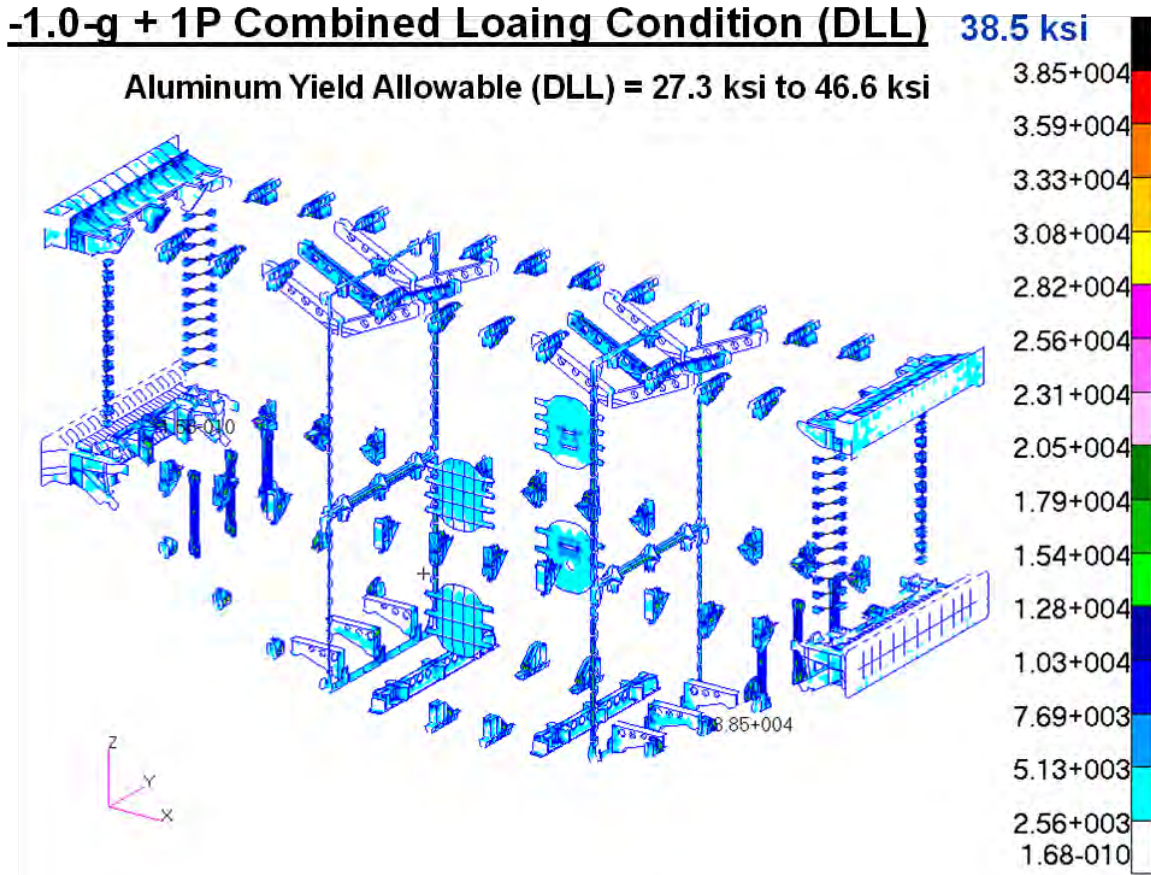
**Figure 4-43. von Mises Stresses on Metallic Fittings in -1.0-g + 1P Condition**

For aluminum fittings, von Mises stresses are plotted in Figure 4-43 for the -1.0-g + 1P combined loading condition. The design values of the aluminum fitting are described in detail in Section 4.2.8. The calculated von Mises stresses on the aluminum fittings were compared with the strength design values of aluminum alloys for margin-of-safety calculations. Positive margins were derived on all metallic fittings of the MBB in the -1.0-g + 1P combined loading condition. Detailed margins of safety for the metallic fittings are summarized in Section 4.2.9.

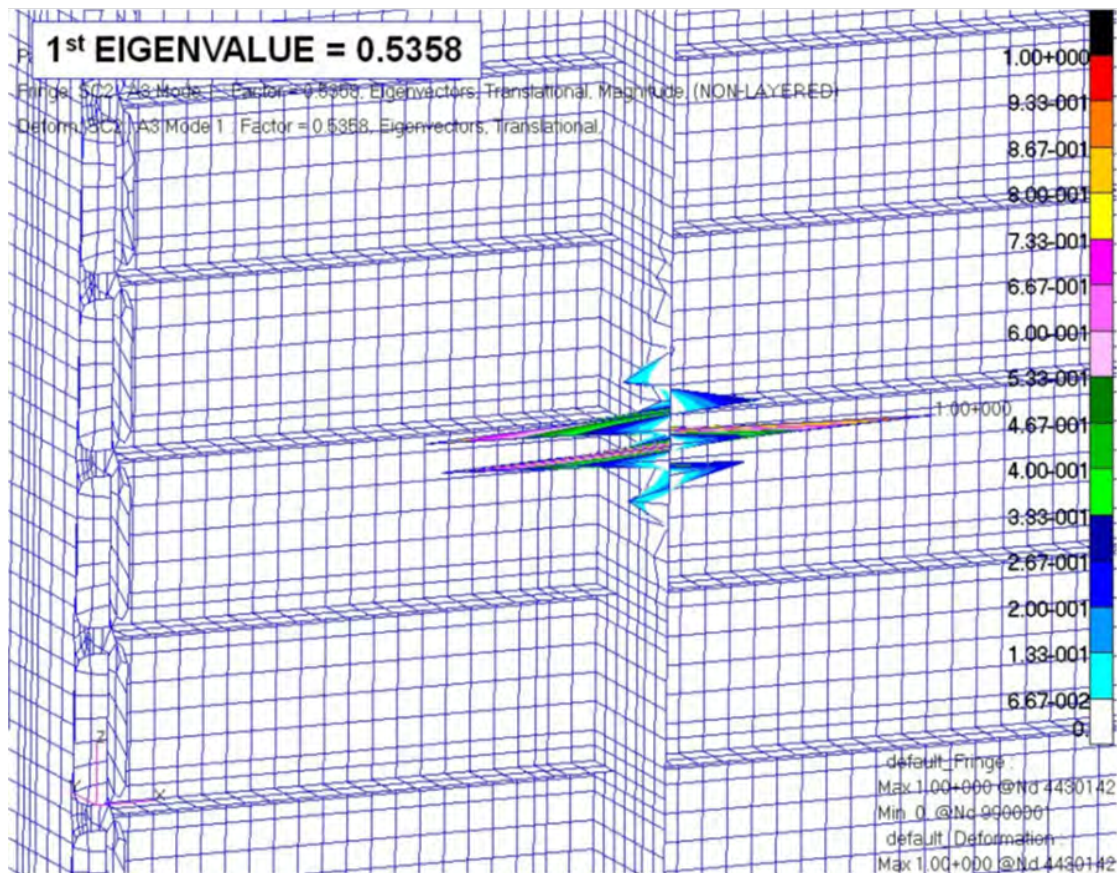
**Figure 4-85. Spurious Mode at Frame Web on the Upper Bulkhead in Linear Buckling Analysis**

mode in buckling analyses. However, using 3D elements for frames in the global model of the MBB was not feasible. Therefore, a simpler approach was taken to solve this numerical issue. The transverse shear moduli of the Rohacell foam core were increased by a factor of 10. After this modification to the frames, the spurious mode was reduced in the buckling analyses. Later, in the nonlinear analyses of the MBB, it was found that the misrepresentation of the transverse shear stiffness of sandwich frames also caused some numerical convergence difficulties. Similar changes were made to the transverse shear stiffness of frames, which enabled better convergence in nonlinear analyses. To investigate the influence of this transverse shear modulus change on the strains in frames, linear static results from the FEM with modified frame stiffness and the original global FEM were compared. It was found that the strain values on the frames and their adjacent structure were almost identical, authenticating the use of modified frame stiffness in the buckling and nonlinear analyses.

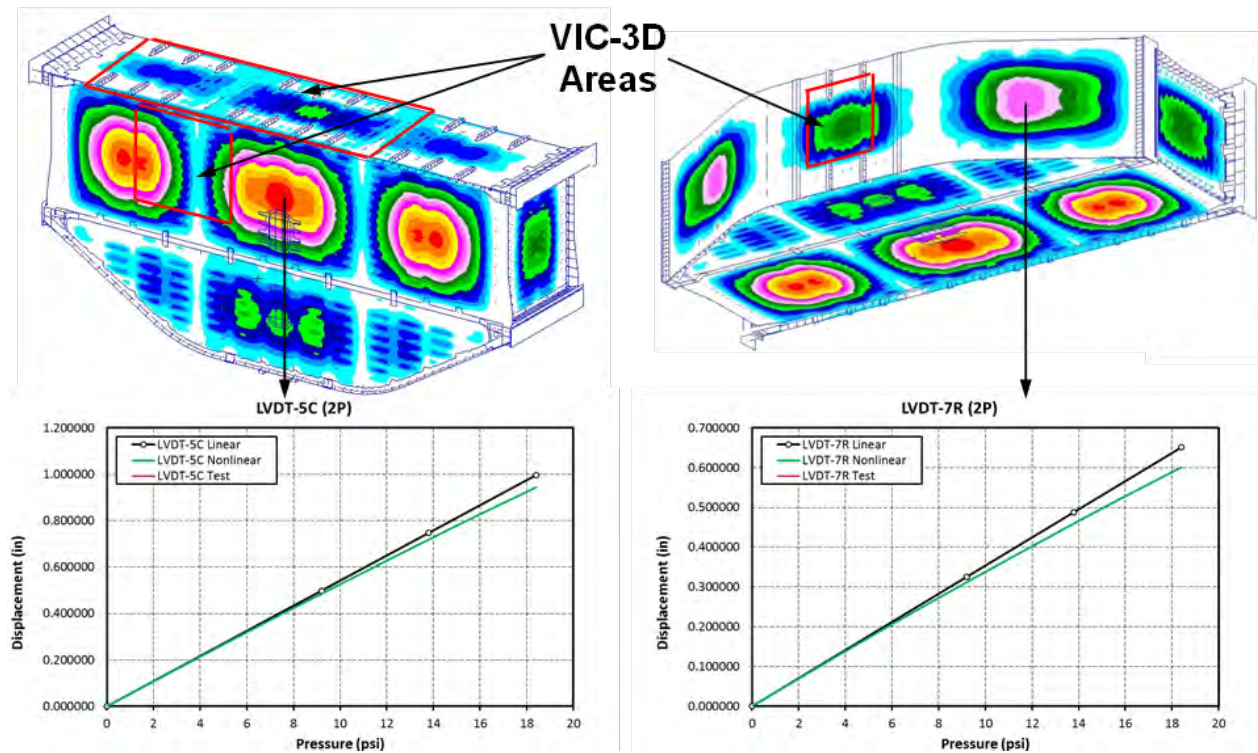
Figure 4-109. VIC-3D and LVDT Measurements of the MBB in 2P Condition

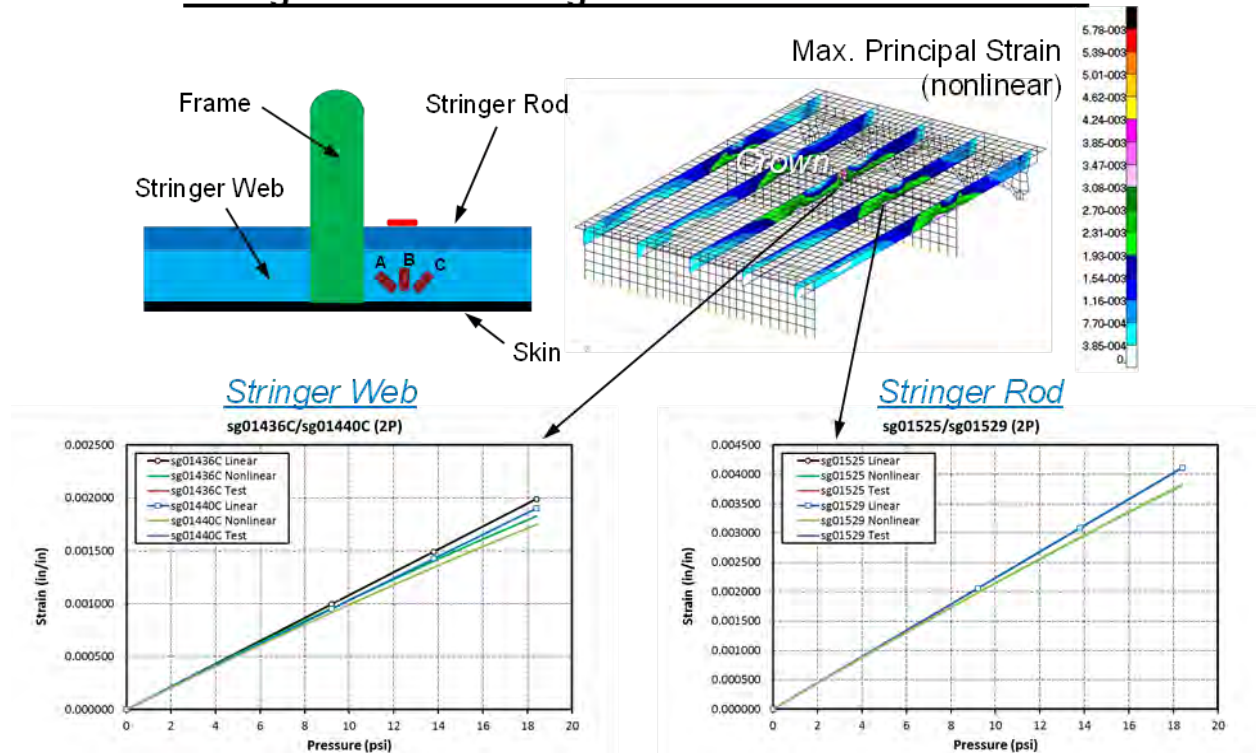
Figure 4-111. Strains on Crown Stringer Webs and Stringer Rods in 2P Condition

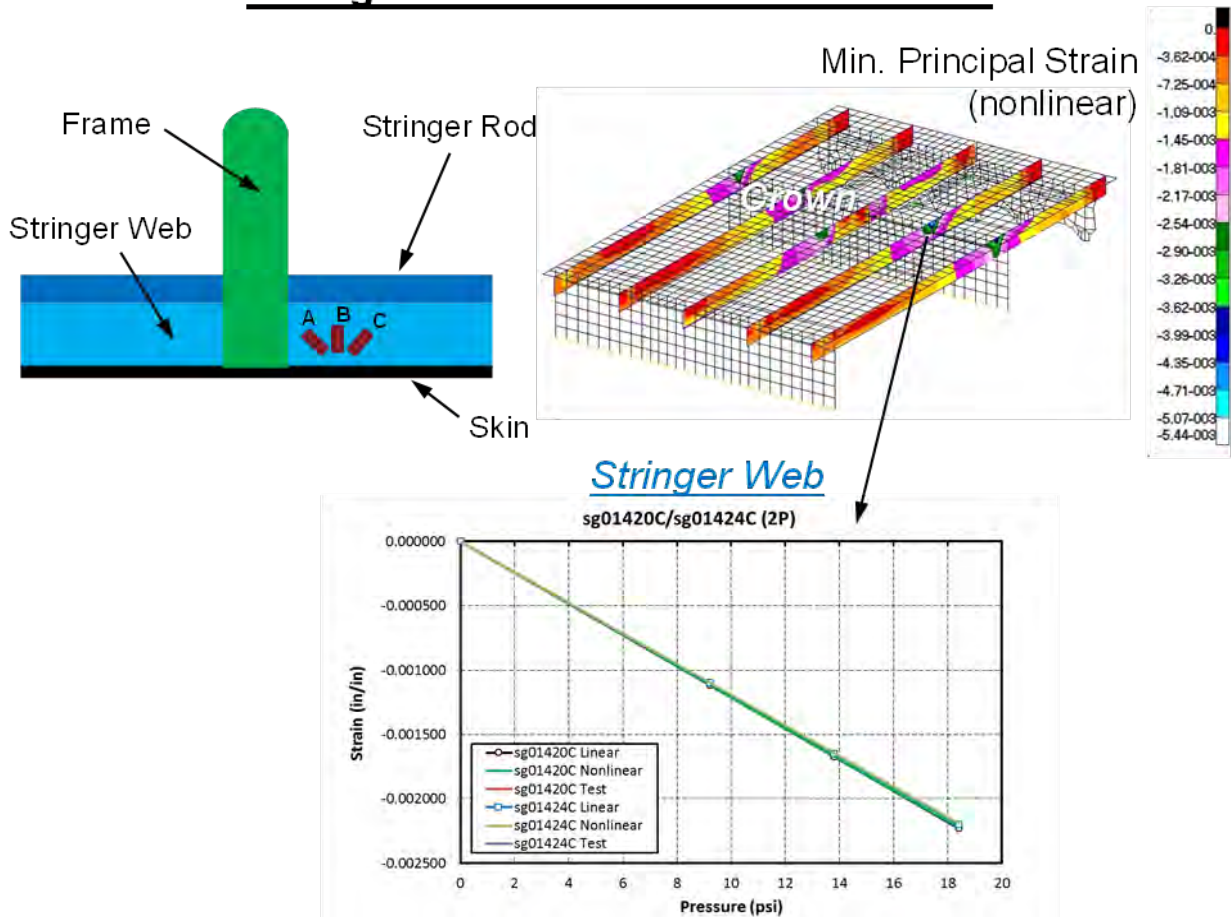
Figure 4-112. Strains on Crown Stringer Webs in 2P Condition

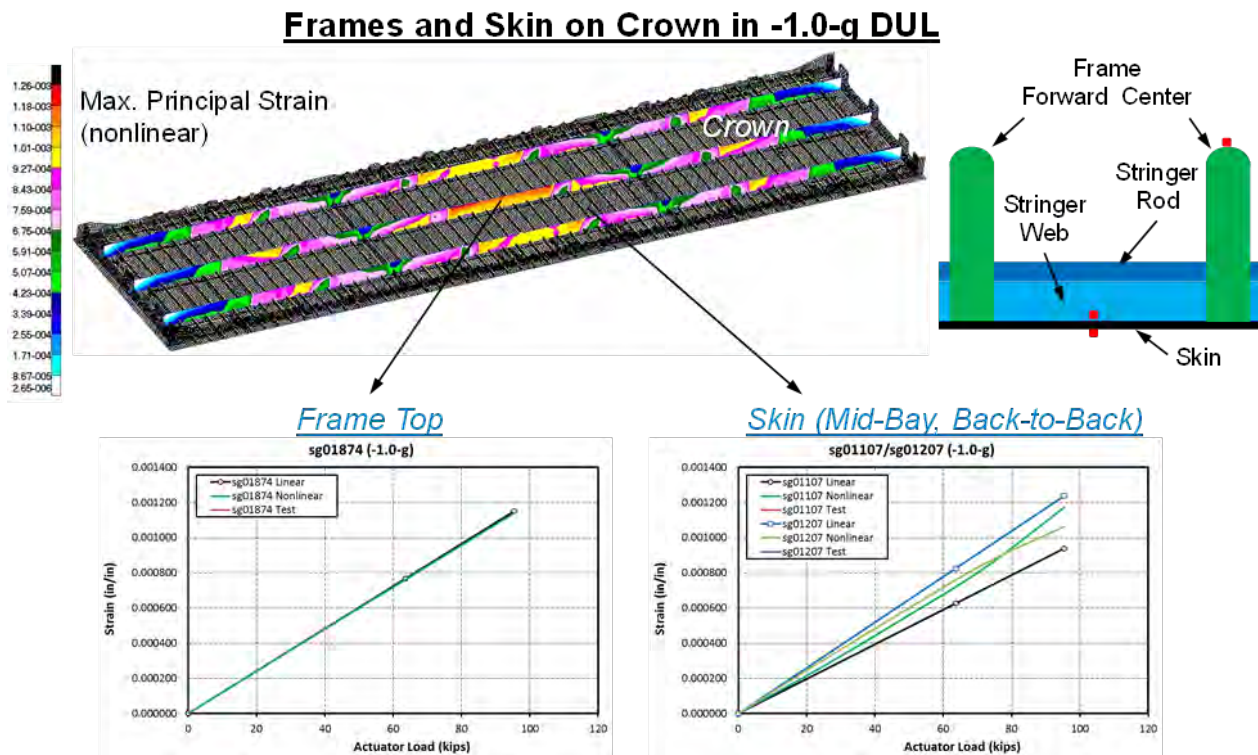
Figure 4-155. Strains on Crown Frames in -1.0-g DUL Condition

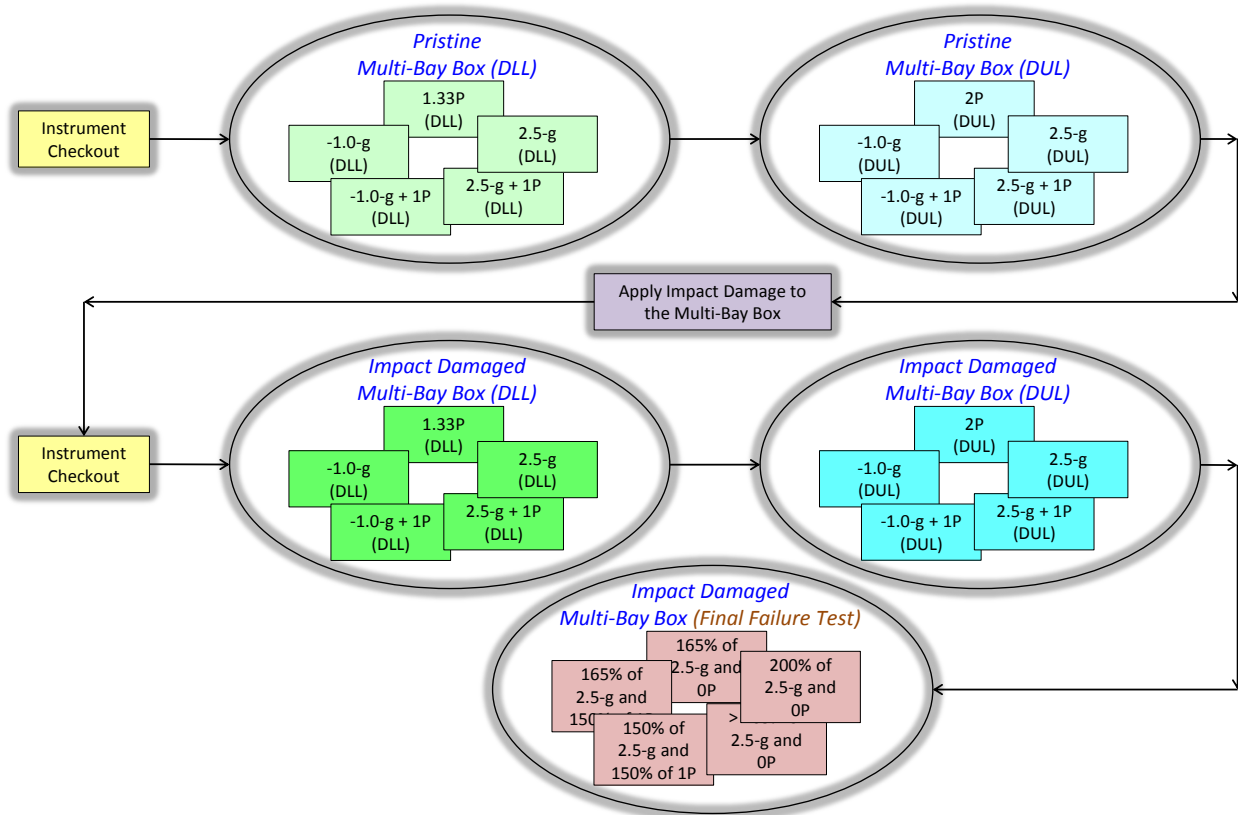
Figure 7-19. Flowchart of the MBB Structural Tests
