The MISSE 7 Flexural Stress Effects Experiment After 1.5 Years of Wake Space Exposure

Kate E. Snow¹, Kim K. de Groh², Bruce A. Banks³

¹Hathaway Brown School, Shaker Heights, OH 44122

²NASA Glenn Research Center, Cleveland, OH 44135

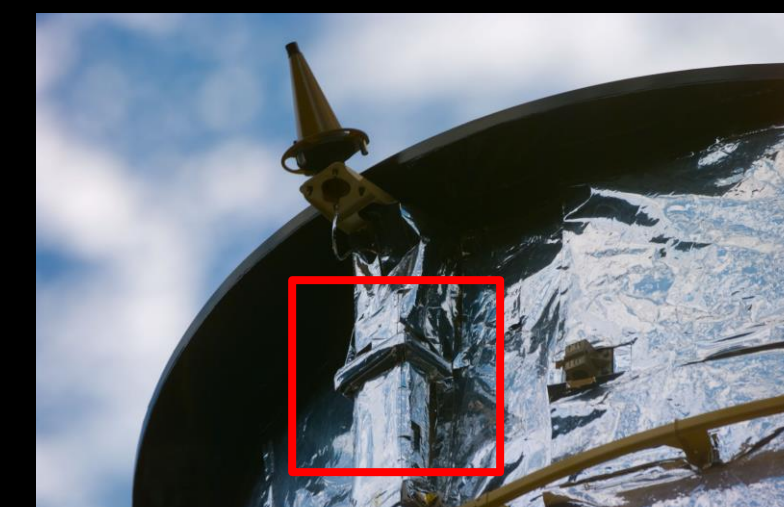
Spacecraft blanket wrapped about a corner on the HST

- Pictured below are examples of how insulation blankets are bent while in flight
- Depicted in the image on the left is an example of a polymer insulation being bent around a corner on the Hubble Space Telescope (HST)
- In the image on the right, more bent polymer blankets can be seen on the HST during flight

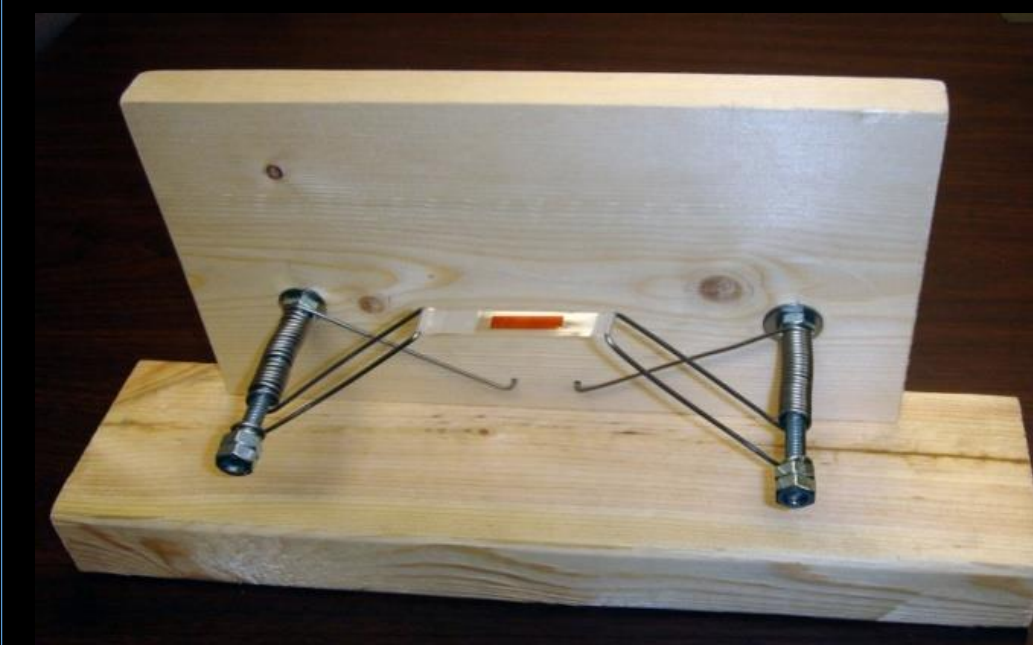
Figure 1

Figure 1: The bend test mechanism in its idle state; the polymer being tested rests atop the Kapton stretched across the center

- Half the samples are to be analyzed for space-induced embrittlement using a non-standard bend-test procedure in which the strain to induce surface cracking was determined
- Testing is conducted on a semi-suspended pliable surface held up with two supports to bend the samples without imposing a bulk tensile stress
- Successively smaller mandrels (cylindrical steel pieces) were used to apply surface strain to samples. There were 23 mandrels (dia. range: 1.253 cm to 0.052 cm), providing varying strains. As diameter of mandrel decreased, strain on sample surface increased

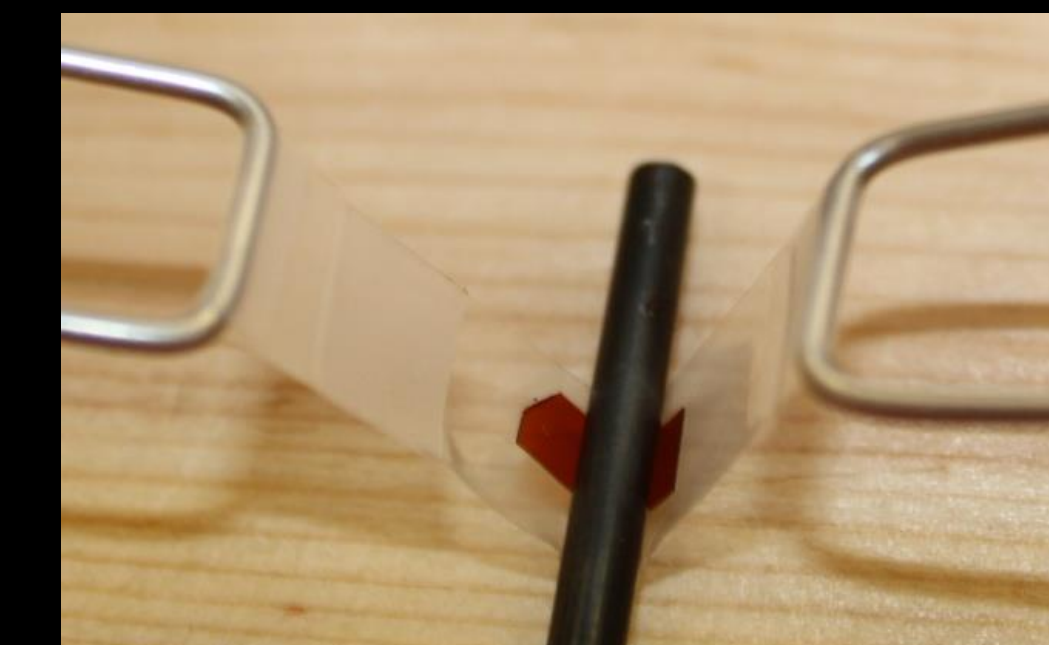
Figure 2

Figure 2: The bend test mechanism in its testing state; the polymer being tested wraps around the circumference of the mandrel with the space exposed surface in tension
