# Magnetospheric Multiscale Mission Micrometeoroid/Orbital Debris Impacts

Spacecraft Anomalies and Failures Workshop 2017

- Impact with MMS4 shunt resistor, Feb. 2, 2016
  - Impact with MMS4 wire boom, June 12, 2016

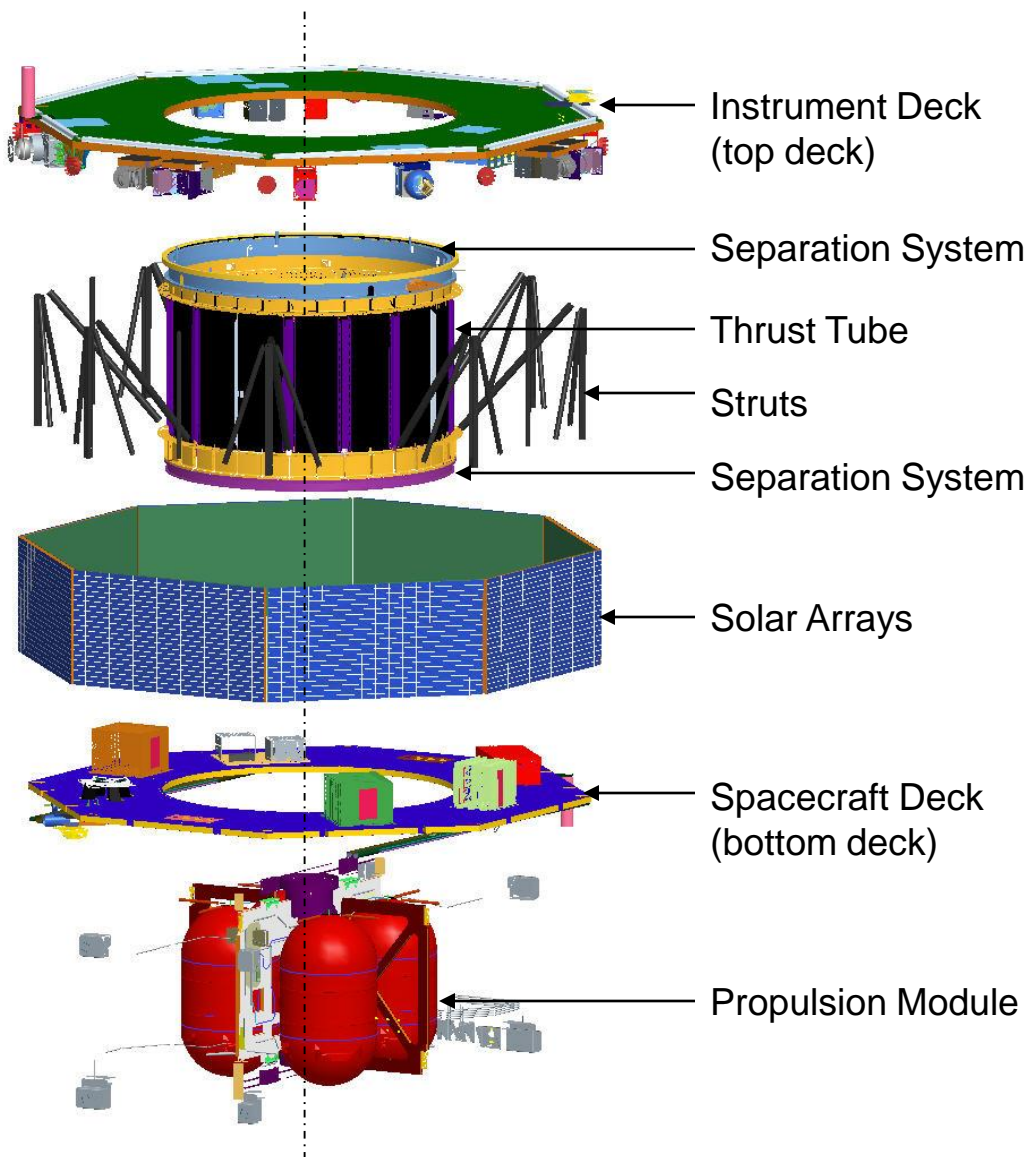
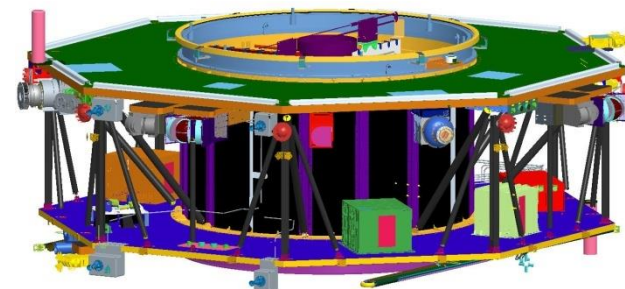
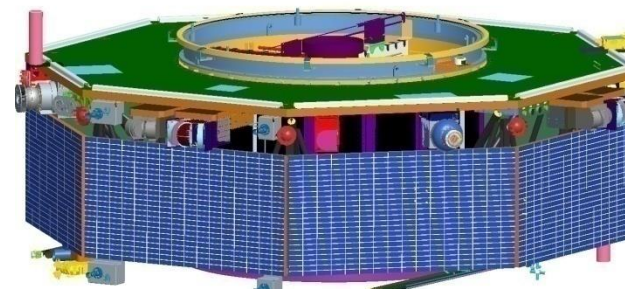
# Observatory Layout

Dry mass average 938 kg  
 Initial fuel mass 412 kg  
 Diameter ~ 3 m; height ~ 1 m  
 Four 60 m wire booms, stiffened  
 by 3.05 RPM spin

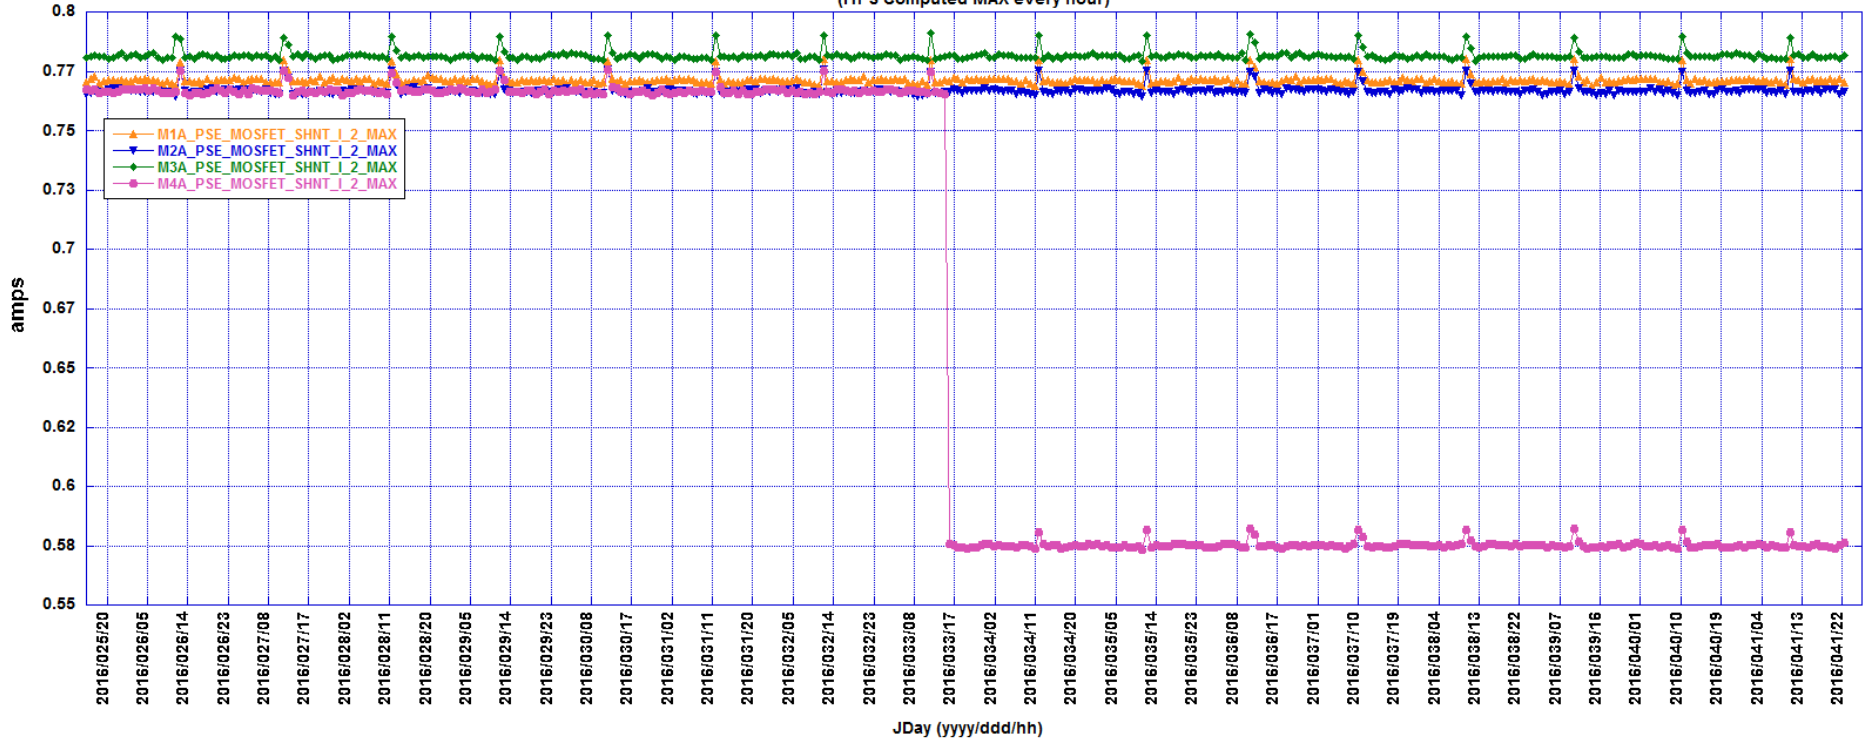
# MMS4 Shunt Resistor Data, Feb. 2, 2016

- Data from MMS4 for Feb. 2, 2016 showed a decrease in one shunt circuit current. This indicates an increase in total shunt resistance. The observed change would be consistent with the total loss of one shunt resistor out of the four in parallel on this circuit

MMS-4: EPS - MOSFET Shunt Current Max Drop  
(ITPS Computed MAX every hour)

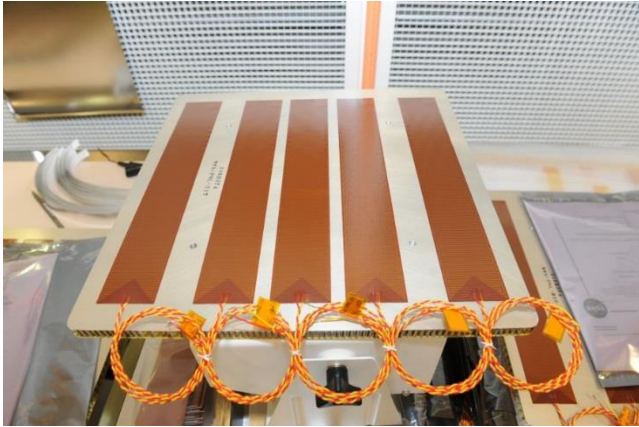
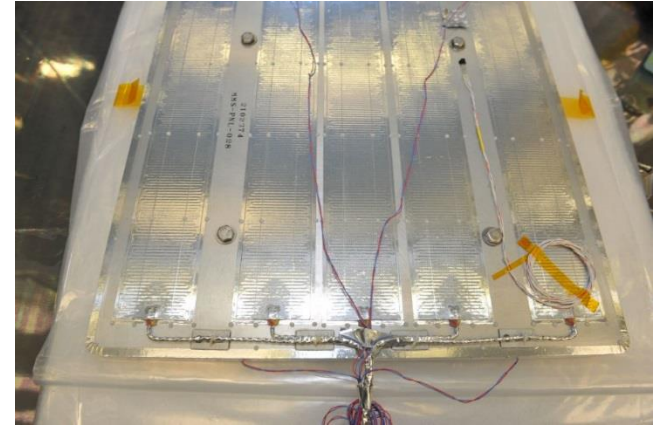
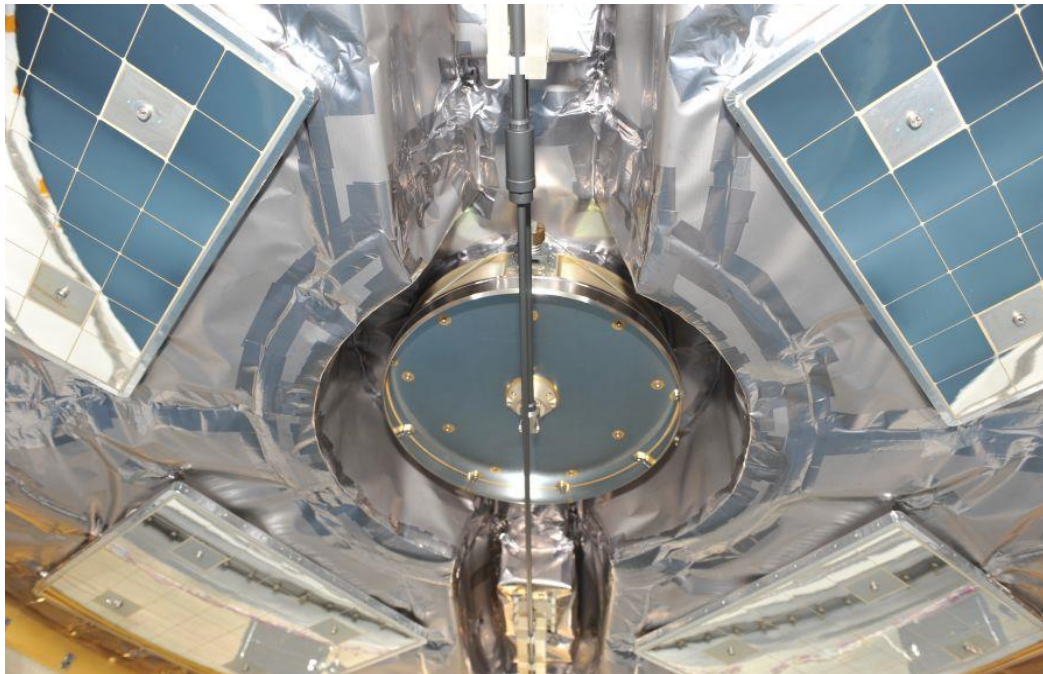
# Shunt Resistors and Radiator Panels

- MMS passes any excess electrical energy produced by the solar arrays through five shunt circuits, each with four resistors
- These resistors are mounted behind four radiator panels (Optical Solar Reflectors [OSRs]) attached to the lower face of the spacecraft. This allows dissipation of the excess energy to space as radiated heat

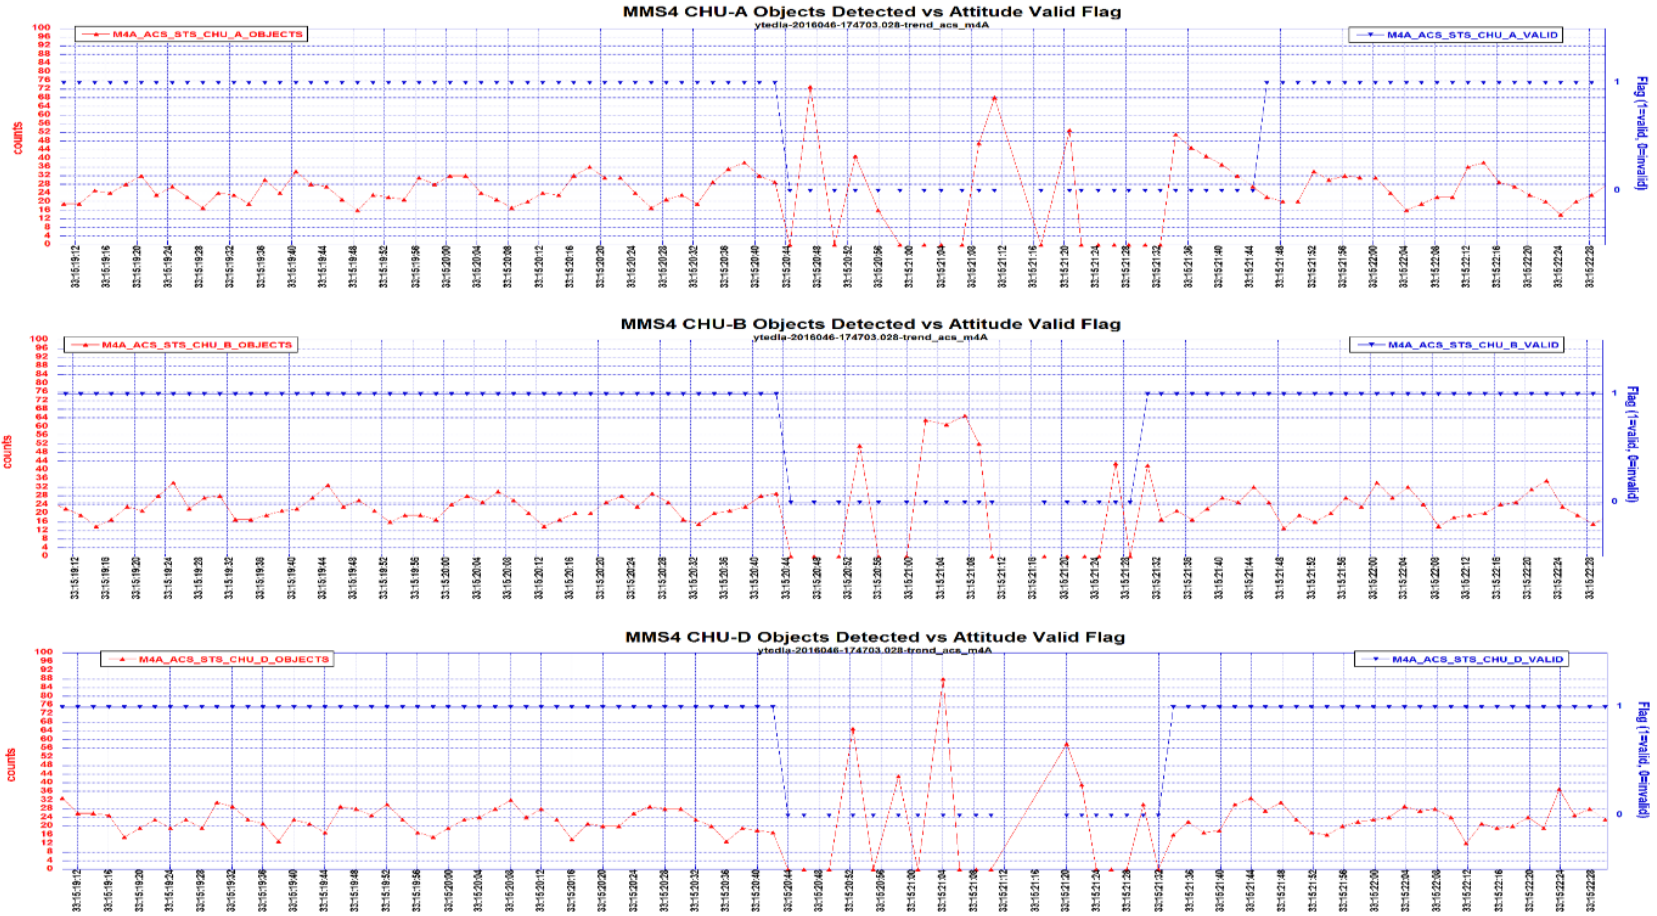
# External Event Evidence 1: Star Cameras

- Initial suspicion: cause was internal to the spacecraft, e.g. a workmanship issue with the resistor. However, data from various onboard systems indicated that a dynamic event occurred simultaneously with the change in resistance

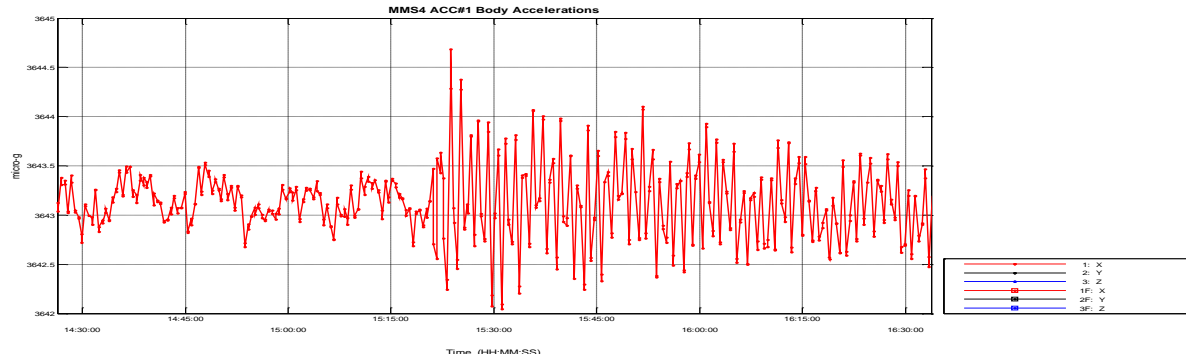
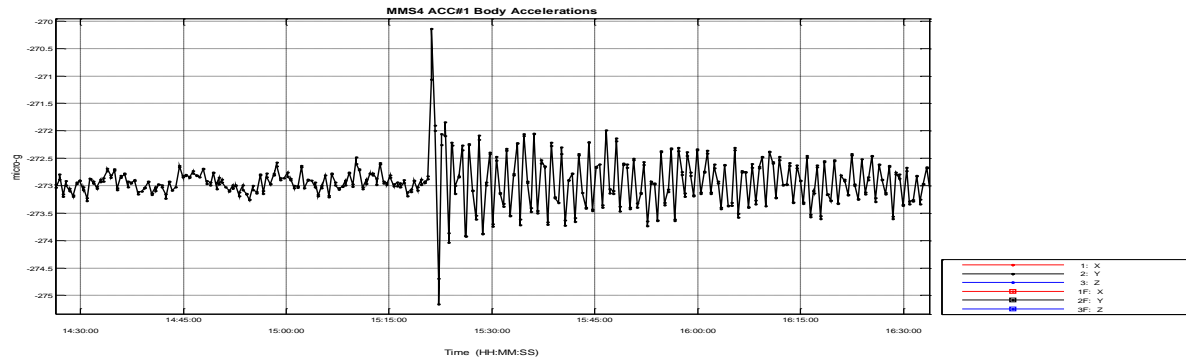
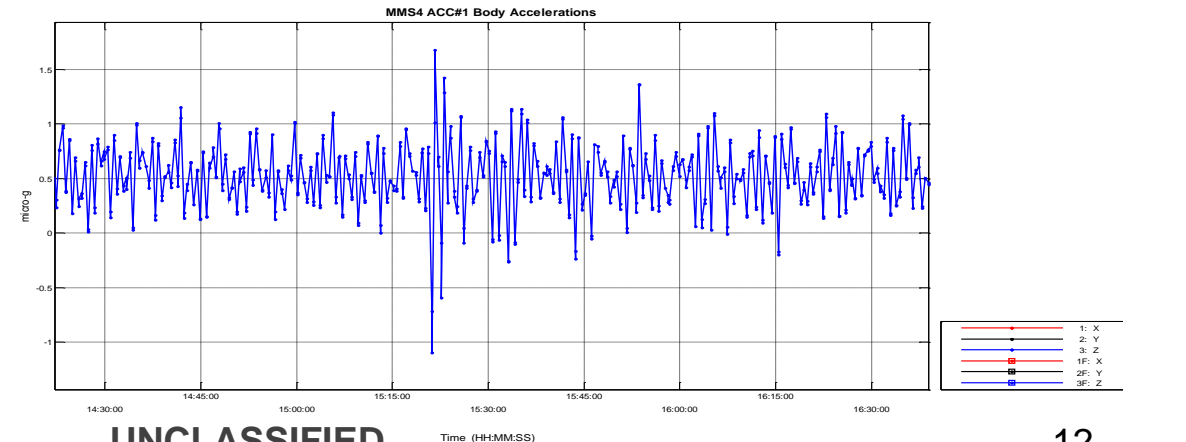
# Accelerometer Measurements

X-axis: Initial spike -0.8 micro-g

Note: All three axes only sampled every 30 s, so actual first motion may not be observed

Y-axis: Initial spike 2.8 micro-g

Z-axis: Initial spike -1.7 micro-g

Resulting relative velocity direction estimate: 30.3 deg below spin plane

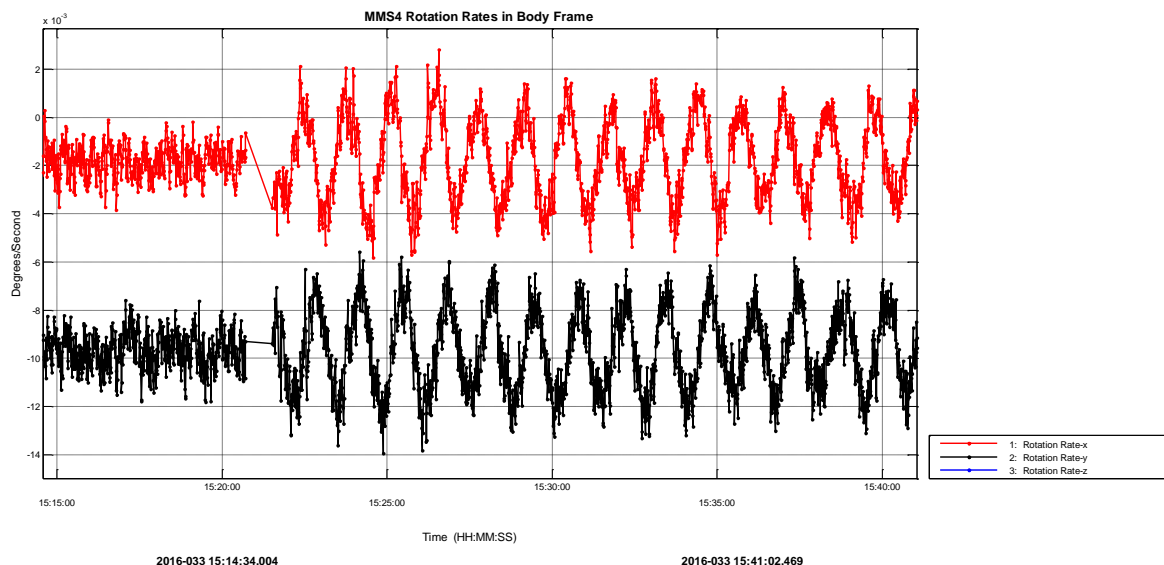
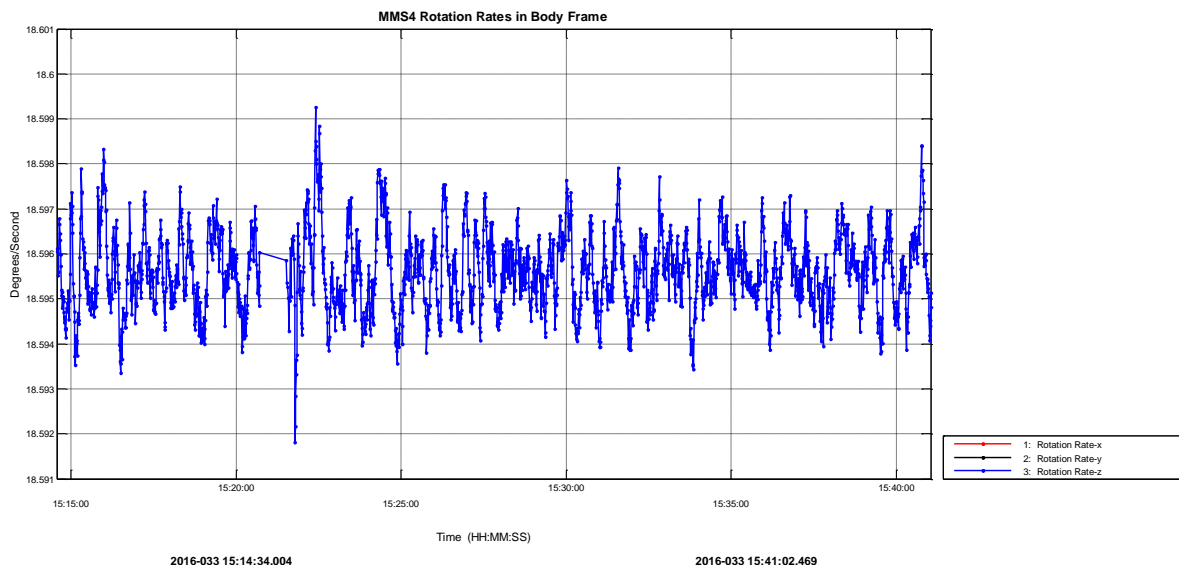
# Rotation Rates, Transverse and Axial

*Transverse:*  
Nutation/boom  
vibration evident

Note brief  
dropout resulting  
from star  
cameras being  
blinded/resetting

*Axial:* No change  
in spin rate  
evident

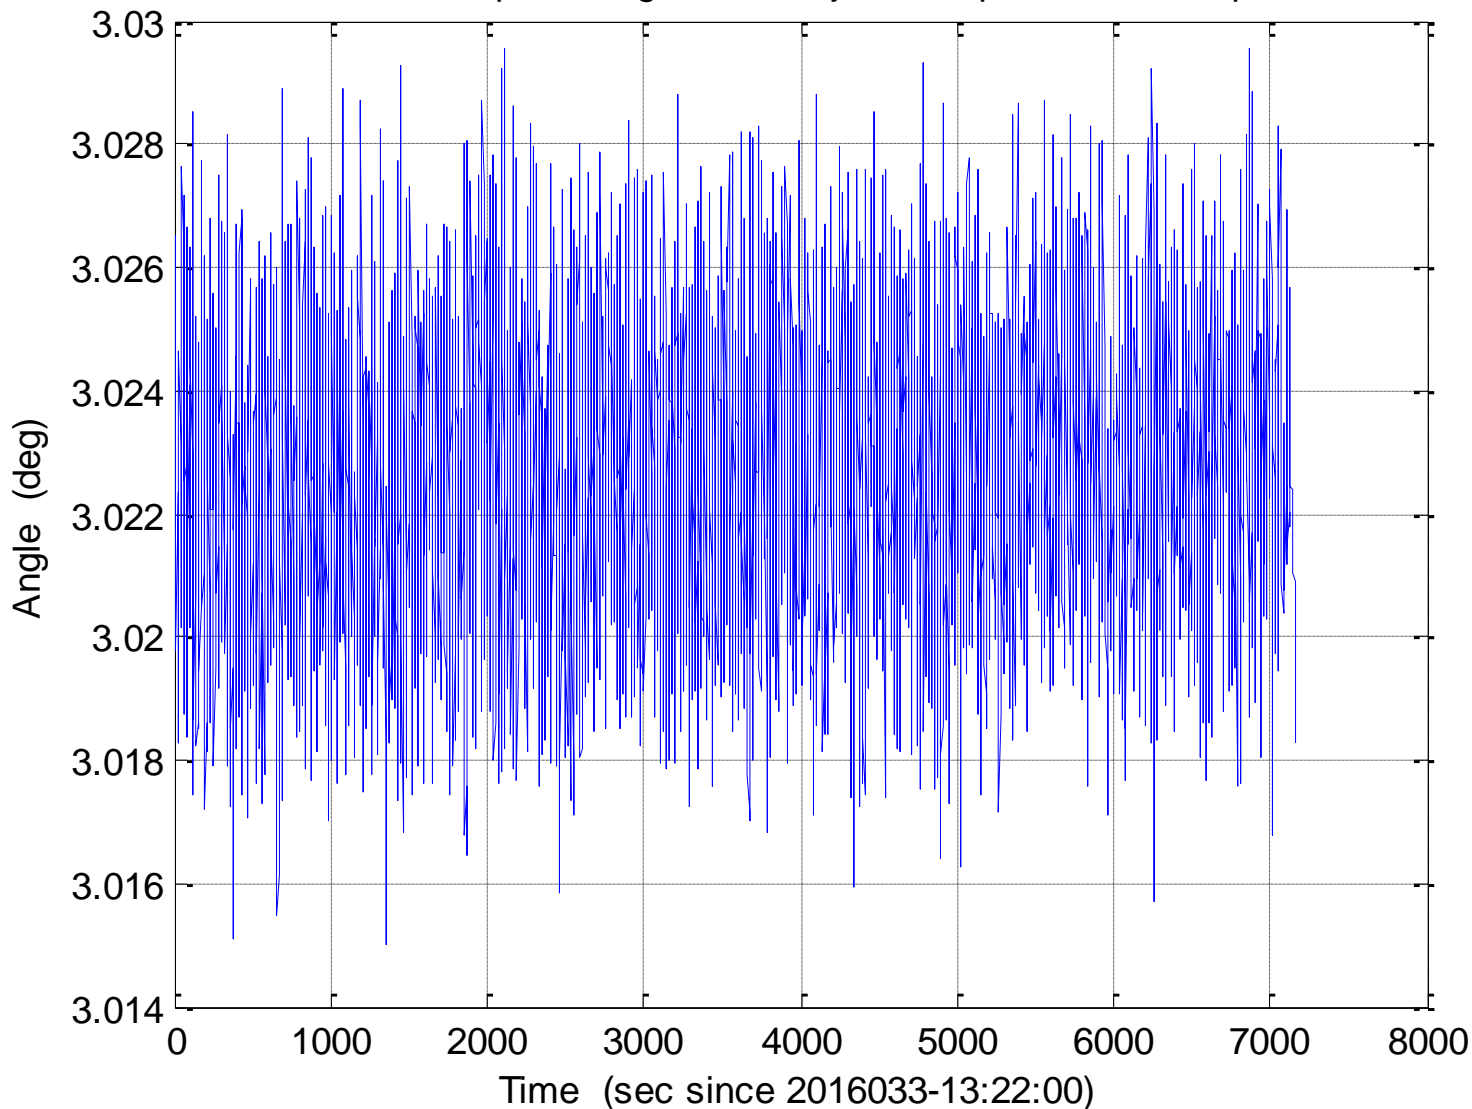
# Pointing Angle Before Event

MMS4 Before Impact: Angle from Major Principal Axis to Ecliptic Pole

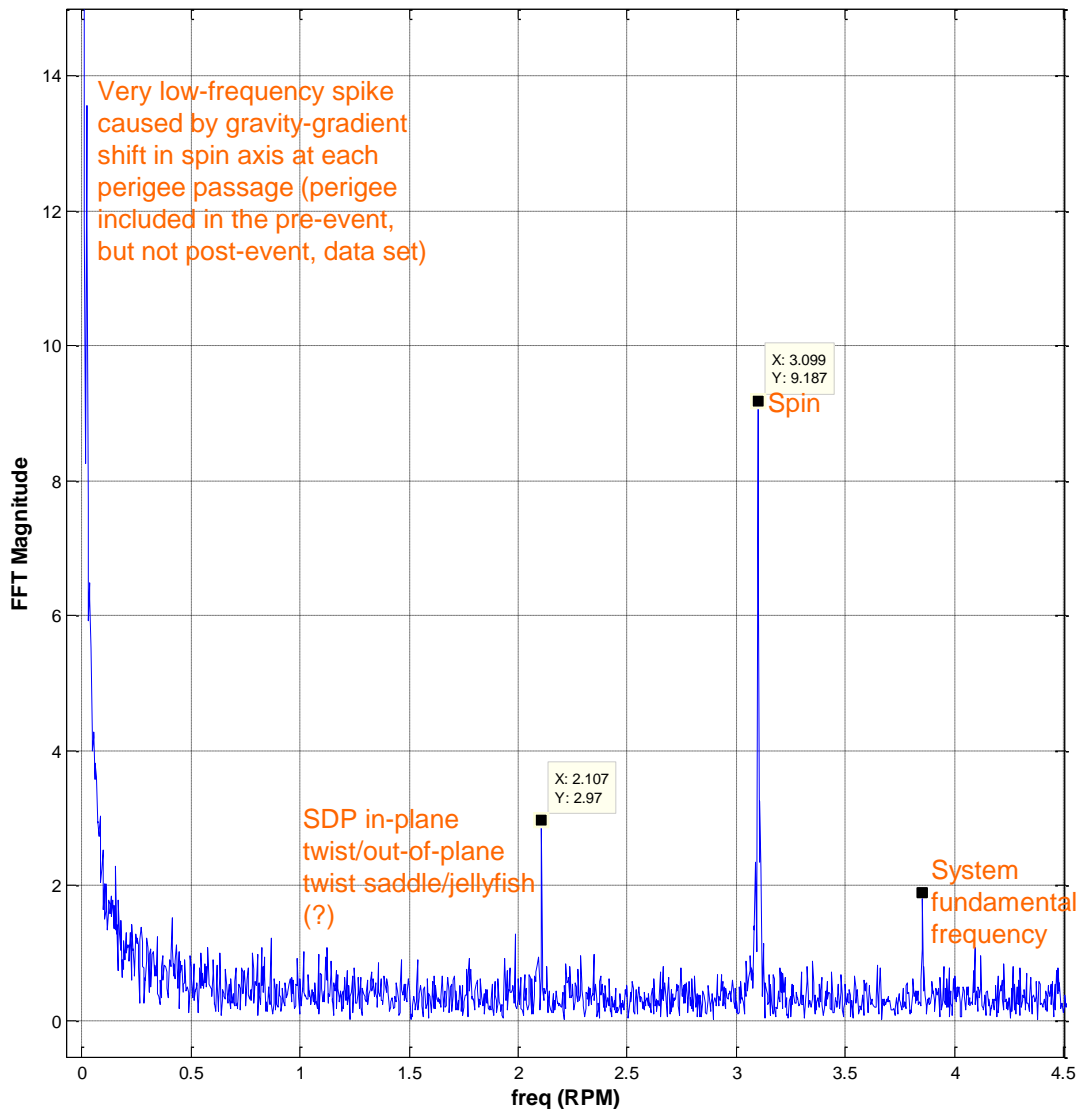
# FFT of Pointing Angle Before Event

Magnitude of FFT of Angle Between MMS4 Principal Axis and Ecliptic Pole

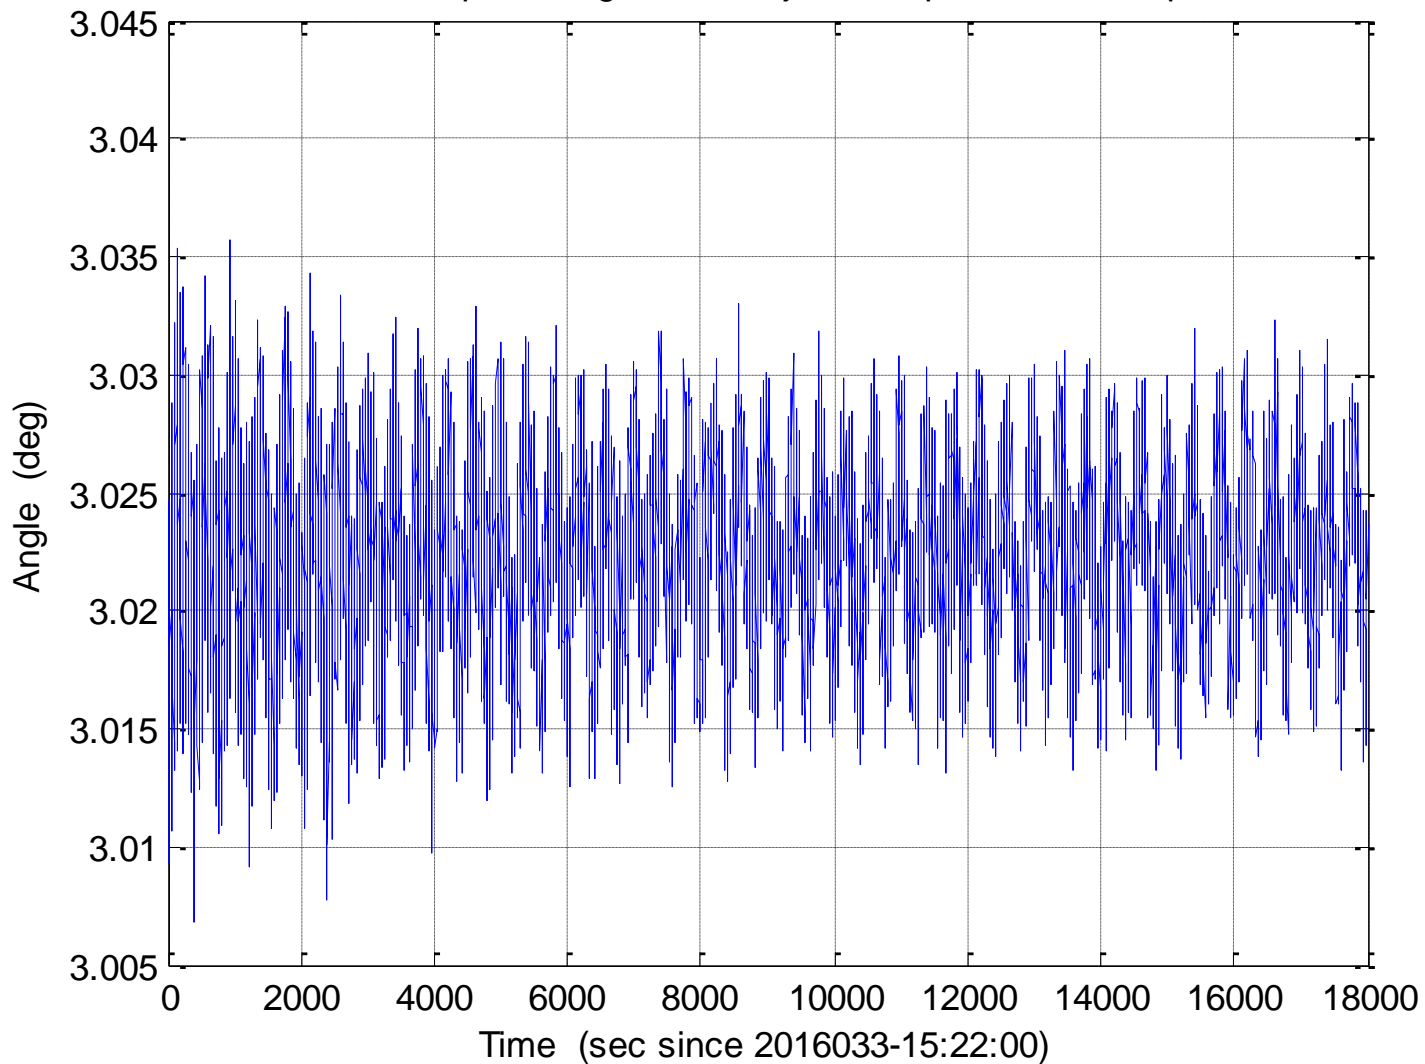
# Pointing Angle After Event

MMS4 After Impact: Angle from Major Principal Axis to Ecliptic Pole

Vibration with  
period of ~400 s  
dominates  
response

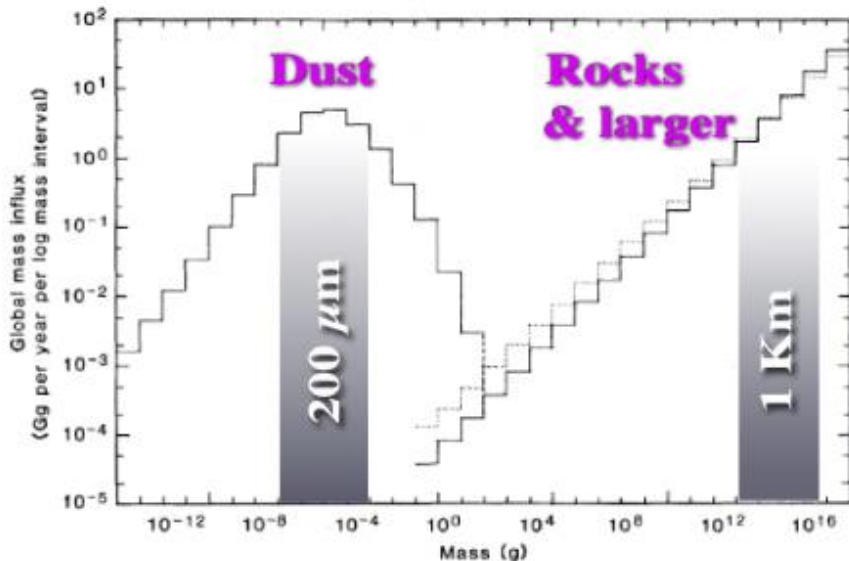
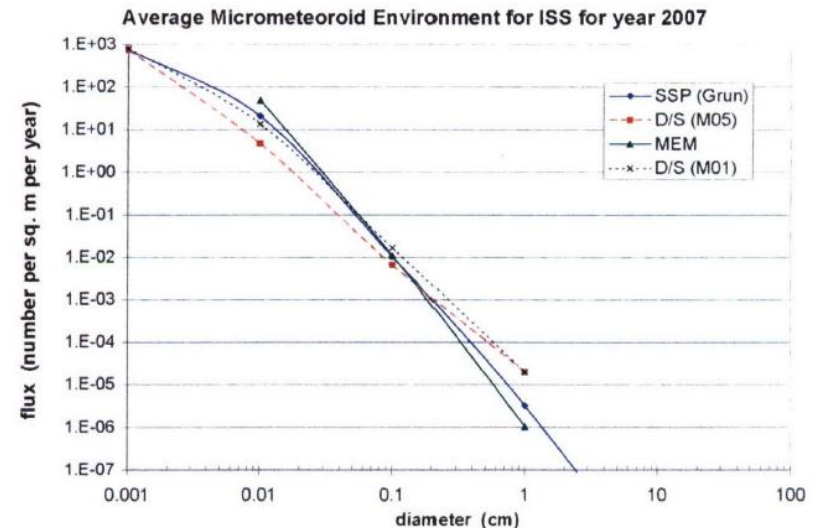
Figure 2. Micrometeoroid particle fluxes from various models.

- Two possible sources have been studied:
  - Micrometeoroid (dust particle)
  - Debris originating in GEO and perturbed by lunisolar gravitation plus solar radiation pressure (SRP) to point of impact
- Micrometeoroid (dust) population:
  - Overall mass range:  $\sim 10^{-14}$  to  $10^0$  gm
  - Peak mass range:  $\sim 10^{-8}$  to  $10^{-3}$  gm ( $\sim 2 \times 10^{-4}$ -0.9 mm diameter)
  - Flux tails off quickly:  $\sim 10^{-3}$  as high at 1 mm diameter as at 0.1 mm\*

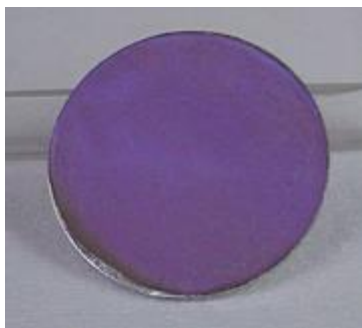
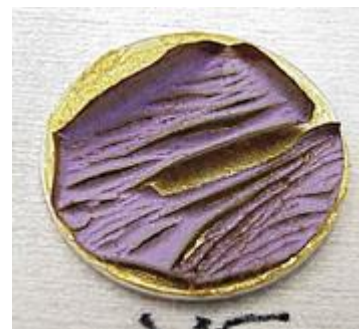
- Debris originating in GEO: GEO spacecraft have inclinations that oscillate between 0 and ~15 deg, as a result of lunisolar perturbations. The impact latitude of -21.2 deg exceeds this range; the impact radius was also 6,012 km above GEO
- However, objects released from GEO that have high area/mass ratios ( $> \sim 15 \text{ m}^2/\text{kg}$ ) experience significant solar radiation pressure (SRP) perturbations in eccentricity (and so radius) and inclination
- References:
  - “Long-Term Dynamics of High Area-to-Mass Ratio Objects in High Earth Orbit”, Rosengren and Scheeres, 2013
  - “Long-Term Evolution of Geosynchronous Orbital Debris with High Area-to-Mass Ratios”, Pardini and Anselmo, 2006
- Possible debris source: multi-layer insulation (MLI). MLI degrades in GEO. See Tedlar thin film before, after 3 years simulated GEO\*:

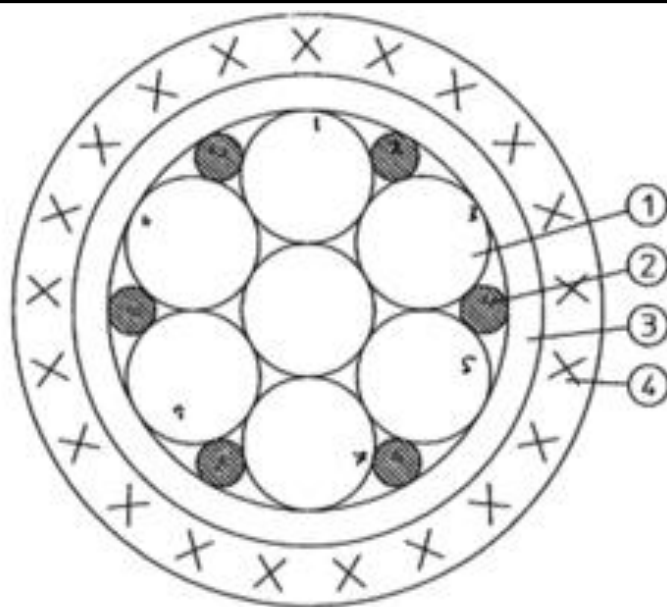
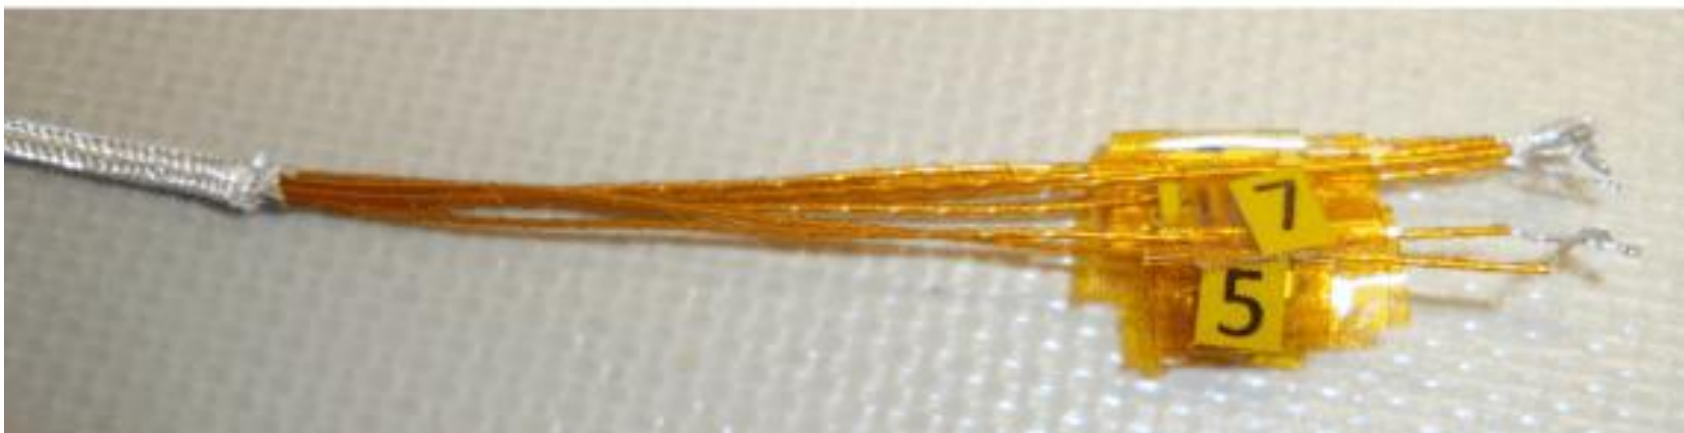
# SDP Wire Boom: 7 Signal Wires

- Small transient in spin rate as derived from Digital Sun Sensor (DSS)
- Subsequent data was degraded, but showed that the tip mass was not lost. Rather, one or more of the 7 SDP4 wires was severed

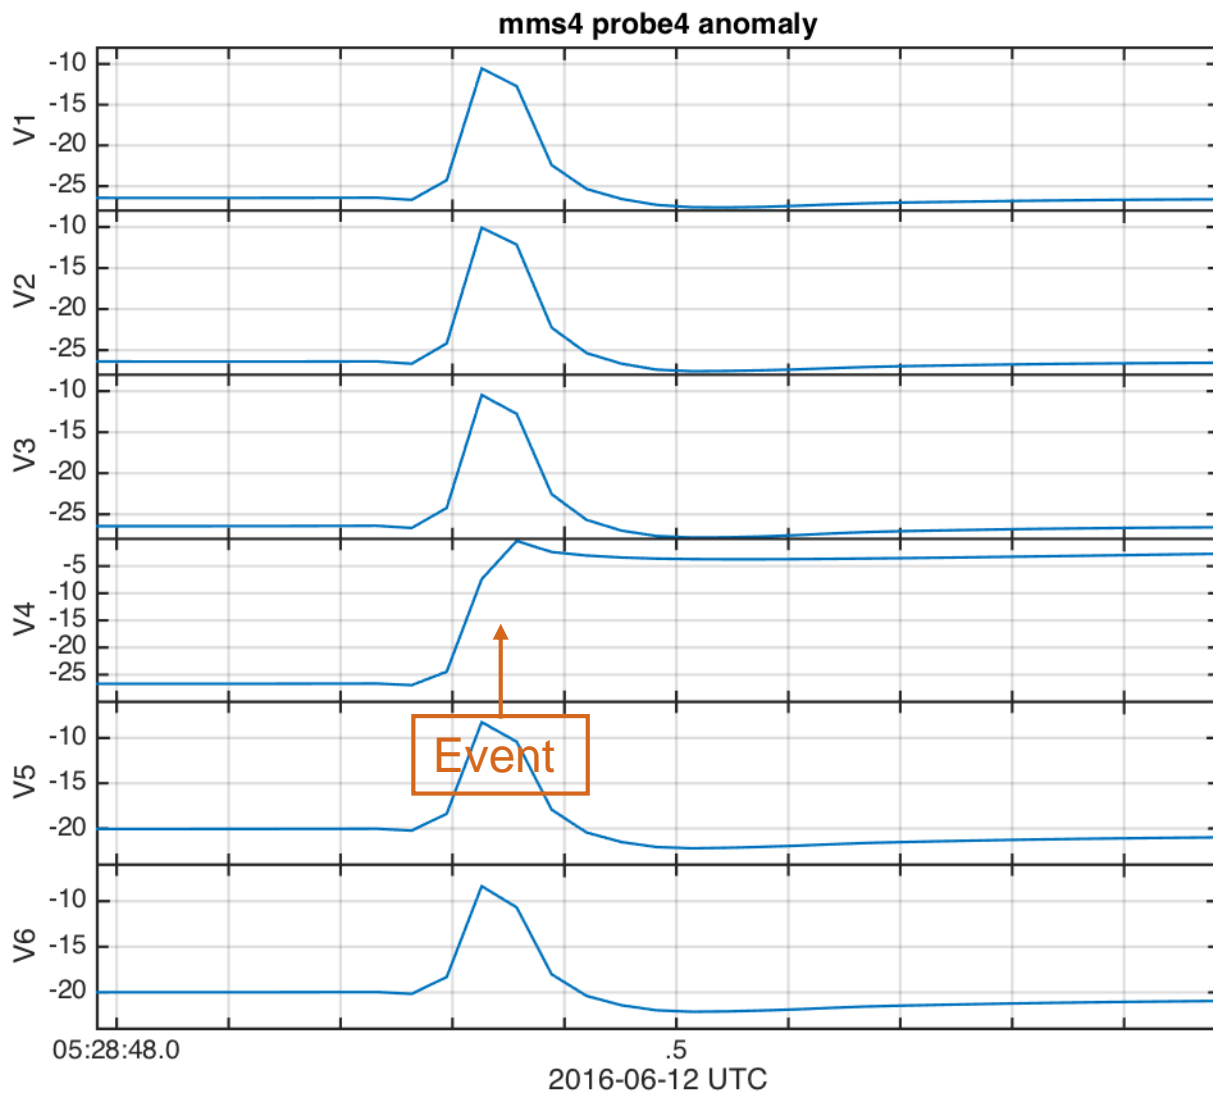
# SDP and ADP Fields Data at Event

- MMS4 (again) experienced an event of this type on June 12, 2016 at 05:28:48.3 UTC. Evidence:
  - Disruption of data from Spin-plane Double Probe (SDP) 4, the electric field sensor at the end of one of the four 60-m long wire booms. Data from the other three SDPs, and the two Axial Double Probes (ADPs), experienced transients at the same time but then recovered

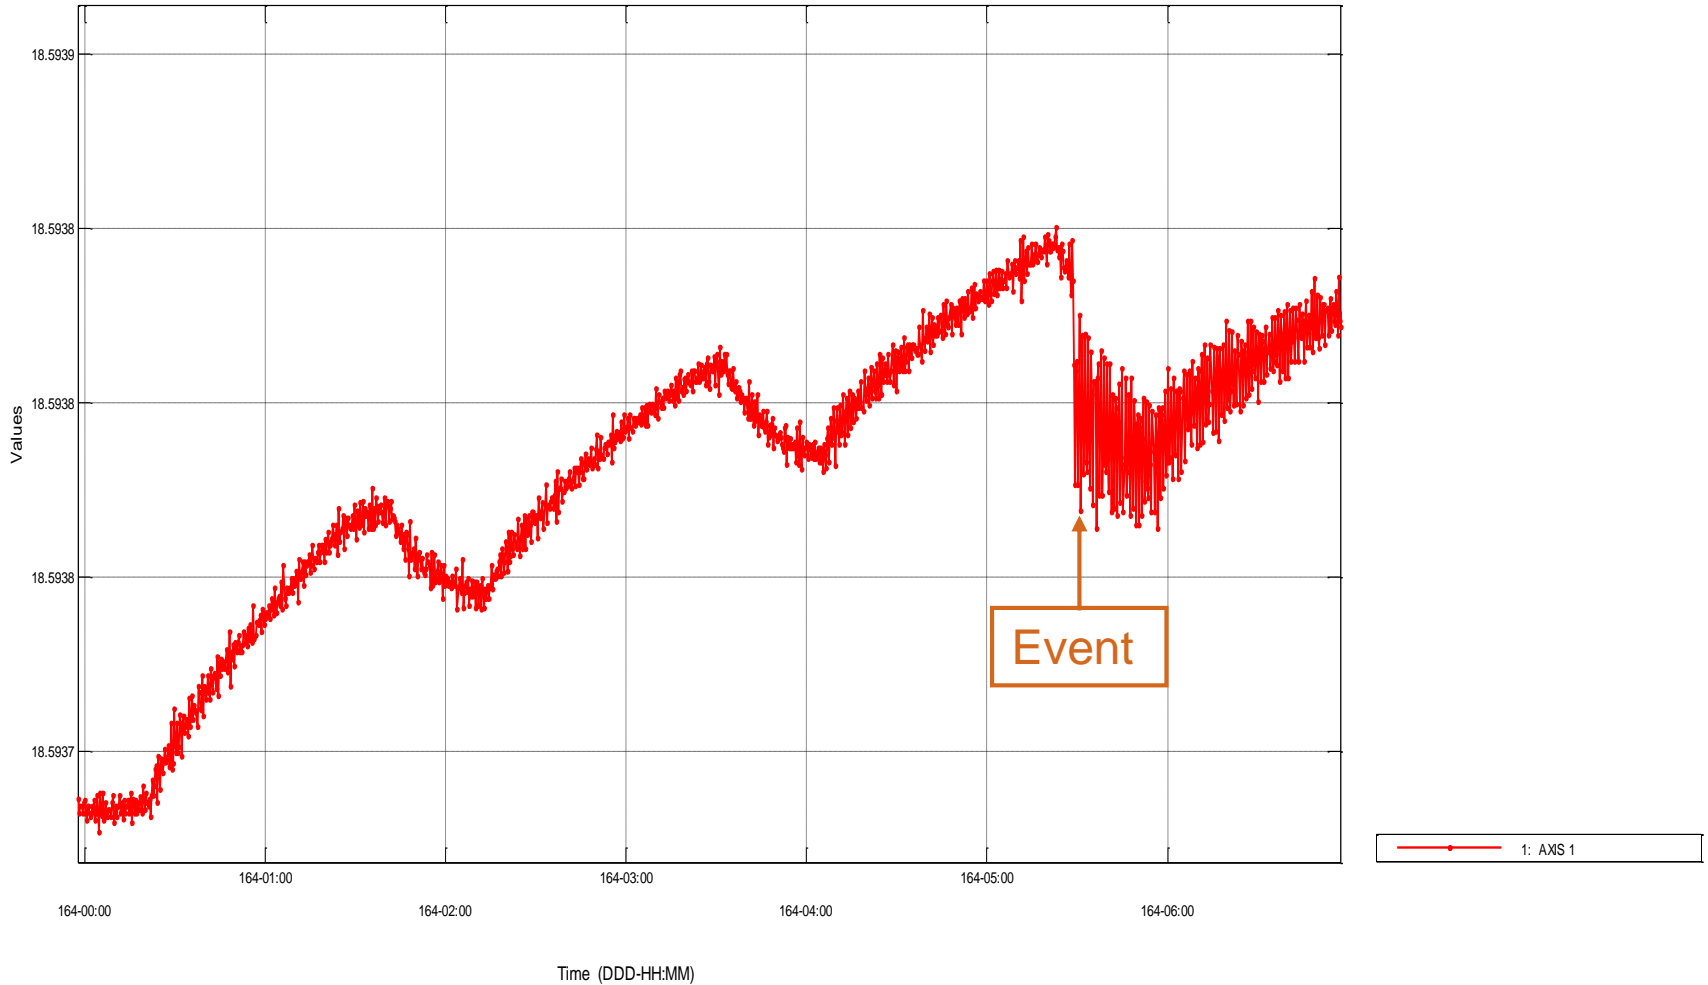
# DSS-Derived Spin Rate at Event

MMS4 Spin Rate from DSS Sun Pulse Times

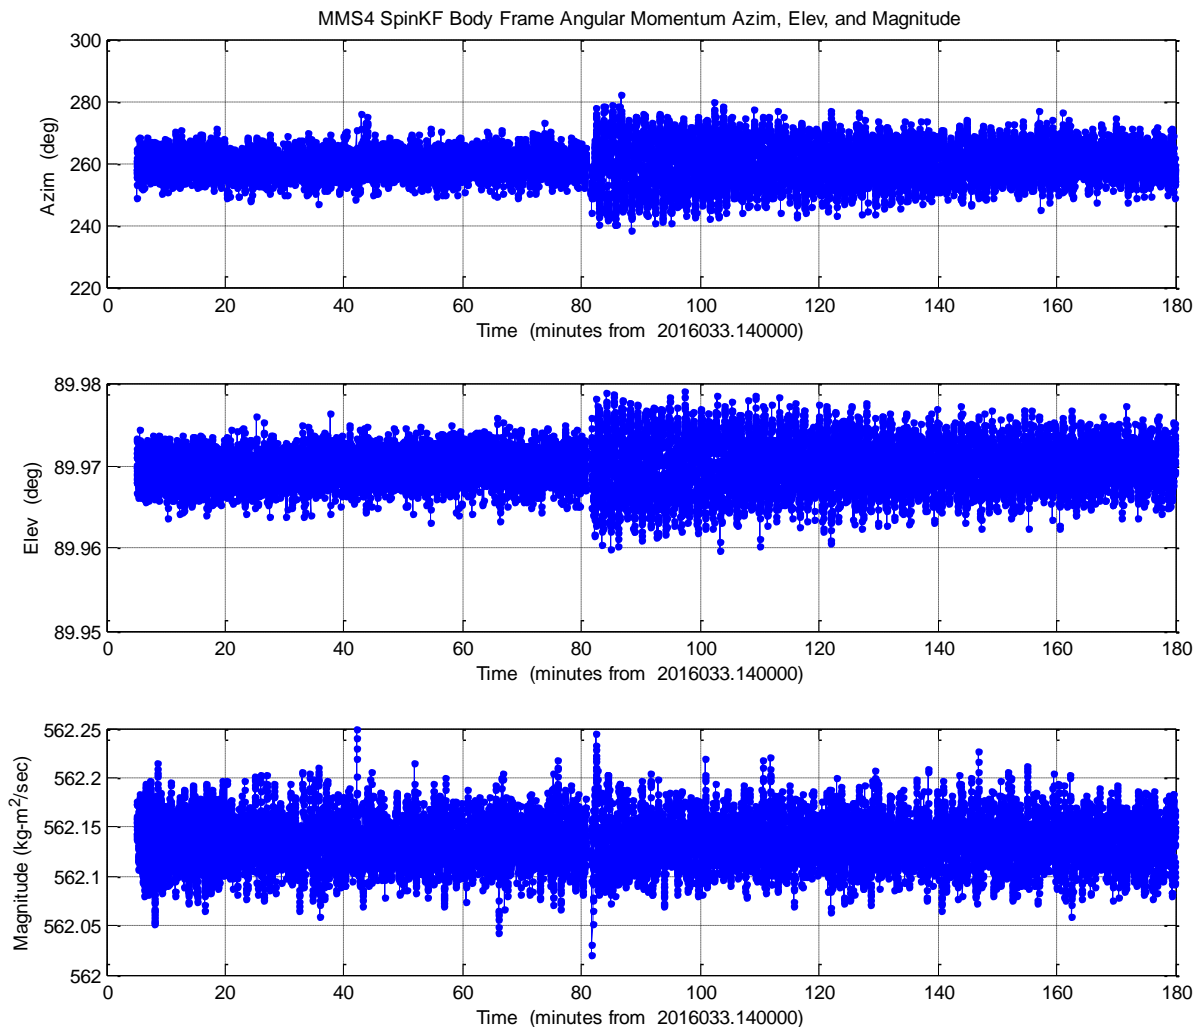
# Angular Momentum, Shunt Event

*Transverse:*  
Nutation/boom  
vibration evident

*Axial:* No change in  
spin rate evident.  
Consistent with  
shunt location being  
close to spin axis

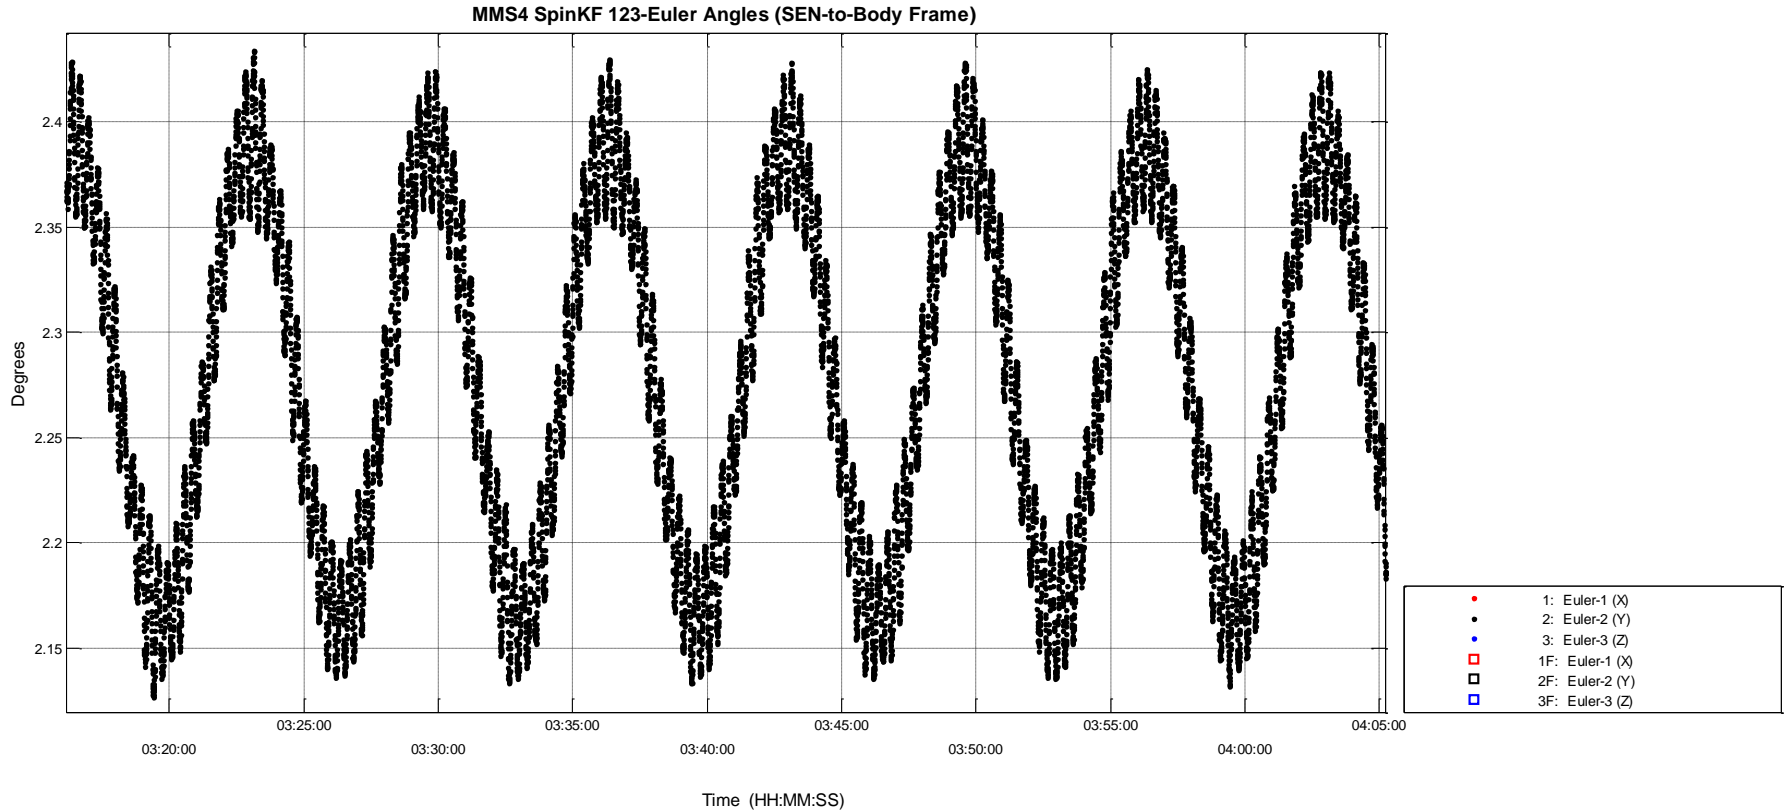
# Pointing Angle After Previous Maneuver

- Oscillation at same ~400 s period is clearly visible
- Observed after all spacecraft maneuvers
- Must be wire boom dynamics excited by thrusting/impact acceleration of central spacecraft body
