The Value of Identifying and Recovering Lost GN&C Lessons Learned: Aeronautical, Spacecraft, and Launch Vehicle Examples

Cornelius J. Dennehy¹
NASA Engineering and Safety Center (NESC)

I. Introduction

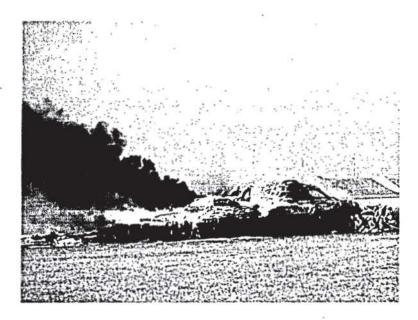
Figure 1: The Crashed B-2 Bomber "Sprit of Kansas" at Andersen Air Force Base

The B-2 "Spirit of Kansas" crash occurred on February 25th, 2008 at Andersen Air Force Base in Guam. Seventeen seconds after takeoff the bomber's crew was unable to control the aircraft and its left wing struck the ground. Before take-off, the plane's computers had called for an internal Air Data System (ADS) calibration. Because of Guam's humidity, there was moisture in the air data sensors during calibration. During taxi for takeoff, the moisture evaporated. The now mis-calibrated ADS sent skewed data to the Flight Control System (FCS), which in turn commanded the aircraft nose up to pitch up 30° upon takeoff. Unable to regain control of the vehicle, the B-2's two-member crew ejected safely just barely before the plane crashed and burst into flames (see Figure 1). The subsequent Air Force investigation concluded that an underlying root cause of the \$1.4B aircraft being totally destroyed was because critical information was not communicated effectively (Ref. 7 and Ref. 8)

The brief history behind this unfortunate incident is as follows. During the B-2's 2006 deployment in Guam, the extremely humid environment required frequent ADS calibrations. Line maintenance technicians telephoned the B-2 manufacturer technical representatives to ask advice on this new environmental issue. Support engineers recommended using the aircraft's pitot heater to dry the Port Transducer Unit's PTU's be-fore calibrating the ADS. Pitot heat is supplied to prevent icing of pitot-static sensors in flight; extensive ground use could overheat and damage the pitot-static system. Several maintenance technicians used pitot heaters successfully to dry moist PTU's and accurately calibrate the ADS, but this technique was neither formalized by a change to the appropriate technical order (i.e., operational procedure) nor captured in a "Lessons Learned" report. The post-crash investigation determined that only some of the ground crews and pilots working with the B-2s during their 2007-2008 deployment were aware of the ADS's sensitivity to moisture and the pitot heat procedural workaround (Ref. 14 and Ref. 15).

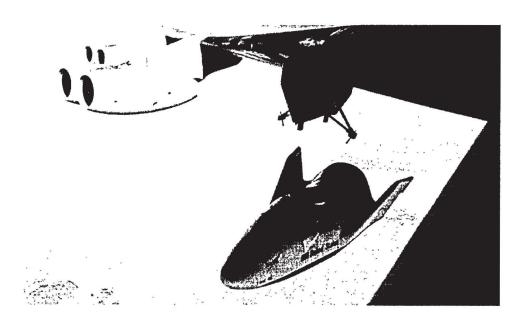
Figure 2: B-52 Carrier Aircraft Drop of V131R X-38 Prototype

On 2 November 2000 the X-38 prototype vehicle V131R, which was an 80% scale version of the Crew Return Vehicle (CRV), conducted its first drop test, or Free Flight One (FF1), over California's Mojave Desert near the NASA Dryden Flight Research Center. As depicted in Figure 2 the B-52 carrier aircraft dropped the V131R prototype at M=0.6 at an altitude of 11,000 m (36,500 ft). Immediately following its release from the B-52 the V131R lifting body made an "unplanned" 360-degree right roll around the velocity vector after it was jettisoned. The vehicle paused at 180° and there was over 1 second of fully inverted flight (Figure 2). Fortunately a safe landing was accomplished with minimal structural damage and the vehicle was recovered intact which greatly supported the investigation of this In-Flight Anomaly (IFA).
