The Hazard of Volcanic Ash Ingestion

John Lekki, PhD

NASA Glenn Research Center

Vehicle Integrated Propulsion Research (VIPR) engine tests to support the R&D of Engine Health Management (EHM) Technologies to augment Aviation Safety

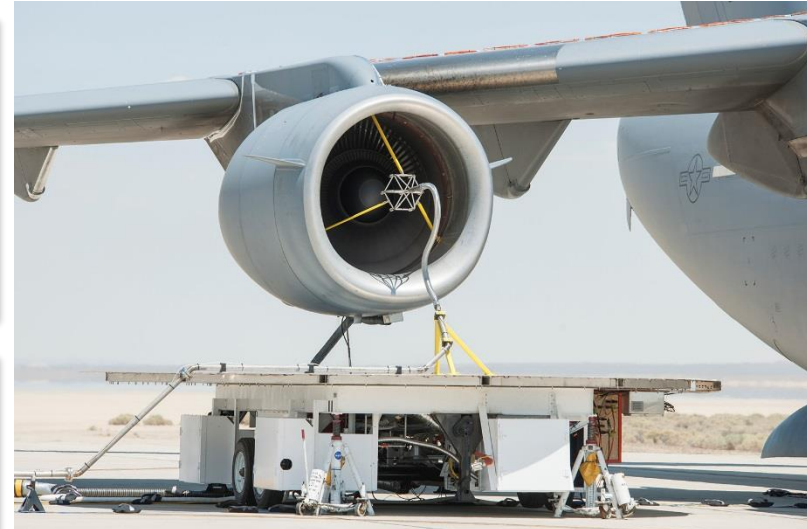
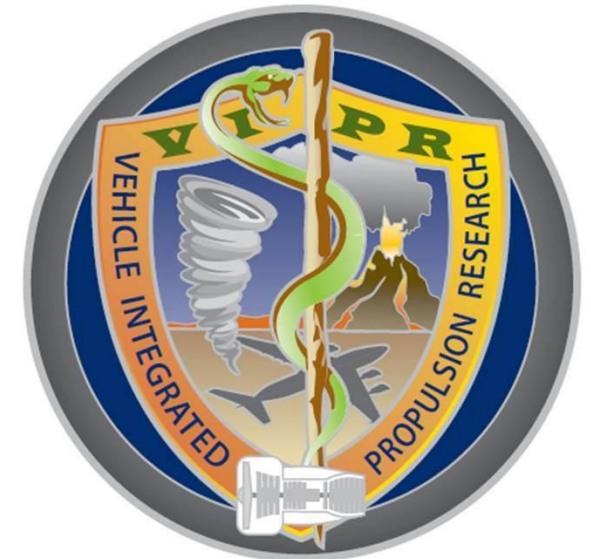
VIPR 2 (JULY 2013): INTEGRATED CORE SENSORS

- SUCCESSFULLY INTEGRATED EXPERIMENTAL TECHNOLOGIES
 - MICROWAVE BLADE TIP CLEARANCE SENSOR
 - THIN FILM PRESSURE SENSORS
- DETECTED & CHARACTERIZED INDUCED FAULT IMPACTS

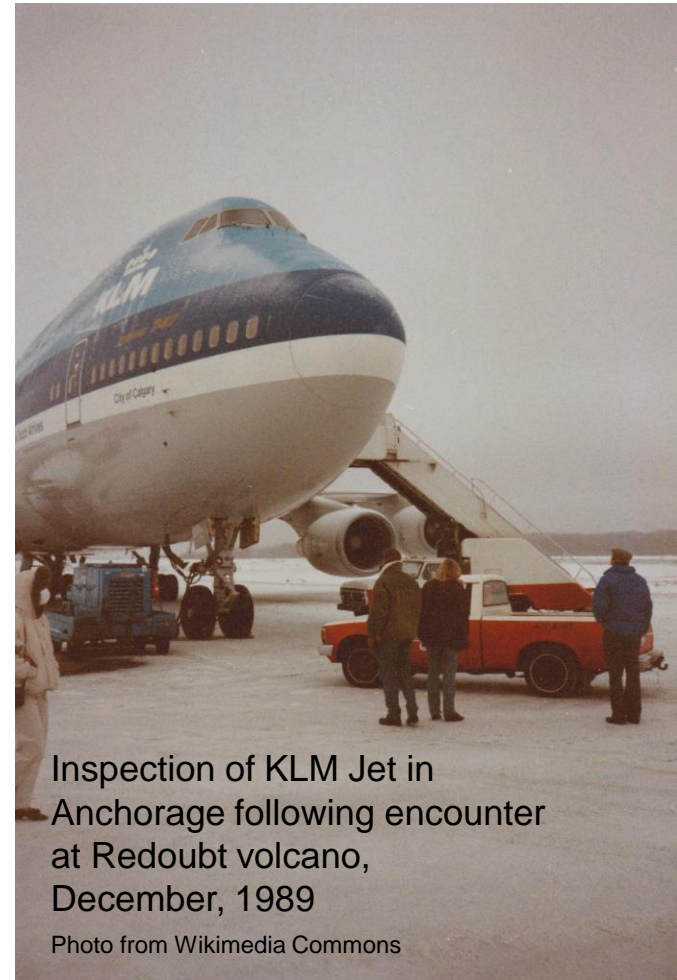
Inspection of KLM Jet in Anchorage following encounter at Redoubt volcano, December, 1989

- From 1952 to 2009, according to a recent study¹, there have been:
 - 129 incidents of planes flying into ash clouds
 - 79 with airframe or engine damage, i.e. about 2 per year since 1976, and
 - 9 with total engine shutdown during flight
- Some most significant encounters:
 - A Boeing 747 flying into an ash cloud at Galunggung Volcano, Indonesia, October 8, 1982, losing power to all four engines, dropping from 36,000 to 14,000 feet before restarting; and
 - A Boeing 747 flying into the ash cloud from Redoubt volcano, Alaska, December 15, 1989, losing power to all engines.

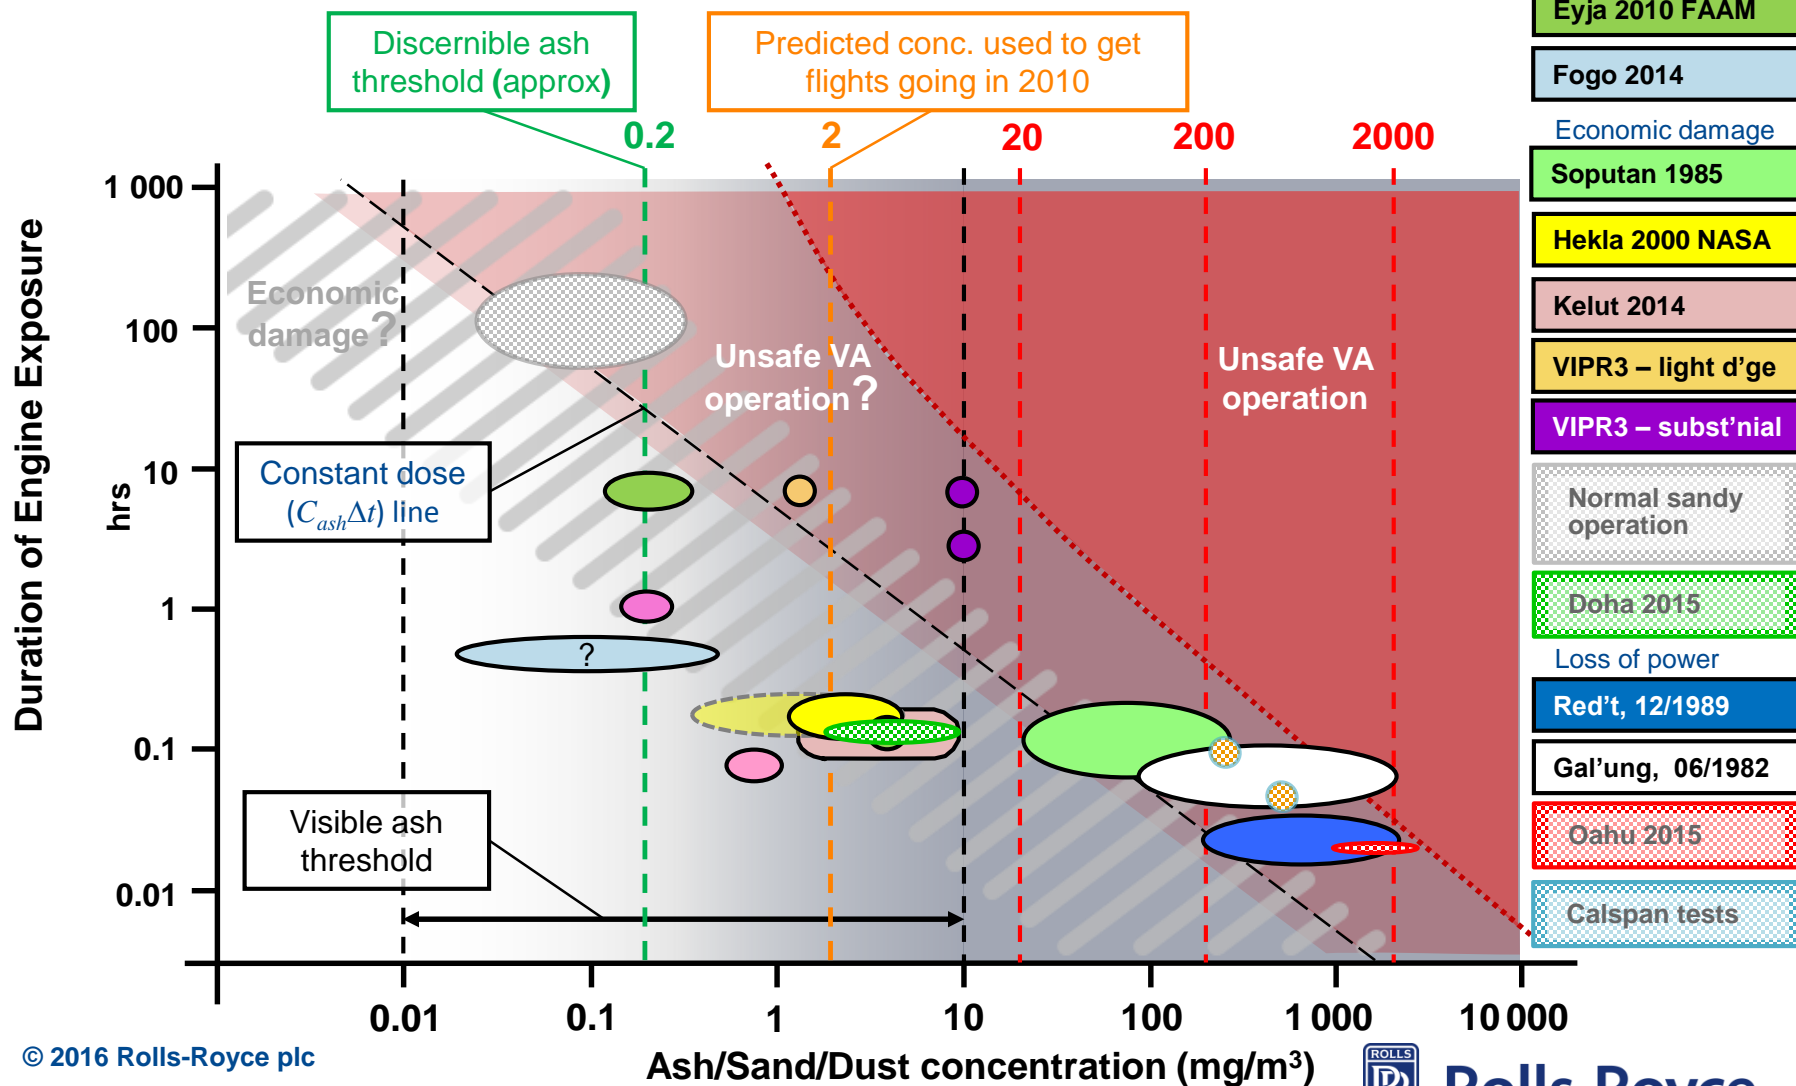
- The DEvAC chart – with latest 2014-2015 data

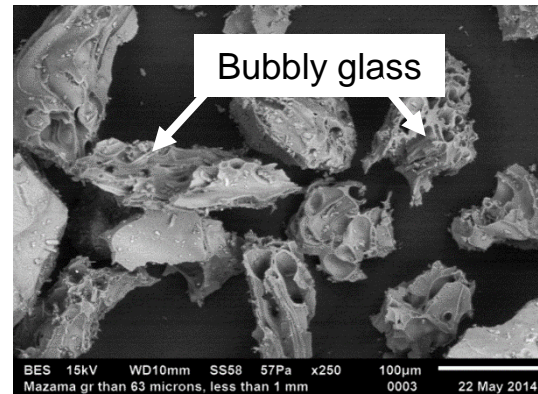
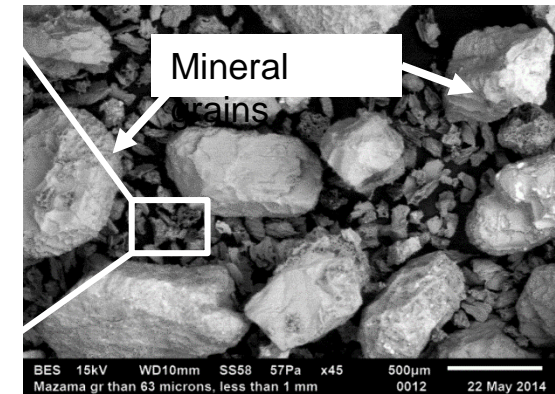
Natural ash fragments from deposit

- The *natural deposit* contained about
 - 10% mineral grains
 - 90% bubbly glass
- The *milled and processed ash* contained no mineral grains that we could find
- We think that most mineral grains were separated out during processing
- The final product was a powder with size range from about 5 to 100 microns

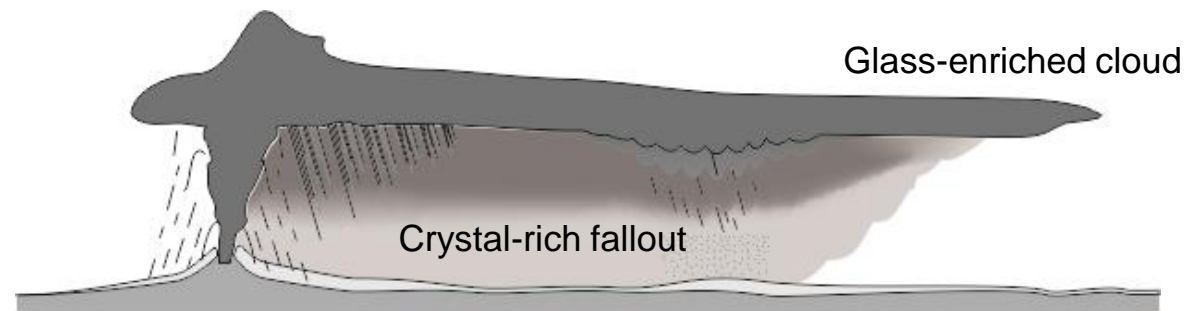
- In real ash clouds crystals fall out first, leaving distal clouds enriched in glass.
- Distal clouds typically contain ash particles tens of microns in size or smaller.
- In these respects, the test ash resembles natural ash in clouds

Particle size Meters to
microns
Distance 0 km

Microns to tens of
microns
1,000 km

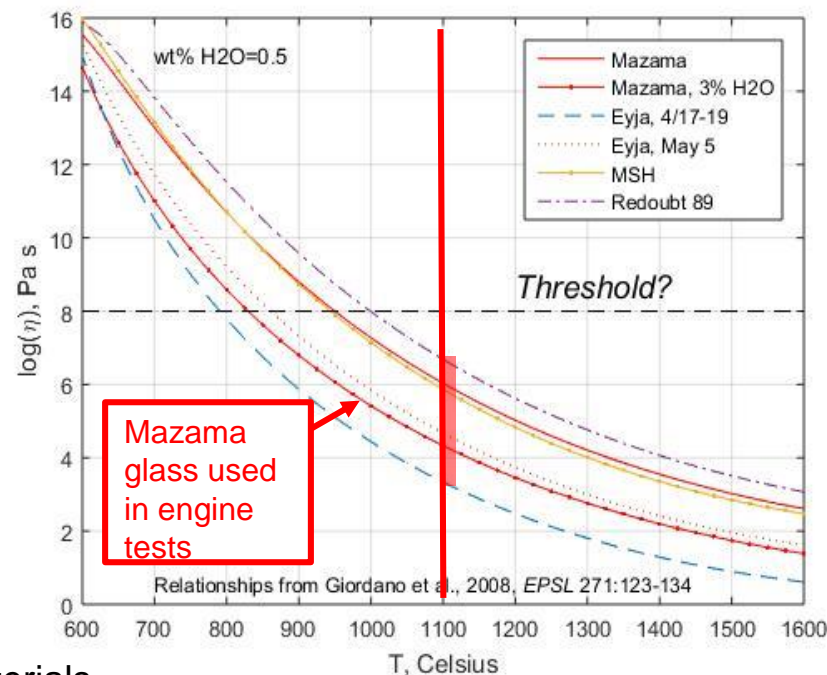
Glass viscosity

- The right-side plot shows the viscosity of this glass relative to other volcanic glasses that have been involved in ash-aircraft encounters
- This viscosity of the test glass is within the range for these other volcanic glasses
- At an operating temperature of 1100° Celsius, viscosities of all these glasses are well below the threshold of about 10⁸ Pascal seconds, below which ash should soften and coat engine parts.
- We are therefore confident that softening occurred during testing.

- No single type of ash is representative of all volcanic materials
- Ash viscosity, the primary factor that determines softening within an engine, can vary over several orders of magnitude.
- The Mazama Ash, used in the VIPR-III engine tests, lies within the range of viscosity of volcanic materials known to have been involved in past aircraft encounters.

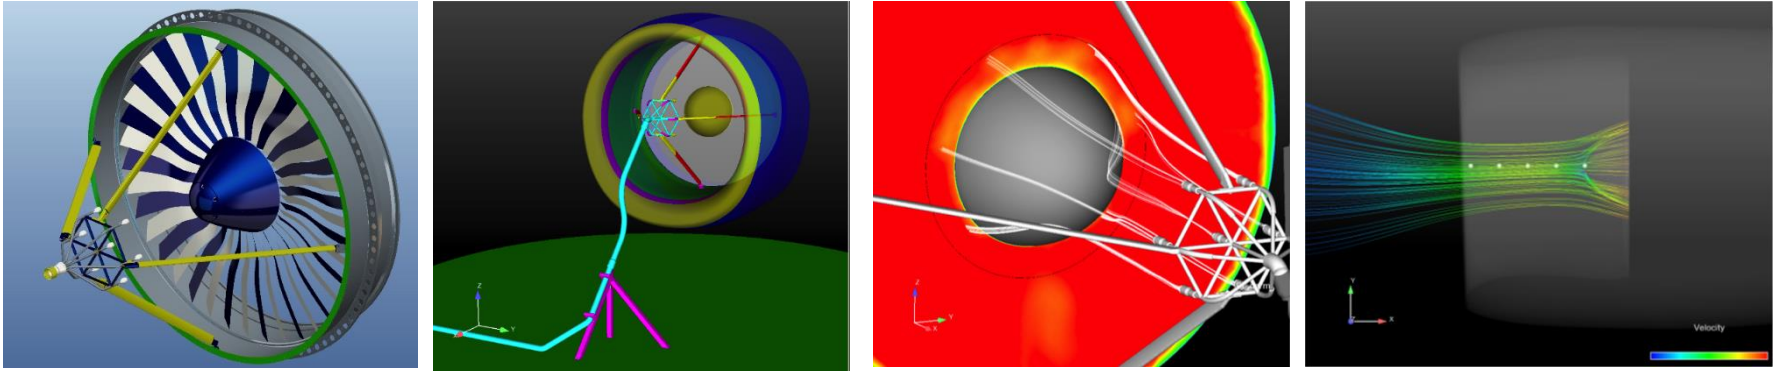
Modeling and Analysis Confirm Controlled Flow into the Core Stream

- The ash did flow into the core stream
- Ash flow was controllable
- The engine ran unabated by the SPIDER/VADR installed in the inlet

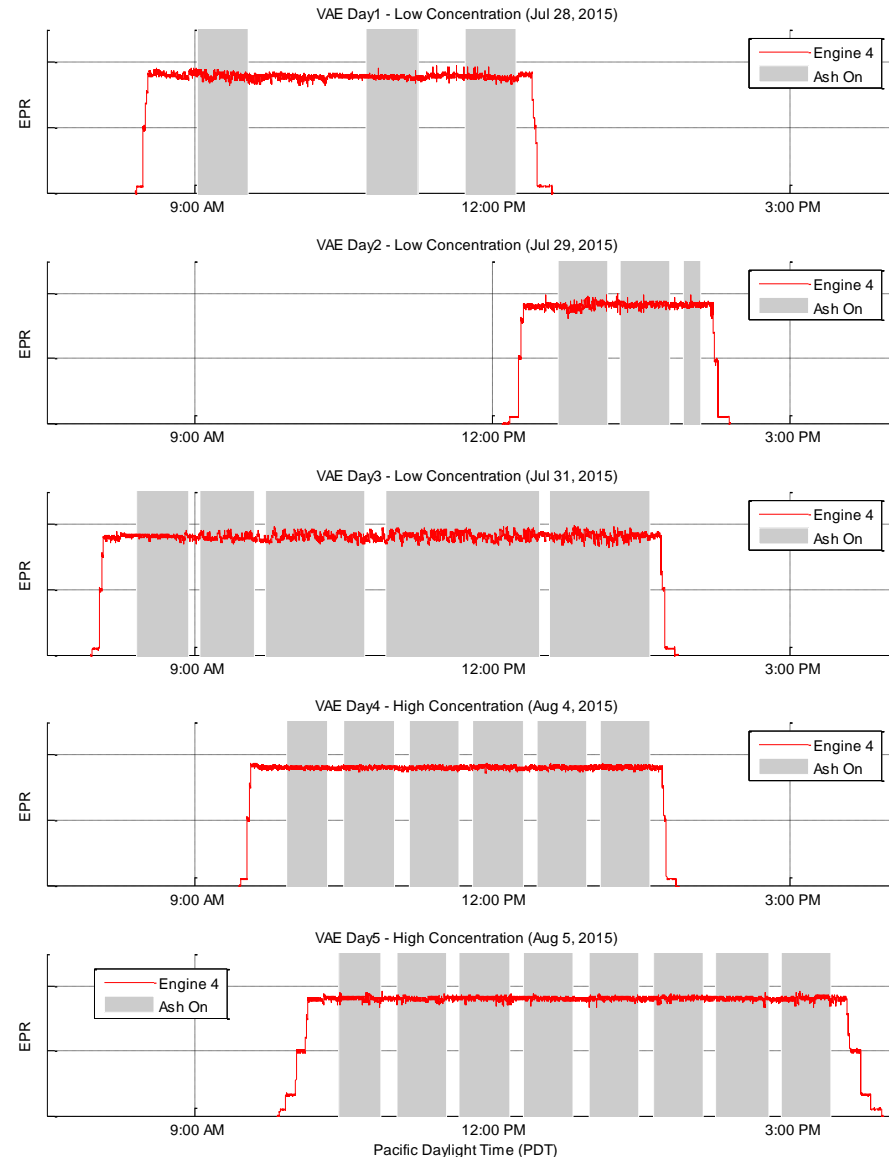
Run duration and amount of ash ingested in engine over 5 days of ash ingestion testing

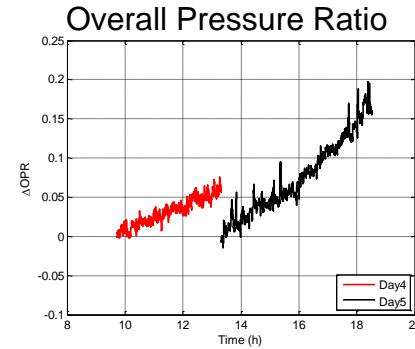
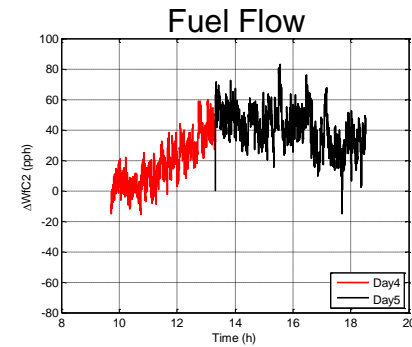
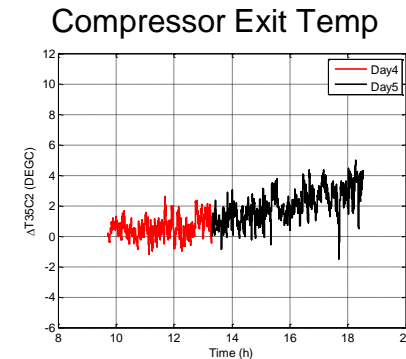
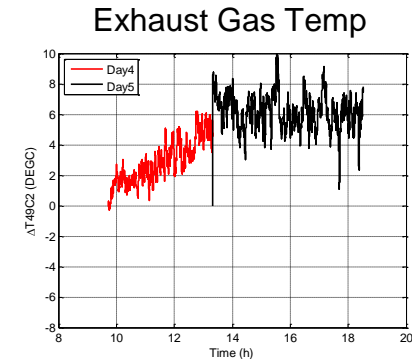
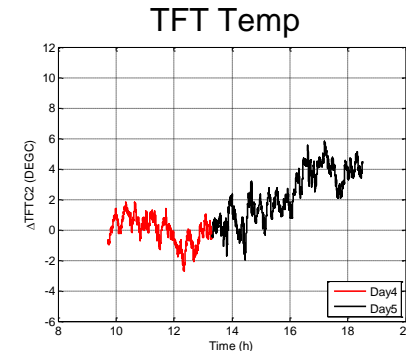
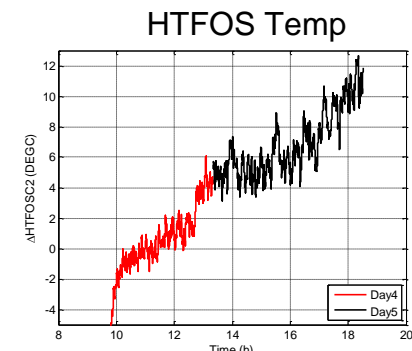
VAE Performance Trend Shifts – Day 4 & 5

Gas Path Measurement Data – Volcanic Ash Test Runs

- Five (5) days of volcanic ash ingestion testing
 - Days 1, 2, and 3 ran low concentration ash ingestion
 - Days 4 and 5 ran higher concentration ash ingestion
- No significant engine performance variations were observed during low concentration ash runs
- On high ash concentration run days, discernable performance trend changes were observed in overall pressure ratio (OPR), fuel flow, compressor exit temperature, and exhaust gas temperature.
- Advanced sensor data tracks performance changes observed elsewhere in engine
 - High Temperature Fiber Optic Sensor (HTFOS) trends with exhaust gas temperature
 - Thin Film Thermocouple (TFT) trends with compressor exit temperature

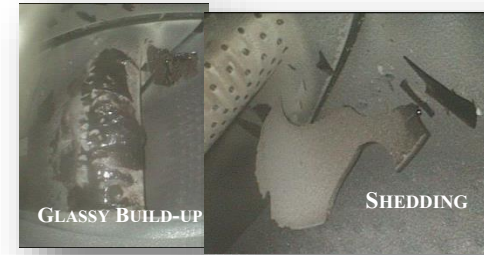
GLASSY BUILD-UP

SHEDDING

TURBINE MOLTEN ASH GLASSY BUILD-UP

ASH SHEDDING
