Implementation of Fiber Optic Sensing System on Sandwich Composite Cylinder Buckling Test

Francisco Peña,¹ W. Lance Richards,² Allen R. Parker,³ Anthony Piazza⁴
NASA Armstrong Flight Research Center, Edwards, CA 93523, USA

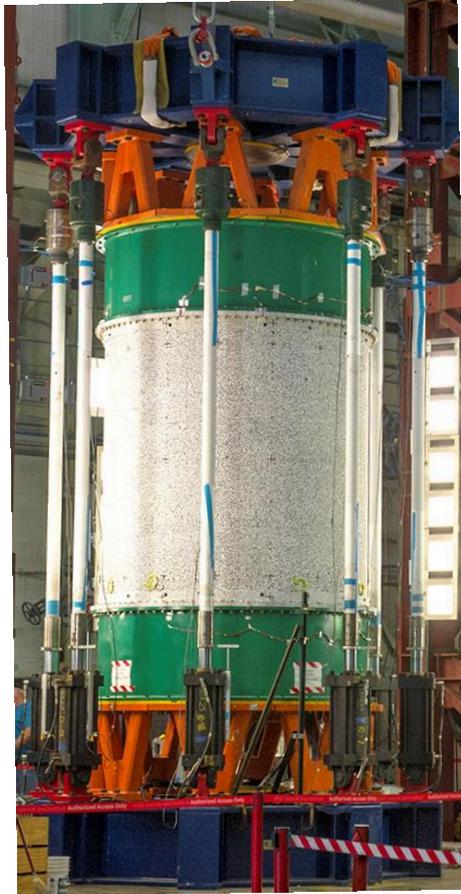
Fig. 1. The CTA8.1 test assembly.

THE National Aeronautics and Space Administration (NASA) Engineering and Safety Center (NESC) Shell Buckling Knockdown Factor (SBKF) project is a multicenter project with the goal of revising buckling design guidelines for selected metallic and composite launch-vehicle shell structures. As part of this effort, several large-scale structural buckling tests will be used to validate high-fidelity buckling simulations used in the development of new buckling knockdown factors. The first composite shell that was tested as part of SBKF was an eight-foot diameter and 10-foot tall sandwich composite cylinder that was fabricated by Northrop Grumman Corporation (Falls Church, Virginia) and was designated “Cylinder Composite Test Article 8-foot-diameter design 1” (CTA8.1). See Ref. [1] for a detailed discussion of this test. This cylinder underwent a series of subcritical axial compression, and combined compression and bending load cases prior to the final load sequence of axial compression up to buckling failure. The sandwich composite cylinder was potted into two interface rings (top and bottom) using an epoxy potting compound and tested in a self-reacting load system. The system applied load to the cylinder through a top and bottom load-introduction structure, as shown in Fig. 1, with eight hydraulic actuators. The load system transferred the load to the composite cylinder through the interface rings. Interface ring bolts were also present as a failsafe measure in case the epoxy potting material failed during testing. During the load sequences, the axial compression loads ranged to more than 850,000 lb, and the equivalent combined compression and bending loads ranged to more than 22 million in-lb. Axial load sequences were executed by applying uniform load to all hydraulic actuators. Combined compression and bending loads were applied by linearly varying loads from 20% of predicted critical load applied load at a designated circumferential position, to zero applied load at 180° circumferential offset. See Ref. [1] for a detailed discussion of this test.

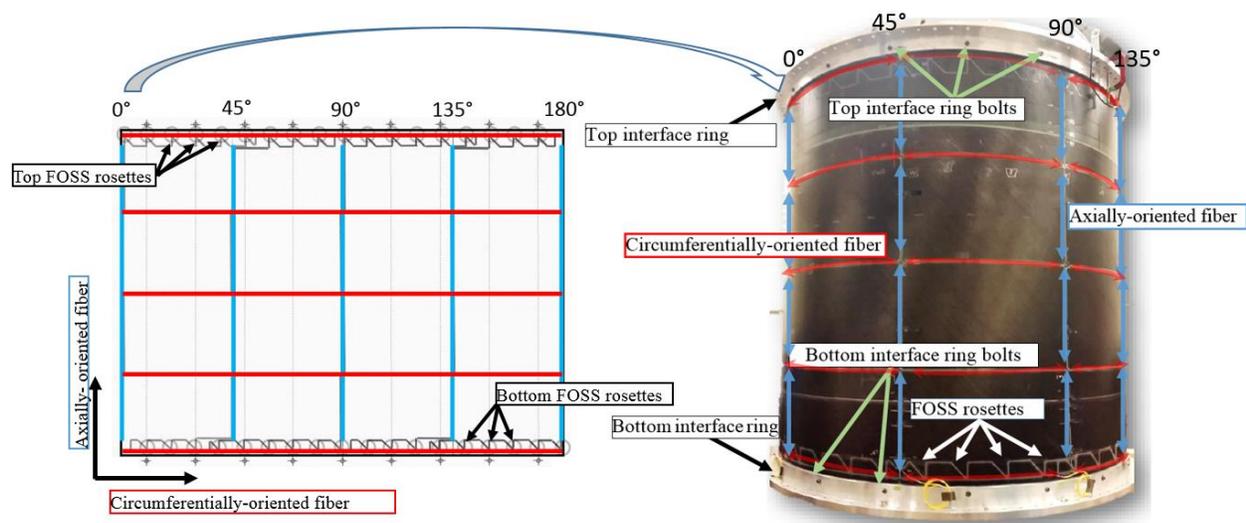
Fig. 2. The FOSS instrumentation layout on the outer mold line.

The primary objective of the FOSS layout was to monitor the load introduction to the composite cylinder by measuring strains near the top and bottom attachment rings. Continuous circumferential fiber optic strain sensors were installed on the test article approximately one inch below the top interface ring and one inch above the bottom interface ring on both the OML and IML. Adjacent fiber optic strain sensors were then installed near the interface rings with varying orientations in order to provide fiber optic strain sensor rosette measurements (see Fig. 2), which are used to provide qualitative principal strain magnitudes and strain orientations.

The secondary objective of the FOSS layout was to characterize the global strain response of the test article. Eight essentially continuous axial and five essentially continuous circumferential stations were installed on both the OML and IML. The axial and circumferential stations were not completely continuous due to the interleaving of multiple fibers; a one-inch bend radius was used in the fiber optic sensor layout to minimize light loss. The fiber optic strain sensor layout in circumferential and axial orientations as well as the sensor installation on the test article is provided in Fig. 2. Throughout this paper the circumferentially-oriented fibers are aligned horizontally, and the axially-oriented fibers are aligned vertically. The locations of the interface rings with the interface ring bolts are also shown in Fig. 2. It should be noted that all optical fibers were installed in a mirrored configuration on the OML and IML so that membrane and bending strains could be calculated.

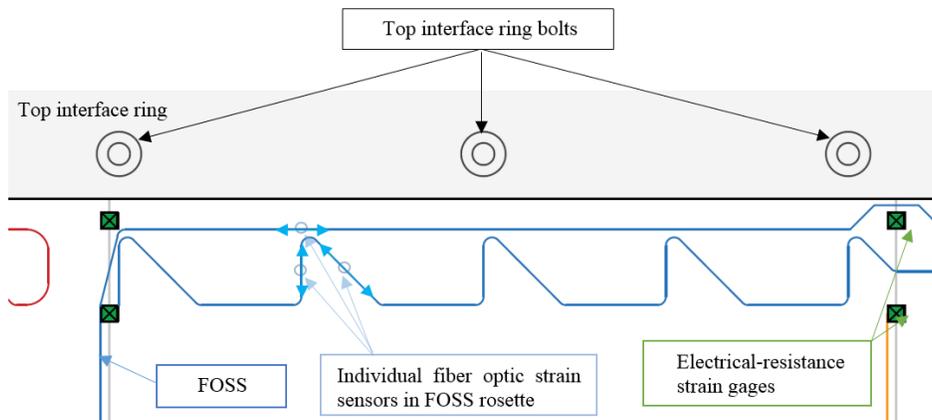
Fig. 3. The FOSS rosette layout.

Fiber optic strain sensing strain rosettes were installed on the test article adjacent to both of the interface rings in order to monitor the boundary conditions near the loading ring attachment points. A partial diagram of the FOSS strain rosette relative to the top interface ring bolt is presented in Fig. 3. Each interface ring had 18 radial bolts (every 20° around the circumference) (Fig. 2 and Fig. 3). Fiber optic strain sensing strain rosettes were installed in line with and midway between bolts in order to interrogate the influence of the bolts on the introduction of the load. Thirty-six FOSS strain rosettes (one every 10°) thus were used on each of the top and bottom IML and OML, for a total of 144 FOSS strain rosettes. The FOSS strain rosette measurements were used to provide a qualitative measurement of the load introduction onto the test article and to verify that the loading was applied as intended: either uniform compression or varying for applied combined compression and bending cases.

A valid strain rosette requires three strain measurements in three unique orientations at a single point. Due to a trade-off between fiber optic cable bend radii versus signal loss, the bend radius of the FOSS layout was limited to 0.5 inch. This relatively large bend radius caused each leg of the FOSS strain rosette to be spaced approximately 2.5 inches from the next. The spacing between the individual legs of a rosette might not be a problem in areas of low strain gradients, but accuracy is lost in areas having high strain gradients. High strain gradients were observed at both interface rings and are discussed below. The FOSS strain rosettes thus are used for qualitative purposes only.

Each FOSS strain rosette leg measured strains in one of three unique orientations (circumferential θ_C , axial θ_A , and at a diagonal 45° angle θ_D) as shown in Fig. 3 and Fig. 4(a). Data from these rosettes were then processed to calculate the principal strain magnitudes (ϵ_1 and ϵ_2) and the principal strain angle (θ_p).

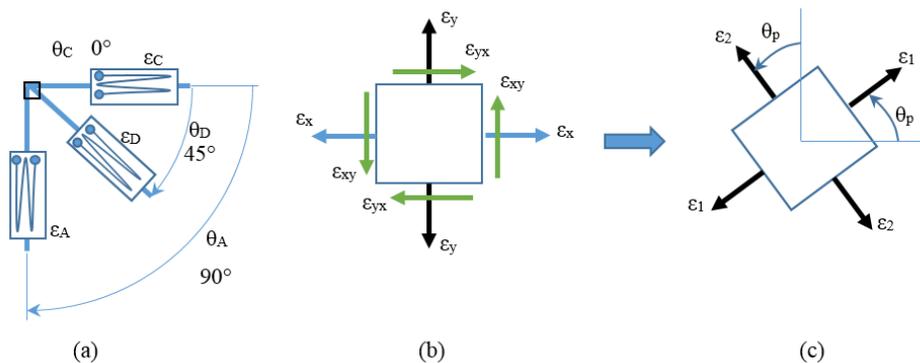
Fig. 4. (a) three-element rectangular rosette of a traditional strain gage; (b) element strains at given coordinate; and (c) element strain transformed to principal coordinate.

where ε_C is a strain measurement oriented in the circumferential direction, ε_D is a strain measurement oriented diagonal 45° from the circumferential direction toward the axial direction, and ε_A is a strain measurement in the axial direction; see Fig. 4(a). The reference angles for each leg of the rosette are θ_C, θ_D and θ_A , which are also illustrated in Fig. 4(a). The axial and circumferential directions were chosen as the two reference orthogonal orientations, therefore ε_x is the circumferential strain, ε_y is the axial strain, and γ_{xy} is the shear strain relative to the circumferential and axial orientation and is the sum of shear terms ε_{xy} and ε_{yx} in the strain tensor; see Fig. 4(b). Once the two orthogonal strains (ε_x and ε_y) and shear strain (γ_{xy}) are obtained, the principal strain magnitudes (ε_1 and ε_2) and principal strain angle (θ_p) can be calculated (Ref. [3] and Ref. [4]) using Eqs. (2) and (3).

An illustration of element strain transformed to principal coordinate is illustrated in Fig. 4(c). Equation (2) is used to compute the principal strain magnitudes and Eq. (3) is used to compute the principal strain angle. The primary loading condition being axial compression, the minor principal strain (ε_2) was monitored since it corresponded to the largest compressive strain. (The axial leg of a FOSS strain rosette would have the largest effect on the minor principal strain.) An example of the real-time minor principal strain indicator along the aft IML for a uniform compressive load of $50\% P_{cr}$ (critical buckling load, calculated using linear eigenvalue finite-element analysis as the buckling load of the nominal cylinder design) is presented in Fig. 5. The average minor principal strain from the FOSS strain rosette was $-1,365$ microstrain. Variations in the minor principal strains may be due to a combination of FOSS measurement system uncertainty, large rosette size and local stress or strain concentrations from the attachment-ring interface that may have affected one or more of the three independent legs of the FOSS strain rosettes.

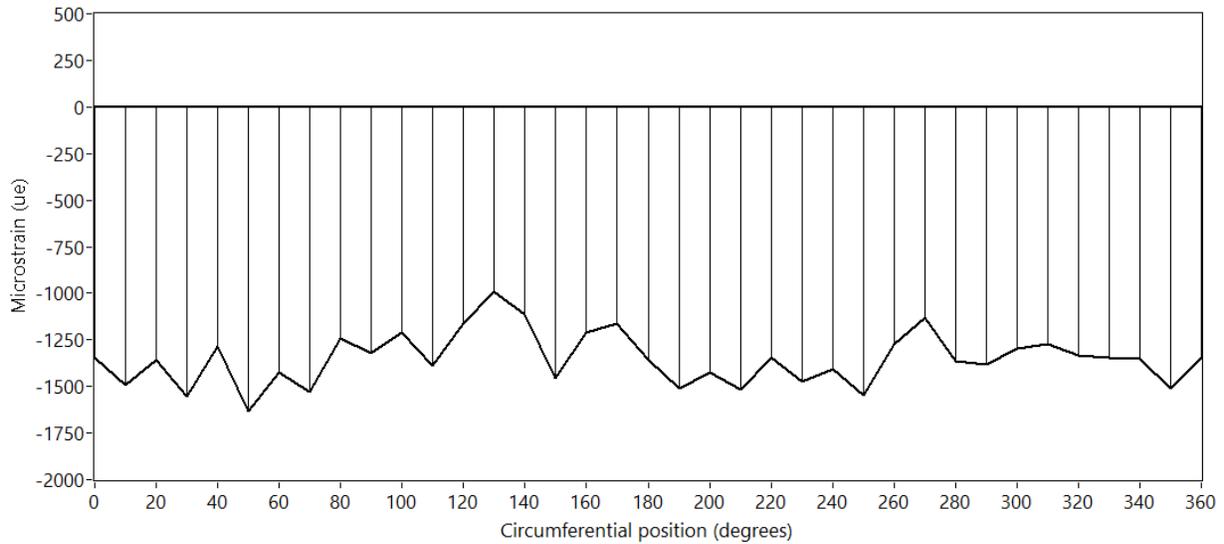
Fig. 5. An example of the real-time minor principal strain indicator along the aft inner mold line for a uniform compressive load of $50\% P_{cr}$.

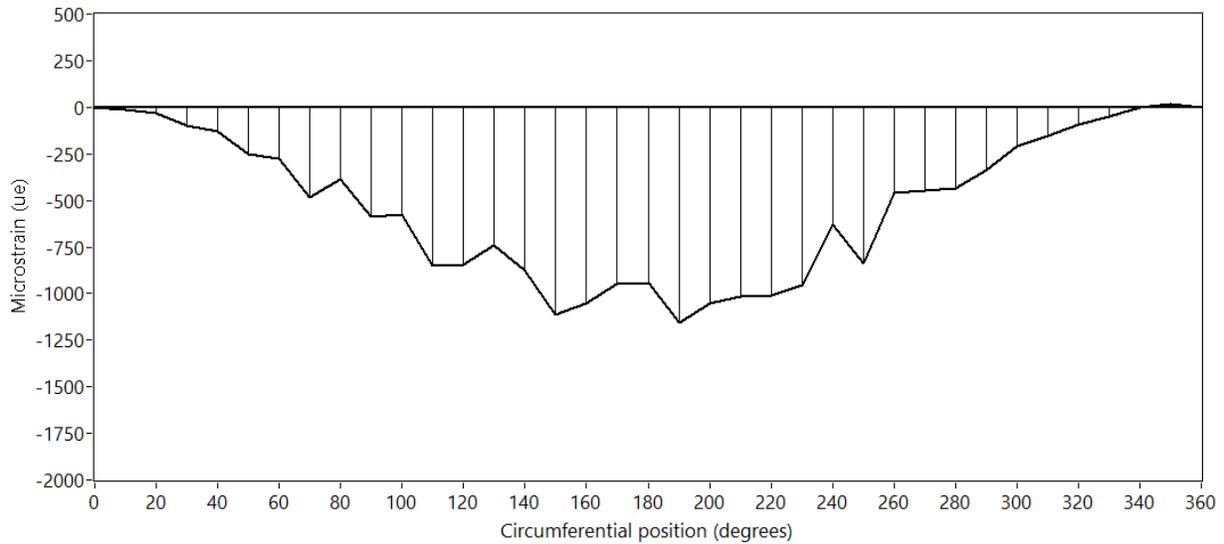
Fig. 6. An example of the real-time minor principal strain indicator along the aft inner mold line for a compression and bending load case with maximum applied compression at the 180° circumferential position.

An example of the real-time minor principal strain indicator along the aft IML for a compression and bending load case with maximum applied compression at the 180° circumferential position is presented in Fig. 6. In this figure, it is seen that the minor principal strain reaches maximum compression at the 180° circumferential position. It is evident that the load tapers off as a function of circumferential position and reaches its lowest compressive strain at the 0° circumferential position and the 350° circumferential position. These rosette measurements indicate that the bending loads with maximum compression near 180° were imparted to the cylinder as intended. Variations in the minor principal strains may be due to a combination of measurement uncertainty and local stress or strain concentrations from the attachment-ring interface that may have affected one or more of the three independent legs of the FOSS strain rosettes.

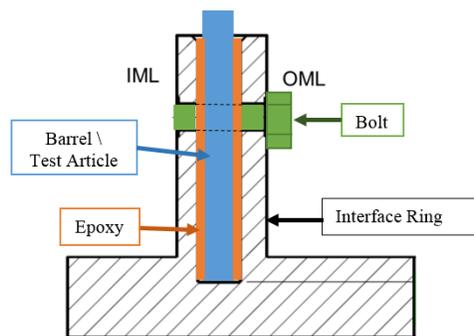
Fig. 7. Cross section of the interface-ring region of the CTA8.1 test-article assembly.

During axial load cases ranging from 20% to 50% P_{cr} , several “popping” noises were heard by test engineers. These audible “pops” were found to correlate with localized abrupt increases in strain radiating from multiple sources near the interface-ring-to-bolt interface. An illustration of the interface-ring region of the CTA8.1 test-article assembly is shown in Fig. 7.

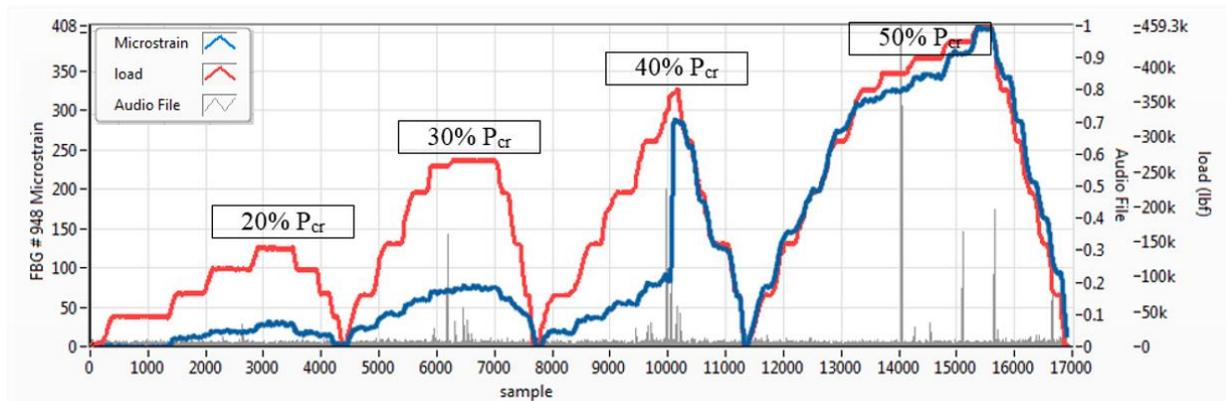
Fig. 8. Example of a “pop,” recorded microstrain at the 30° circumferential position near the interface ring (blue), recorded load profile from load sequences 20% to 50% P_{cr} (red), and normalized microphone audio file (gray).

Data of a single FBG on a circumferential fiber at the 30° circumferential position and adjacent to the interface ring, data from the axial load cells, and the normalized audio data from a microphone are overlaid in Fig. 8 and plotted against sample number (equivalent to time). The data presented in Fig. 8 were collected from multiple load sequences ranging from 20% to 50% P_{cr} . Each load sequence included planned hold periods in order to allow test engineers to evaluate the state of the structure under load. The 20%, 30%, 40% and 50% P_{cr} compression load sequences were executed over three days of testing, therefore the data sample number, rather than time, is provided.

The data presented in Fig. 8 indicate that prior to sample 10,000 the amount of strain (blue) experienced by the barrel was essentially proportional to the applied load (red). At approximately sample 10,000, an abrupt increase in strain occurred, without an abrupt change in applied load, and an audible “pop” was recorded. After sample 10,000, the relationship between applied load and strain changed. These sensor readings were not necessarily an indication of substrate damage directly underneath the sensor, but an indication that the local stiffness changed, which resulted in a change in the load field that was observed by the sensor. It was assumed that the material failure was localized since the results of the event were not captured by instrumentation elsewhere on the structure. These local damage events did not impact the load-carrying capability of the global structure. Additional audio events occurred throughout testing that did not impact the individual strain sensor at circumferential position 30° (Fig. 8).

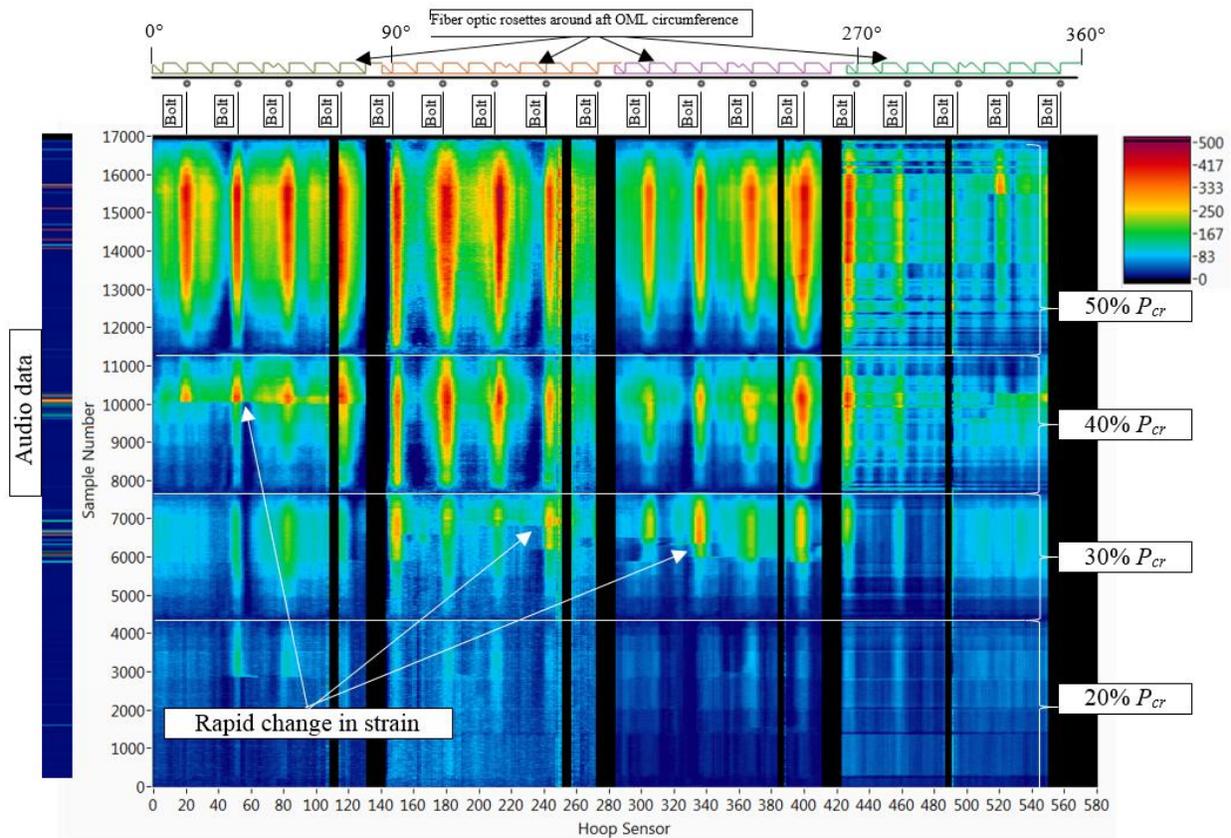
Fig. 9. Two-dimensional intensity plot of hoop strain (color ramp) above the bottom interface ring plotted around circumference (x-axis) versus sample number (y-axis) for load sequences from 20% to 50% of P_{cr} .

The distributed strain data from FOSS can be used to create two-dimensional (2D) contour plots of the strain magnitude plotted against both the sensor location around the circumference of the barrel and against the accumulated sample number indicating axial load case (ranging from 20% to 50% P_{cr}). As an example, such a 2D contour plot for circumferential hoop strain gradients around the aft OML circumference is shown in as Fig. 9, in which the contour indicates the strain level, the horizontal axis indicates the hoop sensor number (proportional to the circumferential position), and the vertical axis indicates the sample number (relating to the load sequence). Additionally, the fiber layout at the top of Fig. 9 indicates the circumferential position of the end-ring bolts and the FOSS rosettes. Comparing the circumferential positions of the high-strain (red) regions with the bolt holes indicates that the strain gradients were radiating from the interface-ring-bolt locations. At low sample numbers in low load levels, the strains around the circumference are reasonably uniform; however, the strains at the bolt locations increase, sometimes suddenly, as the load level increases. The first of these sudden changes in strain appears to occur at a sample number 3,000, and is seen most pronounced at sensor numbers near 50. Additional sudden increases in strain occur between sample numbers 6,000 and 7,000, and 10,000 and 14,000. It was believed that the circumferential strain gradients shown in Fig. 9 were indications that the bond between the epoxy potting and the composite barrel failed (in shear), resulting in a load path change. The epoxy initially provided a large area around the circumference of the barrel through which to distribute load. As the epoxy failed, the attachment ring bolts were left to carry the axial load. In comparison to the epoxy contact area, the bolt contact area was much smaller and caused high stress near the bolt-to-attachment-ring interface.

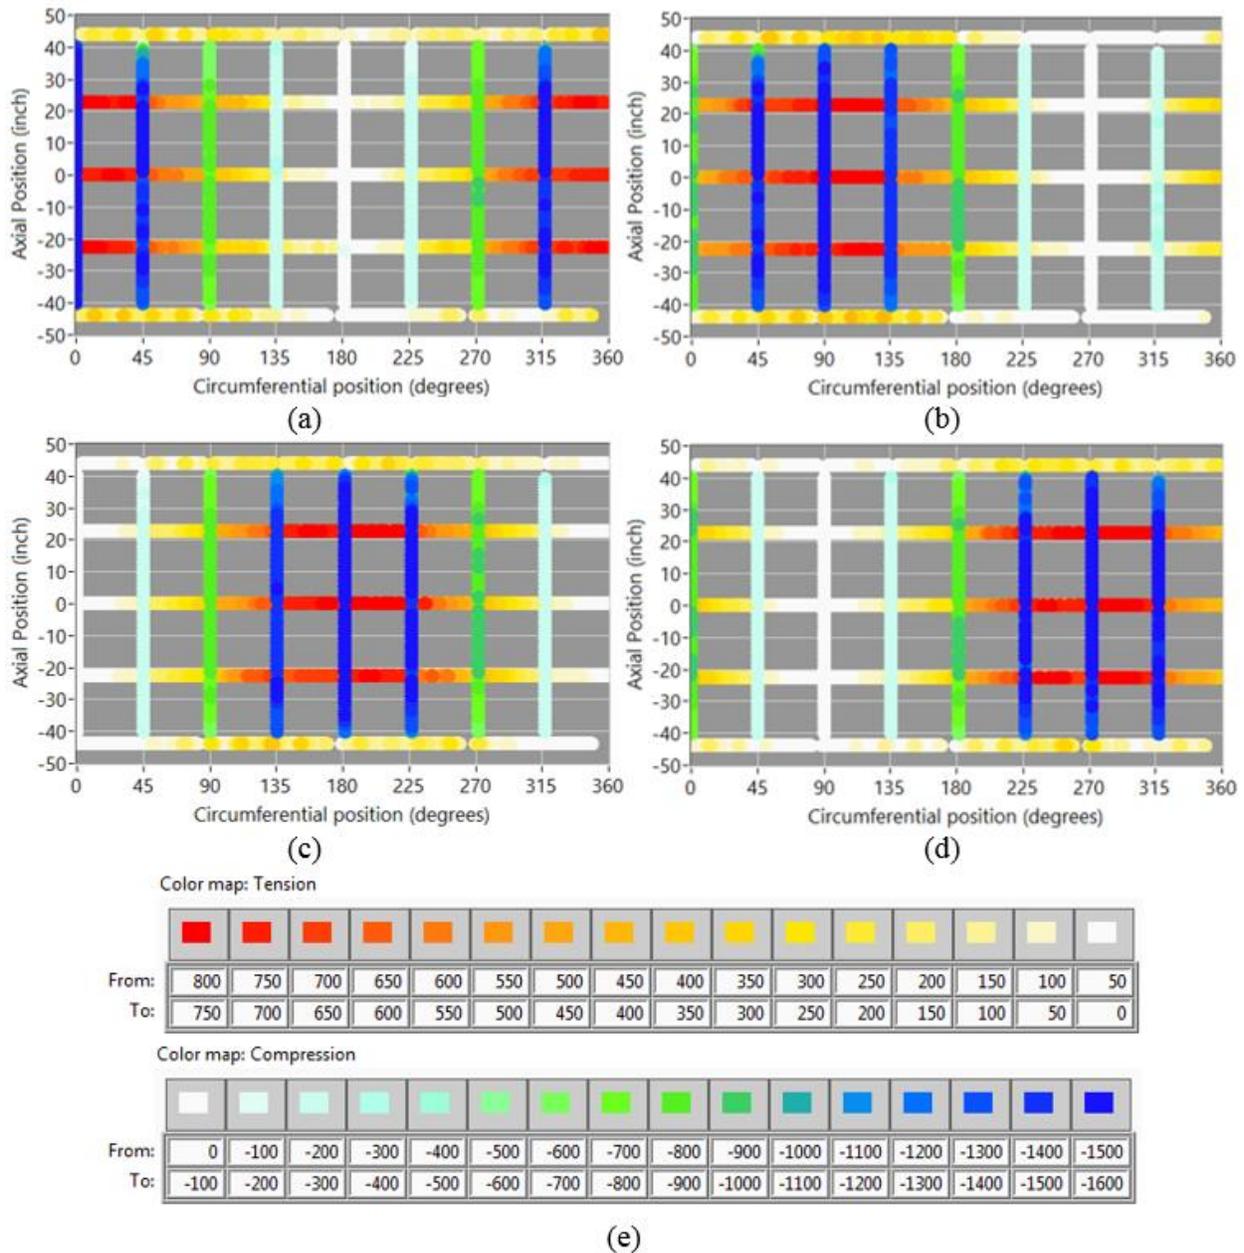
Fig. 11. Distributed strain measurement on the inner mold line during simulated compression and bending load cases with maximum applied compression at: (a) 0° circumferential position, (b) 90° circumferential position, (c) 180° circumferential position, (d) 270° circumferential position, and (e) microstrain color scale.

An example of the real-time 2D scatter plot displays of the distributed strain measurements data on the both IML at loads of 20%, 30%, 40%, and 50% P_{cr} , is presented in Fig. 10(a)-(e). Two independent color palettes were used so that both of the strain gradients in both the circumferential direction (tension strain) and the axial direction (compression strain) could be discerned. Since the applied loads were purely compressive, the tensile hoop strains were a result of Poisson's effect, and were therefore of smaller magnitude and opposite sign to the axial compressive strain. As shown in Fig. 10, the axial strains are plotted on a color scale of increasing compression from white to blue, and the hoop strains are plotted on a color scale of increasing tension from white to red.

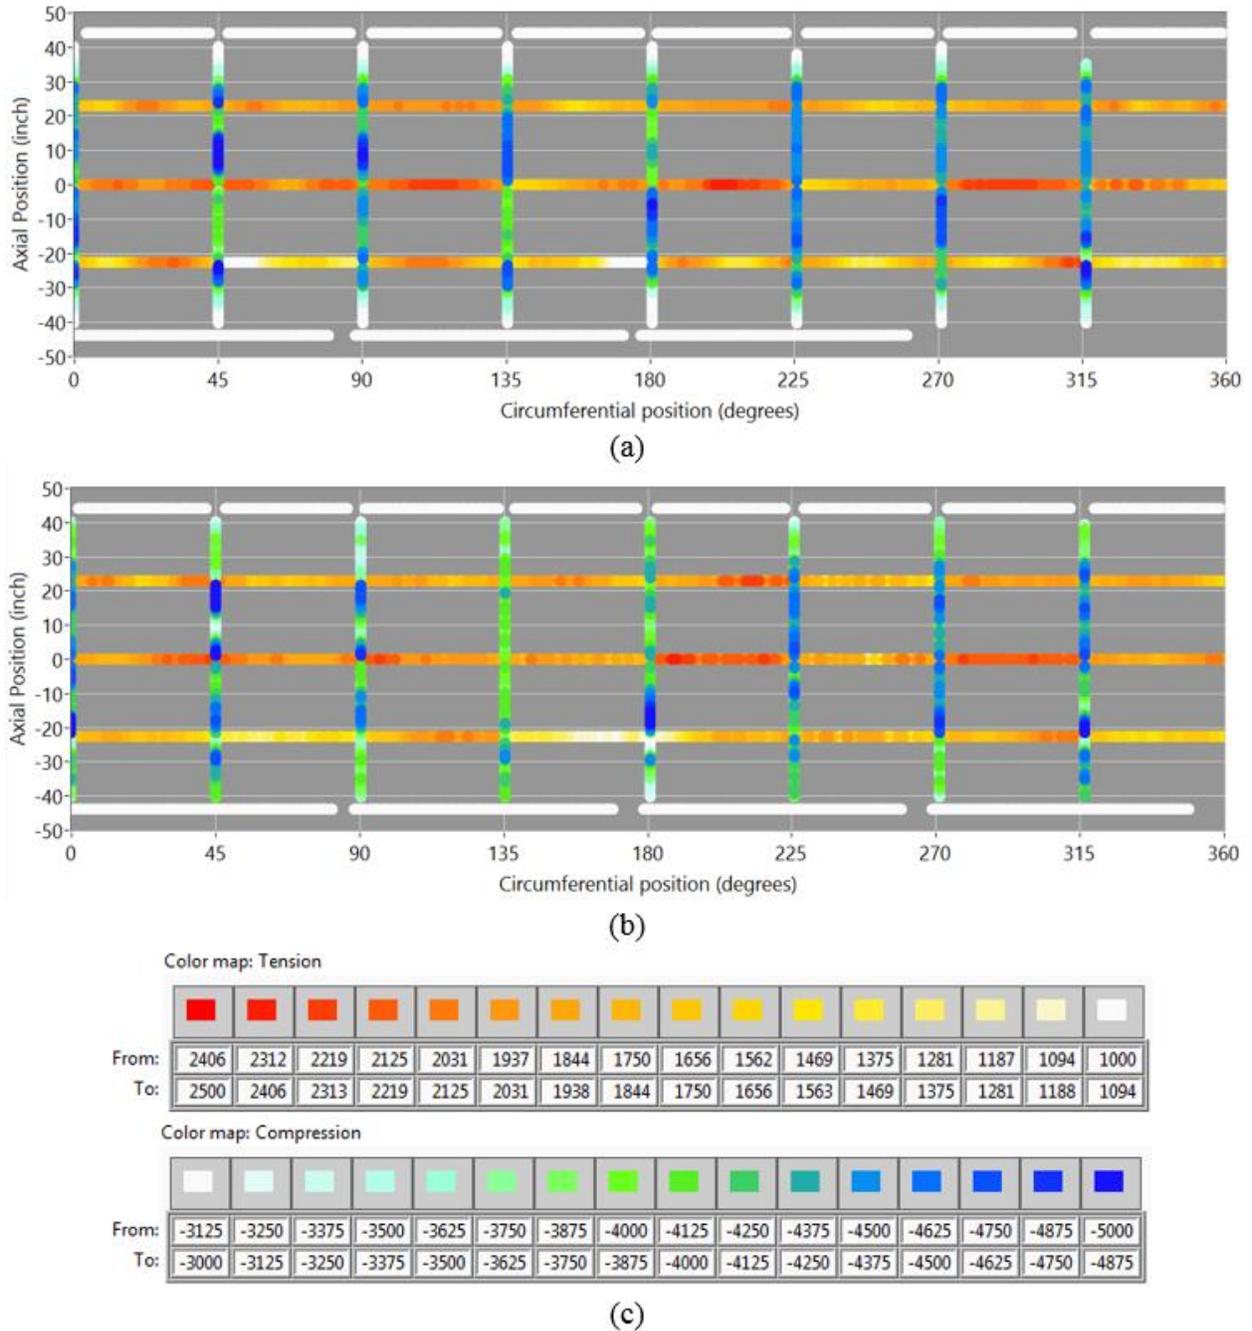
Fig. 12. Distributed strain measurement at 856,900 lbf compression, incipient to failure: (a) outer mold line, (b) inner mold line, and (c) strain color scale.

During the final load sequence, uniform axial compression load was slowly applied to CTA8.1 until catastrophic buckling occurred. The test article failed at 856,900 lbf. The FOSS strain distribution on the OML and IML incipient to failure is presented in Fig. 12. It is evident from this figure that the axial strains were not nearly as uniformly distributed as shown in Fig. 10 in the axial compression load cases at lower percentages of P_{cr} . This difference is due to non-uniform prebuckling deformations that grow with increasing loads.

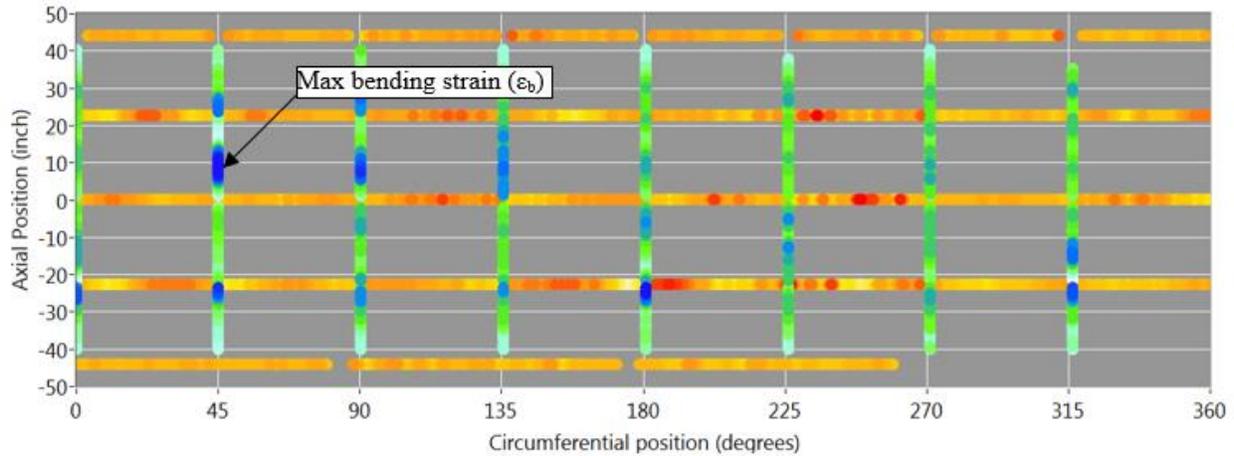
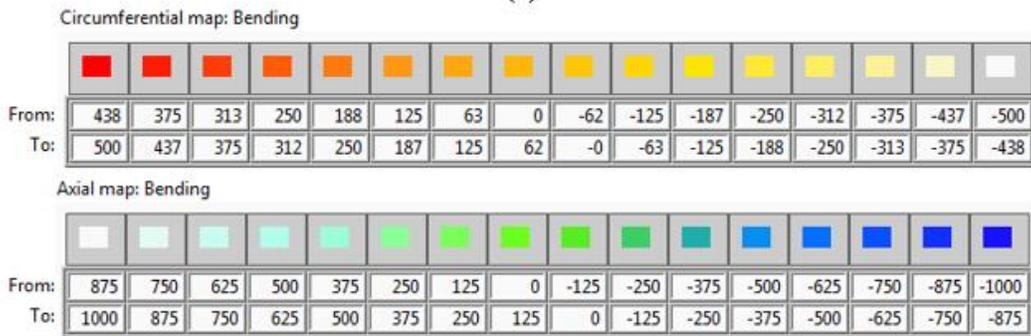
Fig. 13. (a) distributed bending-strain measurements at maximum load incipient to failure, and (b) bending-strain intensity color scale.

where $\epsilon_{OML,i}$ is the strain on the OML at the i th index station and $\epsilon_{IML,i}$ is the strain on the IML at the i th index. An image of the FOSS-calculated bending strains incipient to failure is presented in Fig. 13(a) and (b). In the absence of bending deformations in the cylinder wall during loading, the bending strains are zero, but when bending deformations begin to occur, the bending strains begin to grow in magnitude. Figure 13 shows that the maximum bending strain monitored by the FOSS just before failure was at the 45° circumferential position, and approximately 10 inches above the mid-height of the cylinder.

The load time history and the FOSS time histories of the OML and IML axial strains at the point of maximum bending strain identified in Fig. 13(a) and (b) and Fig. 15(a) and (b) are shown in Fig. 16. The left-hand vertical axis scale is the axial strain in microstrain for the OML (blue) and IML (green) FOSS measurements. The right-hand vertical axis scale is the indication of the magnitude of applied load (red). It can be seen in the figure that the OML and IML strains begin to deviate from one another at higher load levels due to the bending caused by the onset of buckling.

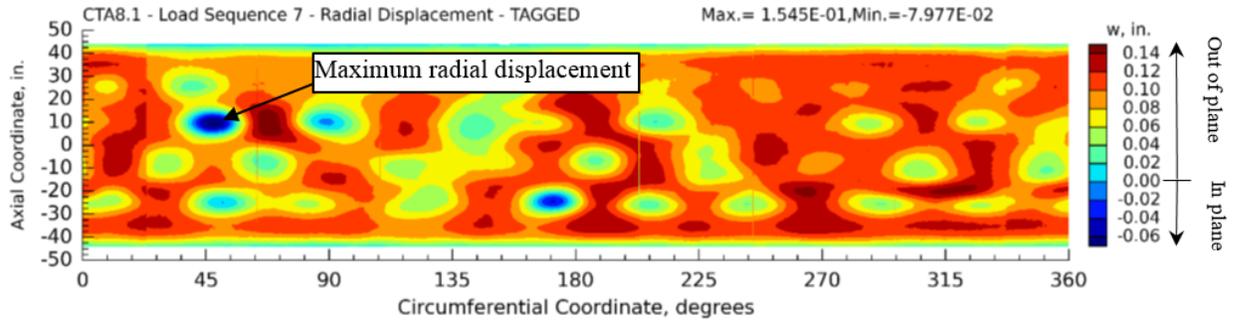
Fig. 14. Low-speed digital image correlation, outer mold line view, radial displacement contour plot incipient to failure.

Data captured from the high-speed DIC system provided additional evidence of the failure location for CTA8.1. Just before failure, the largest radial displacement was from an inward-facing dimple located at 45° in the circumferential coordinate and positive 10 inches above the mid-length of the barrel, which was moving inward faster than at any other location. The low-speed DIC results just prior to failure are presented in Fig. 14, where w is the radial displacement in inches. The high-speed DIC was able to capture the material rupture after loss of stability at the same location as the maximum bending strain measured from FOSS during failure.

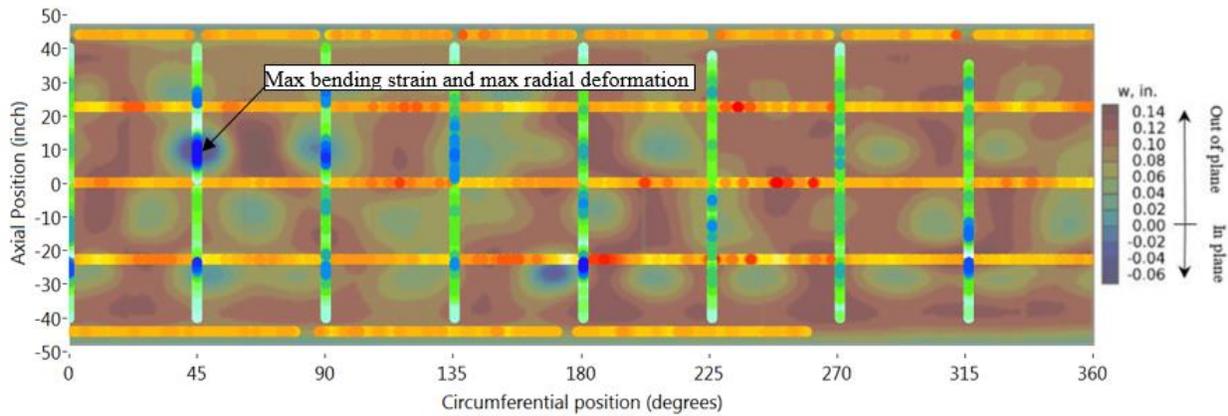
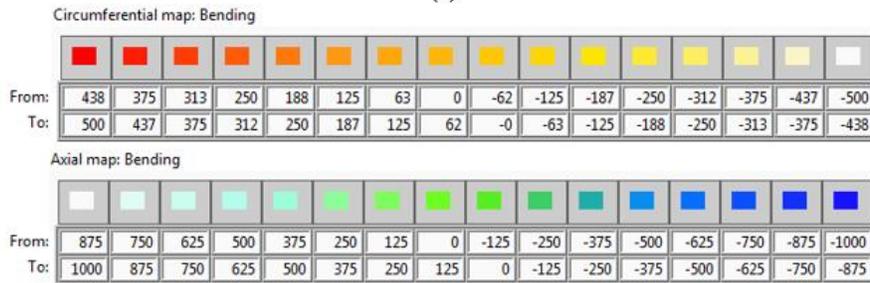
Fig. 15. (a) fiber optic sensing system bending strain overlaid on digital image correlation outer mold line radial displacement contour incipient to failure, and (b) bending-strain intensity color scale.

The combination of high density and the continuous nature of the distributed fiber optic sensing technology also enabled a comparison between the radial displacements captured by the DIC to the distributed bending-strain measurements. A comparison of the FOSS bending strain overlaid on the DIC radial displacement contour is presented in Fig. 15(a) and (b).

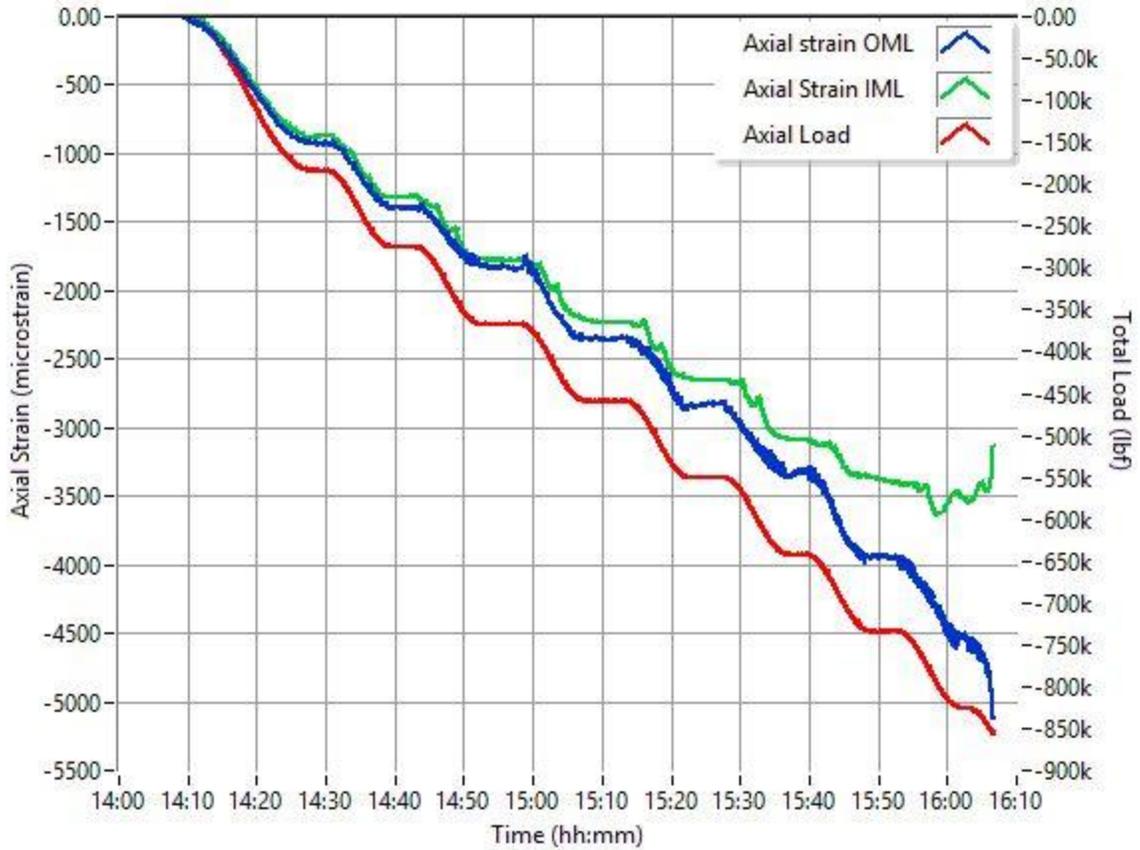
Fig. 16. Time history of outer mold line (blue) and inner mold line (green) axial strains at the location of maximum bending strain as compared to axial applied load (red).

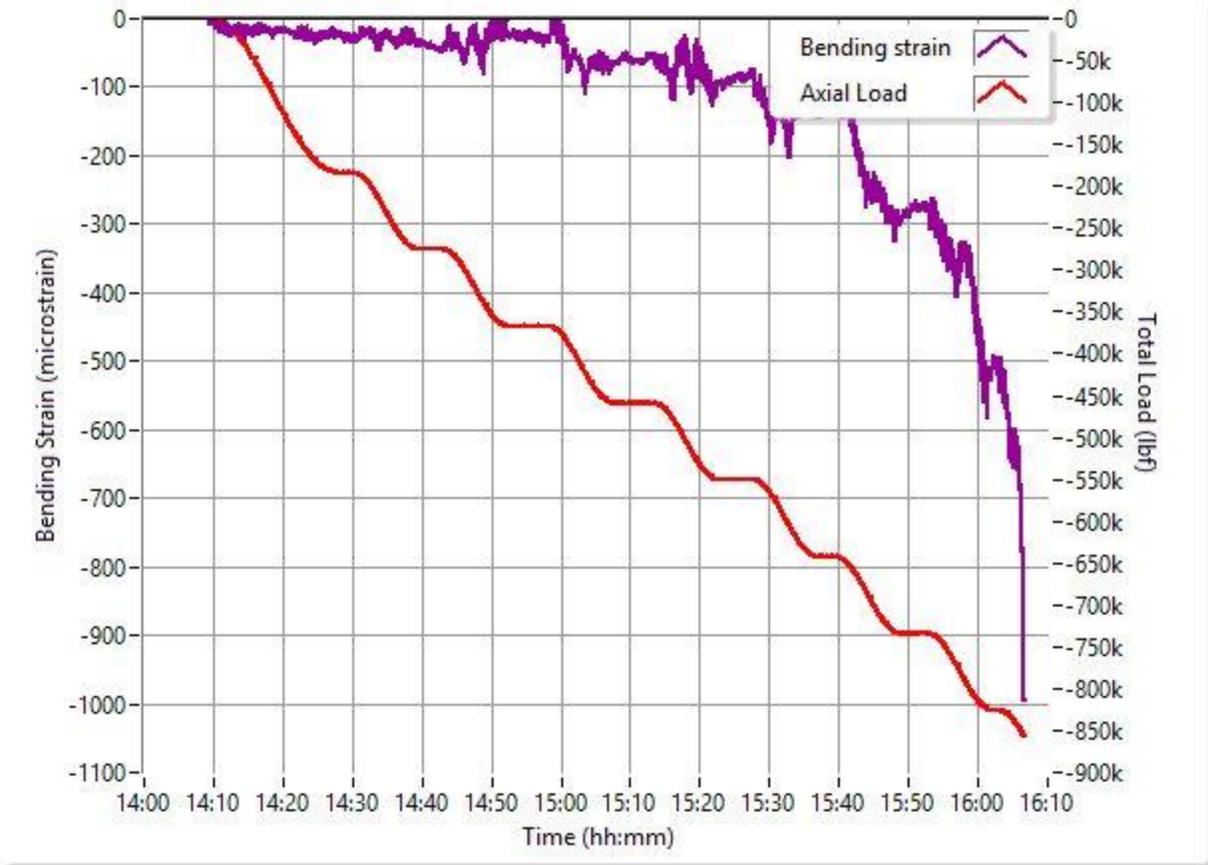
Fig. 17. Time history of bending strain (purple) at location of maximum bending strain as compared to axial applied load (red).

The time history of the bending strain calculated at the point of maximum bending strain is presented in Fig. 17. The left-hand vertical axis scale is bending strain (purple) and the right-hand vertical axis the magnitude of applied load (red). It can be seen that the bending strains grow more rapidly as load increases, which leads to the large radial deformation and, ultimately, to the sudden collapse of the test article.
