NASA/TM—2018–219849

# **Sandwich Structure Risk Reduction in Support of the Payload Adapter Fitting**

*A.T. Nettles, J.R. Jackson, and W.E. Guin  
Marshall Space Flight Center, Huntsville, Alabama*

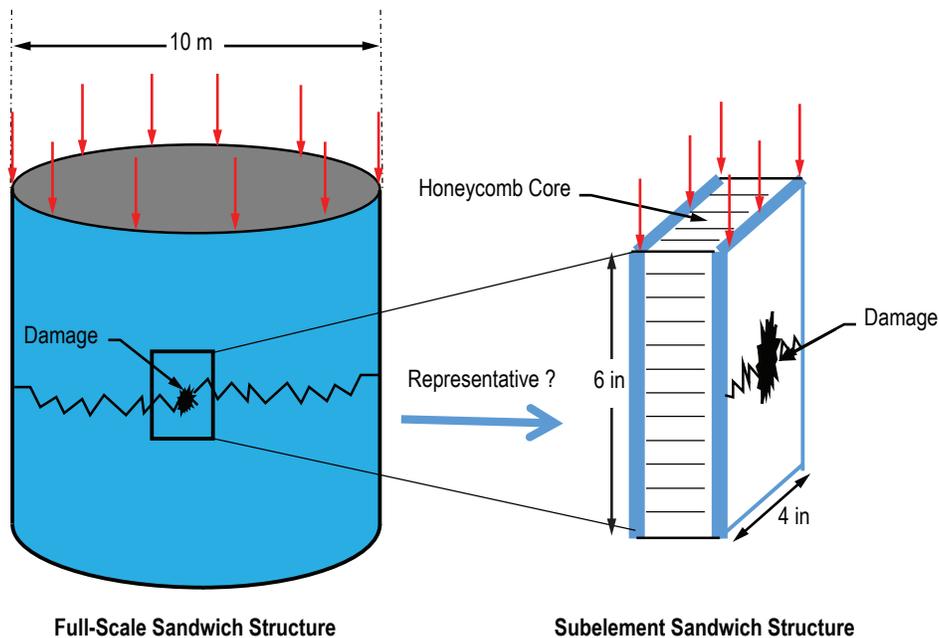
Figure 1. Schematic of problem being addressed in this Technical Memorandum.

This section addresses the issue of test panel size for compression-after-impact (CAI) testing of honeycomb sandwich structure. CAI testing determines failure of the material and does not consider global buckling. Global buckling will be briefly mentioned later. More specifically, the following information sheds light on the answer to the question, How large a panel test is needed to obtain the necessary information to assess a full-scale part when material failure is considered? This paper is only intended to address the effects of damage within the acreage of honeycomb sandwich structure and excludes details such as joints, ply drops, etc. This information is of the most value since the vast majority of foreign object impacts will occur in the acreage sections. This section also assumes a large cylinder as the full-scale structure. The problem being addressed is sketched schematically in figure 1. Dimensions in the figure are for example only.

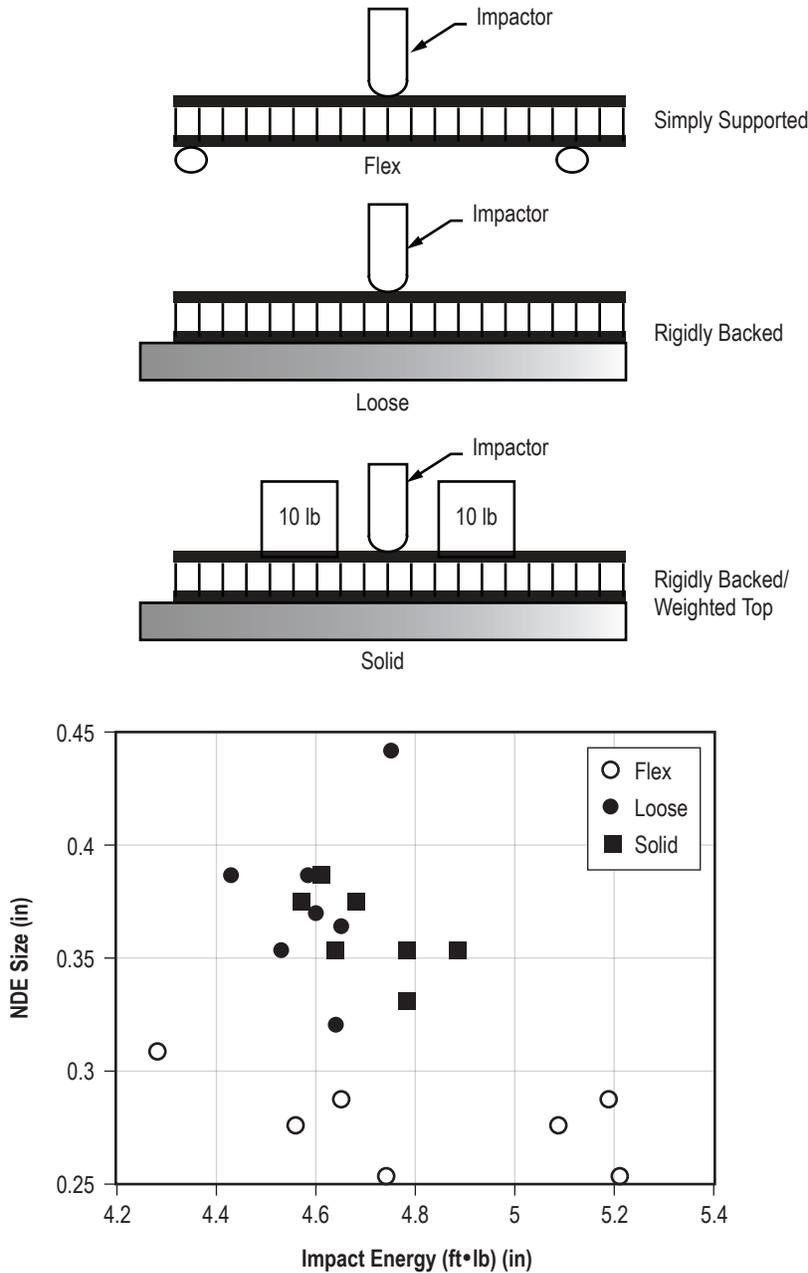
Figure 2. Plot of damage size incurred versus impact energy for three target boundary conditions.<sup>1</sup>

A CAI test actually consists of the following two parts: (1) The infliction of the damage and (2) subsequent load-carrying capability of the damaged sandwich structure. Since the thickness of the subscale panels (test specimens) is the same as the actual test article, this leaves the effects of boundary conditions as the difference in response to an impact for full-scale and subscale testing. This has been looked at previously by the authors of reference 1 and in an FAA report (see ref. 2). Figure 2 is from reference 1 and shows that for the three boundary conditions tested, either method in which the back face of the impacted sandwich structure was rigidly supported over its entire area gave the most damage (as assessed by flash thermography) for a given impact energy level.

Thus the conclusion was reached that if all sandwich structures were rigidly backed while undergoing impact, then the most damage would be inflicted into the panel, due to any given impact event. Rigidly backed panels cannot flex and absorb elastic energy to help diffuse the energy of the impact; all of the impact energy goes into the form of damage to the panel. This represents a conservative or ‘worst-case’ scenario for any given impact event. In addition, if all sandwich structures are rigidly backed and not allowed to flex, then all panels would have the same boundary condition regardless of size; whereas, if the panels were simply supported, the amount of damage would depend on the span between the supports.

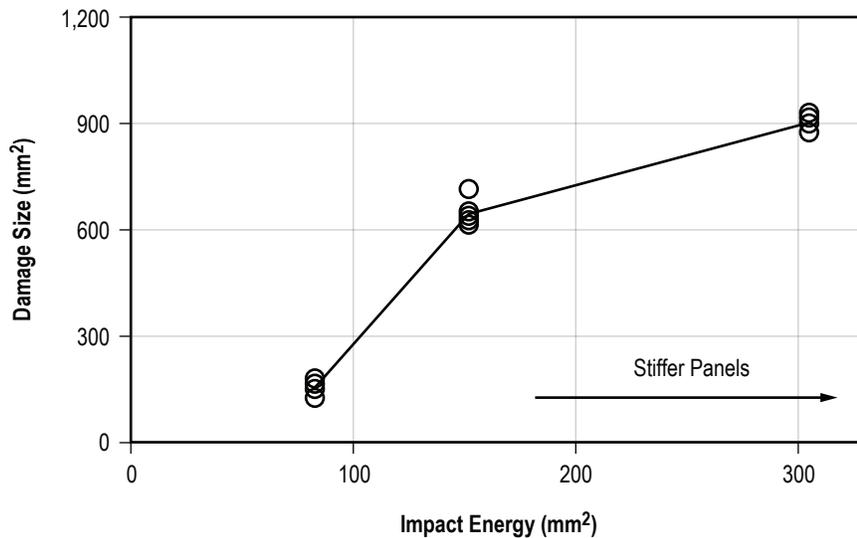
Figure 3. Plot of damage size incurred for a given impact energy as the stiffness of the target increases.<sup>2</sup>

Figure 3 is from reference 2 and shows something similar to what was found in reference 1. As the impacted sandwich panels are supported such that they are ‘stiffer’ (less flex allowed), more damage is incurred for a given impact energy. In reference 2, it was concluded that in order to produce repeatable results “...a possible method is to support the back facesheet of the panel over its entire area, thus canceling the effects of global geometry.” This is the same conclusion as was obtained in reference 1.

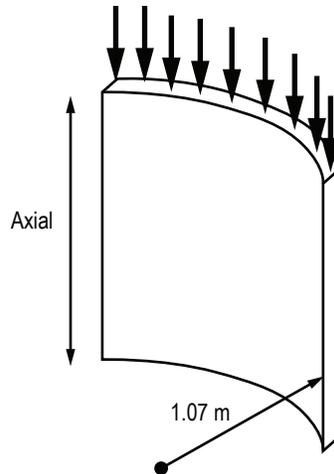
Figure 4. Schematic of loading on subelement curved panels.<sup>2</sup>

Thus, the size of the panel to undergo CAI testing can be rendered moot if the impact event is accepted as a ‘worst case scenario’ and all panels rigidly backed. Once damage is inflicted, the next step in a CAI test is to axially load the panel in compression until failure. The CAI strength of three different-sized panels was obtained and presented in reference 2. In addition, some of these panels had a curvature of  $r = 1.07$  m to assess if curvature would have any effects on the results. The axial loading on a curved panel is shown in figure 4 for clarity. Results of these tests are shown in figure 5.

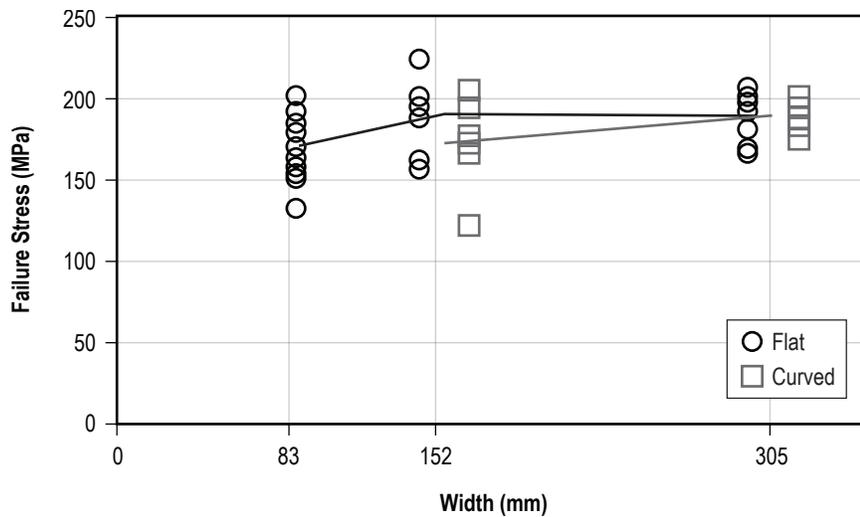
Figure 5. Results of panels tests from reference.<sup>2</sup> Panel width versus CAI failure stress.

One should note that in this study, the wider panels sustained more severe damage since they produced targets that were more rigid than the narrow ones. Despite this, the results show that the smallest panels gave a slightly lower strength than the wider ones. In addition, the curvature of some of the panels had no effect on the resulting CAI strength. Thus if a smaller panel is used to represent a larger one, the results may be conservative, and the larger panels would actually have more load-carrying capability. The lower strength of the narrowest panels was attributed to the interaction of the damage zone with the test panel edges. For the wider panels, the damage zone was sufficiently far away from the edges to cause no detrimental effects. From the conclusion in reference 2, “The global geometry (width and curvature) of specimens larger than a standard size did not affect the damage tolerance of impacted composite sandwich specimens.”

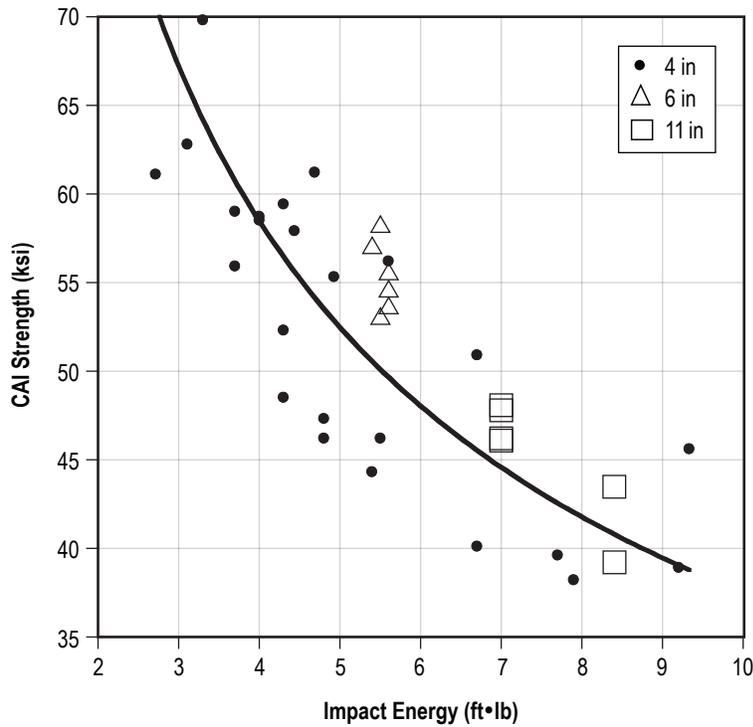
Figure 6. Results of CAI honeycomb panel tests performed by the author (unpublished results).

In a series of unpublished tests performed by the authors, CAI strength of different-width CAI honeycomb sandwich panels was conducted to assess any size effects. These results are shown in figure 6 and show that no difference could be detected between the wide panels and the smaller ones. The widest panel in the above results may still be considered relatively small compared to a part, such as a 10-m-diameter cylinder. The next section will give physical reasons why larger panels would not be expected to fail at a different load.

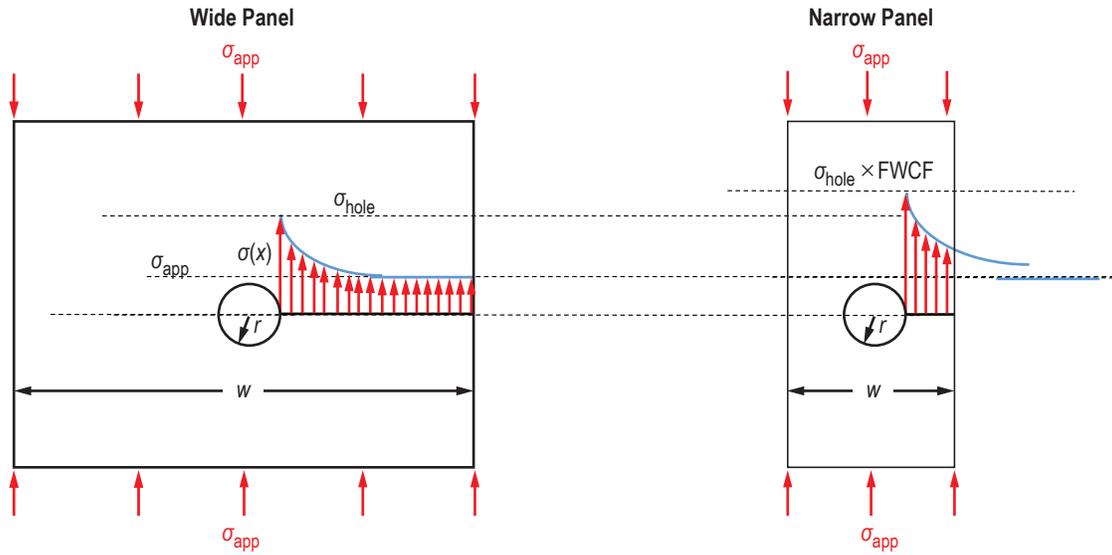
Figure 7. FWCF for holes.<sup>13</sup>

edge is reached, the maximum stress ( $\sigma_{\text{hole}}$ ) will increase even more to accommodate for this. The amount the maximum stress increases due to the edge being close to the hole is given by the finite width correction factor (FWCF) and varies from 1 for wide panels to infinity for the hole being at the edge at the panel edge.

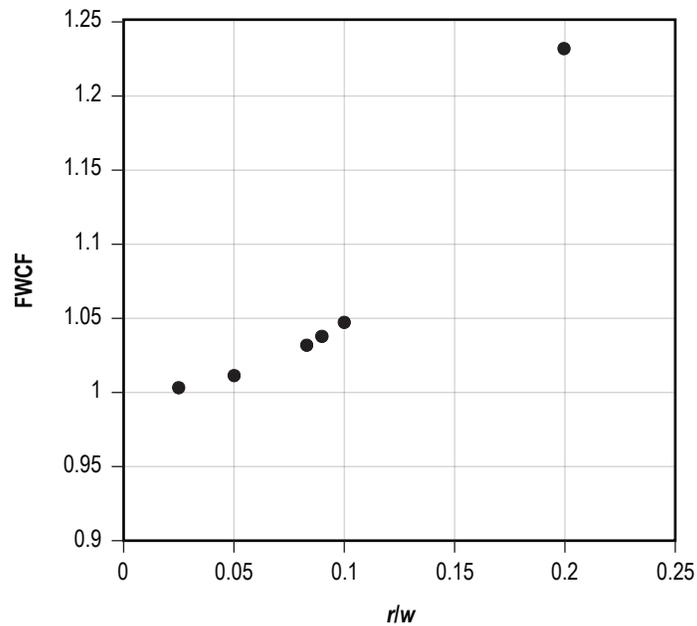
Figure 8. FWCF as a function of  $r/w$ .

A plot of FWCF as a function of  $r/w$  is shown in figure 8.

When  $r/w$  values are less than 0.025 (hole far from edge), the FWCF is essentially one, thus no correction factor is needed. For a baseline 4-in-wide panel, this equates to a damage size of about 0.2 in. This is a little smaller than what would be expected for a typical BVID for an 8-ply sandwich structure. However, the error is on the side of conservativeness and larger panels would record a higher ultimate stress than the typical 4-in-wide panels. There is no way to decrease the compressive ultimate load carrying capability by increasing the specimen size. Even though a much larger volume of material is being tested, the classical Weibull strength reduction distribution due to small flaws randomly distributed throughout the volume does not apply, as these small flaws are quickly blunted by the carbon fibers (redundant crack stoppers) in the polymer resin. In addition, the induced damage will govern the failure. This damage is a given size, regardless of panel size. This is why coupon level tests (from which allowables are calculated) are accepted being as small since all biases due to small specimen size err on the side of conservativeness. For carbon fiber reinforced polymers, larger-scale structures will demonstrate a higher ultimate stress since the biases due to small specimen geometry (mainly edge effects) are accounted.

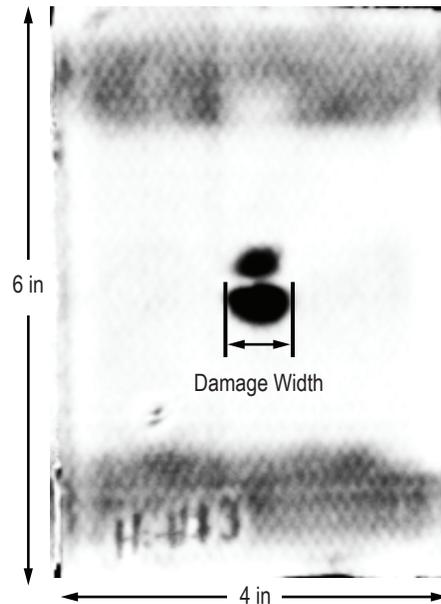
Figure 9. Flash thermography image of impact-damaged sandwich specimen with damage width noted.

Of the parameters that can be used to predict the residual compression strength of an impact-damaged sandwich structure, damage width (as detected by either flash thermography of C-Scan) has been found to be the best indicator.<sup>1</sup> An example of an impact-damaged specimen with the width of damage noted is shown in figure 9.

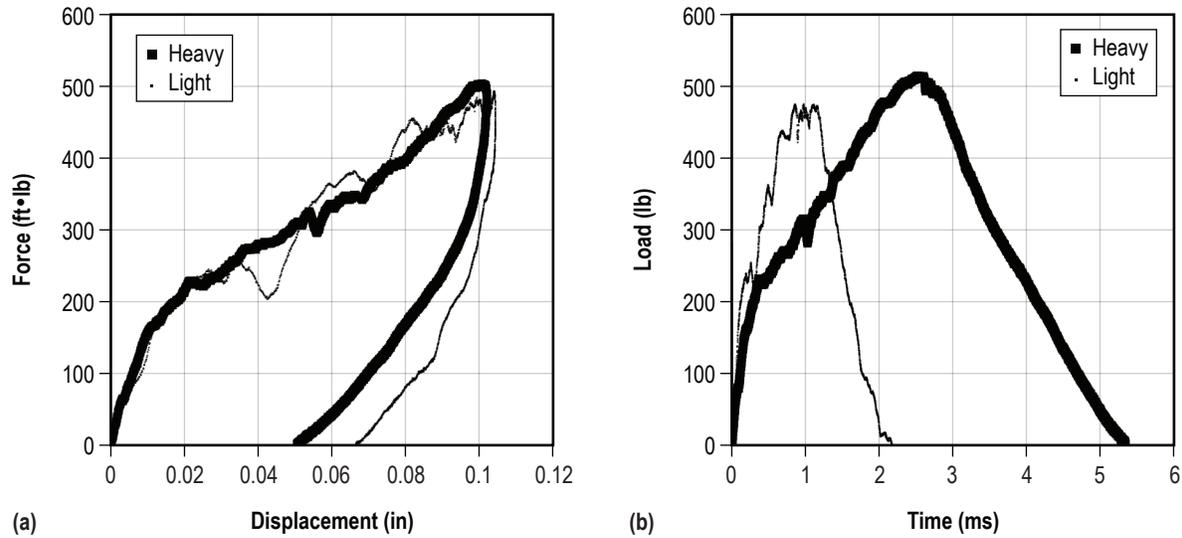
Figure 10. Data for impacts with light and heavy masses: (a) Load-versus-deflection data and (b) load-versus-time data.

The results showed little difference in maximum load of impact, and no different damage size as ascertained by flash thermography or dent depth. The results are summarized in table 1. Examples of the load/time and load-deflection curves of the two types of impacts are shown in figure 10. The force/displacement traces are similar and, as expected, the duration of the impact for the heavier mass is longer, but of the same magnitude as the light mass. This indicates that any noted differences would be due to a time effect (viscoelasticity).

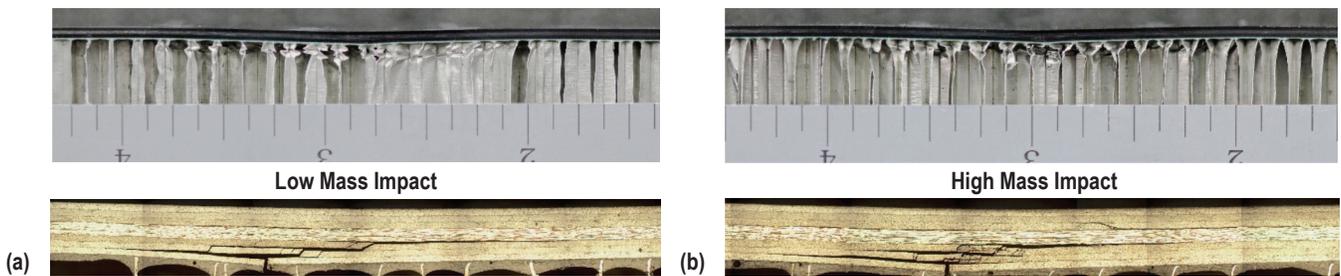
Figure 11. Photographs of core damage (top) and facesheet damage (bottom) for the (a) low-mass impact and (b) high-mass impact.

As a final check of any differences in the light and heavy mass impacts, the specimens were sectioned through the impact zone, and the through-thickness damage recorded. Upon sectioning, the type and extent of damage did not appear to vary. Examples of the core damage and facesheet damage from each type of impact are given in figure 11. Thus it was concluded that the mass of the impactor was not a variable.

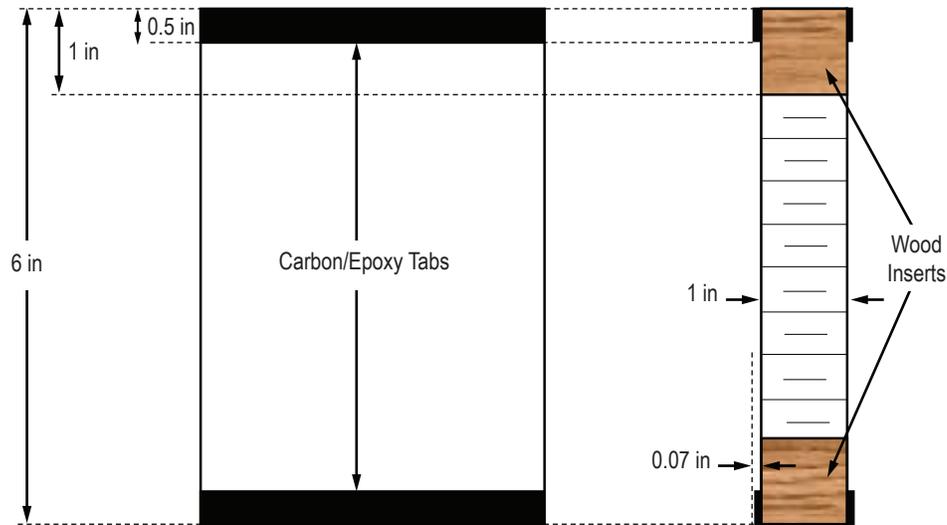
Figure 12. Schematic of specimens used in this study.

Figure 12 is a schematic of the specimens used in this study. They consisted of 1-in-thick aluminum honeycomb with a density of 3.1 lb/ft<sup>3</sup>. The facesheets were made of IM7/8552 carbon/epoxy, and each face was 8-ply with a layup of [+45/0/-45/90]s. The facesheets had a nominal cured thickness of 0.049 in. The 6-in-tall by 4-in-wide specimens were machined from a larger panel that was manufactured by automated tape laying. FM300 film adhesive was placed between the laminate and the core.

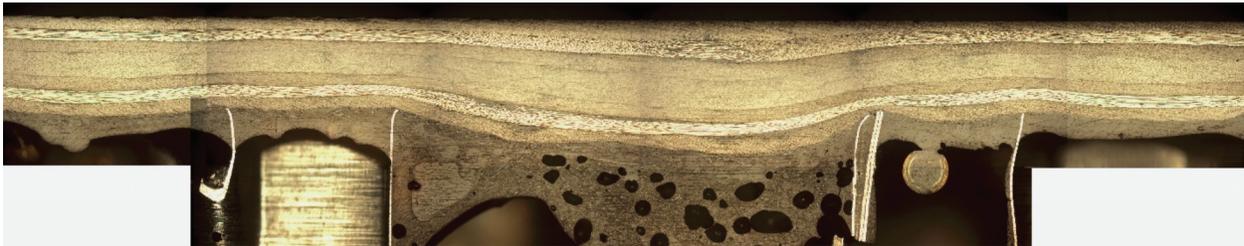
Figure 13. Cross section of fiber waviness caused by core splice adhesive.

Since the honeycomb core comes in finite sizes, pieces of it must be joined to manufacture the full-scale structure. This is done by using a ‘core splice’ adhesive that is essentially a foaming epoxy that bonds the edges of the pieces of honeycomb. Depending on the processing technique and quality, these core splices can have a varying effect on the facesheets as they are laid up and cured on top of these splices. An example of excessive fiber waviness that can result from automated tape laying over a core splice is shown in figure 13. Typically, fiber waviness is to be minimized to maintain the stability of the load-bearing 0° fibers. In order to assure minimal risk, the effects of impacts directly over these core splices were assessed.

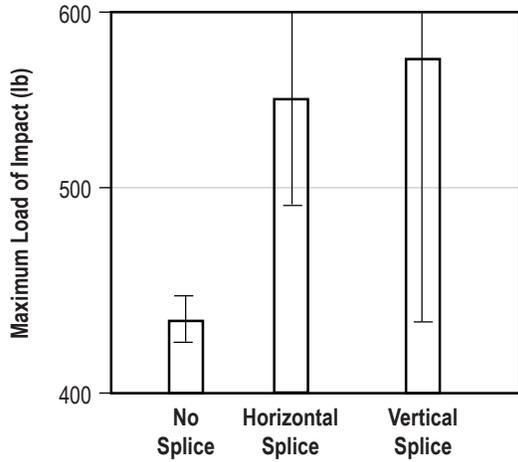
Figure 14. Maximum load of impact data for specimens with and without core splices impacted at 2.3 ft•lb of impact energy.

A graphic summary of these results with those in table 3 are given in figures 14,15,16 and 17. The results show that the dent depth was smaller and the NDE signature was larger in the direction of the core splice for specimens with the splices as shown in figure 18. The instrumented impact data indicated that the maximum load of impact was higher for impacts over a core splice.

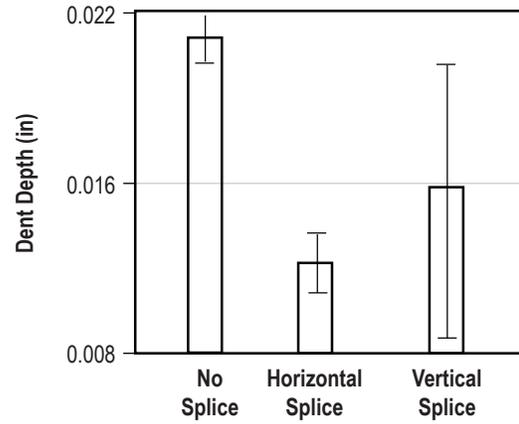
Figure 15. Dent depth data for specimens with and without core splices impacted at 2.3 ft•lb of impact energy.

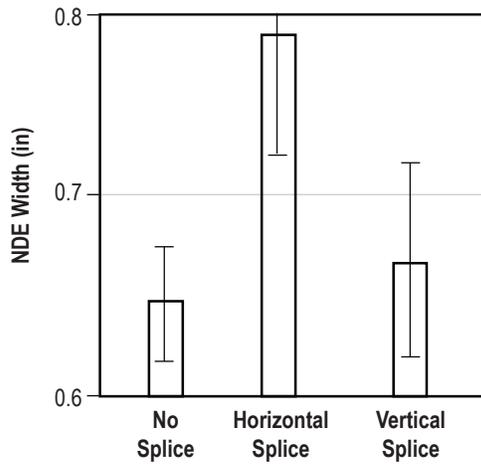
Figure 16. NDE width data for specimens with and without core splices impacted at 2.3 ft•lb of impact energy.

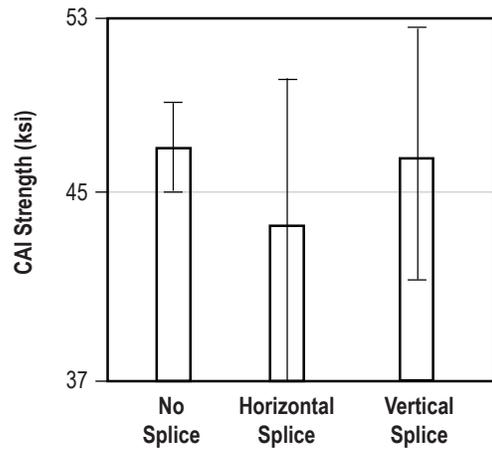
Figure 17. CAI strength data for specimens with and without core splices impacted at 2.3 ft•lb of impact energy.

The compression tests showed that the vertical splices had no detrimental effect on compression strength, but the horizontal splices failed lower than similarly impacted specimens with no core splice. This is not surprising, given that the damage width as measured by NDE was wider for the horizontal splices and, as stated earlier, damage width appears to be the governing factor in determining CAI strength. The core splice specimens showed large amounts of scatter in CAI strength compared to those specimens with no core splice.

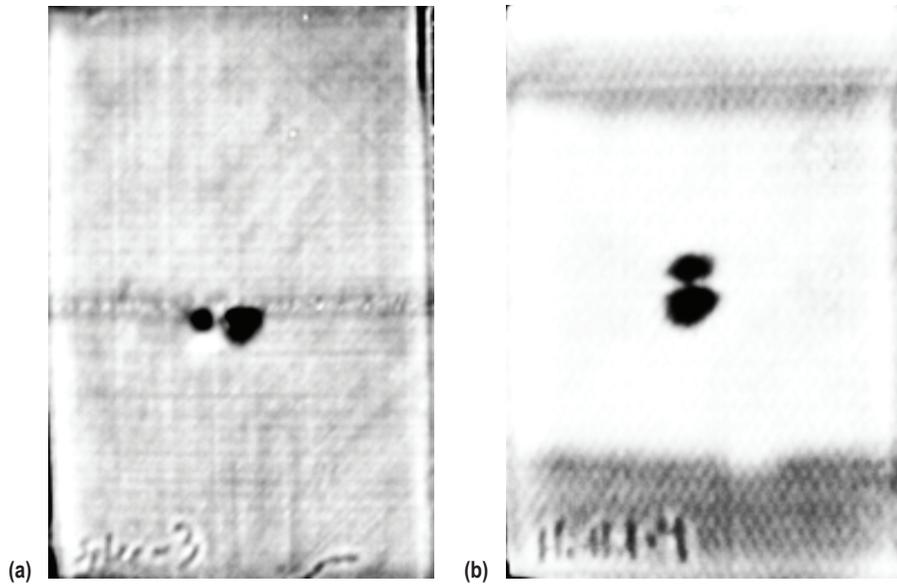
Figure 18. Flash thermography indications of 2.3 ft•lb impacts: (a) Over a core splice and (b) not over a core splice.

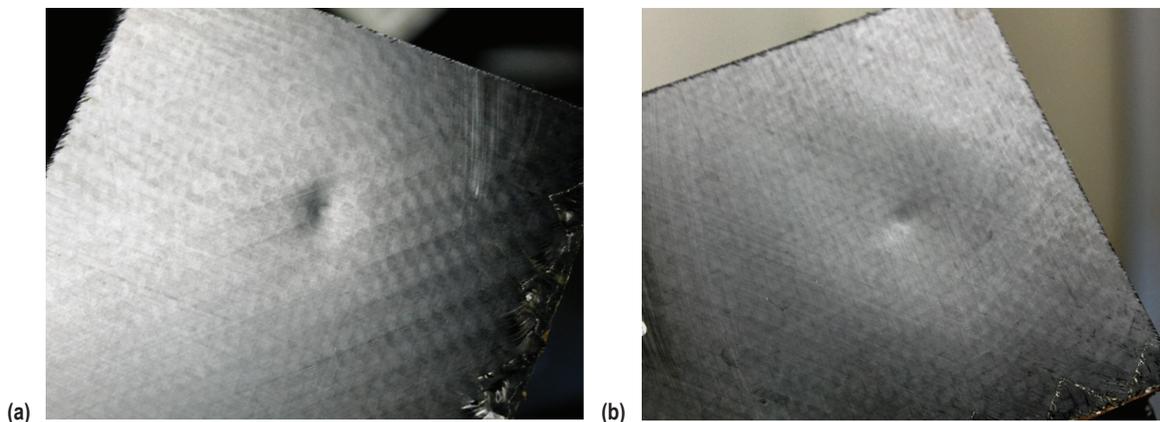
Figure 19. Visual comparison of 2.36 ft•lb impacts: (a) Over a core splice and (b) not over a core splice.

A visual comparison of specimens with and without a core splice impacted at 2.3 ft•lb is shown in figure 19. Although the impact not over the core splice measures an overall deeper depth, the impact over the core splice is more localized (overall dent not as wide and more gradual) and is thus actually easier to see.

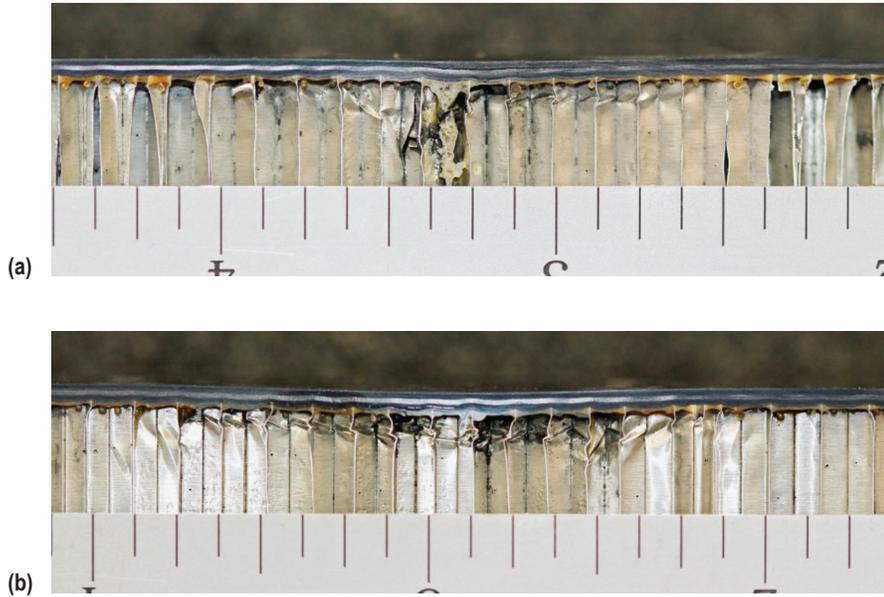
Figure 20. Cross sections of dents due to 2.3 ft•lb impacts in specimens:  
(a) With a core splice and (b) without core splice.

Cross-sectional views of the dents shown in figure 19 are shown in figure 20. Note that there is more core crushing in the specimen with no splice. A closer examination of the damage in the facesheets are shown in figure 21.

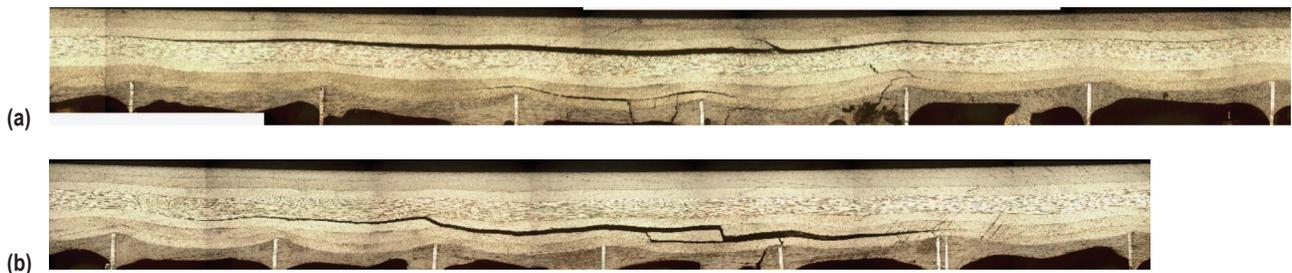
Figure 21. Damage in facesheets of the two specimens in figure 20:  
(a) Over core splice and (b) no core splice.

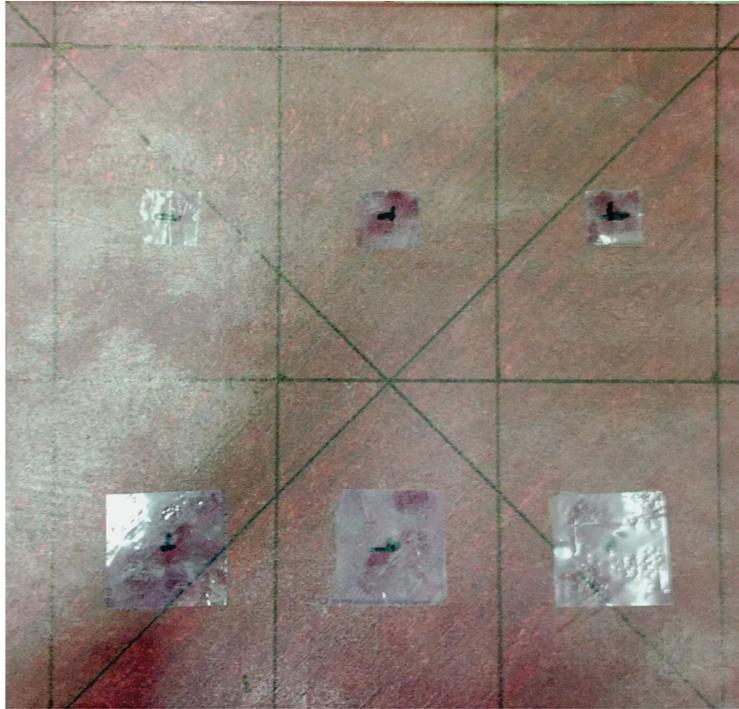
Figure 22. Photograph of square pieces of Teflon™ (FOD) placed on facesheet before bonding to the core.

Other than impact damage, another type of damage that may possibly occur to the structure is the presence of foreign object debris (FOD) within the laminate during processing. The most common example of this is a piece of release film or Teflon tape finding its way into the structure during processing. A real-world example of this occurred on the X-33 liquid hydrogen tank, which failed partly due to the existence of FOD between the facesheet and core. With this in mind, a series of tests were conducted to assess the compression strength of sandwich structure with FOD between the facesheet and core. The results are shown in table 6. The FOD was represented by square pieces of Teflon either 1 or 2 in on a side as shown in figures 22 and 23. Three replicates were fabricated with 1-in square sections of FOD, and three replicates were fabricated with 2-in square sections of FOD.

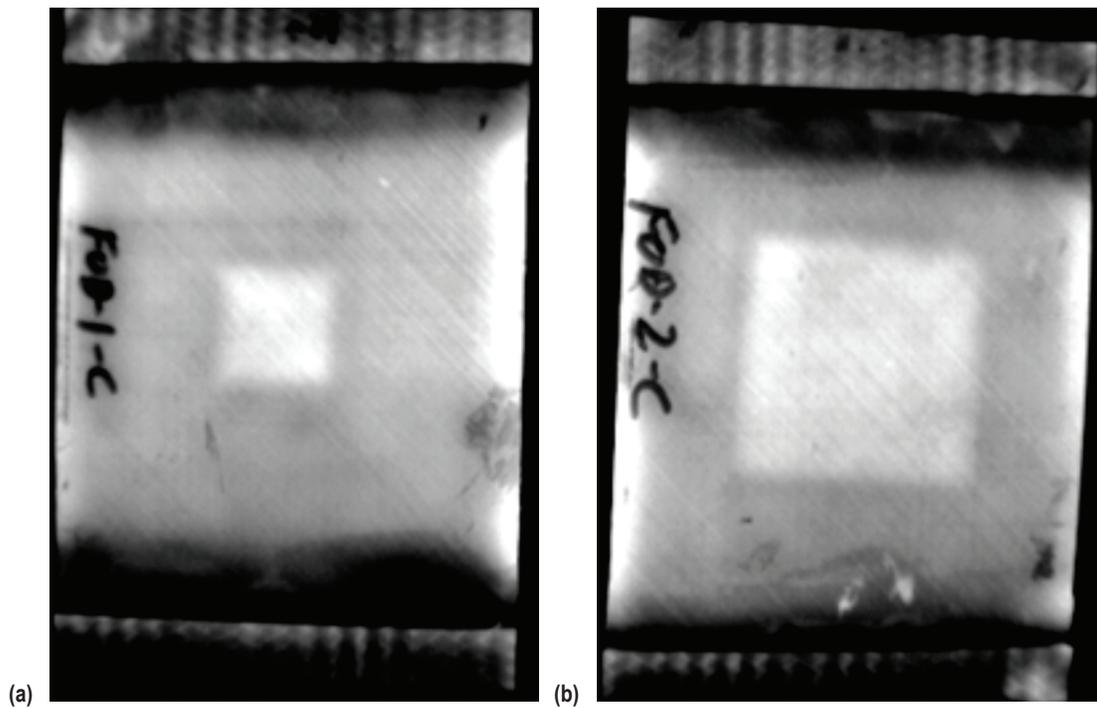
Figure 23. Flash thermography of square pieces of Teflon FOD placed between facesheet and core: (a) 1-in square and (b) 2-in square.

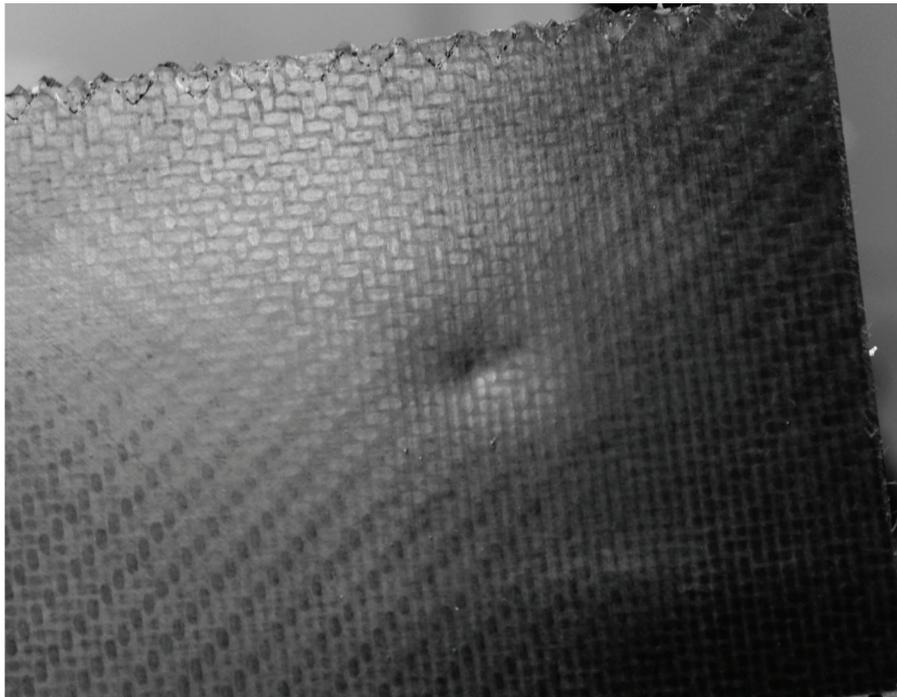
Figure 24. Visual damage to facesheet of type II sandwich structure impacted at 2.3 ft•lb of energy.

The impact energy that caused BVID on the first type of panels was used to impact the new type of sandwich structure. The dent depths were smaller for the new specimens due to the higher density core; however, the damage was still visible as shown in figure 24.

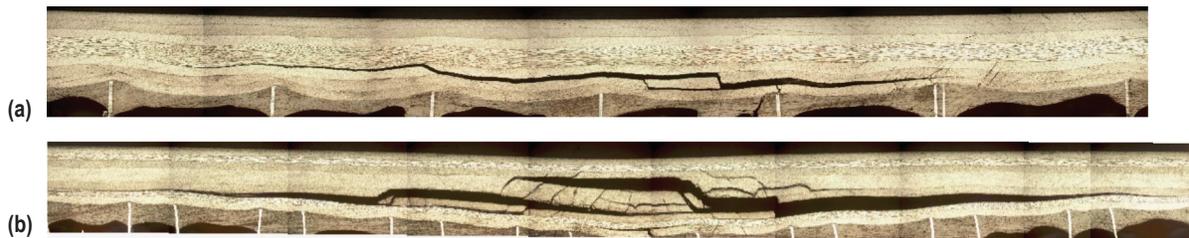
Figure 25. Cross-sectional views of impact damage to (a) type I specimen and (b) type II specimen.

A cross-sectional view of the damage formed from a 2.3 ft•lb impact on a type II specimen is shown at the bottom of figure 25, and a similar view from a 2.3 ft•lb impact on a type I specimen is shown at the top of the figure. The larger damage areas as detected by NDE is evident as there is more damage through the thickness of the specimen.

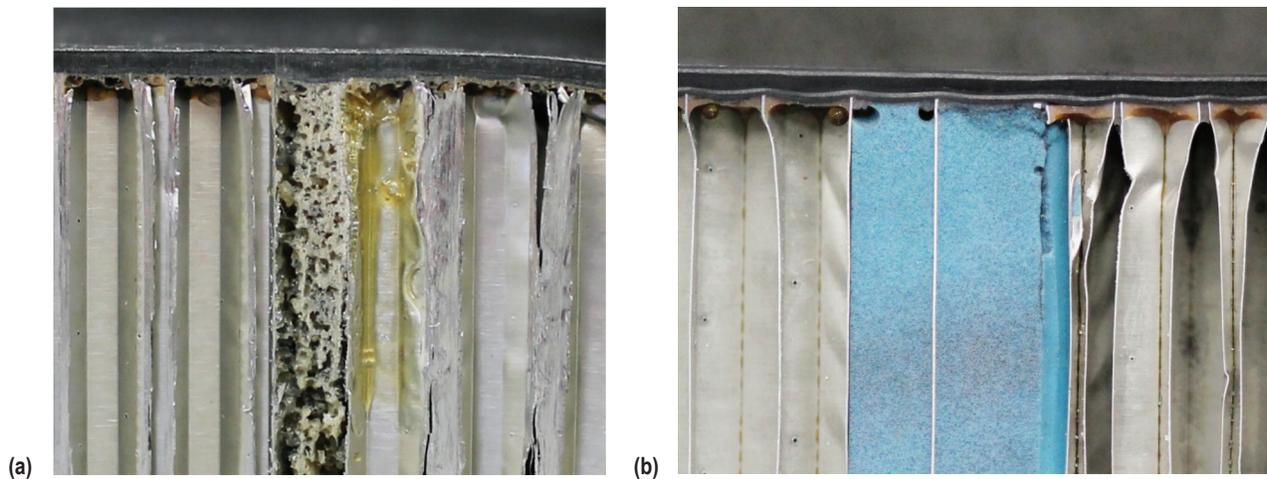
Figure 26. Two types of core splices: (a) Foaming adhesive splice and (b) paste adhesive splice.

The newer type II specimens had core spliced together by injecting a paste epoxy into the gap between core sections rather than by a foaming film adhesive as was done with the first set of sandwich specimens. Photographs of the two types of core splices (in the 90° direction) are shown in figure 26. Figure 13 shows the 0° ply waviness that occurs in the foam adhesive type splice. Figure 27 shows the improved straightness of the fibers over the paste adhesive type splice. Since the type I specimens demonstrated a lower CAI strength when the impact was directly over a horizontal core splice, some CAI tests were performed on the new type of core splice. Table 8 summarizes impacts over the new core splice.

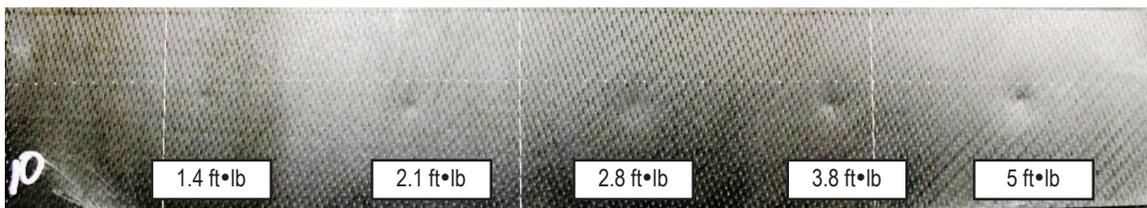
Figure 28. Impact trials on cloth-covered honeycomb sandwich structure.

Since the facesheets are now thicker, the energy needed to create BVID had to be determined. It was assumed that this energy would be greater than the 2.3 ft•lb needed for the noncloth-covered sandwich structure. Figure 28 shows some trial hits on sections of cloth covered sandwich structure.

A general consensus was that close to 3.8 ft•lb impact was readily visible. This represented a 54% increase in impact energy needed for BVID over the noncloth-covered honeycomb sandwich structure. However, since the facesheets are thicker, they may handle this increased impact energy such that the CAI strengths of the cloth- and noncloth-covered sandwich structure would be similar. Table 9 shows the results of CAI testing on cloth-covered honeycomb sandwich structure.

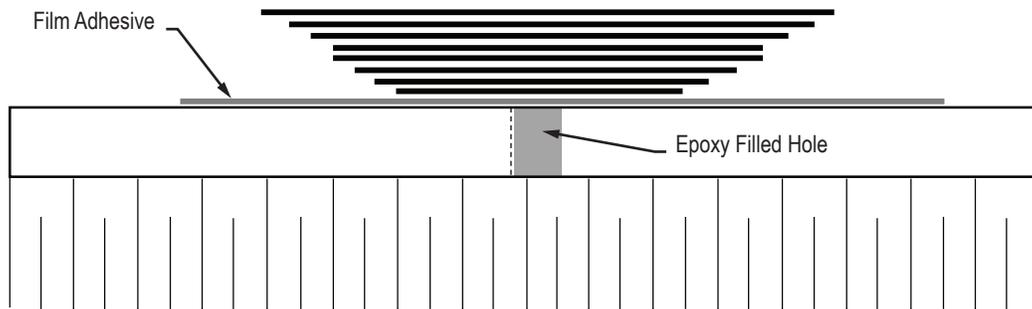
Figure 29. Schematic of reverse wedding cake repair.

The first repairs were done on specimens with holes since misdrilled holes are not an uncommon occurrence. Simple patch repairs consisting of 8 plies of IM7/5320-1 out-of-autoclave (OoA) carbon/epoxy were used for the repairs. The holes were first filled with epoxy resin to prevent the patches from draping into the hole during cure once the holes were filled with epoxy and the epoxy cured. The surface of the specimens to which the repair was to be bonded was prepared by abrading until the outermost fibers in the top layer was visible. Preliminary testing on similar samples demonstrated that a more aggressive surface preparation kept the patches from popping off during compression testing. The patches had the same layup as the parent laminate [45/90/-45/0]s. FM 300 film adhesive was used between the patches and the specimens to aid in adhesion. The plies of the patches were made successively smaller by 0.25 in per ply to minimize edge effects. The patches were circular with an outermost diameter of 3.5 in (innermost diameter of 2 in). The patches were applied with the smaller plies close to the specimen ('reverse wedding cake') and with the larger plies next to the film adhesive ('wedding cake'). Schematics of these repairs are shown in figures 29 and 30. A front view photograph of a repaired specimen is shown in figure 31.

Subsequent compression testing of these specimens gave strength results of 80.9 and 82.1 ksi for the reverse wedding cake and wedding cake samples, respectively. The failure zone of the wedding cake repair was near the original hole, and the failure location of the reverse wedding cake sample was away from the repair. However, the strength values demonstrated that about 94% of the undamaged strength ( $\approx 90$  ksi) was recovered.

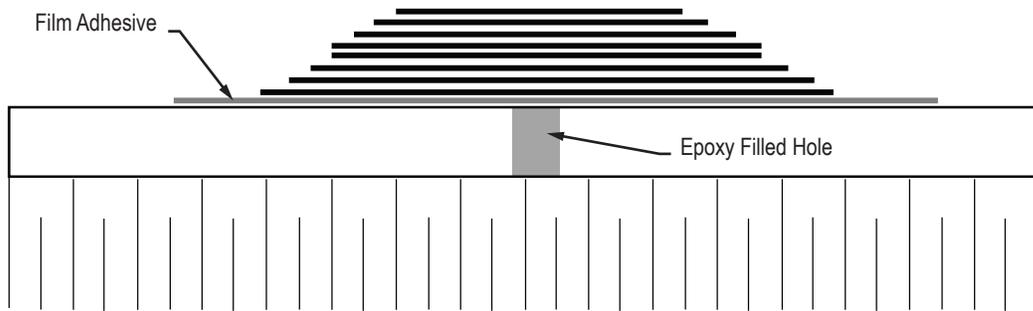
Figure 30. Schematic of wedding cake repair.

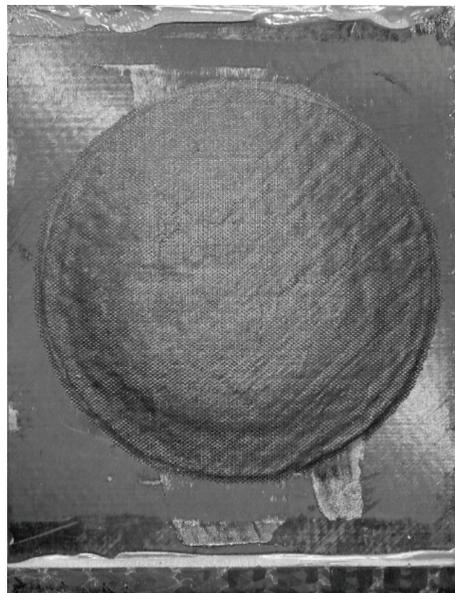
Figure 31. Photograph of repaired specimen.

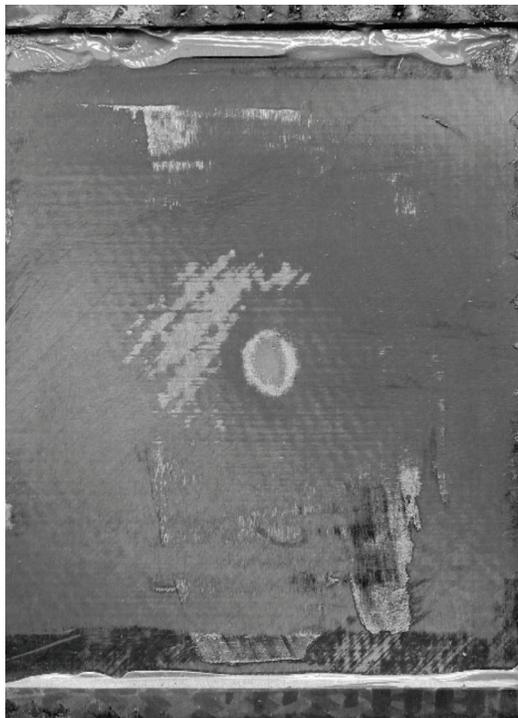
Figure 32. Photograph of impact dent filled and smoothed with epoxy.

The next set of specimens had the dent filled smooth with epoxy resin before applying the film adhesive and patch. A photograph of an impacted specimen with the dent filled flush to the surface with epoxy is shown in figure 32. Table 10 lists the results of the compression strength of these repaired specimens.
