# Wide-Field Infrared Survey Telescope (WFIRST): Composite Structure Verification for Operational Temperatures

James Mondello<sup>a</sup>, Paul Baird<sup>b</sup>, Lisa Bartusek<sup>b</sup>, David Content<sup>b</sup>, Robert Egerman<sup>a</sup>, Joseph Marzouk<sup>b</sup>,  
Bonnie Patterson<sup>a</sup>, Thomas Quinzi<sup>a</sup>, Benjamin Rodini<sup>b</sup>, Cory Smiley<sup>a</sup>, J. Scott Smith<sup>b</sup>  
<sup>a</sup>Harris, Rochester NY; <sup>b</sup>NASA Goddard Space Flight Center, Greenbelt MD

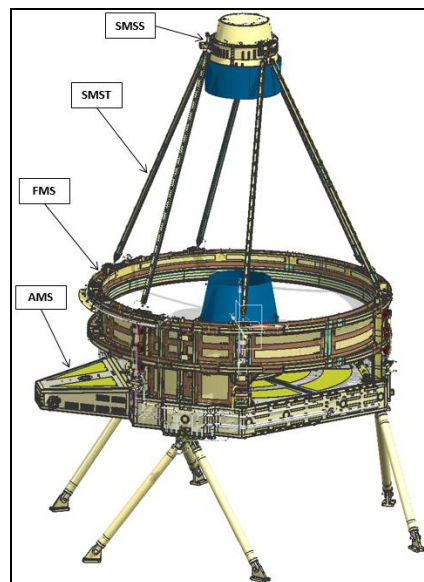
Figure 1: AMS, FMS, SMST, and SMSS hardware will be repurposed for the WFIRST mission

The WFIRST mission leverages a repurposed, space-flight-qualified 2.4-meter, obscured two-mirror telescope, modified to include the addition of a tertiary mirror (for the wide-field instrument) to create a three-mirror anastigmatic optical configuration and achieve wide field of view (FOV) capability<sup>1-3</sup>. The repurposed components of the optical telescope assembly (OTA) are shown in Figure 1 and include the aft metering structure (AMS), forward metering structure (FMS), secondary mirror support structure (SMSS), and secondary mirror support tubes (SMSTs), which together form the forward optical assembly (FOA) portion of the telescope.

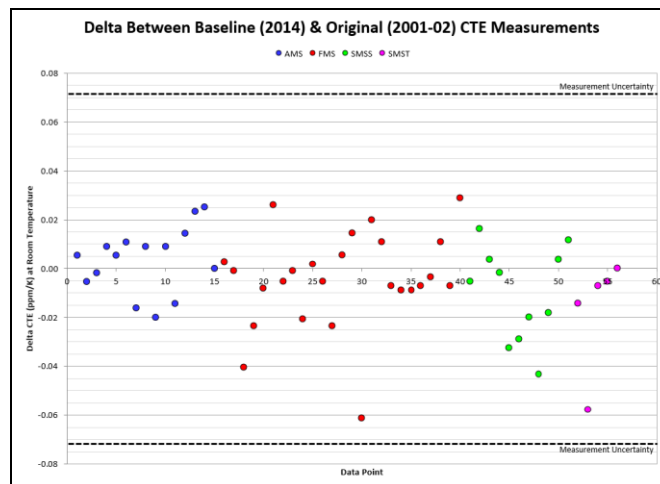
Figure 2. Retesting of original CTE coupons at room temperature demonstrated that there was no statistical change due to material aging (within measurement uncertainty)

CTE coupon testing was performed as part of early operational temperature studies to mitigate risk. CTE coupons from the original build of the FOA structures have been retained and maintained in controlled storage. Room temperature CTE tests on the heritage coupons were re-performed at Harris using the same methodology (a precision dilatometer) to understand if there were any changes due to composite aging. The CTE values from the re-test performed in 2014 were compared to the original test values from 2001-2002, and the results are shown in Figure 2. For all coupons tested, there was no statistical difference between the re-tested and original values, and all differences were within measurement uncertainty. The outcome of this testing demonstrated that the composite materials used in the repurposed hardware retained their stability-critical CTE performance over time during storage.

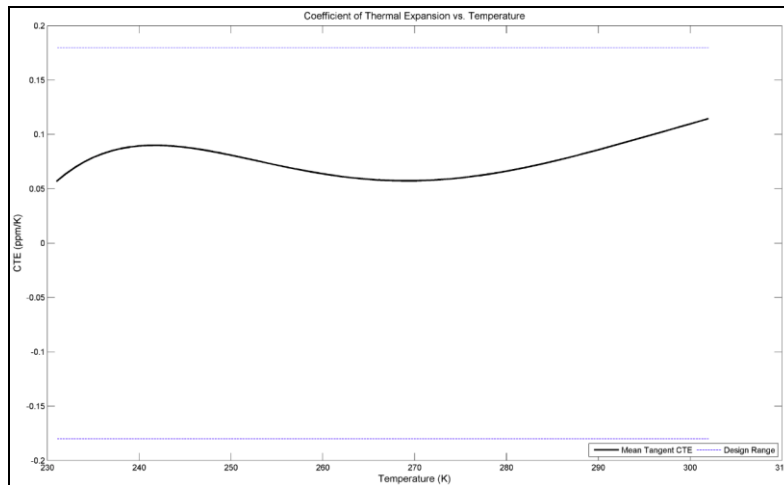
Figure 3. CTE of carbon fiber reinforced composite materials showed insensitivity to temperature change over the tested range and were within original design acceptance criteria

After completion of room temperature CTE testing, the heritage coupons were then CTE tested over an extended temperature range. The results were compared to the room temperature values, along with original design acceptance ranges, which are typically used as a basis for Monte Carlo analyses used to verify FOA optical performance. For the carbon-reinforced composite laminates tested, the CTE was relatively insensitive to temperature over the range tested, and values were within original design acceptance ranges. A typical plot of CTE versus temperature is shown in Figure 3. The one exception was for a boron/carbon-reinforced composite laminate, with CTE decreasing more significantly at

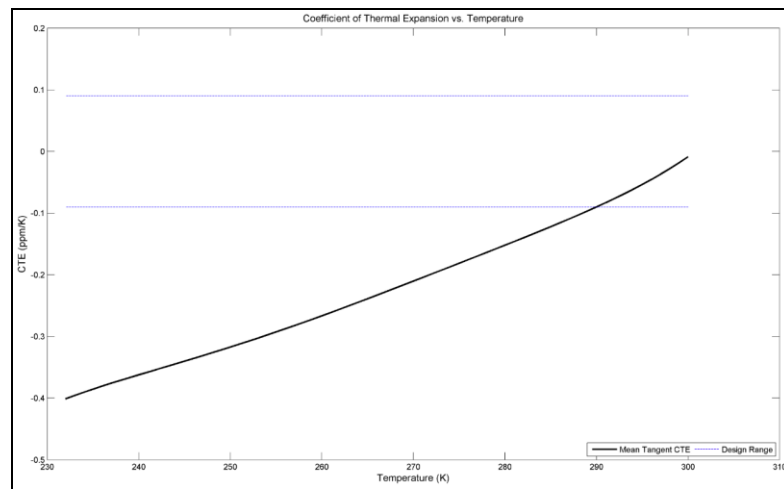
Figure 4. CTE of boron/carbon fiber reinforced composite material showed higher sensitivity to temperature change over the tested range

colder temperatures, as shown in Figure 4. This was not an unexpected result based on the presence of the non-carbon-based fiber in this laminate and its behavior with temperature.

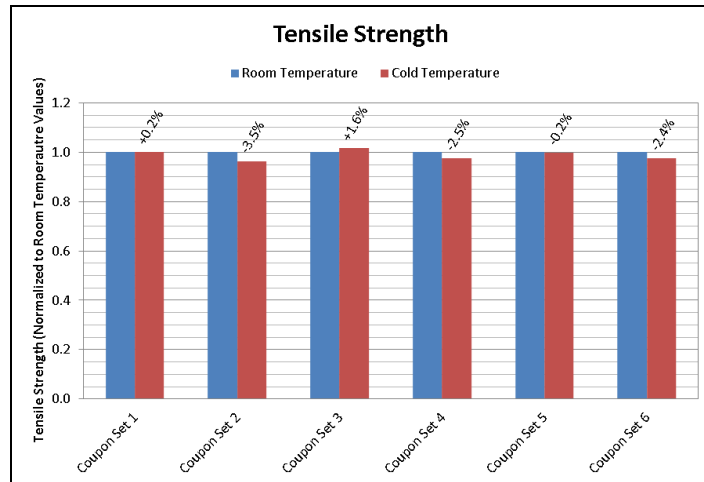
Figure 5. No statistical difference was observed in tensile strength due to thermal cycling of the coupons

During operational temperature studies, tensile testing was also performed to assess the impact of thermal cycling on tensile strength. Heritage CTE coupons from the original build of the FOA structures were also utilized for this activity with modifications to allow for tensile testing. For each composite laminate type, samples were tensile tested at room temperature without thermal preconditioning to form a baseline and were compared to samples tensile tested after thermal cycling. A comparison of thermal cycled to uncycled tensile strengths is shown in Figure 5. While some variation was seen, there was no statistical difference observed due to thermal cycling of the coupons. These results verified that room temperature tensile properties of the composite laminates were not altered due to thermal cycling.

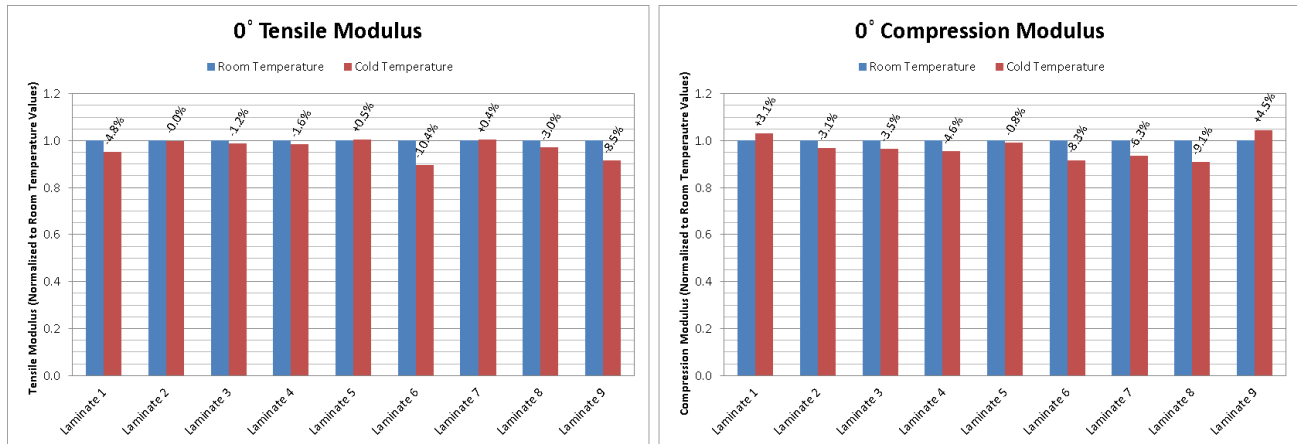
Figure 6. Laminate mechanical test results were typically in-family with room temperature values within  $\pm 15\%$

A majority of the laminate mechanical test results fell within  $\pm 15\%$  of room temperature values, demonstrating robustness to the WFIRST operating environment. As an example, a comparison of cold temperature tensile modulus and compression modulus to room temperature values is shown in Figure 6. CTE variation over temperature was minimal, reinforcing the results observed during earlier coupon testing described in Section 2.1.

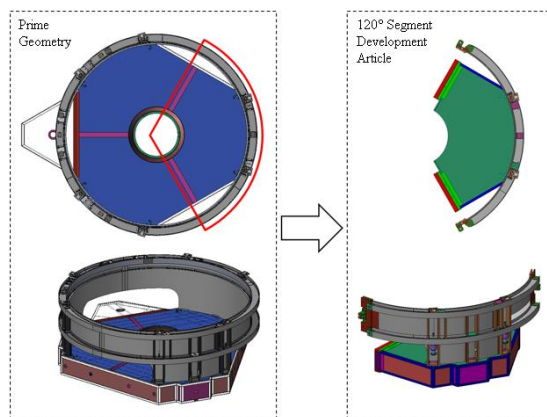
Figure 7. AMS and FMS development articles are full-size 120° segments representative of the prime hardware

The AMS and FMS development articles are full-sized 120° segments of the prime hardware and contain representative bond geometries and material types. The development articles were fabricated and assembled during the original hardware build using consistent processes, and are representative of material aging and workmanship contained in the prime hardware. A CAD depiction of the development articles is shown in Figure 7.

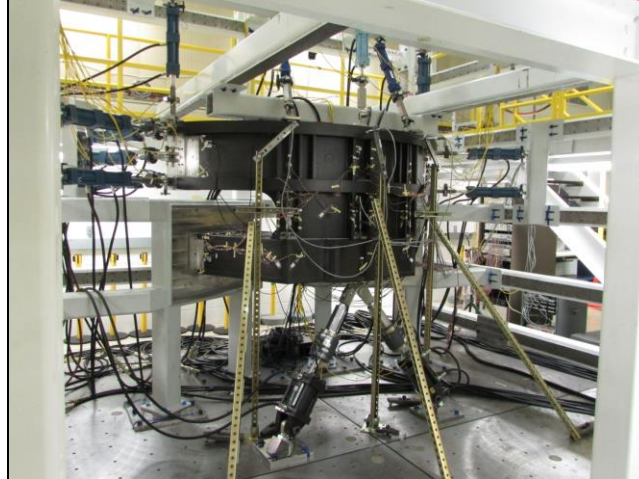
Figure 8. The AMS/FMS static load testing was conducted in the Harris environmental test facility SLT tower and utilized nineteen actuators to apply interface and body loads

The baseline SLT was conducted to demonstrate structural integrity of the development hardware after previously observed environmental conditions and approximately fourteen years in storage. Additionally, the baseline SLT was used to obtain strain and deflection data for comparison of structural behavior before and after thermal cycling. During the static load testing, ten load cases were simulated in the structures to provide representative loading conditions in the bonds with the lowest thermal margins. The test was performed in the Harris environmental test facility SLT tower and utilized nineteen hydraulic actuators to apply interface and body loads. The AMS and FMS were instrumented with thirty-five single axis strain gages, eighteen tri-axis rosette strain gages, six linear variable differential transformers (LVDTs), and twenty-six acoustic emission (AE) sensors to monitor the real-time test behavior. The test configuration is shown in Figure 8.

After completion of thermal cycling, the AMS and FMS development articles were re-configured in the Harris environmental test facility SLT tower, as shown in Figure 8. All instrumentation remained in the same locations on the hardware, and the same load cases from the baseline SLT were repeated for the post-thermal-cycle SLT.

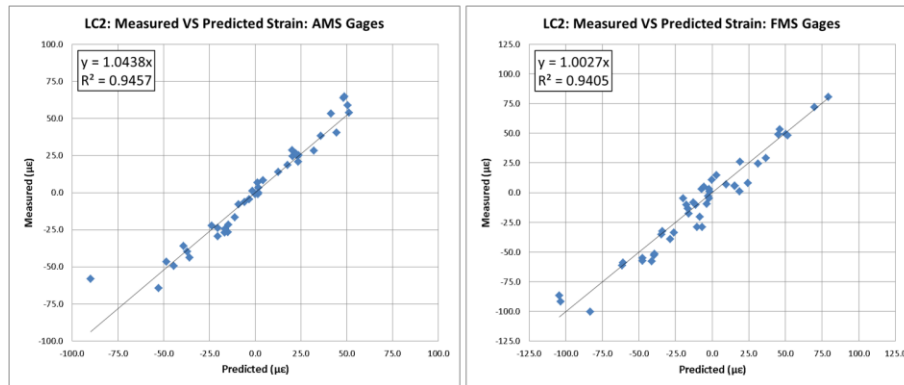
Figure 9. Good correlation was observed between measured and FE predicted strain for the AMS and FMS

The measured strain data from the baseline SLT were compiled and compared to finite element (FE) predictions. Good correlation was observed between measured strain values and FE predicted strain values for all load cases, indicating that the model was a valid representation of the hardware. To determine the level of correlation, measured values were plotted against predicted values, and a linear least-squares regression line was fit to the data. The regression line was forced through the origin, and the resulting slope and  $R^2$  parameters were used together to describe the correlation of the data. The slope of the regression line provides a metric to evaluate how well the average measured values matched the average predicted values. For a perfect correlation, the slope of the regression line would be 1. The  $R^2$  value (coefficient of determination) provides a metric to evaluate how much scatter there is around the fitted regression line. A regression line that perfectly describes the test data would have an  $R^2$  value of 1. An example of the measured-to-predicted strain for a baseline load case is shown Figure 9.

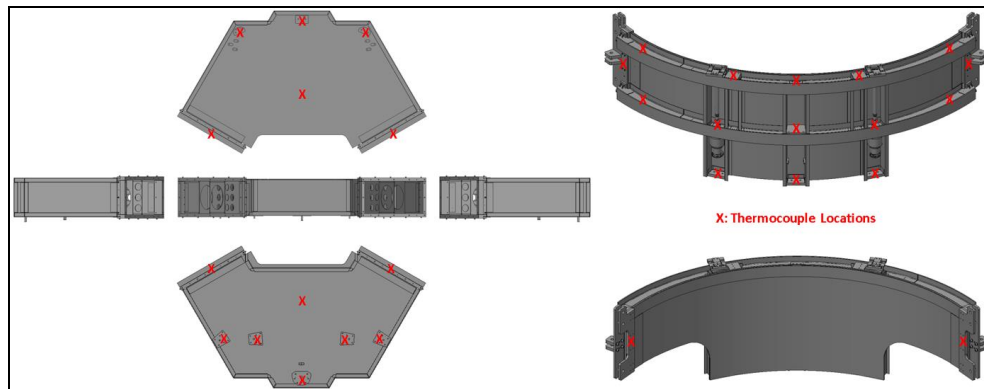
Figure 10. Thirty-nine thermocouples were located on the AMS and FMS development articles to monitor hardware temperature in situ

After completion of the baseline SLT, the AMS and FMS development articles were thermal cycled in an air-controlled chamber. The hardware was cycled between 253K and 311K for multiple iterations to envelope the potential operational temperature range with additional margin. To monitor the part temperatures in situ and accurately control ramp rates

and dwell times, thirty-nine thermocouples were located on the metallic fittings and composite panels of the AMS and FMS as shown in Figure 10.

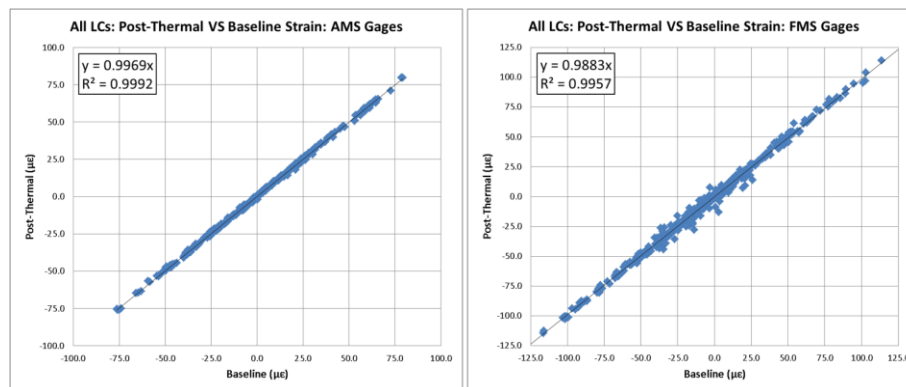
Figure 11. Excellent correlation was observed between post-thermal-cycle and baseline strain for the AMS and FMS

For this testing, the measured strain data from the post-thermal-cycle SLT were compared to the measured strain data from the baseline (pre-thermal-cycle) SLT. Excellent correlation was observed between the post-thermal-cycle SLT and baseline SLT measured strain for all load cases, demonstrating that the thermal cycles did not alter or damage the structures. The post-thermal-cycle versus baseline AMS and FMS strain data, compiled for all load cases, is shown in Figure 11.

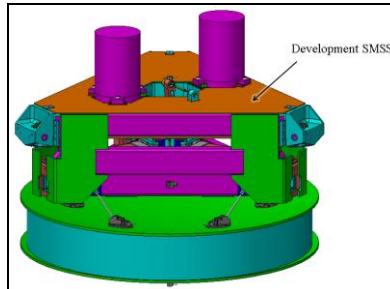
Figure 12. SMSS development article is a full-size structure representative of the prime hardware

The SMSS development article is a full-sized prime-like structure and contains representative bond geometries and material types. The development article was fabricated and assembled during the original hardware build using consistent processes, and is representative of material aging and workmanship contained in the prime hardware. For this testing, the SMSS was assembled with aluminum mass simulators of the mirror and actuators to form the development secondary mirror assembly (SMA) article. A CAD depiction of the development article is shown in Figure 12.

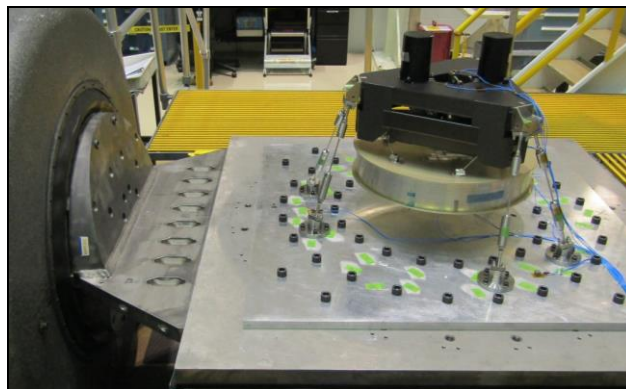
Figure 13. The SMA random vibration testing was conducted using the Harris environmental test facility MB C210 shaker system and was instrumented with fifteen triaxial accelerometers

The baseline random vibration test was conducted to demonstrate structural integrity of the development hardware after previously observed environmental conditions and approximately fourteen years in storage. Additionally, the baseline test was used to obtain dynamic response signatures for comparison of structural behavior before and after thermal cycling. The random vibration testing was performed in three axes with multiple load increments. Low-level vibration surveys were performed before and after the full-level test sequence for each axis to verify no structural changes occurred. The test was performed using the Harris environmental test facility MB C210 shaker system. The test instrumentation consisted of fifteen triaxial accelerometers, with three control accelerometers located on the fixture and twelve response accelerometers located on the SMA development article. The SMA was supported on the shaker using flexures to simulate the stiffness of the SMSTs. The test configuration is shown in Figure 13. During each test, frequency response function (FRF) plots were generated for each response accelerometer using the excitation axis of a fixture accelerometer as the reference. FRF plots from each portion of the test sequence were overlaid and compared to one another to look for any frequency shifts that could indicate structural failure, focusing on the in-axis responses (i.e., the accelerometer axis corresponding to the test excitation axis).

After completion of thermal cycling, the SMA development article was re-configured on the Harris environmental test facility MB C210 shaker system, as shown in Figure 13. All instrumentation remained in the same locations on the hardware, and the same dynamic load levels from the baseline random vibration test were repeated for the post-thermal-cycle random vibration test.

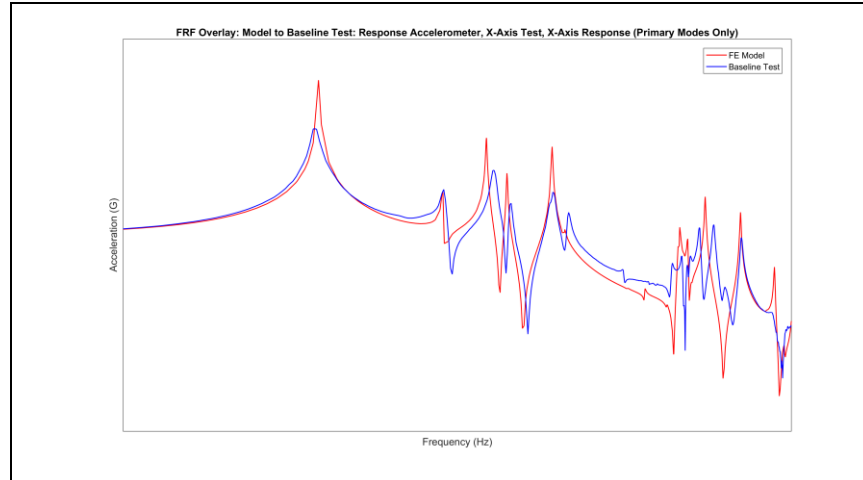
Figure 14. Strong correlation was observed between baseline test and FE model FRF plots, especially for lower frequency modes

The FRF plots generated during the baseline random vibration test were overlaid and compared to FRF plots predicted by the FE model using visual inspection of the overlay as well as numerical comparison of frequencies for primary modes that demonstrate significant mass participation in the model. Strong correlation was observed between the response signatures, and most primary modes were within 3%, especially lower frequency modes, indicating that the model was a valid representation of the hardware. An example of the model-to-baseline test FRF overlay is shown in Figure 14.

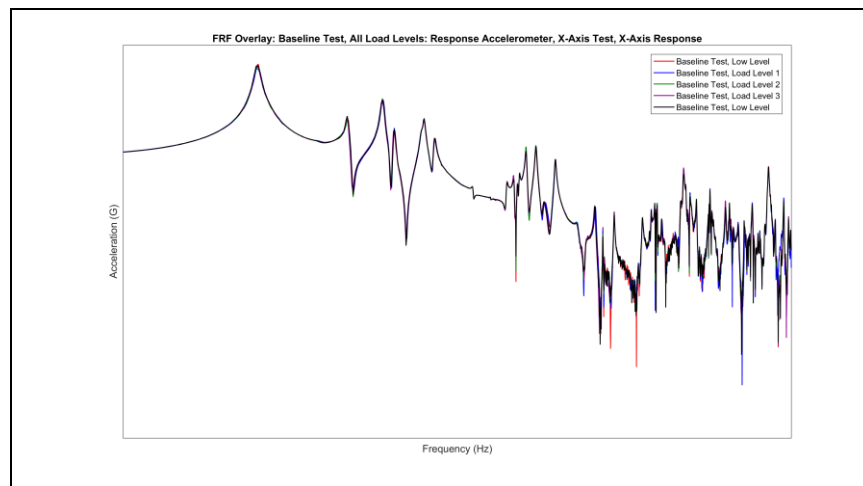
Figure 15. FRF plot overlays were consistent for load levels during the baseline random vibration test

FRF plot overlays were also generated for each load level performed during the baseline random vibration testing. Consistent response signatures between load levels were observed for all accelerometers and test axes, indicating linear behavior within the structure and demonstrating that structural integrity did not degrade as load level was increased (shown in Figure 15). Finally, ultrasonic inspections performed before and after the baseline random vibration test were consistent and did not provide any evidence of structural failures.

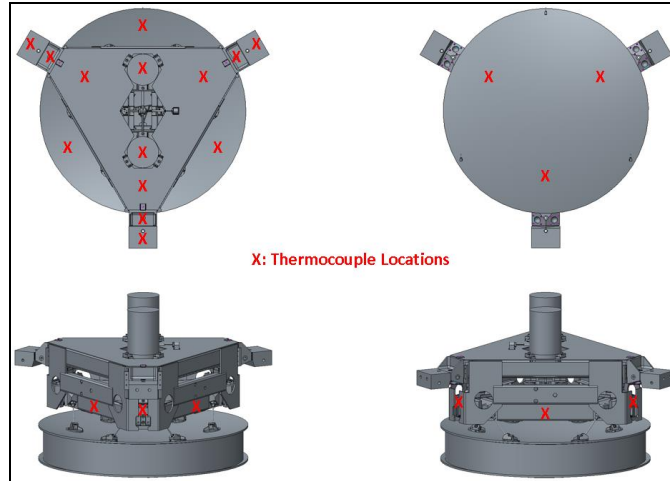
Figure 16. Thirty-five thermocouples were located on the SMA development article to monitor hardware temperature in situ

After completion of the baseline random vibration test, the SMA development article was thermal cycled in an air-controlled chamber. The hardware was cycled between 253K and 311K for multiple iterations to envelope the potential operational temperature range with additional margin. To monitor the part temperatures in situ and accurately control ramp rates and dwell times, thirty-five thermocouples were located on the metallic fittings and composite panels of the SMA as shown in Figure 16.

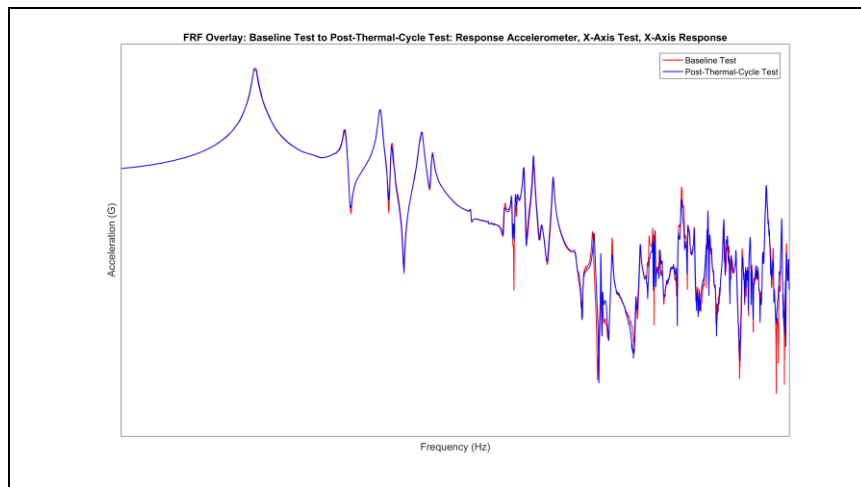
Figure 17. Excellent correlation was observed between post-thermal-cycle test and baseline test FRF plots

For this testing, the FRF plots generated on the post-thermal-cycle random vibration test were overlaid and compared to FRF plots generated during the baseline random vibration test; primary mode frequency values were also compared. Excellent correlation was observed between post-thermal-cycle and baseline response signatures for all test axes and accelerometers, and most primary modes were well within 1%. An example of the baseline-to-post-thermal-cycle test FRF overlay is shown in Figure 17.
