# Mitigation of Electrostatic Hazards on Spacecraft

***Abstract***— Spacecraft are complex systems operating in challenging environments that require customized testing procedures designed to mitigate the unique hazards of a space launch environment. As an example of those testing procedures, we describe the test methodology and recommendations developed to mitigate electrostatic discharges that could have triggered an explosion of the Space Shuttle during launch, return to launch site, abort after one orbit, or during normal landing.

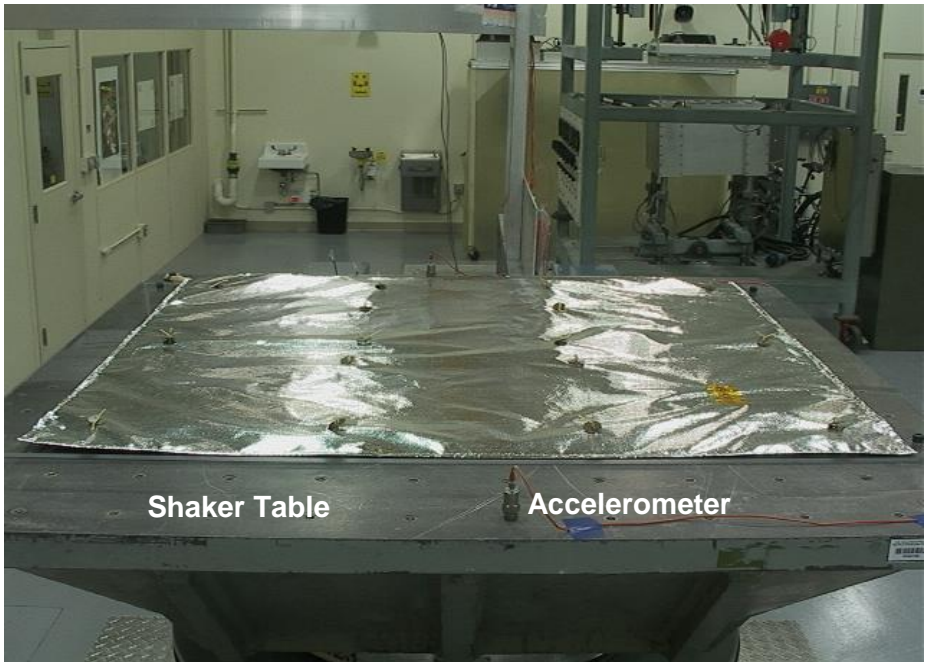
To produce a charging scenario that would approach what the MLI blankets might encounter during flight, shaker table experiments (Unholtz Dickie Vibrating Test System) were performed that simulated the amplitude, the frequency of vibrations, and the changing accelerations experienced by payloads in the payload bay (Fig. 2). An aluminized TCS (no Beta cloth) MLI blanket that measured 41.5 by 36 inches was custom-built to represent one of the largest blankets used in the Shuttle payload bay. After cutting one side of the blanket to expose the inner layers, resistance measurements between each inner layer and the outer layers were conducted using a PRS-812 meter. The first three inner layers had a resistance between them on the order of a few kilohms, the same as inner layers 4 through 8. However, inner layers 1 through 3 were not connected to inner layers 4 through 8, even though they were stapled together and bound with the Beta glass cloth tape. None of the inner layers were connected to the outer layers of the MLI blanket.

**Figure 2.** Shaker table experiment with aluminized MLI blanket.

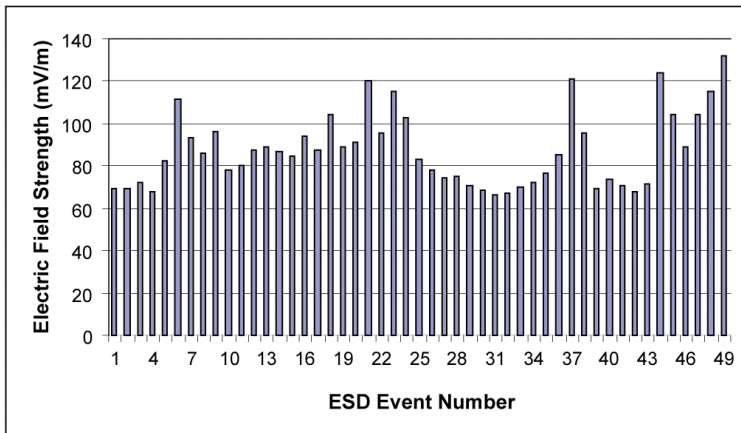
**Figure 5.** Electrostatic discharge events monitored with an EM Eye instrument during the vertical shaker table experiment.

ESD event measurements were also performed with the EM Eye device (Fig. 5). Forty-nine events were recorded during measurements of inner layer 4, and some events were relatively large.

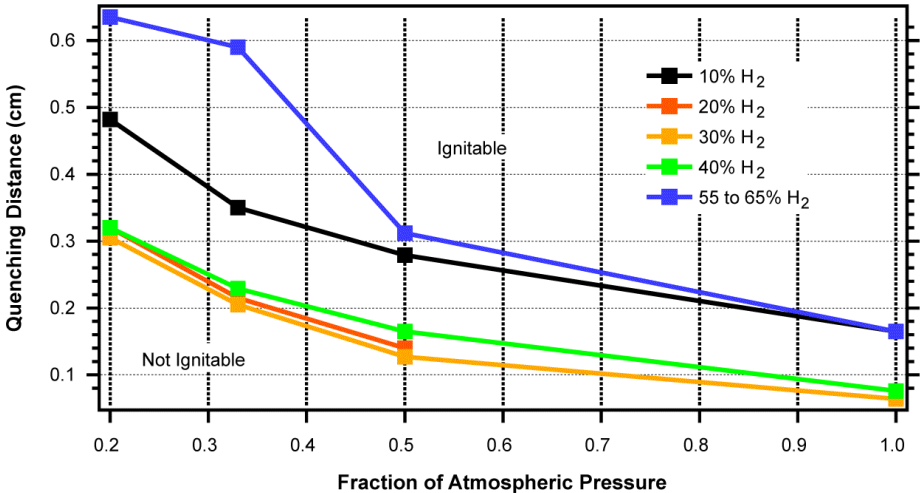
Similar relationships hold for the quenching distance. The quenching distance is the distance at which no ignitions can occur as the electrodes are moved closer together. Experimental quenching distances as a function of pressure for various hydrogen gas mixtures are given in Figure 7.

**Figure 7.** Quenching distance for various hydrogen gas mixtures as a function of pressure [data from Lewis and von Elbe, 1987].

If the blanket layers are too close together when they spark, although the spark may have sufficient energy to ignite the gas, the separation may be below the quenching distance and no ignitions will occur. Even though Tuff buttons are used to minimize billowing, it is possible for the MLI blankets to physically separate above the quenching distances.
