Nature-Inspired Motivation for Developing Self-healable Electrical Insulation

Tiffany S. Williams, Ph.D.
Materials and Structures Division
NASA Glenn Research Center
Cleveland, OH

March 19, 2018

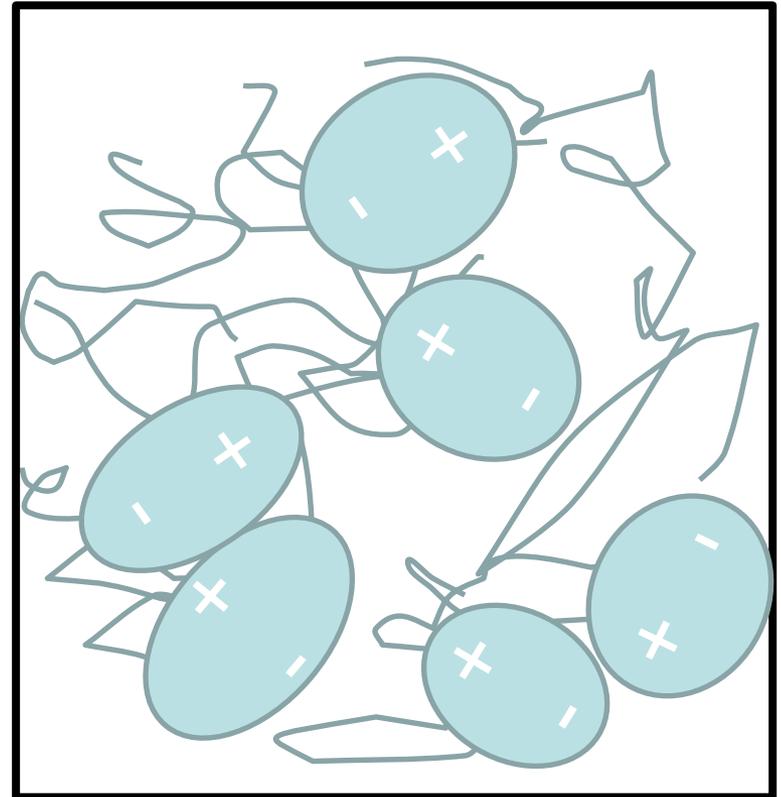
Ionic clusters and other bonds that can break and reform

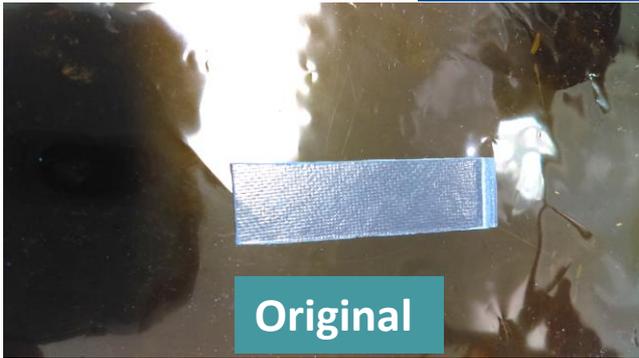
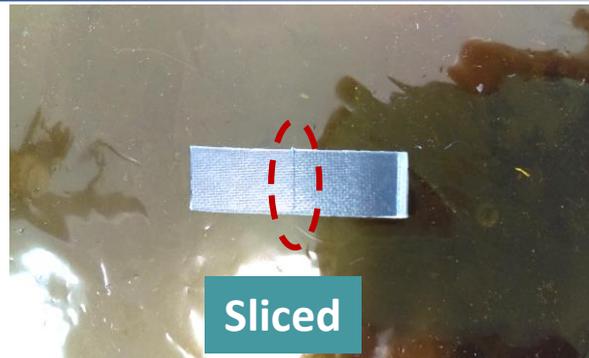
Surlyn film was cut and then heated to induce healing.

1st healing cycle → Only 67% recovery w/o additional heating

Elevated heating after mending is believed to activate ionic crosslinks.

Achieved 90-97% recovery when samples were dwelled at 70°C.

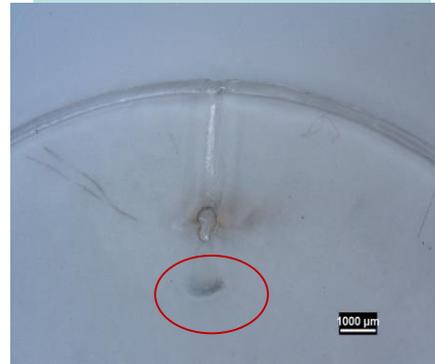
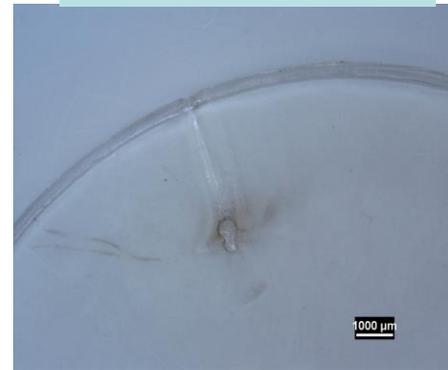
Before Testing

1 hour post-test

Day 3 post-test

Day 7 post-test

- Samples were dwelled at 70°C for 7 days after testing.
- Surlyn did not show evidence of healing at most severe damage site
- Some discoloration cleared by day 7
- No healing can occur after thermal degradation
- Dielectric testing did not follow after dwelling at 70°C for 7 days because damage was still noticeable

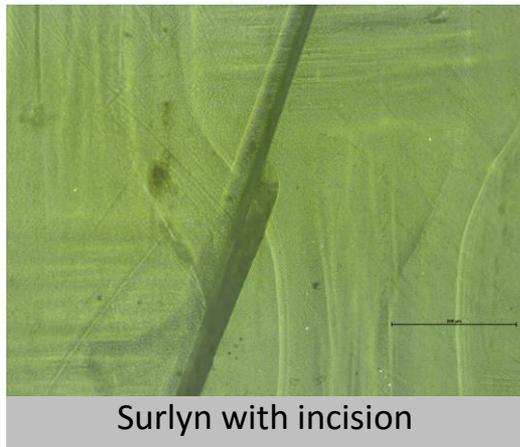
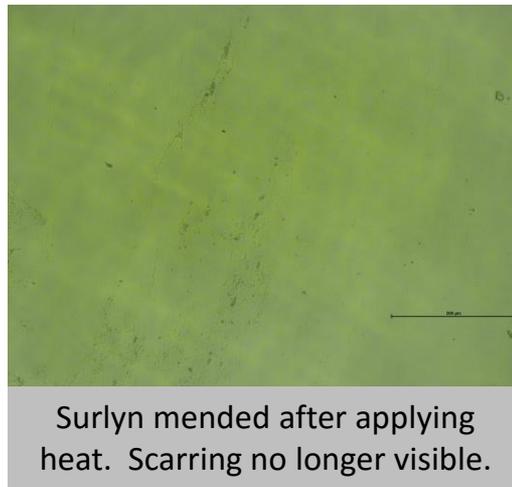
Surlyn was cut and then tested on dielectric rig. Most severe damage site fell along the incision line.

Surlyn	Surlyn (Cut)	Surlyn (Healed)
Breakdown Voltage (kV)	16.8 ± 1.09	~9.7	~15.7

~93% recovery in dielectric strength after healing
