# Testing and Development of NEA Scout Solar Sail Deployer Mechanism

The Near Earth Asteroid (NEA) [1] Scout is a deep space CubeSat designed to use an 86 m<sup>2</sup> solar sail to navigate to a near earth asteroid called VG 1991. The solar sail deployment mechanism aboard NEA Scout has gone through numerous design cycles and ground tests since its conception in 2014. An engineering development unit (EDU) was constructed in the spring of 2016 and since then, the NEA Scout team has completed numerous ground deployments aiming to mature the deployment system and the ground test methods used to validate that system. Testing a large, non-rigid gossamer system in 1G environments has presented its difficulties to numerous solar sailing programs before, but NEA Scout's size, sail configuration, and budget has led the team to develop new deployment techniques and uncover new practices while improving their test methods. The program has planned and completed 5 separate full scale sail deployments to date, with a flight sail deployment test scheduled for FY18. The paper entitled "Design and Development of NEA Scout Solar Sail Deployer Mechanism" [2] was presented at the 43<sup>rd</sup> Ae

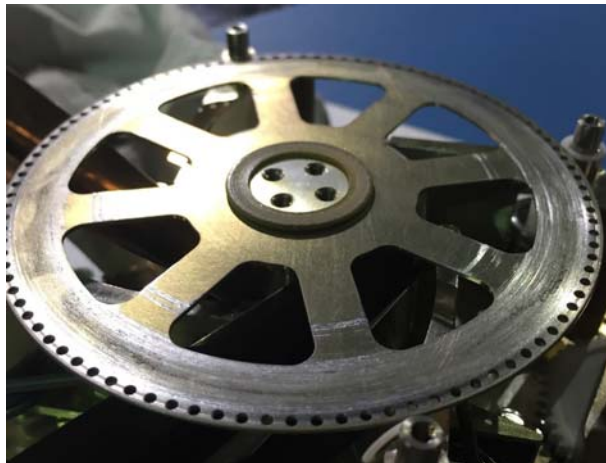
**Figure 4. Visible wear on top flange caused by boom coil irregularities. Note that the gold conversion coat has been removed.**

Second, the rotating flanges were too thin to resist loads from the improperly boom coils and deformed. We did not understand the spring energy in the booms and that the thin flanges would be in the spring energy’s load path. The flanges and gears were not stiff enough to resist and deflected through the as-designed air gaps into the structural components.

There were clear signs of interference and wear on most of the rotating components within the deployer. As the SSD was tediously deconstructed, each part was inspected and any wear and debris was photographed. It was clear that the as-designed air gaps had closed either during assembly or operation. Some of these air gaps were 0.25 mm or less and resided between stiff structural plates and thin, rotating flanges (Figure 2, 3). The flanges deformed during spooling and/or deployment and contacted their neighboring structural components. This produced gouges, aluminum dust and removed the chemical conversion coating from the contacting surfaces. Images of the damage are shown below (Figure 4, 5).

The interferences were removed by making larger air gaps between the rotating components. The flange damage was repaired and the base plate was redesigned to accommodate for the new motor design. The gears’ height was reduced by about 0.2 mm and 0.2 mm shims were added between the top flange and top plate. These changes nearly tripled the air gap widths, allowing for spooling irregularities and reduced the wear observed at the next deployment tests.

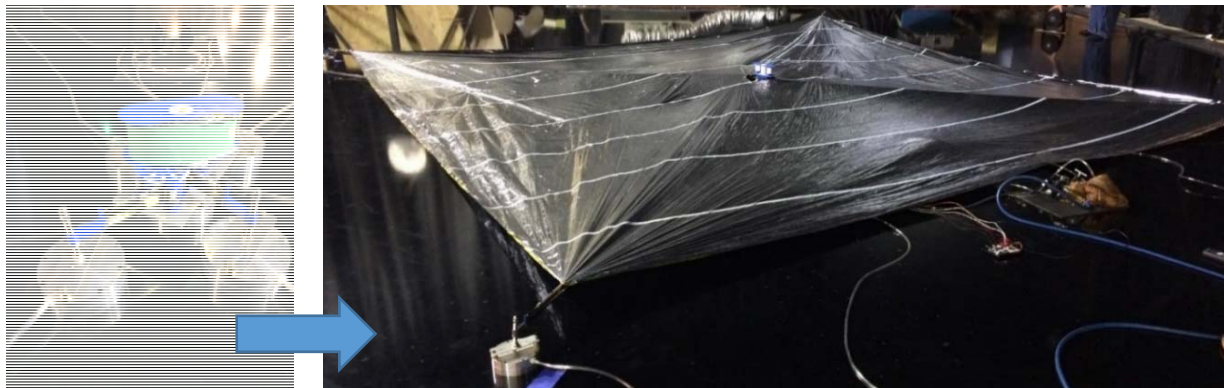
The facility, also known as the “Flat Floor”, allowed air bearings to float across the surface of the epoxy floor with negligible friction. Without friction loads, the air bearings were intended to simulate two lateral degrees of freedom in the floor’s plane and a rotational degree of freedom normal to the floor. The team attached the deployer body and each boom tip to an air bearing and a compressed air supply (Figure 9). The “frictionless system” was supposed to help study the SSD’s natural deployment motion, angular rates and angular accelerations. This information would have been beneficial for the guidance and control team’s deployment modes and models, but the forces created by the air supply hoses dominated deployment dynamics and produced inconclusive results. The air bearings were never used again on account of their high inertias and hose-induced loads.

**Figure 9. First sail deployment test: half scale 3D-printed prototype.**

The first lesson learned relates to the air bearings. The air bearings were a large mass at the end of each boom (Figure 9). Even after allowing 3 degrees of freedom, the bearing masses dominated the boom tips' natural paths. The air hoses connected to each air bearing also introduced significant friction forces into the system. Though the air bearings were frictionless, their air supply hoses had to drag along the floor and the hoses bending resistance completely overwhelmed the booms' restoring forces. This problem only worsened as the booms increased in length until the booms eventually buckled. For large sail systems, large masses at the boom tips will dominate deployment dynamics and lessen the booms' abilities to self-correct. Avoid large masses and force inputs near boom tips during deployment testing.

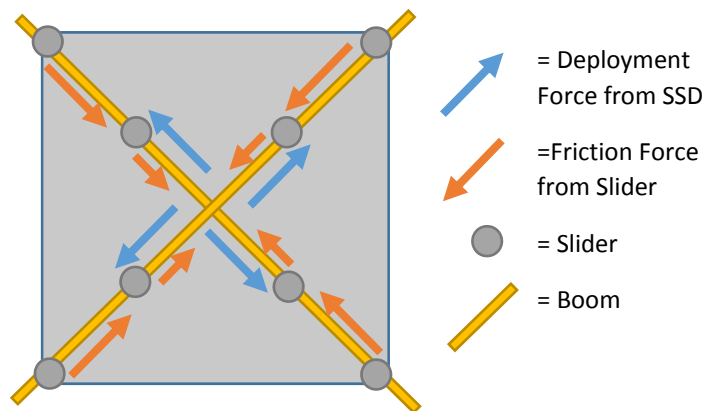
**Figure 14. Deployed sail and deployment force diagram.**

The final contributor to boom buckling is the boom mass. On orbit, the booms would not need to compete with gravity to support their own weight or deployment friction forces created by boom supports, sail friction or static electricity. As friction and electro-static forces move further from the boom root, the boom root's restoring moment and stiffness loses any ability to correct. Figure 14 shows that the friction forces furthest from the boom roots dominate boom deployment dynamics.

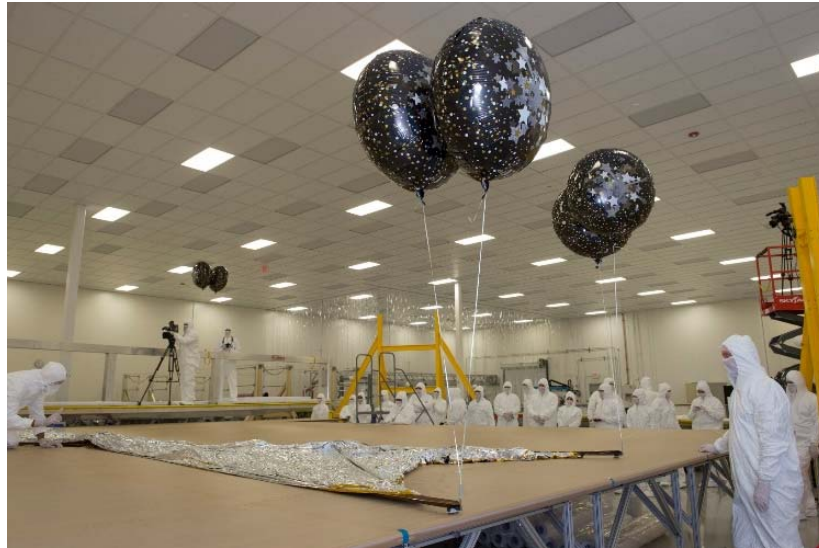
**Figure 15. Boom tip gravity offloading.**

After observing this characteristic in many boom-only deployments, the team determined that any effort to gravity offload the boom tips would remove 1G deployment characteristics and produce a more flight-like test. Many offload options were traded, but tying balloons to the boom tips proved to be the simplest solution (Figure 15). By removing some weight and friction forces from the regions furthest from the boom root, the booms followed a more flight-like deployment path (similar to what was observed at the half scale tests). Furthermore, boom tips were more realistically affected by the sail edge tensioning created at the final stages of deployment (Figure 11 D-E). The gravity offload and friction reduction methods gave the team far more insight in the boom behavior on orbit.
