# Testing and Maturing a Mass Translating Mechanism for a Deep Space CubeSat

Near Earth Asteroid (NEA) Scout is a deep space satellite set to launch aboard NASA's Exploration Mission 1. The spacecraft fits within a CubeSat standard 6U (about 300 x 200 x 100 mm) and is designed to travel 1 AU over a 2.5 year mission to observe NEA VG 1991. The spacecraft will use an 86 m<sup>2</sup> solar sail to maneuver from lunar orbit to the NEA. One of the critical mechanisms aboard NEA Scout, the Active Mass Translator (AMT), has gone through rigorous design and test cycles since its conception in July of 2015. The AMT is a two-axis translation table required to balance the spacecraft's center of mass (CM) and solar sail center of pressure (CP) while also trimming disturbance torque created by off-nominal sail conditions. The AMT has very limited mass and volume requirements, but is still required to deliver a large translation range—about 160 x 68 mm—at sub mm accuracy and precision. The system is constrained to operate in complete exposure to space with limited power and data budgets for mechanical and thermal needs. The NEA Scout team developed and carried out a rigorous test suite for the

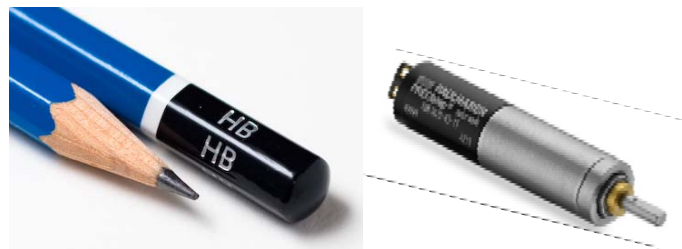
**Figure 2. Size comparison of 6mm stepper**
