NASA/TM—2018-219928

# Degradation of Intercalated Graphite Epoxy Composites Exposed to Low Earth Orbit

*James R. Gaier and Kim K. de Groh  
Glenn Research Center, Cleveland, Ohio*

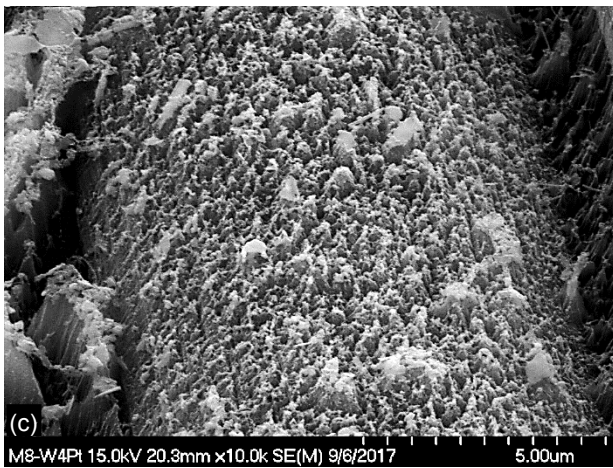
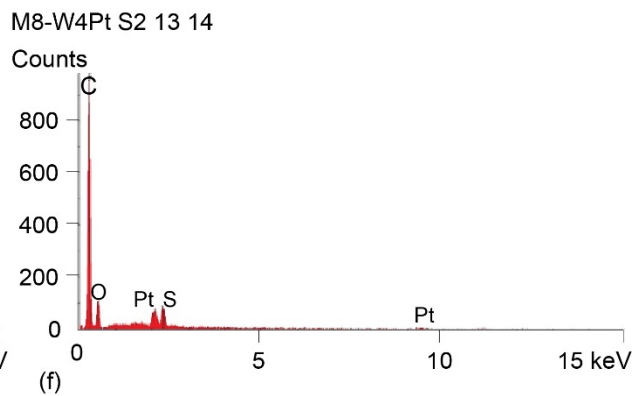
Figure 6.—FESEM images of the exposed region of the M8-W4 P100/Epoxy sample showing the P100 fiber at (a) 2500 $\times$ , the epoxy at (b) 2500 $\times$ , the P100 fiber at (c) 10000 $\times$ , the epoxy at (d) 10000 $\times$ , and EDS of the (e) P100 fiber and the (f) epoxy showing unmistakable signs of degradation.

Figure 6 shows comparable photomicrographs for the space-exposed regions. There was obvious AO etching of both the fibers (Figure 6(a) and (c)) and the epoxy (Figure 6(b) and (d)), but the AO degradation was much less than was seen in the EOIM-III samples (Figure 7). This is expected because of the lower AO fluence in the ORMatE-III sample.

Both Figure 6 and Figure 7 illustrate that the epoxy eroded in the AO at a much faster rate than the fibers. This is consistent with accepted erosion yields for the two materials (Ref. 7). The cone shaped micro-texture is confirmation that the AO degradation of the ORMatE-III samples was dominated by those times when the ISS reorientation caused it to be oriented in the AO ram direction (Figure 6(d)).

The EDS spectrum of the region on the fiber indicated by the box in Figure 6(a) is shown in Figure 6(e). The spectrum was very clean showing only the carbon of the fiber and a small platinum peak from a coating applied to enable the measurement. Figure 6(f) shows the EDS spectrum from a region dominated by the epoxy. Unsurprisingly, in addition to carbon and platinum seen on the fiber, components of the epoxy, oxygen and sulfur, were also detected. There were no indications of contamination in these spectra. Perhaps the most common contaminant would be outgassing from silicones, which would be visible as a silicon peak. Not only was there no silicon peak in these samples, but there was also none found in space suit fabrics that were exposed at the same time on ORMatE-III (Ref. 13).

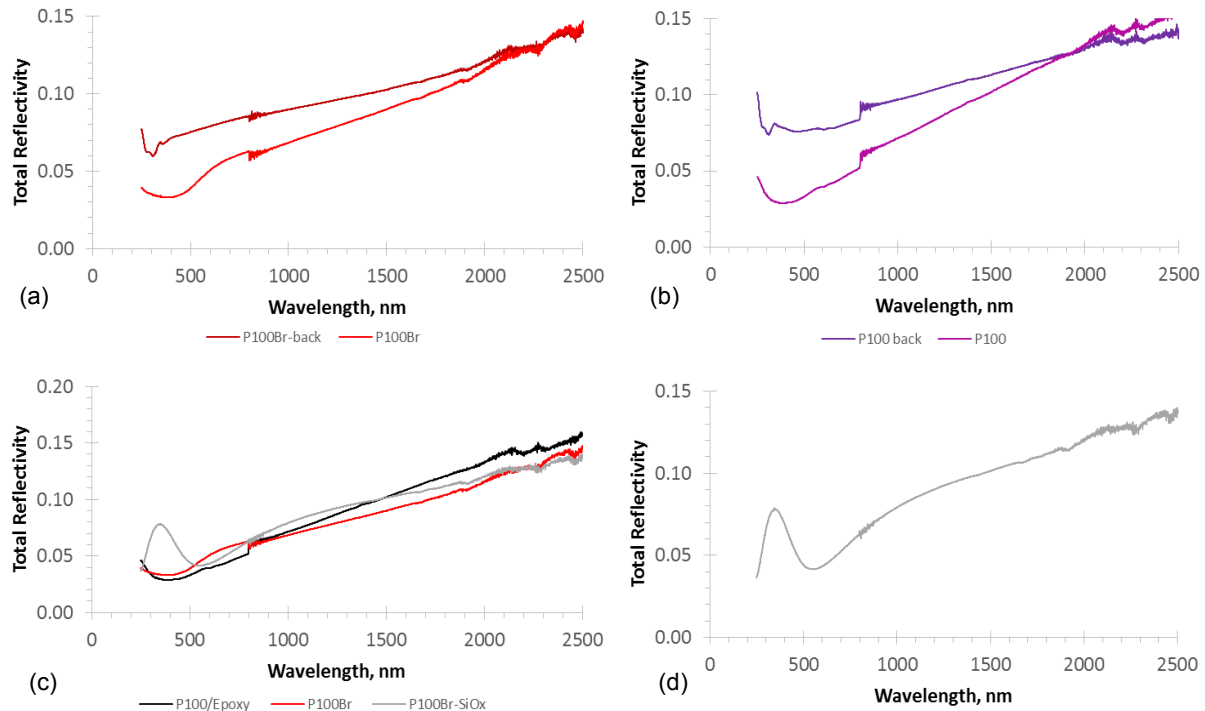
Figure 11.—The 250 to 2500 nm spectra of the composite samples flown on ORMatE-III (a) W4 P100/epoxy composite, (b) W5 P100-Br/epoxy composite, (c) W6 SiO<sub>2</sub>-coated P100-Br/epoxy composite, and (d) comparison of the three.

The reflectance spectrum in the 250 to 2500 nm wavelength range is important because that is the region where the sun emits over 99 percent of its intensity. Figure 11(a), and (b), show the reflectance spectrum of unprotected P100/epoxy composite (W4) and unprotected P100-Br/epoxy composite (W5) and respectively. Shown for comparison for W4 and W5 is the spectrum from the back side of the sample, which was protected from the AO and solar UV radiation environment. The analyses above showed that the elemental composition of the composites was unchanged, but a texture developed with features on the order of 0.5  $\mu\text{m}$ . No new spectral features were seen in this spectral region, but both samples had increased absorption in the UV region. The pristine composite had a crossover with decrease IR absorption above about 1900 nm, whereas the bromine intercalated fiber composite had essentially the same IR absorption above 2200 nm.

Figure 11(c) shows the spectrum of the SiO<sub>2</sub>-coated P100-Br/epoxy composite (W6). Note the strong reflection feature that peaks around 350 nm. This UV-centered peak tailed into the visible part of the spectrum and was responsible for the violet color noted in the survey photography. Figure 11(d) shows spectra of the three composites exposed to the LEO environment superimposed. It is interesting to note that, despite the texturing of the unprotected composites, the reflection spectra are nearly the same, except for the region around the 350 nm SiO<sub>2</sub> peak.

The  $\alpha$  calculated from the ORMatE-III composites spectra were nearly identical. Both pristine and intercalated uncoated samples had an  $\alpha$  of 0.94 and the SiO<sub>2</sub> coated sample had an  $\alpha$  of 0.93. Regarding the thermal properties, utilizing bromine intercalated fiber composites and/or coating the composite with SiO<sub>2</sub> had no practical effect. The  $\alpha$  of the EOIM-III samples was not calculated, but it is clear from the spectrum that the  $\alpha$  increased slightly, probably to about 0.96 to 0.98.

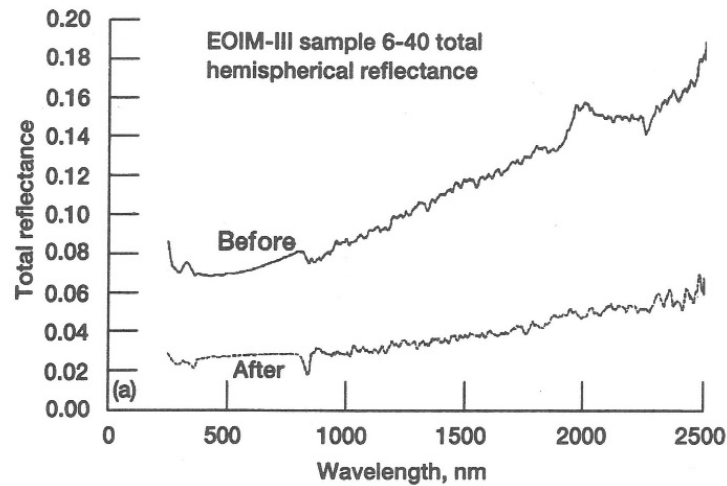
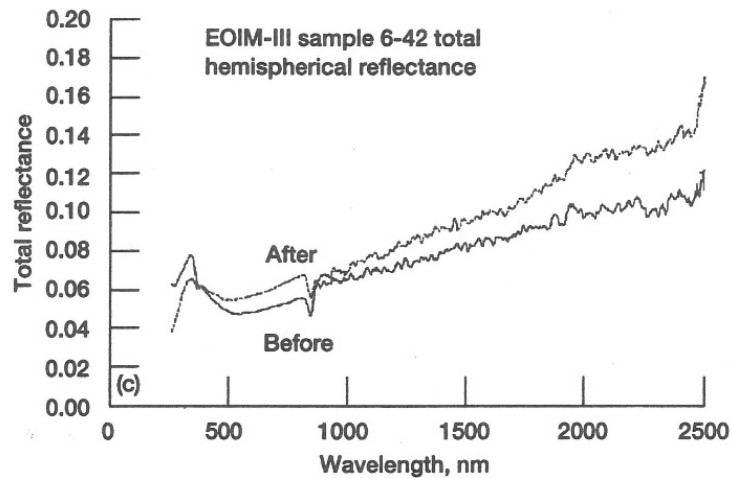
Figure 12.—The 250 to 2500 nm spectra of the composite samples flown on EOIM-III (a) P100/epoxy composite corresponding to W4, (b) P100-Br/epoxy composite corresponding to W5, (c) SiO<sub>2</sub>-coated P100-Br/epoxy composite corresponding to W6. Reproduced from Reference 8.

Surprisingly, the data from the corresponding composites flown EOIM-III looked very different (Figure 12). The spectra that were measured before the EOIM-III flight look similar to the spectra measured of the back side of the ORMatE-III composites. But the post-flight EOIM-III spectra exhibited a decrease in the total reflection decreased by about a factor of 3 across the entire spectrum. At no wavelength did the two curves approach each other (Ref. 8).

Contrary to the unprotected P100/epoxy and P100-Br/epoxy spectra above, the spectrum of the SiO<sub>2</sub>-coated P100-Br/epoxy composite in the EOIM-III looked similar. This raised the question of why were the spectra of the unprotected composites so different, and the protected composites similar. It seems unlikely that instrument or procedural differences between the experiments conducted 20 years apart would account for the differences since the pre-flight EOIM-III and the back-side ORMatE-III were similar and the post-flight SiO<sub>2</sub>-protected composite spectra were similar. Thus it seems likely that there were real spectral differences between unprotected composites exposed to 42 h of ram AO and to one-third that in the ORMatE-III samples decreased the solar reflection significantly, particularly in the infrared.
