# Oxygen Generation Assembly Design for Exploration Missions

**Future Exploration missions will require an Oxygen Generation Assembly (OGA) to electrolyze water to supply oxygen for crew metabolic consumption. The system design will be based on the International Space Station (ISS) OGA but with added improvements based on lessons learned during ISS operations. These improvements will reduce system weight, crew maintenance time and resupply mass from Earth while increasing reliability. Currently, the design team is investigating the feasibility of the upgrades by performing ground tests and analyses. Upgrades being considered include: redesign of the electrolysis cell stack, deletion of the hydrogen dome, replacement of the hydrogen sensors, deletion of the wastewater interface, redesign of the recirculation loop deionizing bed and redesign of the cell stack Power Supply Module. The upgrades will be first demonstrated on the ISS OGA.**

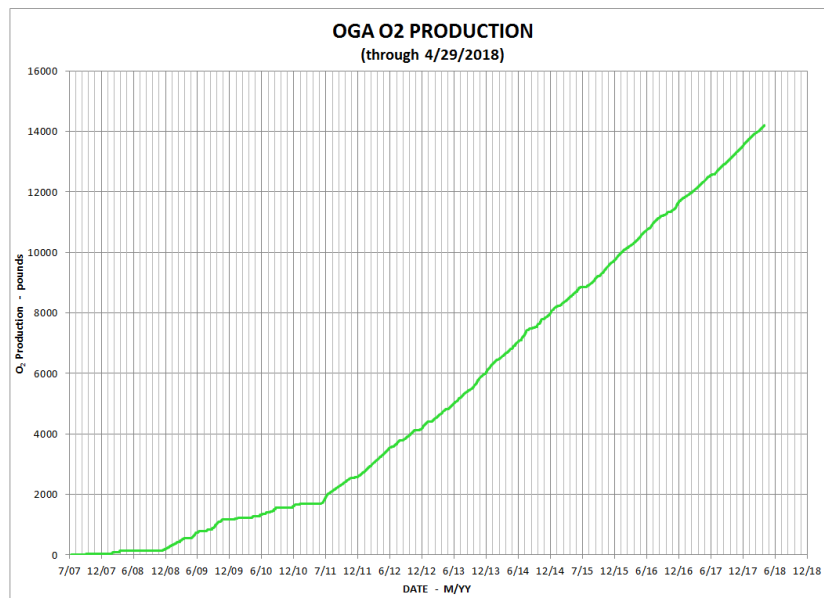
**Figure 1. Total Oxygen Produced by the ISS OGA**

As of April 29, 2018, the OGA has produced over 14,202 lbm of oxygen and 1,775 lbm of hydrogen. The currently installed OGA cell stack has accumulated a total operating time of 12,711 hours. See Figure 1 for a plot of oxygen produced over time.

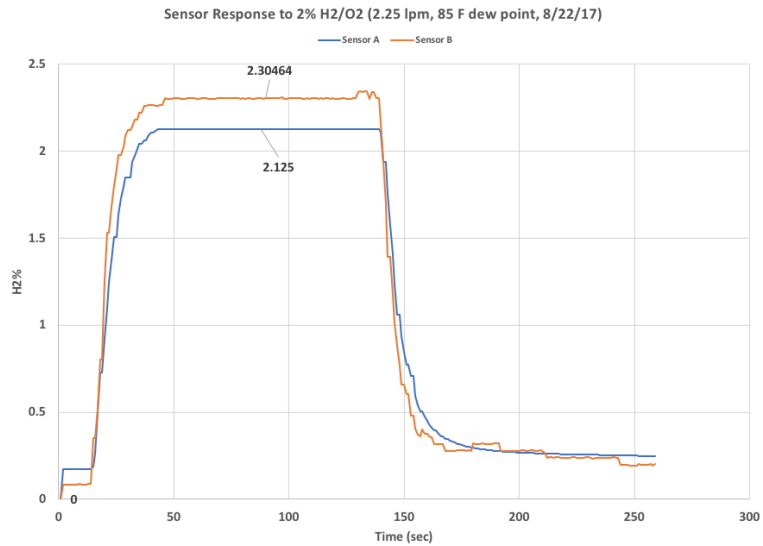
**Figure 7. Hydrogen Sensor Response**

The bench test rig is designed to supply humidified gas mixtures of oxygen, hydrogen and nitrogen to the hydrogen sensor under test. K-bottles of hydrogen, oxygen and nitrogen provide source gas. The oxygen and hydrogen are metered using mass flow controllers to provide precise mixtures from 0 to 3% hydrogen in oxygen. The gas mixtures are humidified, close to 100% relative humidity, to simulate the product oxygen from the cell stack. Periodic nitrogen purging is also performed during bench testing to simulate on-orbit shutdown and startup nitrogen purging. Sensor response is compared to the expected response. For example, when exposed to 1% hydrogen in oxygen, the actual response is recorded to determine the amount a particular sensor is under-reporting or over-reporting. An example response is shown in Figure 7. Two percent hydrogen in oxygen gas (as determined by the hydrogen and oxygen mass flow controllers) is flowed through two candidate sensors. Both sensors over-report the amount of hydrogen, by 6.3% and 15.2%. Over-reporting is considered conservative and not a safety risk (although could lead to nuisance shutdowns depending on the amount of offset). Over-reporting is not necessarily considered a disqualifying characteristic. During bench testing, five sensors were eliminated (see Table 3).

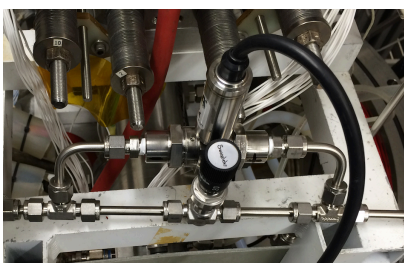
**Figure 9. Hydrogen Flow Sensor**

A valve (acting as an orifice) and a delta pressure sensor were installed in both the hydrogen vent line and oxygen outlet line of the OGA Test Bed. The modified hydrogen vent line is shown in Figure 9. Reliably sensing flow at different production rates was demonstrated. Hydrogen flow, as sensed by the delta pressure sensor (in red), and cell stack current (in blue), is depicted in Figure 10. The relationship between flow rate and cell stack current is illustrated. Further analysis will be performed to determine how small of an external hydrogen leak can be detected with the flow sensors.

Existing sensors can provide an indication of external hydrogen leakage from the cell stack or RSA. Pressure sensors monitor the recirculation loop pressure and quantity sensors monitor the quantity of water in the RSA. An external leak can cause a drop in the recirculation loop pressure and RSA water quantity if the leak is large enough. To provide finer leak detection, new sensors are required. Flow sensors in the hydrogen vent line and the oxygen outlet line are proposed. An external leak of hydrogen will cause a decrease in flow of hydrogen out of the hydrogen vent line. A cross cell leak, allowing hydrogen to flow out of the oxygen outlet line, will cause an increase in total flow out of the oxygen outlet line. Gas flow can be sensed in various ways. One method of detecting flow is to sense delta pressure across an orifice installed in the line.

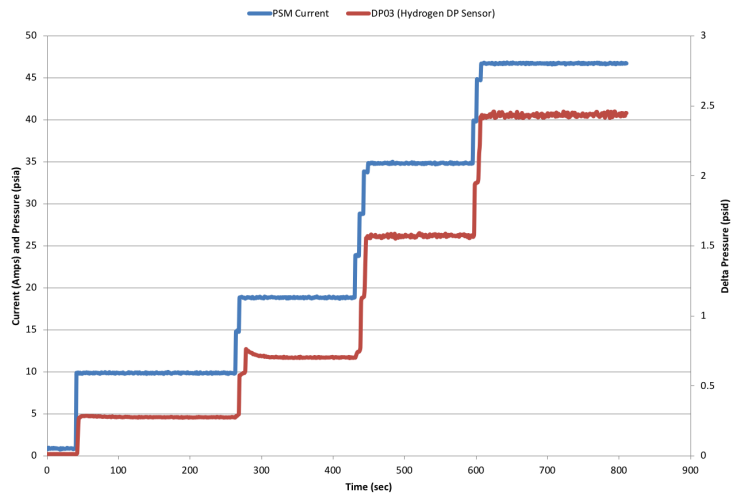
Figure 10. Hydrogen Flow and Cell Stack Current

Hydrogen Flow, OGA Test Bed, 1/28/16
