Long Duration Wear Test of the NASA HERMeS Hall Thruster

Prepared for the
54th Joint Propulsion Conference
cosponsored by AIAA, SAE, and ASEE
Cincinnati, Ohio, July 9–11, 2018

NASA/TM—2018-219960

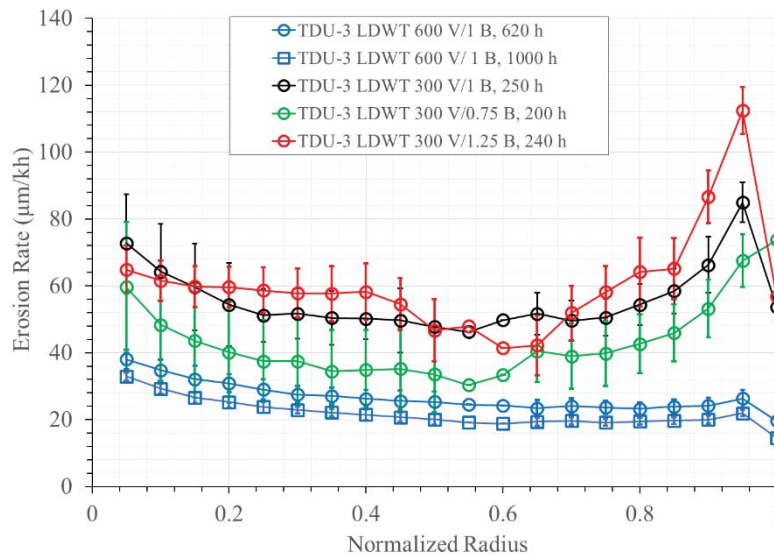
Figure 4 shows the IFPC erosion rates measured near the 8 o'clock mask during the LDWT as a function of normalized IFPC radius. In Figure 4, a normalized radius of 0 corresponds to the edge of the IFPC closest to the cathode whereas a radius of 1 corresponds to the edge closest to the discharge channel. It is important to note that the truncation of the data near the inner IFPC edge is due to the fact that the employed masks only cover approximately 95 percent of the IFPC.

Consistent with previous empirical and analytic results, for all operating conditions, the erosion rate is observed to minimize near the center of the IFPC and gradually increase towards the keeper and discharge channel (Refs. 5, 30, and 31). It is important to note that, as shown in Figure 5, the local maxima shown in Figure 4 near a normalized radius of 0.9 represent a continuous trend and are, therefore, not outliers. Despite the observed consistency in radial variation, the magnitude of the erosion rate is a strong function of discharge voltage. As shown in Figure 4, the radially-averaged erosion rate increases by approximately 76 percent between the 600 and 300 V conditions performed at the nominal magnetic field strength.

Figure 4.—IFPC erosion rates near the 8 o'clock mask from the TDU-3 LDWT.

As discussed in previous work, the observed erosion trends with discharge voltage are likely driven by shifts in the axial location of the acceleration region (Refs. 5, 30 to 32). Specifically, laser-induced fluorescence (LIF) measurements have shown that the acceleration region shifts downstream at lower discharge voltages (Ref. 31). This shift results in a concomitant increase in beam divergence and, thus, the number of eroding ions reaching the IFPC (Refs. 5, 30, and 31).

In addition to the impacts of discharge voltage and magnetic field on IFPC wear, the results in Figure 4 also provide insight into how IFPC erosion changes over the thruster lifetime. Specifically, the erosion rates measured after 1000 h of operation at 600 V were lower at all radii by an average of 20 percent compared to those measured after 620 h of operation. This decrease in erosion rate with time is outside of the empirical uncertainty and was also observed during previous wear testing of TDU-1 (Refs. 4 and 5).

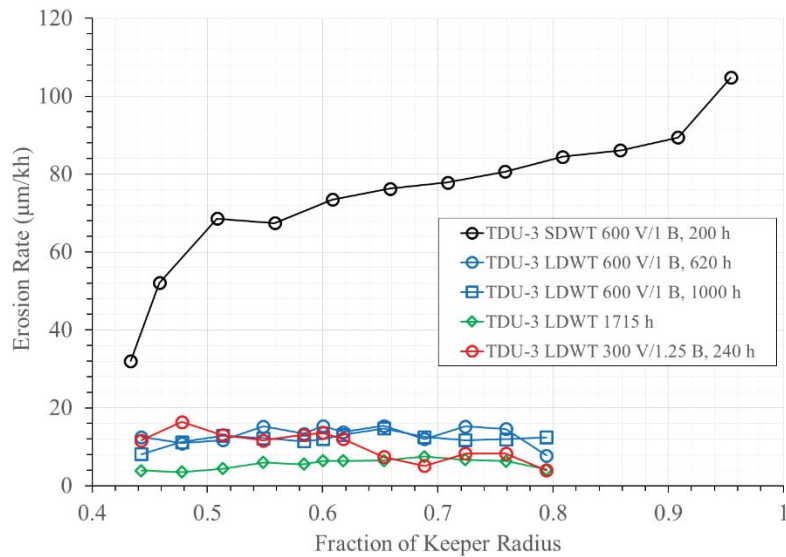
Figure 8.—Keeper erosion rates from the TDU-3 SDWT and LDWT for operation at 600 V, 12.5 kW, and nominal magnetic field.

As shown in Figure 8, the keeper during the LDWT eroded at a radially-averaged rate of approximately 13 $\mu\text{m}/\text{kh}$ independent of operating condition, which represents a decrease of 84 percent relative to the results acquired during the portion of the SDWT operated at the 600 V/ 1 B condition (Ref. 5). Furthermore, unlike during the SDWT, no significant radial variation in erosion rate was observed (Ref. 5). Qualitative confirmation of these results is shown by features visible in the 3D renderings of the cathode keeper acquired post-test and shown in Figure 9. Consistent with the results shown in Figure 8, the elevated plateaus corresponding to the masked regions of the keeper are much less pronounced for the LDWT than for the SDWT. This is particularly striking as each of the unmasked regions of the SDWT keeper accumulated approximately one-fifth the hours of those on the LDWT keeper (Ref. 5). It is important to note that the surface doming observed in Figure 9(b) was also present in pre-test scans and thus is likely an artifact of the pre-test polishing and not plasma exposure. Taken together, these results confirm the strong link between cathode position and keeper erosion rates and indicate that the upstream shift in cathode position successfully mitigated the elevated erosion rates observed during the SDWT.

It is important to note that the observed keeper step sizes were too small to be processed using the ISO method discussed previously. Instead, as done in both previous wear tests, the keeper data were analyzed manually using commercial software provided by the profilometer manufacturer. As discussed in Williams, et al. (Ref. 5), the SDWT keeper erosion data at the 600 V/1 B condition was acquired during the comprehensive performance characterization of TDU-3. As such, during the SDWT, TDU-3 was operated over a range of throttle conditions and magnetic field settings, resulting in increased uncertainty in the erosion measurements (Ref. 5). However, previous work has indicated that this increased uncertainty is smaller in magnitude than the wear rate reduction observed between the SDWT and LDWT (Ref. 5). As such, the increased uncertainty associated with nonwear point operation during the SDWT does not impact the overall conclusion that the upstream shift of the cathode significantly reduced keeper erosion rates.

As discussed by Lopez Ortega, et al. (Ref. 33), the decrease in keeper erosion for the upstream cathode location is likely due to an increase in shielding provided by the IFPC against ions originating close to the discharge channel. Specifically, the upstream shift reduces the effective downstream view factor of the keeper. Since it is postulated that thruster ions (i.e., those born in the thruster channel, acceleration region, or near-field plume) are the primary cause of IFPC and keeper erosion, this reduction in view factor should reduce the number of thruster ions incident on the keeper, resulting in the observed reduction in keeper erosion rates (Refs. 30 and 33).

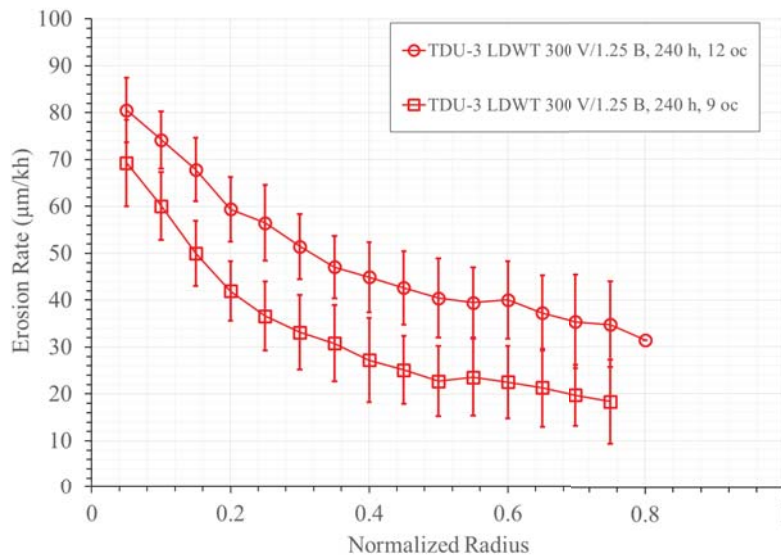
Figure 11.—Comparison of OFPC erosion rates measured near the 12 o'clock (12 oc) and 9 o'clock (9 oc) masks.

Similar to the approach taken with the IFPC, in order to assess the azimuthal symmetry of the OFPC wear mechanisms, profilometry measurements acquired near both the 12 and 9 o'clock masked regions were compared for the 300 V/1.25 B operating condition. The results are shown as a function of normalized OFPC radius in Figure 11. Contrary to the IFPC results, the azimuthal variation in wear rates was greater than the measurement uncertainty, suggesting that the OFPC wear was asymmetric for this operating condition. However, it is important to note that the pre-test surface finish in both of these regions was different. Specifically, the 12 o'clock mask was placed over a region of polished graphite whereas the region near the 9 o'clock mask was unpolished.
