Title: Cumulative Distribution of Ballistic Impact Failures of Common Twisted-pair Data Cables at Orbital Speeds

Keywords: MMOD; ISS; C&DH; twisted-pair cable;

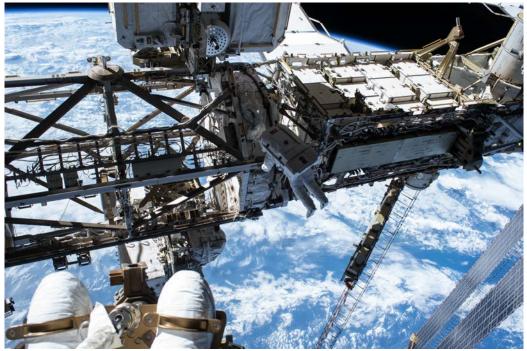
Figure 1. An ISS truss with exposed C&DH and power cables as imaged during an Expedition 48 extravehicular activity (EVA) of Commander Jeff Williams and Flight Engineer Kate Rubins [7].

The ISS Command and Data Handling (C&DH) system utilizes the MIL-STD-1553 data bus system [1,2] to interconnect its various subsystems such as the Multiplexer De-Multiplexers (MDMs) [3]. The 1553 data bus system is composed of shielded, twisted-pair cables and is doubly redundant. There are 45 MDMs on the ISS with 21 of these MDMs external to the habitable volume. The data buses that service these systems are exposed to the micrometeoroid-orbital debris (MMOD) environment especially in the case of open ISS structures such as the P3 or S3 truss segments like that shown in Fig. 1.

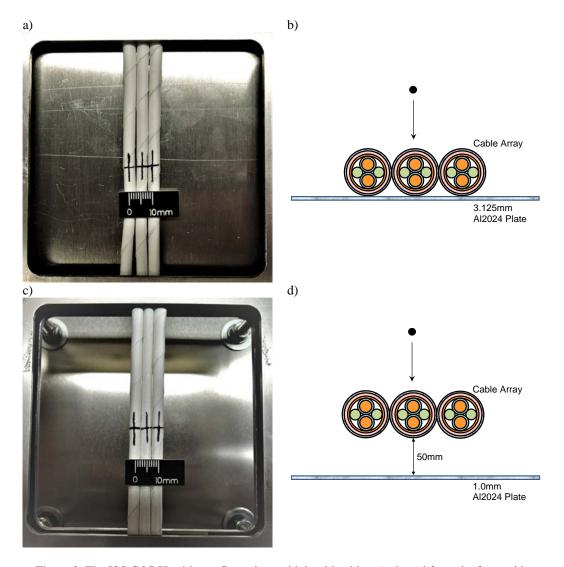
Figure 2. The ISS C&DH cable configurations with hard-backing a) viewed from the front with a b) cross-section schematic and suspended c) viewed from the front with a d) cross-section schematic. Cross-section schematics are not to scale.

The MIL-STD-1553 data cables on ISS structures are both directly supported by structural elements and unsupported runs between them; therefore, both supporting schemes have been considered [8]. This effort used wo types of experimental articles to reflect each scheme with characteristic examples shown in Fig. 2. The cables that are in the experimental articles have come from decommissioned MIL-STD-1553 flight cables provided by the ISS program office's prime contractor, the Boeing Company. The supported configuration, shown in Fig. 2a, consists of cables placed side by side over a 3.175mm aluminum hardback, which is schematically rendered as a cross-section in Fig. 2b. The unsupported configuration, shown in Fig. 2c, consists of cables held in place by a frame separated from a 1mm aluminum witness plate by at least 50mm, which is schematically rendered as a cross-section in Fig. 2d. Cable runs have been doubled or tripled to improve the probability of an impact as there is a small impact aim point uncertainty associated with the aerodynamic effects from the experiments.

cross-product of the projectile impact vector and the cable axis (vertical in Fig. 2a and 2c). This study has considered both spherical aluminum and steel projectiles at impact speeds of 7.0±0.3km/s [8].

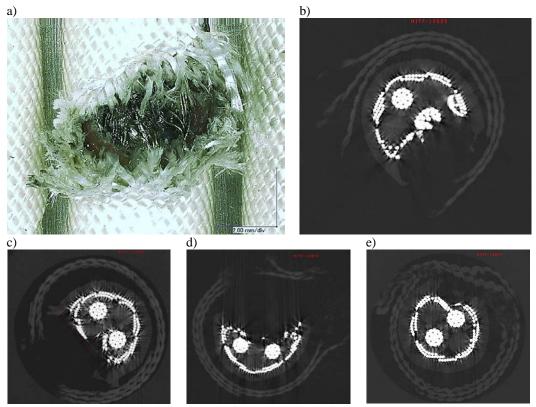
Figure 4. Typical impact results at 7 km/s for ISS C&DH cables including a) an optical micrograph from HITF15035 (a 0.6 mm Al2017 projectile) and b) a CT cross-sectional image of HITF15035. Additional CT cross-sectional images of c) HITF15040 (a 0.6 mm Al projectile), d) HITF15043 (a 0.44 mm SS440C projectile), and e) HITF150447 (a 0.44 mm SS440C projectile).

Typical results of four experiments that resulted in a short of the twisted-pair data cables are given in Fig. 4 for normal to the cable and 45° to normal to the cable. The impact obliquity is relative to the plane that contains the length of the cable and the

Figure 4 includes an optical micrograph and the corresponding CT-radiograph of HITF15035 in Fig. 4a and Fig. 4b, respectively. As can be seen in Fig. 4a, much of the shielding has been exposed by the impact event, and that the shielding came into contact with one of the conductors resulting in a short as seen in Fig. 4b. This condition resulted from an impact of a 0.6 mm Al2017 spherical projectile at 7.25km/s. What can also be seen from this pair of images is that the final condition of the internal, cable-components is only easily seen from the CT-radiograph, so only when CT-radiographs are obtained are impact locations known with certainty. CT-radiographs have not been obtained for all ninety-seven experiments due to the volume of work and the complexity of CT-radiography; however, optical microscopy with continuity and short-circuit measurements are sufficient for determining loss-of-function.

During the full course of this study, both types of failure modes (shorts and open circuits) have been observed in the hypervelocity experiments; however, the smallest particles that result in permanent, loss-of-function of the cable generally result from short circuits before open circuits. Other representative short circuits from additional aluminum and steel impacts are shown in Fig. 4c through Fig. 4e.

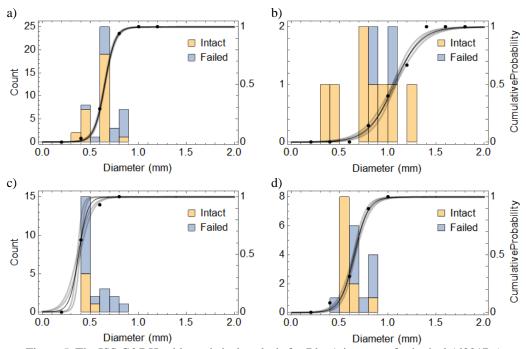
Figure 5. The ISS C&DH cable statistical analysis for 7 km/s impacts of spherical Al2017 a) at normal incidence and b) 45° to normal, and spherical SS440C c) at normal and d) 45° to normal. The plots show the cumulative count and probability of failure as a function of projectile diameter.

Due to the non-uniformity of internal materials, a pronounced variability for the outcome has occurred with the same particle size resulting in both closed and short circuits depending on the impact conditions. To illustrate this, the count of particles that resulted in an intact cable for a given particle size bin is shown in Fig. 5 as an orange

bar for each impact condition. Similarly, the count of particles that resulted in a failure, short or open conductor, for a given particle bin are shown as a stacked blue bar. The combined height of the two bars is the total number of impacts considered for a given impact condition, and this total count includes all of the experiments performed under this study as well as the experiments documented in Ref. 4. As can be seen, the count of intact results generally decreases with impact particle size, and the count of failed results generally increases with impact particle size.

This failure probability is also shown in Fig. 5 as the data points, and they correspond to the secondary ordinate. To model this failure probability, a nonlinear regression to a logistic function with the independent variable of diameter, d, has been performed. The failure probability, P_F , is given by:
