# The Demonstration of a Robotic External Leak Locator on the International Space Station

Adam J. Nails, Tim Bond, Chris Crow, Jesse Buffington  
NASA Johnson Space Center, 2101 NASA Parkway, Houston, TX 77058

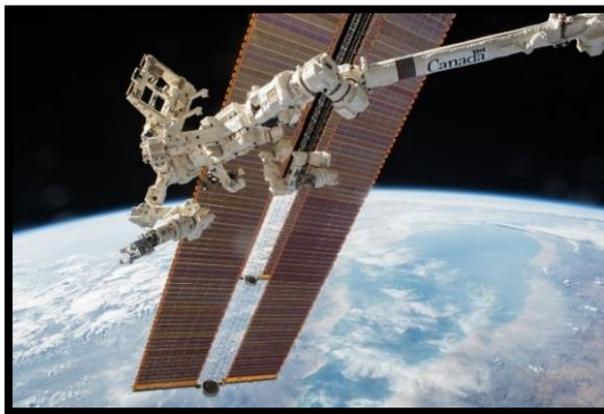
*Figure 2:* RELL attached to the SSRMS/SPDM during the Technology Demonstration in December 2016.

RELL is currently stowed inside the ISS, though an external stowage bay is currently in development. The Japanese Experiment Module (JEM) Airlock is used to transfer RELL to the external environment where it is picked up by the Space Station Remote Manipulator System (SSRMS) and Special Purpose Dexterous Manipulator (SPDM), as shown in Figure 2. After the SPDM grapples RELL, operations are controlled entirely from the ground, minimizing impact to the ISS on-orbit crew. Ground operators maneuver the robotic assets around the ISS in predetermined trajectories based on potential leak locations.

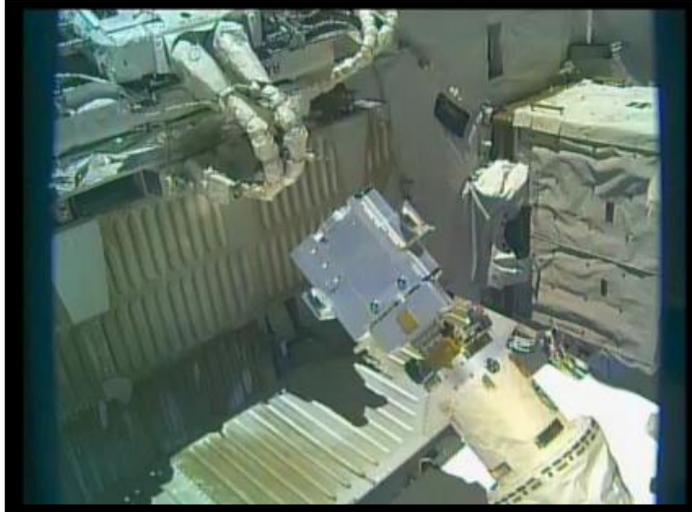
**Figure 7:** A screenshot of RELL scanning RBVM P1-3-2 as taken from the mast camera of the SSRMS.

Upon completion of the natural environment scans, RELL proceeded to scan the RBVMs, PFCS and Z1 Truss. RELL proceeded through planned maneuvers at each RBVM, unsure of what to expect. RELL measured a large ammonia signal that seemed to be emanating from RBVM P1-3-2, which happened to be the first RBVM that was scanned (see Figure 7 below). The total pressure was two orders of magnitude larger than any other pressure observed, as can be seen in Figure 8. It appeared that RELL had in fact measured the known ammonia leak. The team thought it prudent to pause in this area for an entire orbit (~90 minutes) to determine how the signal changed throughout the orbit. The ammonia signal did in fact change in a sinusoidal nature as the ISS went around the Earth, as shown in Figure 9. This was expected, due the changing temperatures around the ISS as it goes around the Earth and is similar to the diurnal affect measured during the natural background scans. However, the rising and falling of the natural background pressure does not temporally match up exactly with the rising and falling of the ammonia signal. Also, the magnitude of the variation is far greater than would be explained by bulk temperature change assuming the ammonia behaves as an ideal gas. More work is needed to understand the exact cause of this phenomenon but for now, this diurnal variation is another factor that needs to be taken into account when searching for leaks.

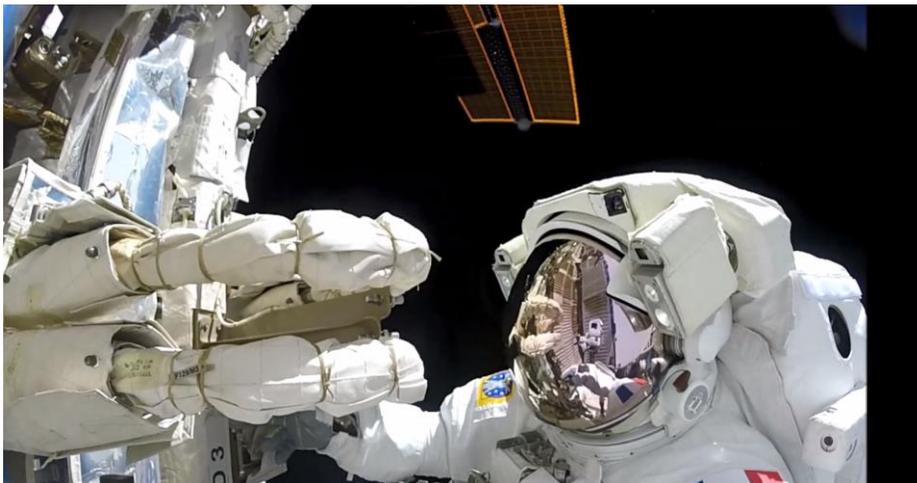
**Figure 14:** A screenshot from the EVA GoPro during inspection of RBVM P1-3-2.

During the EVA no white flakes were reported by the crew member, nor were there any other signs that implicated one side versus the other. However, upon completion of the EVA, the team reviewed the imagery and video in detail. Figure 14 shows a screenshot of footage taken during the EVA.

It was in watching the EVA GoPro footage that the team noticed multiple white flakes emanating directly from one of the flex lines. White flakes are an explicit sign that ammonia gas is being released into space and condensing. This experience highlighted that high resolution images, coupled with the proper lighting conditions are required to be able to see flakes like this. Standard definition video from the crew member’s helmet camera was not sufficient. This was the final piece of evidence the team needed to have high confidence that the leak was indeed on the “Radiator” side.
