# LONG DURATION WEAR TEST OF THE NASA HERMES HALL THRUSTER

*2018 AIAA Propulsion & Energy Forum  
July 10, 2018*

**Jason D. Frieman, Hani Kamhawi, George  
Williams, and Daniel Herman**

*NASA GRC*

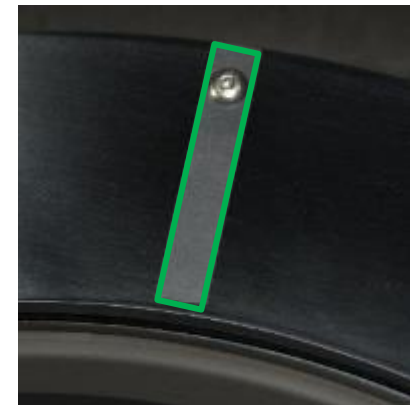
- Graphite IFPC, keeper, and OFPC modified to enable wear measurements
  - Components polished pre-test to maximize surface uniformity
  - Graphite masks installed to provide unexposed reference surfaces:
    - IFPC: two graphite strips covering approximately 95% of radius at 2 and 8 o'clock
    - Keeper: graphite ring with a tab protruding radially inward
    - OFPC: series of graphite strips covering approximately 95% of radius
- Erosion measurements made with a chromatic, white-light, non-contact profilometer
  - Data analyzed per ISO 5436-1 guidance for a type A1 step
  - Typical uncertainties  $\pm 2 \mu\text{m}$  accounting for:
    - Instrument error
    - Surface roughness
    - Non-flat surface geometry

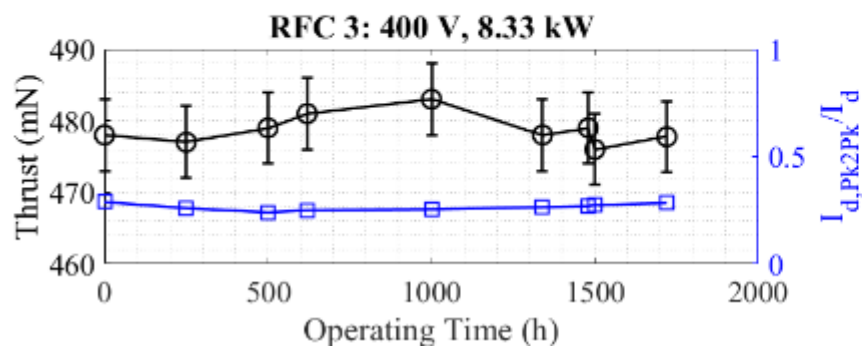
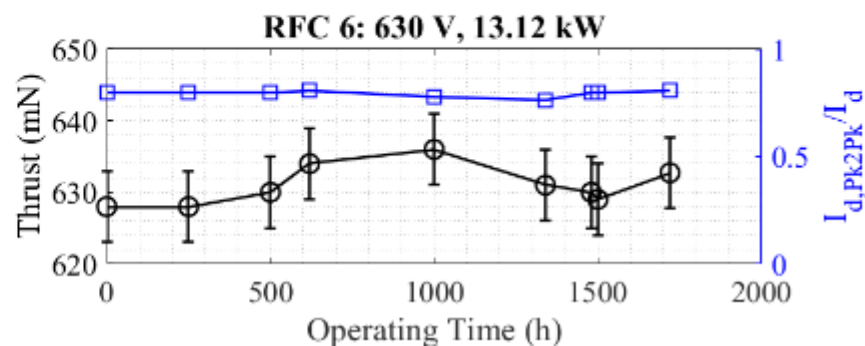
**Performance and stability vary by less than the uncertainty during LDWT and when compared against previous TDU wear tests**

- The NASA HERMeS TDU-3 Hall thruster was successfully operated over 1,720 hours in four different operating conditions in a long duration wear test
- The TDU-3 demonstrated consistent performance and stability over the course of the LDWT and relative to previous wear tests

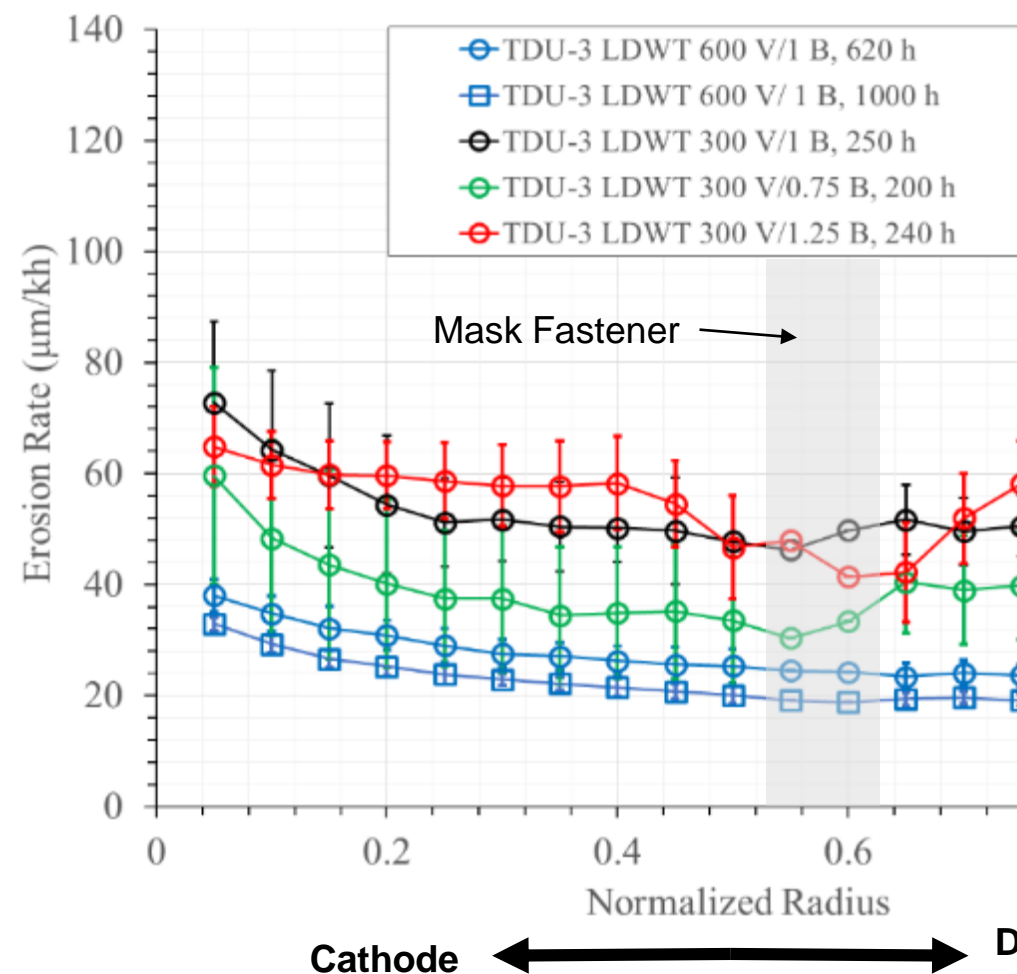
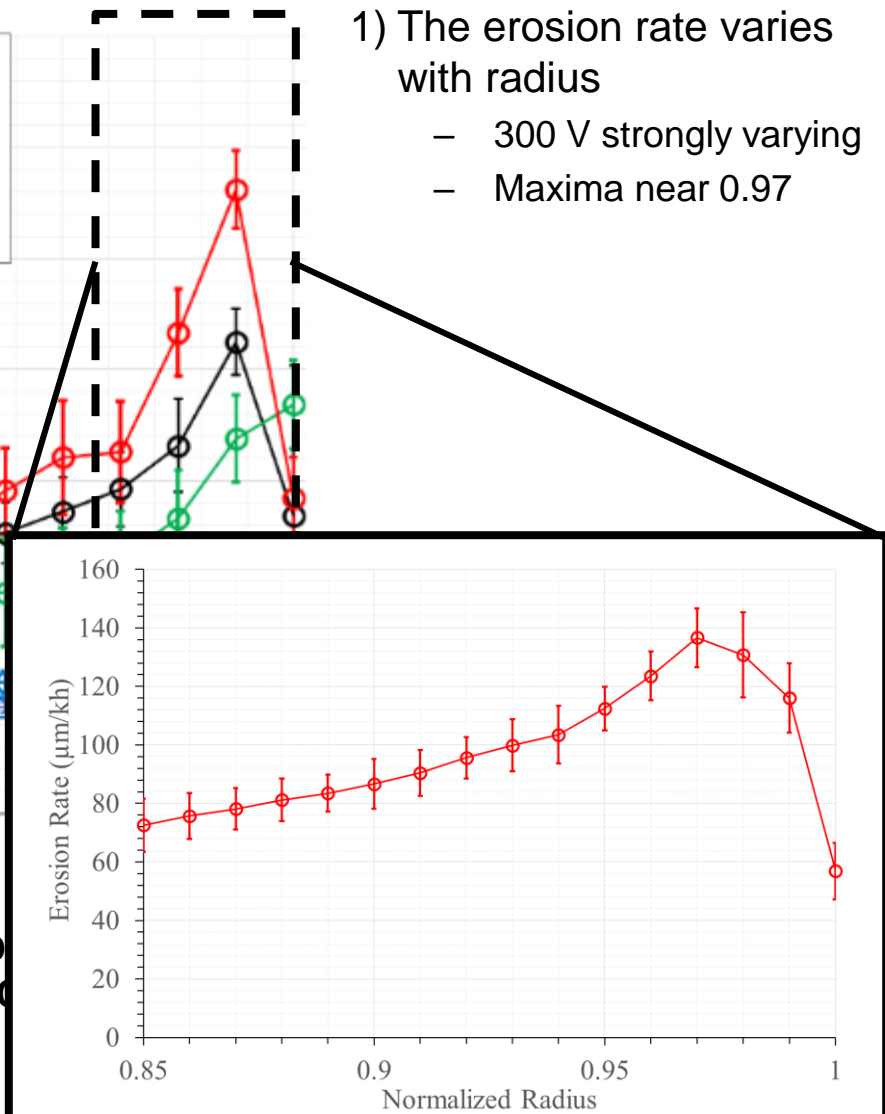
- 1) The erosion rate varies with radius
  - 300 V strongly varying
  - Maxima near 0.97

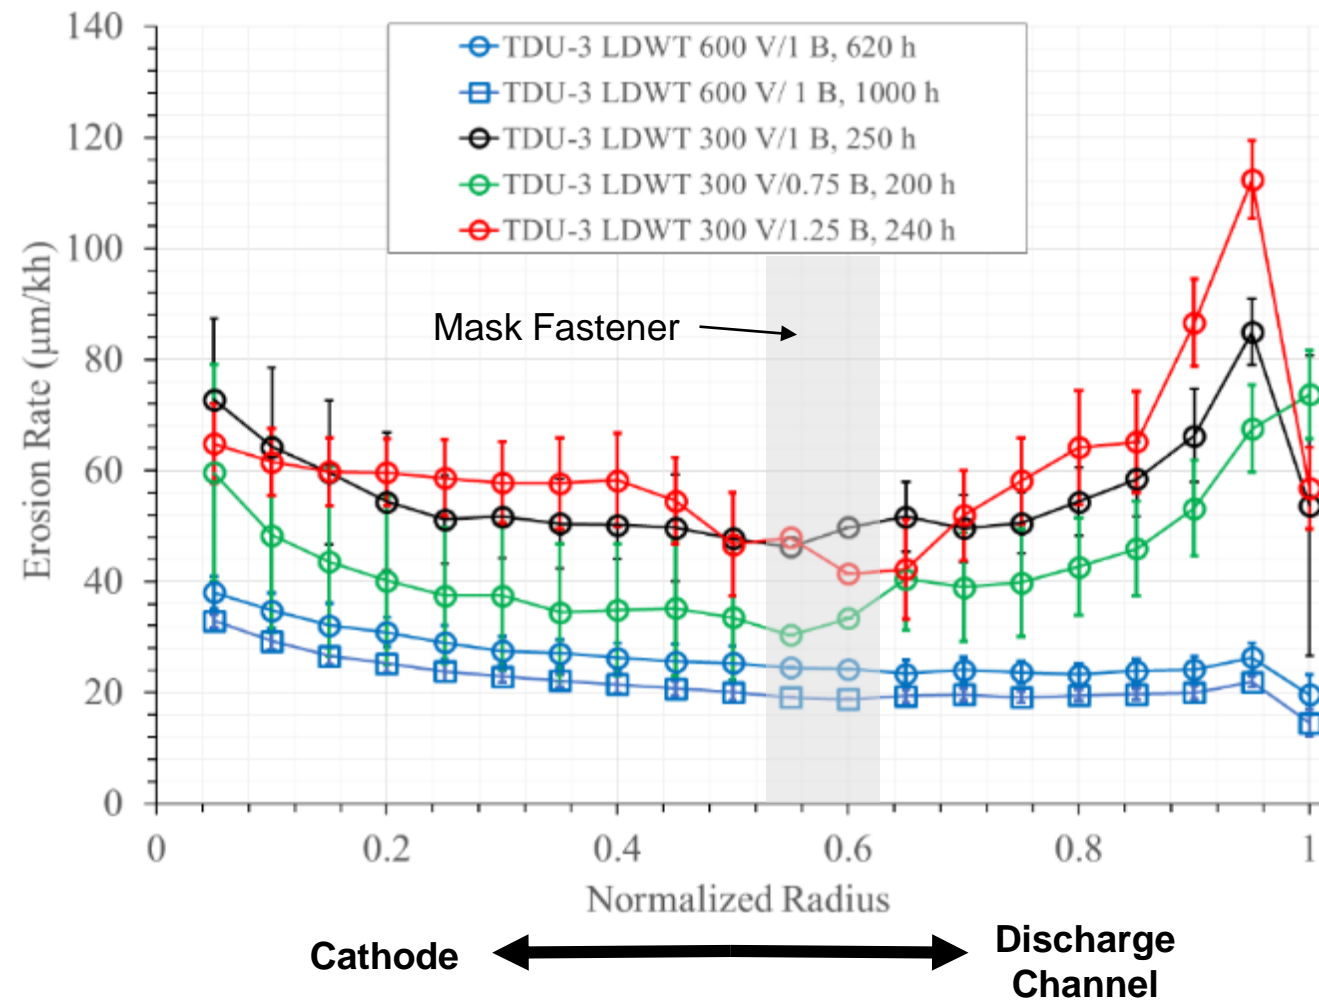
- 1) The erosion rate varies with radius
  - 300 V strongly varying
  - Maxima near 0.97
- 2) The erosion rate at 600 V decreases with time
  - Consistent with TDU-1 wear test
- 3) The erosion rate at 600 V/1 B is 76% less than 300 V/1 B
  - Driven by axial shift in acceleration zone

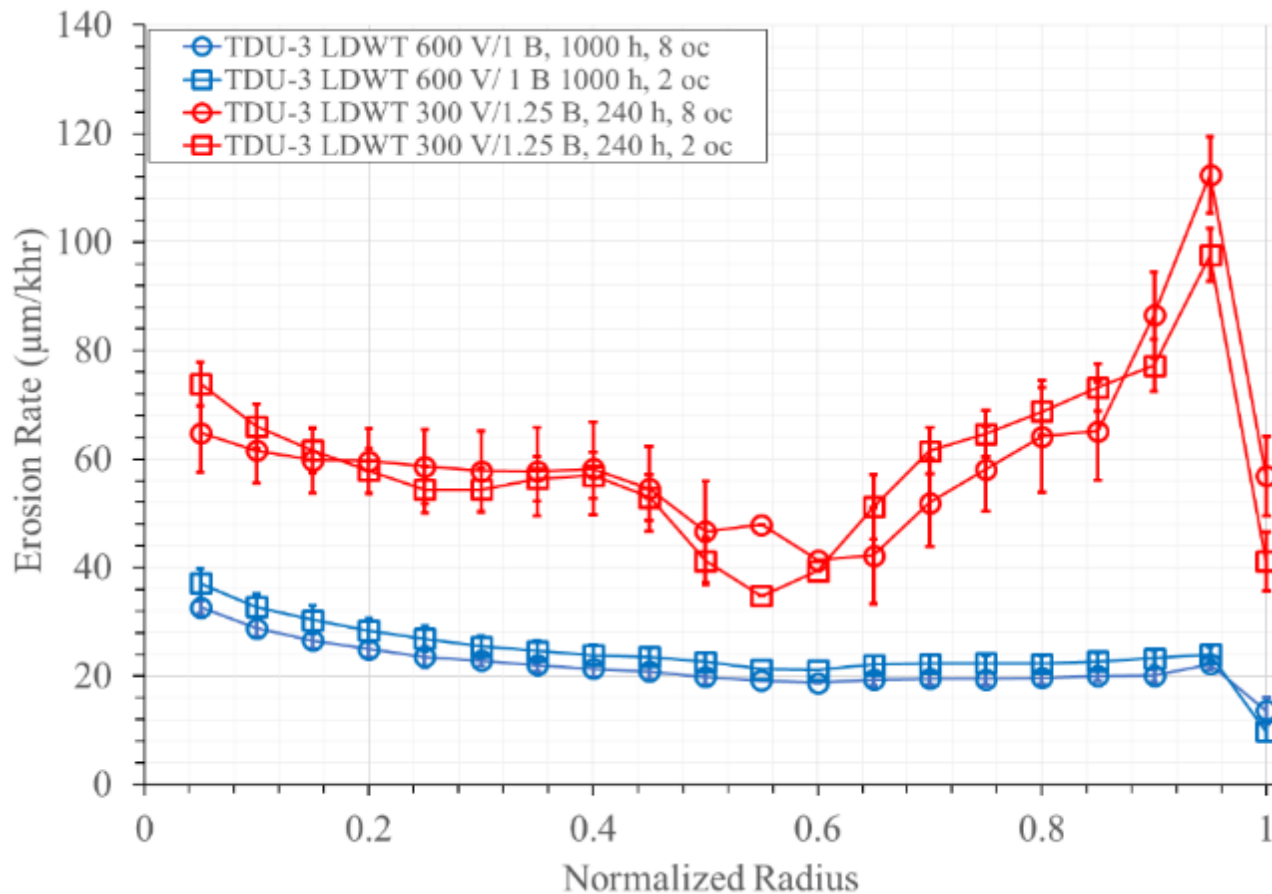
- 1) The erosion rate varies with radius
  - 300 V strongly varying
  - Maxima near 0.97
- 2) The erosion rate at 600 V decreases with time
  - Consistent with TDU-1 wear test
- 3) The erosion rate at 600 V/1 B is 76% less than 300 V/1 B
  - Driven by axial shift in acceleration zone
- 4) At 300 V, the erosion rate increases with magnetic field strength
  - Cause not presently known
- 5) IFPC wear is azimuthally symmetric

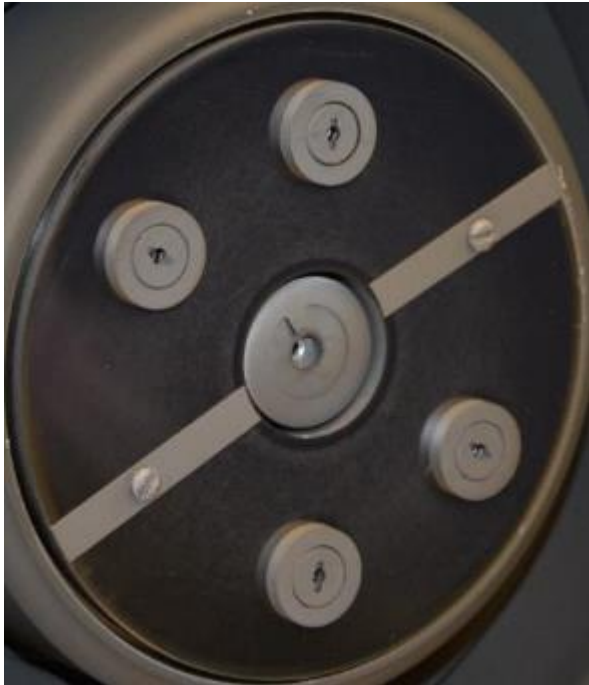
*Beginning of Test: Surface Polished  
Higher Erosion Rates*

- 1) The erosion rate varies with radius
  - Maxima near channel
- 2) The erosion rate at 600 V/1 B is 25% of 300 V/0.75 B
- 3) At 300 V, the erosion rate at 1.25 B is 1.4x higher than at 0.75 B
- 4) OFPC wear appears azimuthally asymmetric
  - Pre-test surface finish different
  - Suggests possible link between surface finish and erosion rates
  - Link would also explain apparent time dependence of OFPC erosion rate

- Increase with magnetic field strength at the 300 V operating condition
  - A potential link between surface finish and erosion rates was observed, which could explain:

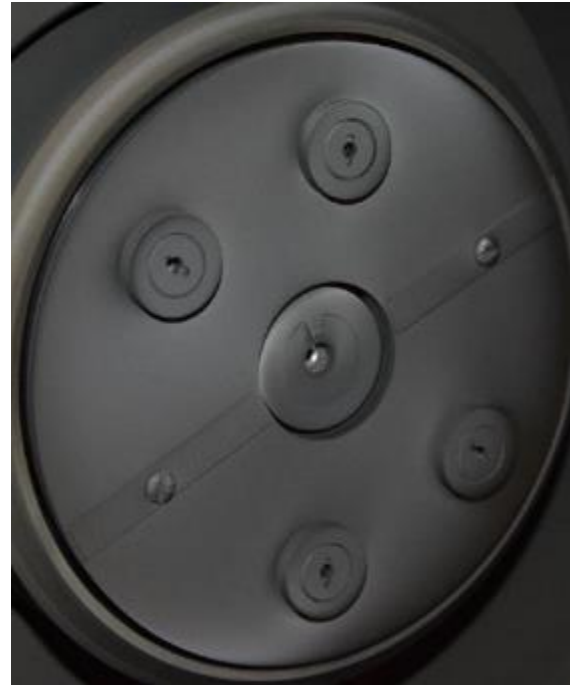
*End of Test: Surface Roughened  
Lower Erosion Rates*
