# IN-SITU DIAGNOSTIC FOR ASSESSING HALL THRUSTER WEAR

54th AIAA/SAE/ASEE Joint Propulsion Conference  
July 10, 2018, Cincinnati, OH

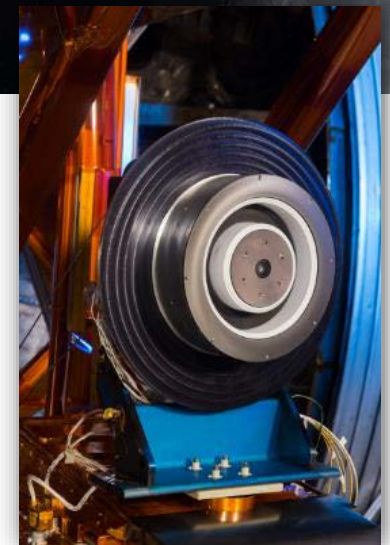
Right: HERMeS TDU-1 Hall thruster<sup>2</sup>

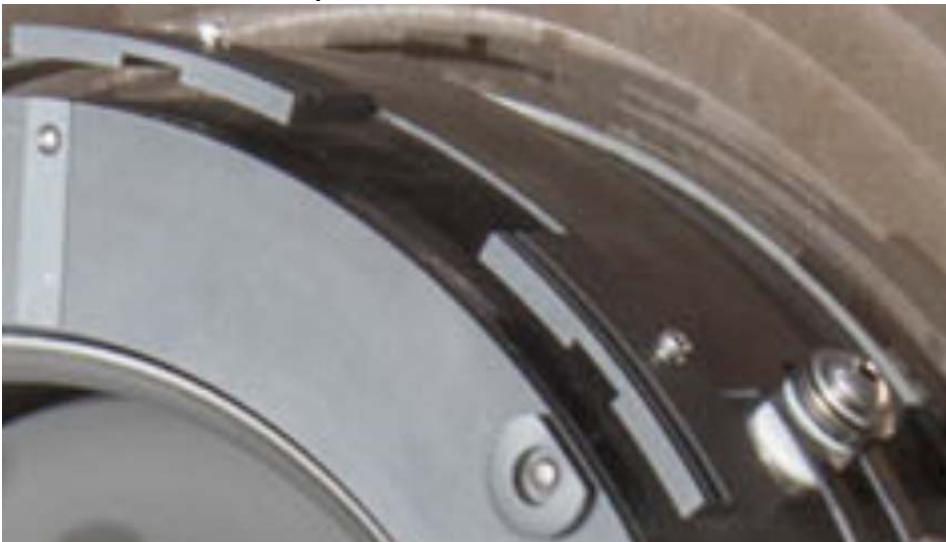
Left: Graphite reference surfaces (at ~12:00 and 2:00 positions on thruster)

Right: CAD model of a graphite reference surface

- Reference measurement is needed to determine how much a feature changes on an absolute scale
- To measure erosion, need a feature to reference against
  - For absolute erosion rates, need an unchanging feature
  - To measure overall erosion trends, can use previous measurements of the desired feature
- Three types of reference measurements used in this study:
  - Separate known feature with an unchanging surface (e.g., a face that does not experience erosion or deposition)
  - Previous measurement of the desired feature (e.g., previous measurements of a diameter)
  - A surface apart from the thruster that does not experience erosion/deposition

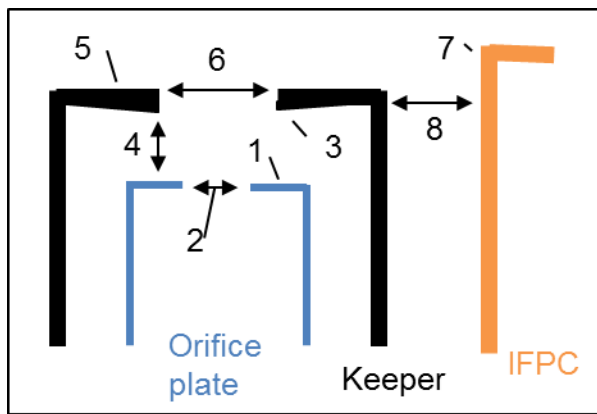
Cathode assembly

#	Measurement
1	Orifice plate surface erosion
2	Orifice plate orifice diameter change
3	Deposition thickness on keeper
4	Gap between keeper and orifice plate
5	Keeper surface erosion
6	Keeper orifice diameter erosion
7	IFPC inner bore erosion
8	Keeper to IFPC gap

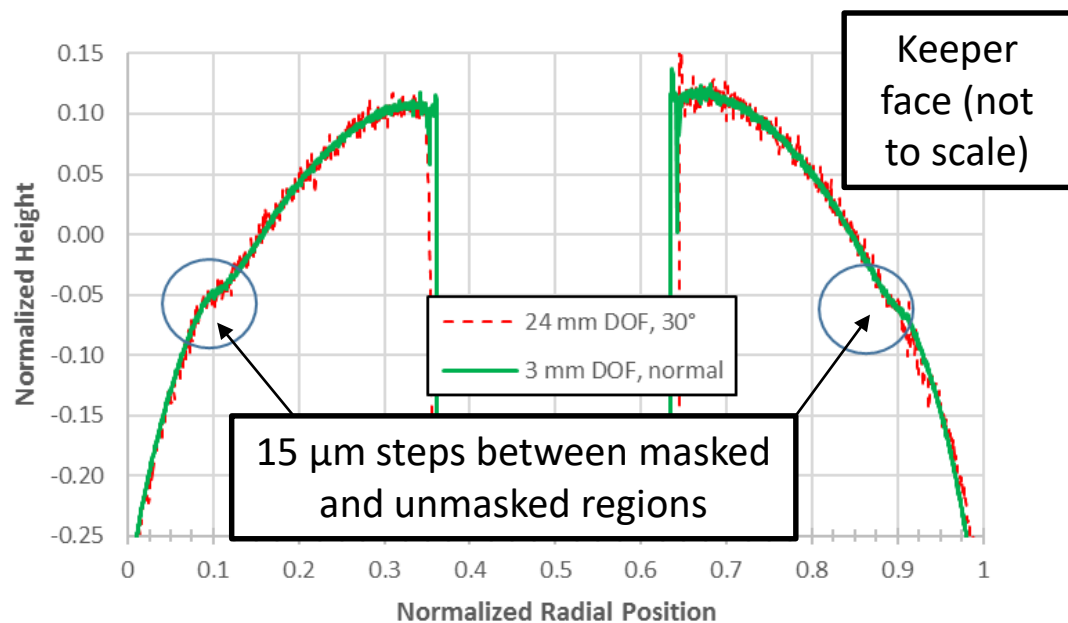
Diagram of 24 mm pen at 30° scanning the keeper and cathode (cross-section)

- Tabletop measurements were performed to compare 3 mm and 24 mm depth of field (DOF) pens (24 mm DOF pen is at 30°)
- Also desired to verify keeper and cathode surfaces could be measured with angled pen
  - 24 mm pen data – lower resolution, but overall similarity to 3 mm pen data
  - Ability to measure protected surface proven

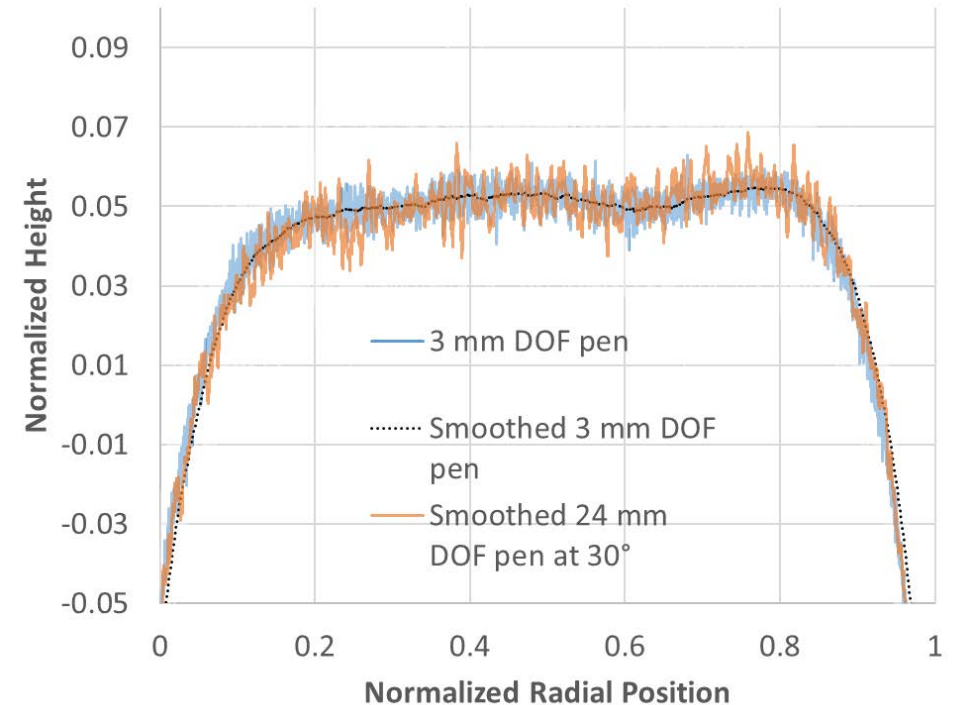
IFPC scan

- Further tabletop measurements were done to compare resolutions of two pens on IFPC
  - Both pens show same curvature on IFPC surface
- Based on previous data, at 600 V, the first detectable erosion on IFPC will be along edges at 425 hours into long duration test
  - Erosion across entire IFPC estimated to be detected no later than 1500 hours into test

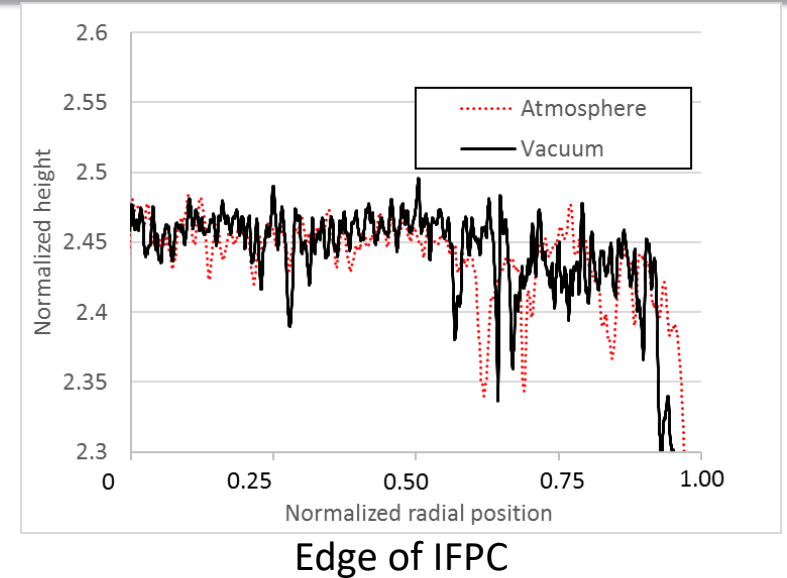
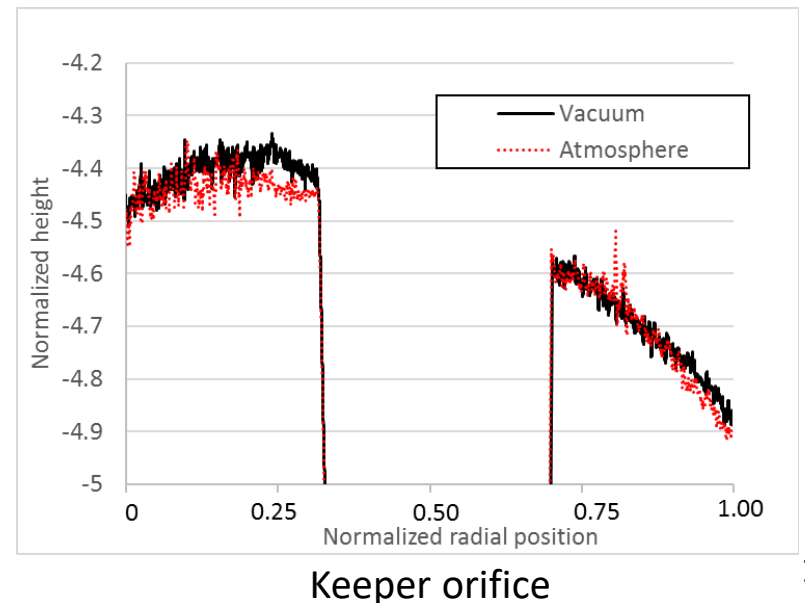
- In-situ diagnostic measurements taken at atmosphere and vacuum:
  - Noise similar for atmosphere and vacuum → vibrations did not affect data
  - Radial scan was taken across thruster → can measure known gaps
  - Reasonable agreement of overall features
  - Area scans omitted due to some issues with fine stages
  - Further refinement needed to determine accuracy of stages
- Data at vacuum also to be used as baseline comparisons for future measurements
