# Refurbishment of NASA’s Johnson Space Center Liquid Nitrogen Bulk Storage Tanks in preparation for Thermal Vacuum Optical Testing of the James Webb Space Telescope (JWST)

This paper describe the challenges of refurbishing six liquid nitrogen bulk storage vessels that are 60 year old. The vessels were refurbished in place and focused primarily on the vacuum annulus. The challenges of vessel research, design engineering and project management will be discussed. The refurbishment of the vessels has extended the life of the vessels for another 35-50 years on the vacuum annulus integrity. The survivability of the bulk storage vessels was tested during the historic hurricane Harvey of 2017 during the 100 day JWST thermal-vacuum test.

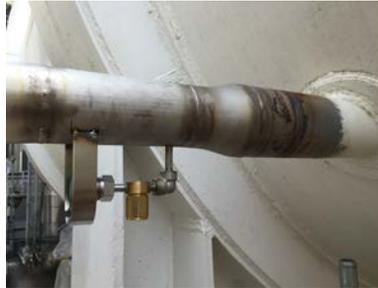
*Figure 1, Typical Thermocouple Vacuum Tube Installation*

The design was completed by JSC. ASME B31.3 was the governing code for the piping. For this phase the design was completed to accommodate field welding. The existing piping was Sch 40 carbon steel piping with carbon steel valves and vacuum TC gauges not rated for outdoor or wetted areas. JSC performed all of the equipment disconnects and to safe all of the vessels. A low pressure nitrogen repress panel was used to repress the annulus and provided low pressure flow when the annulus was exposed to the atmosphere. All new piping is 304 S.S. Sch 10 seamless piping. Each interface between new and existing is a stainless steel to carbon steel weld. All welds were 100% dye penetrant checked. New 2" ASA flanged vacuum isolation valves were replaced. New 2" fail closed solenoid valves were

installed between the vacuum pump and the annulus. The solenoid valves are vacuum rated and will fail close in case of a power loss. During this time a 500 year flood occurred in the Houston, Texas Area hampering our progress.

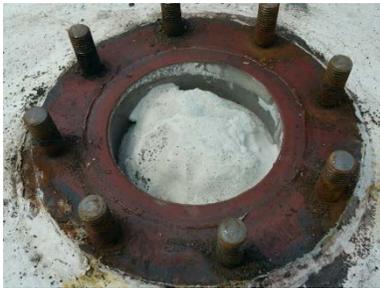
*Figure 2, Pearlite Fill Flange Uncovered*

This stage of the project was an opportunity to perform exploratory engineering on a warm tank to prepare a design for the next phase of the project after the OTIS Thermal Pathfinder test in the Fall of 2016. A six inch pearlite fill flange from one of the tanks was removed to identify the port configuration, see Fig 2-3. The last time these flanges were open was fifty eight years prior to this year. Pearlite was still to the top of the port flange, a gasket with hardened sealant replaced a failed attempt of an O-ring on the blank flange, severely corroded carbon steel studs and finally an RMS on the flange which was unacceptable for vacuum service. Measurements were taken to formulate an engineering design in efforts to remove and replace all of the vacuum jacket safety devices on the pending four tanks.

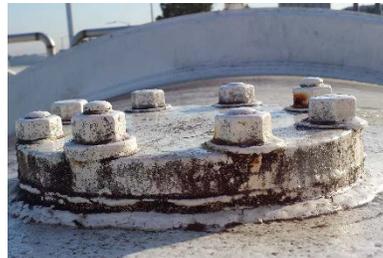
*Figure 3, Pearlite Fill Flange*

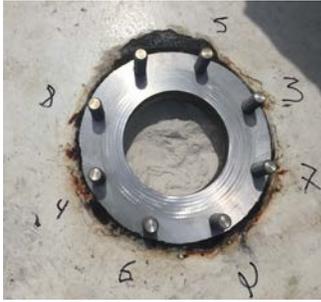
Figure 5, Field Machined Pearlite Fill Flange

All of the carbon steel studs were removed and the welded flange on the vessels was machined in place to a 32 RMS and new 304 S.S. Studs were installed with a high nickel content anti seize compound. A new 304 S.S. blank flange was machined with an O-ring gland for vacuum service. A Viton O-ring was used with an application of Dow Corning vacuum grease. This exploratory engineering solidified the phase 2 plan in efforts to perform the final refurbishment of the vacuum annulus of the last four vessels.

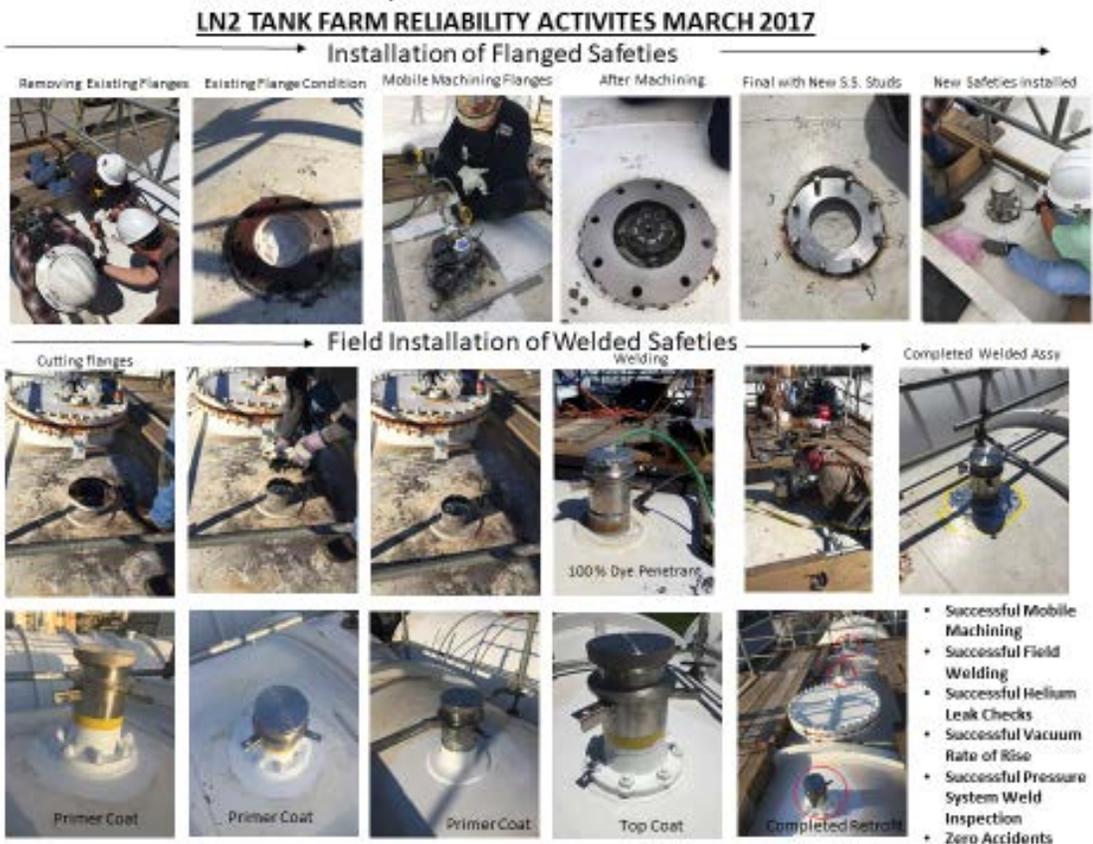
Figure 7, Phase 2 Project Photograph Summary

After a successful Chamber A OTIS Thermal Pathfinder test, the tanks were emptied at the tail end of the chamber test. The LN2 was consumed during the chamber warm up with nitrogen in preparations to warm up the four vessels with the leaking annulus safety devices. With our engineering design in hand JSC went out for request for quotations to provide a service to design, fabricate, remove, replace existing vacuum annulus safety devices. There were several no bids and remaining quotations were in excess of project funding. After two months pursuing a turnkey RFQ to perform the scope of work. JSC shifted gears and managed every aspect of the project by late February 2017 in efforts to meet the flight OTIS Thermal Vacuum test in August 2017. Five separate statements of works were developed. The five statements of work comprised of scaffolding, mobile machining, shop fabrication\welding, field welding and procurement of the annulus safety devices and other piece parts required for the project. The project was completed by May 1<sup>st</sup> 2017 and the overall results after both phases can be illustrated in Figure 6. A photograph timeline summary of phase 2 is shown on Figure 7. All six tanks were placed back into service one month prior to test.
