Stress to Failure Testing of Pressure Vessels
with SHM Sensors at Liquid Nitrogen (LN₂)
Temperature

NASA's Automated Propellant Loading

Stress rupture of all-composite tank to determine SHM performance

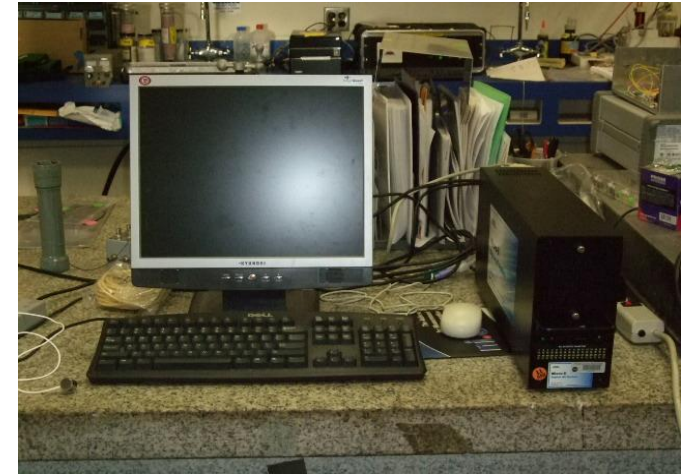
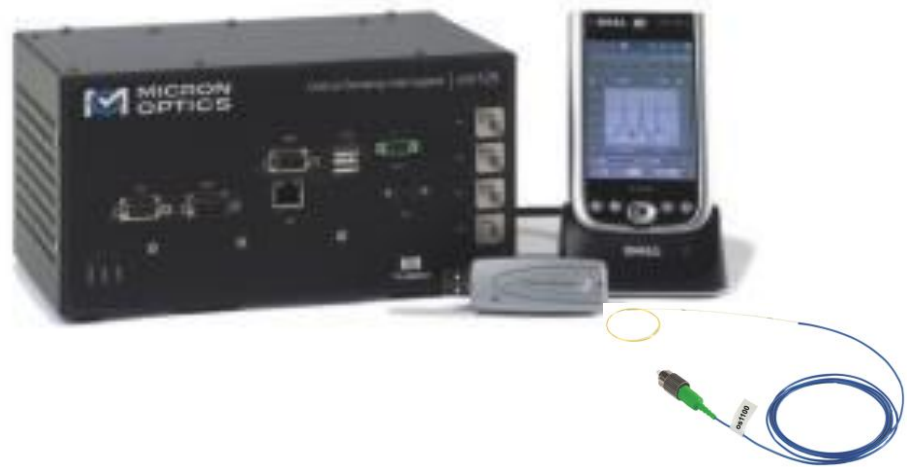
MSFC SHM Assets

1. Fiber optic strain system
2. Acoustic emission system
3. Acellent SMART layer system

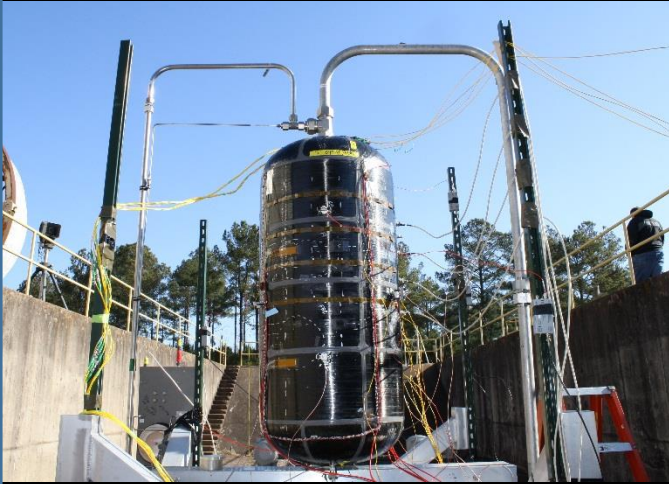
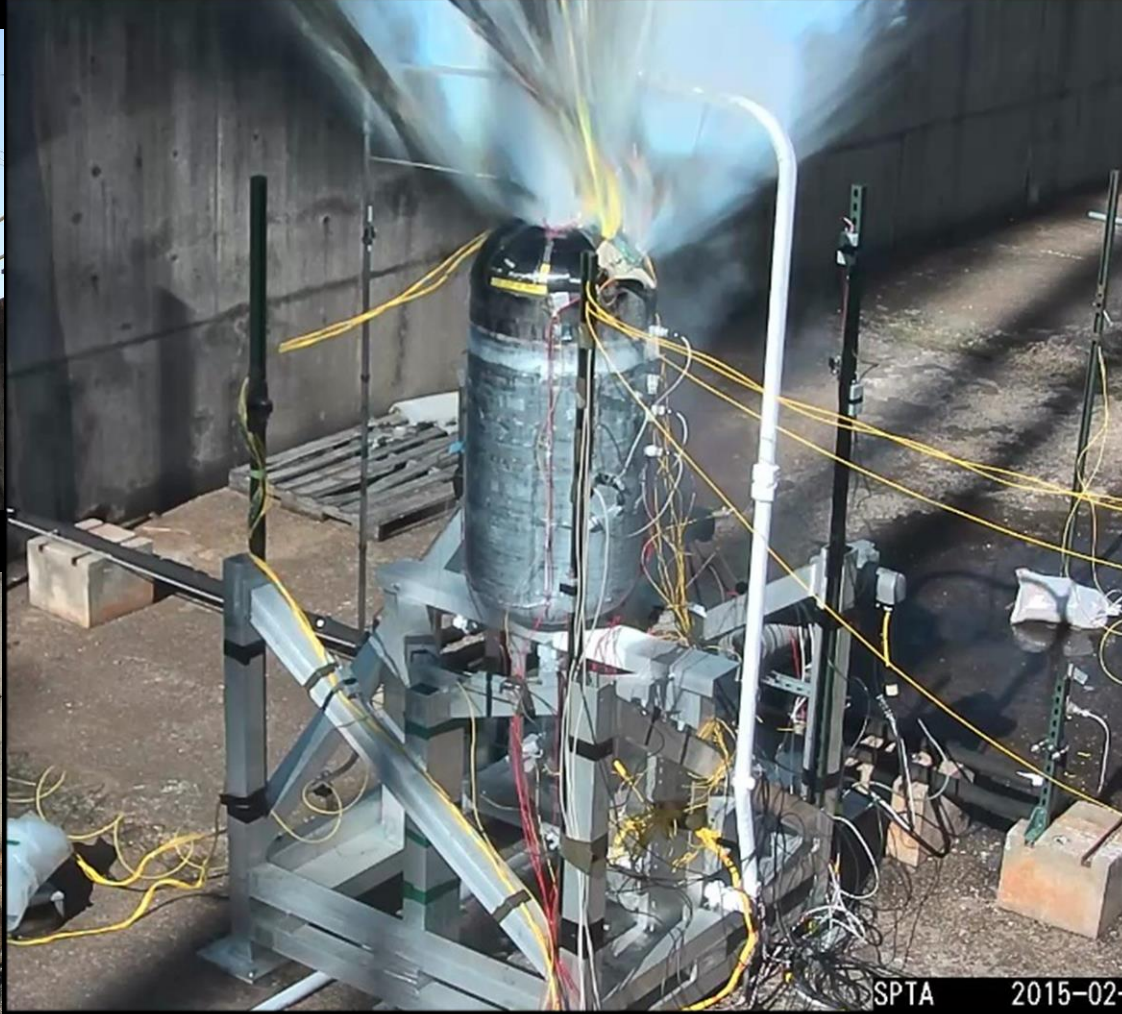
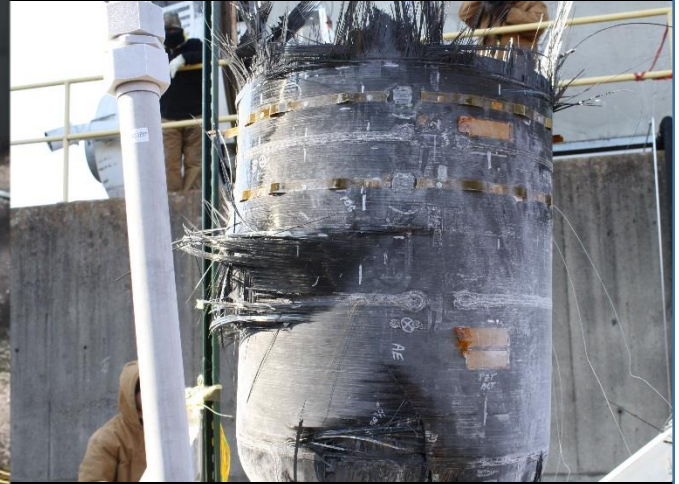
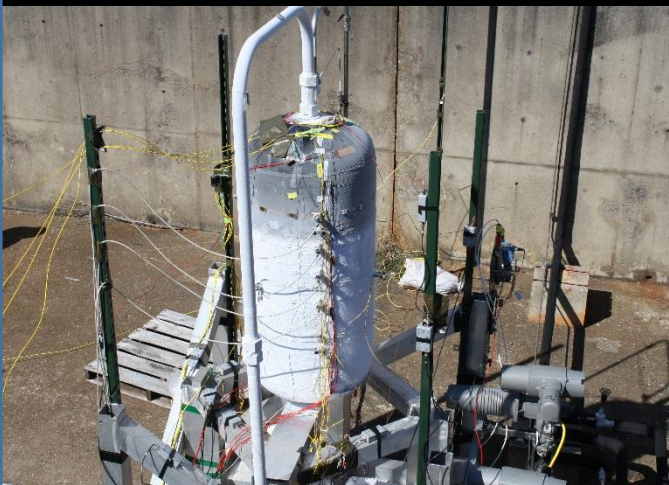
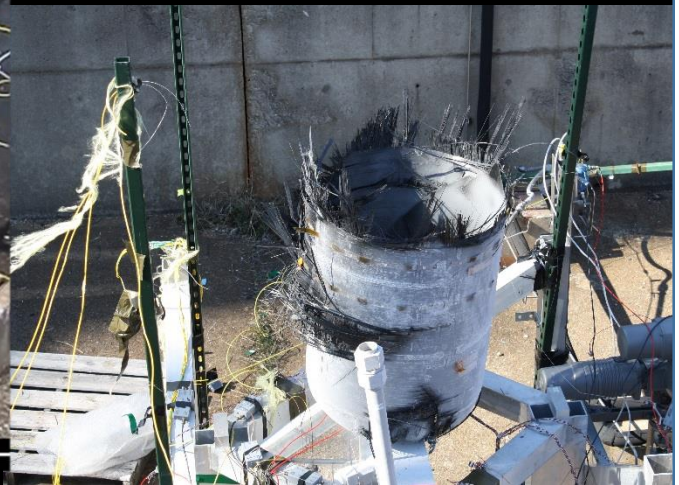
Scorpius Tank: Direct Path Image using Acellent System

Frequency Range	step	Input voltage	Signal type
100kHz – 300kHz	50kHz	50	Burst Tone 5 Lamb wave

Damage accumulation is compared with a baseline reading

- Acellent stayed attached to the vessels during all testing. We used M-bond Epoxy for cryogenic application.
- The data in both cases, optical and electrical, was not corrected for temperature effects; the strips we used were not able to take advantage of temperature compensation that's available from Acellent.
- The sensors held up at the LN₂ temperatures.
- The optical fibers suffered from peak splitting but the data could be averaged, reconstructed, and verified with traditional strain data. Some of the sensors fell out.
- The damage could be detected and reasonably located with the Acellent smart strip patch.
- Ice formation made it difficult to distinguish between structural damage and ice. the Ice damps the acoustic signals but it tends to fall from the structure during testing.
- The AE data is not shown but showed good results

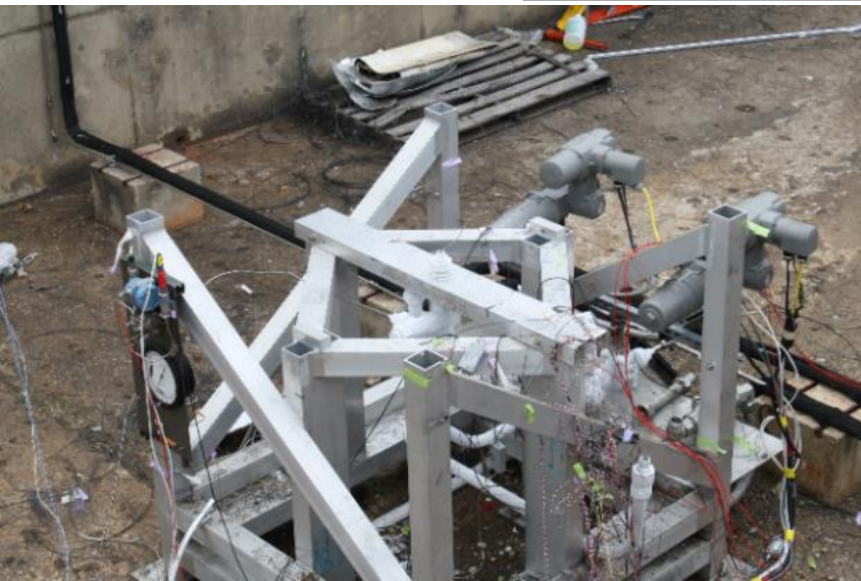
COPV 2 Burst at 3370 psi below the center. It was launched several feet in the air and landed about 350 ft. away.

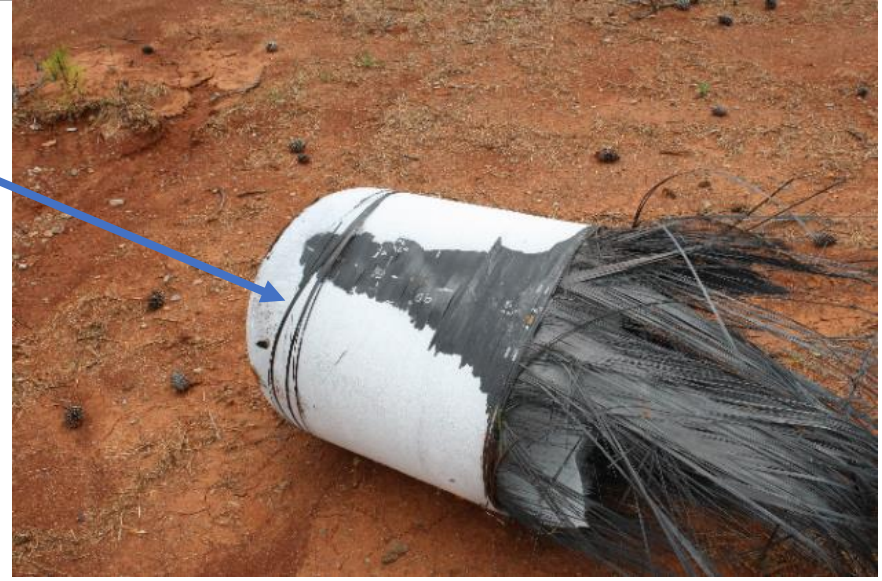
Empty Frame. The tank landed about 350 feet away.
