Composite Technology for Exploration (CTE)

Briefing to SLS USA Team Dec 13, 2018

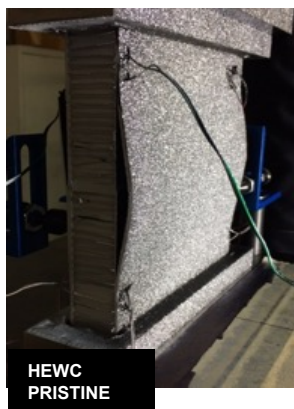
Failed HEWC Coupon

- All pristine HEWC coupons failed above CTE Point Design Limit Load with 2.0 FS
- Progressive damage analysis (PDA) using cohesive zone and COSTR damage model used to predict joint failure
- Failure mode captured in analyses
- Pre-test and post-test correlation achieved within 3% of average test data for all tests

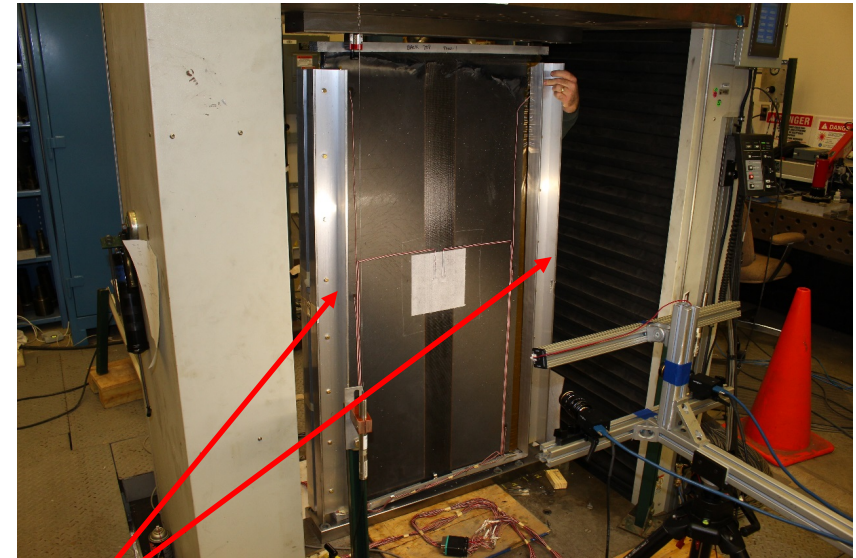
Panel Buckling Test Set-up

Side rails added to prevent buckling

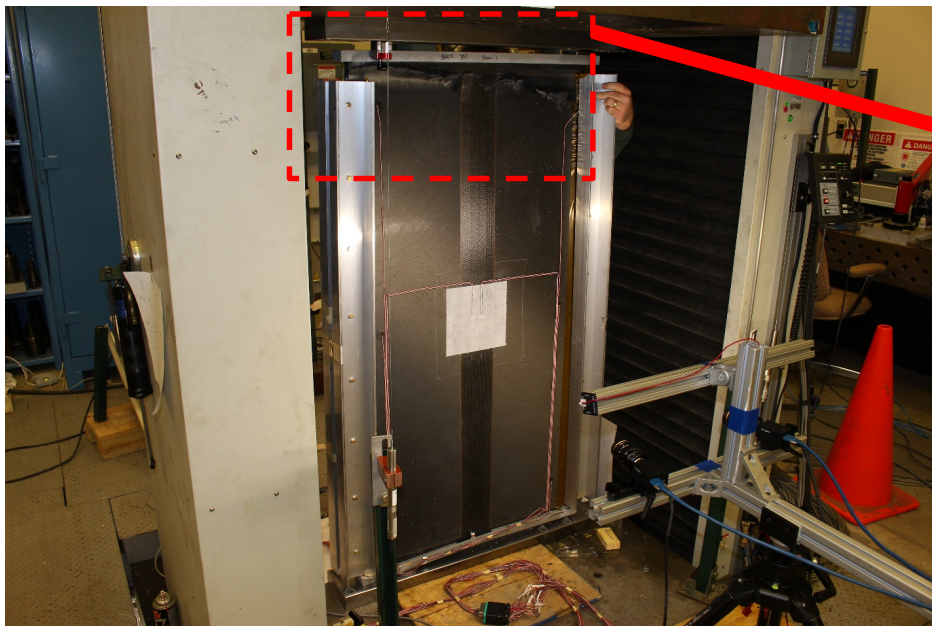
CTE 373-1 Panel at Failure

Failure location along top upper end

Pristine panel failed at 176.8 Kips (5893 lb-f/in)
 DLL with 2.0 FS Is 120 Kips design load

Failure in the end indicates joint strength was 'at least' 5893 lb-f/in
 (For reference AEWC coupon achieved 6966 lb-f/in)
 indicates a MS of 0.47 demonstrated in the scale-up joint

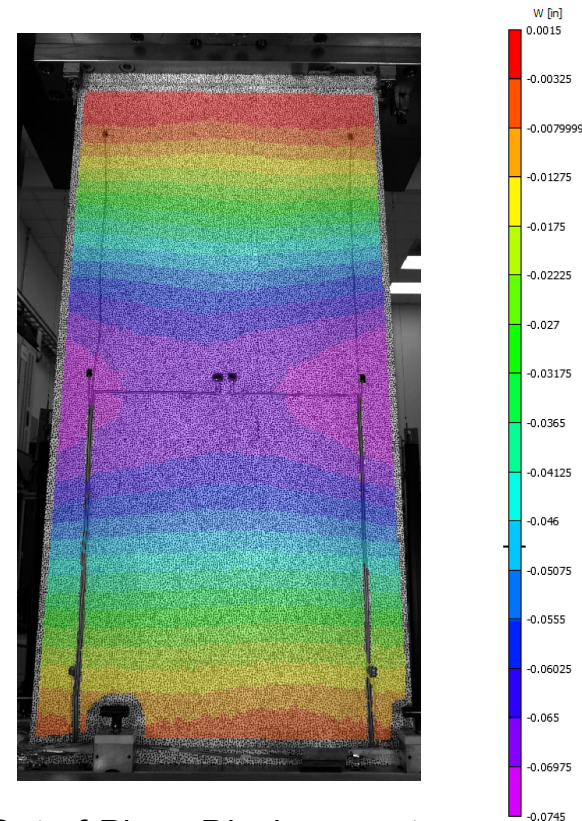
Out-of-Plane Displacement, w
Test Buckling Initiation Load = 60.0 Kips
