Robotic External Leak Locator (RELL) leak plume field detection on the International Space Station (ISS)

SPACE ENVIRONMENT EFFECTS

Robotic External Leak Locator

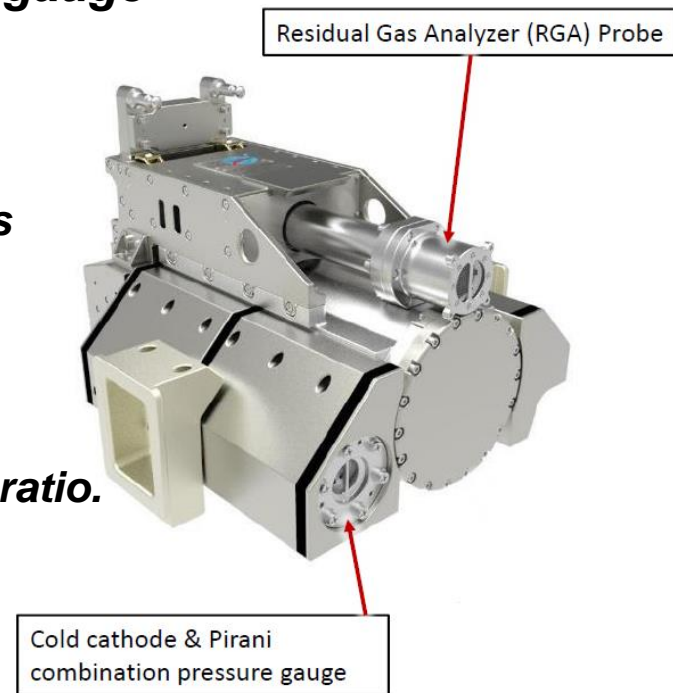
- **Collaboration between NASA's Goddard Space Flight Center and Johnson Space Center**
- **Maneuvered with Space Station Remote Manipulator System (SSRMS) and Special Purpose Dexterous Manipulator (SPDM) robotic arms**
- **PKR 251 Ion Gauge: Combination total pressure gauge**
 - **Pirani gauge**
 - **Cold cathode system**
- **Residual Gas Analyzer – 100**
 - **Quadrupole gas analyzer that measures for a mass range from 1 to 100 ion mass-to-charge ratios**
 - **Heated filament bombards incoming gas with electron creating positive ions.**
 - **The ions are directed toward the quadrupole filter where they are separated by their mass-to-charge ratio.**
 - **A Faraday Cup detector measures current directly and for increased sensitivity, an electron multiplier measures the electron current proportional to ion current.**

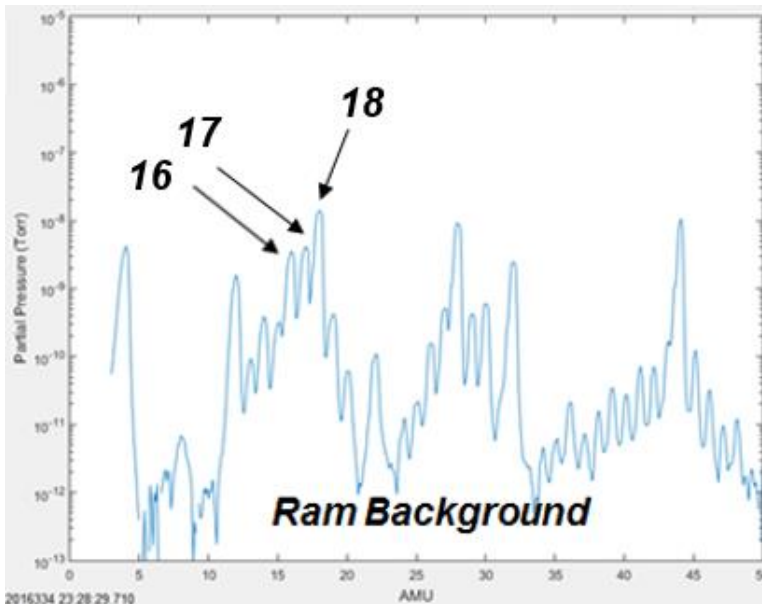
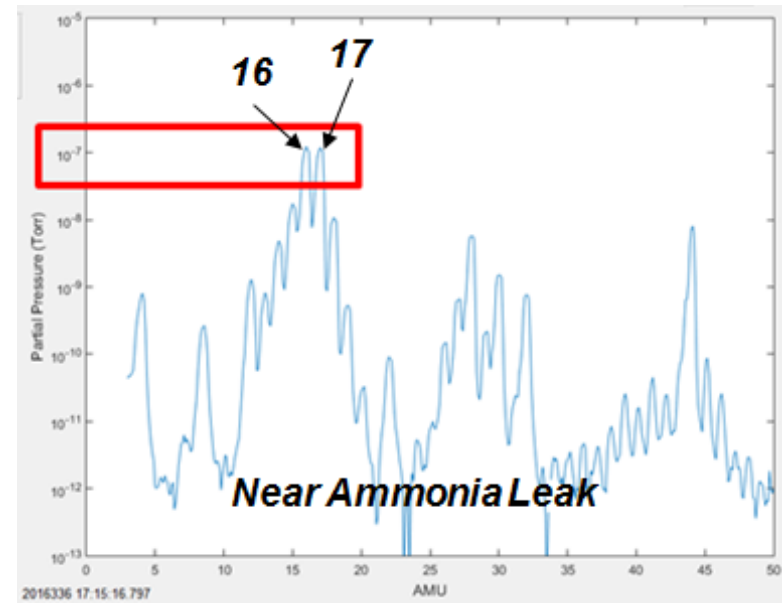
RELL Measurement of Water and Ammonia

- Use ion mass ratios of 16 to 17, in addition to total pressure, to distinguish between water and ammonia
 - Water: 0.04
 - Ammonia: 0.80

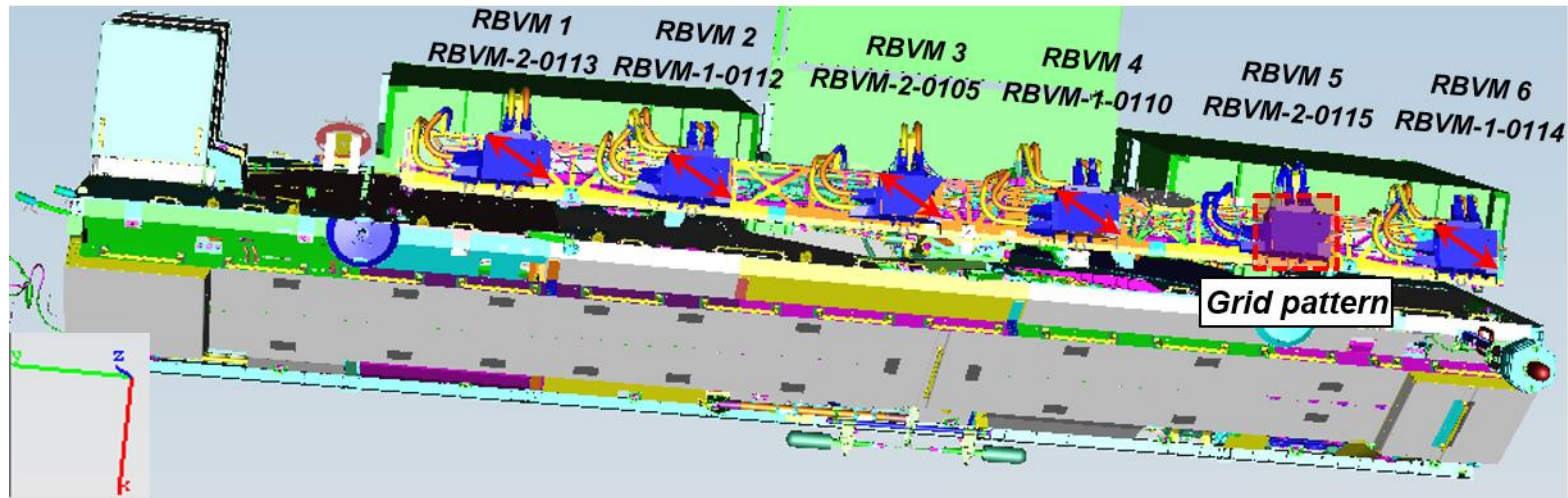
RELL Scanning of RBVMs

- **Six Radiator Beam Valve Modules (RBVMs) on each side of the ISS**
 - **Two per radiator panel**
- **Etc**

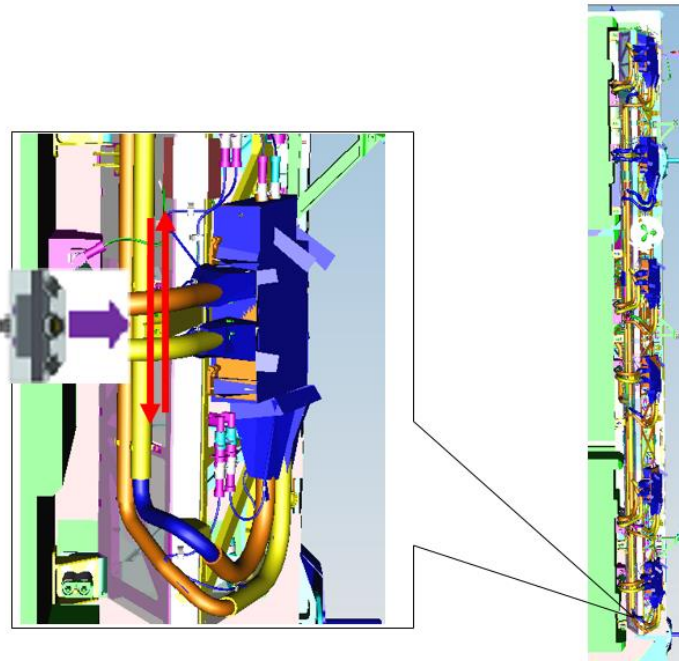
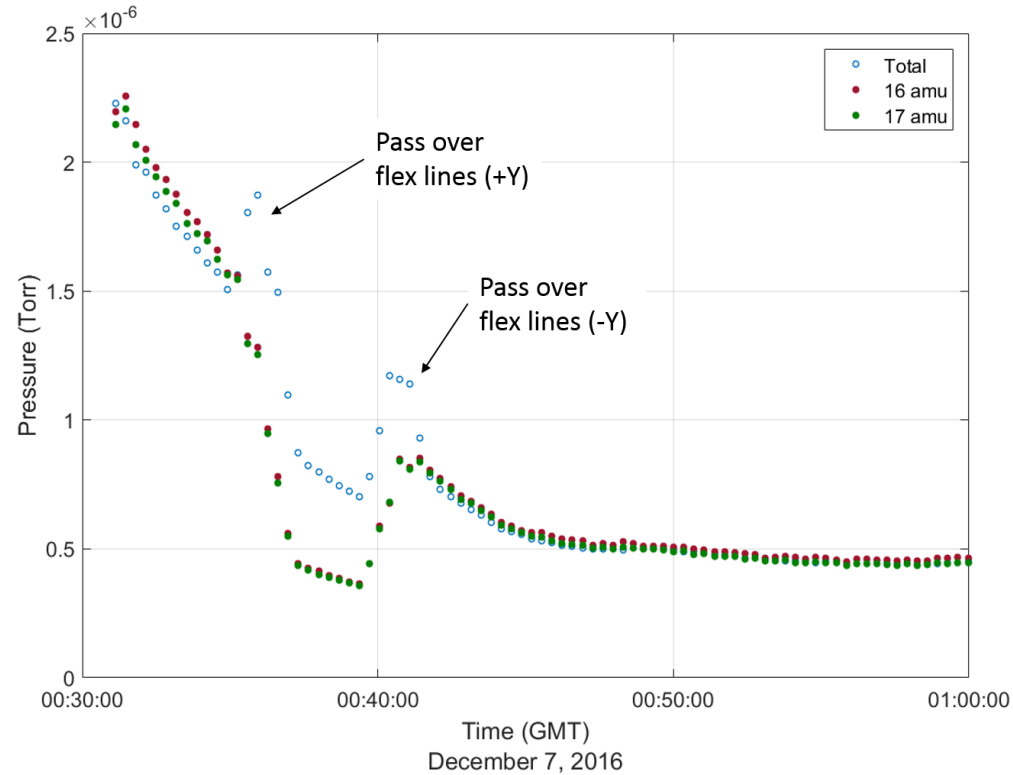
Rescan of RBVM 1

- **An additional day of scanning was planned for the end of the on-orbit demonstration in December 2016 after reviewing the initial scanning data**
- **Pass over RBVM flex hoses and quick disconnects (QDs)**

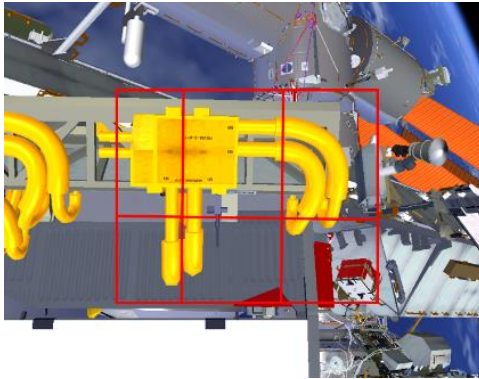
Zenith (-Z) face

- ▶ **RELL approved for external operations in February 2017 after observed EATCS leak rate increased.**

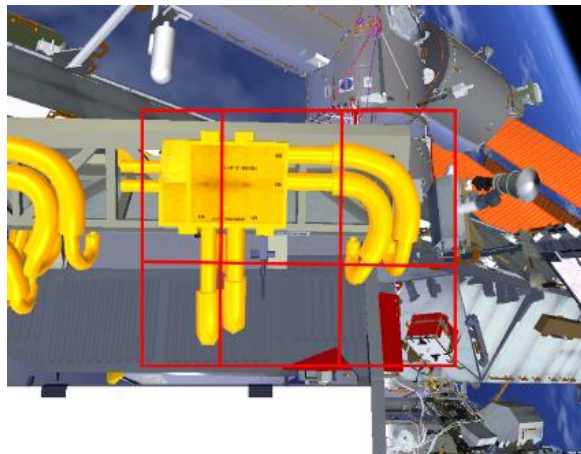
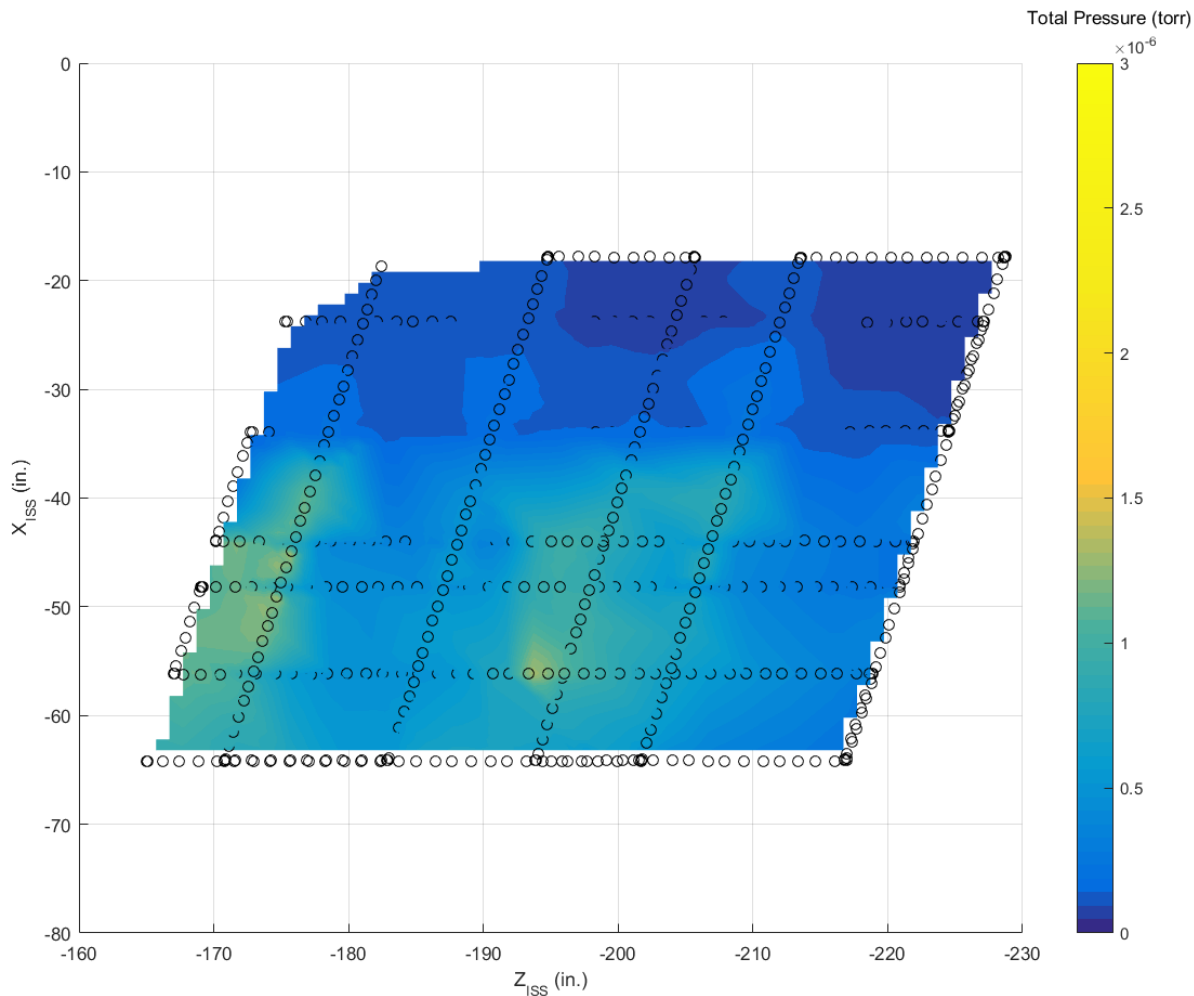
Focused RBVM 1 Inspection: Zenith (-Z) Face

Zenith (-Z) face

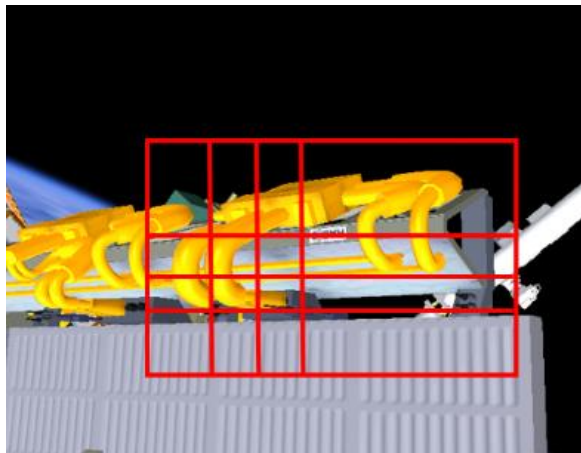
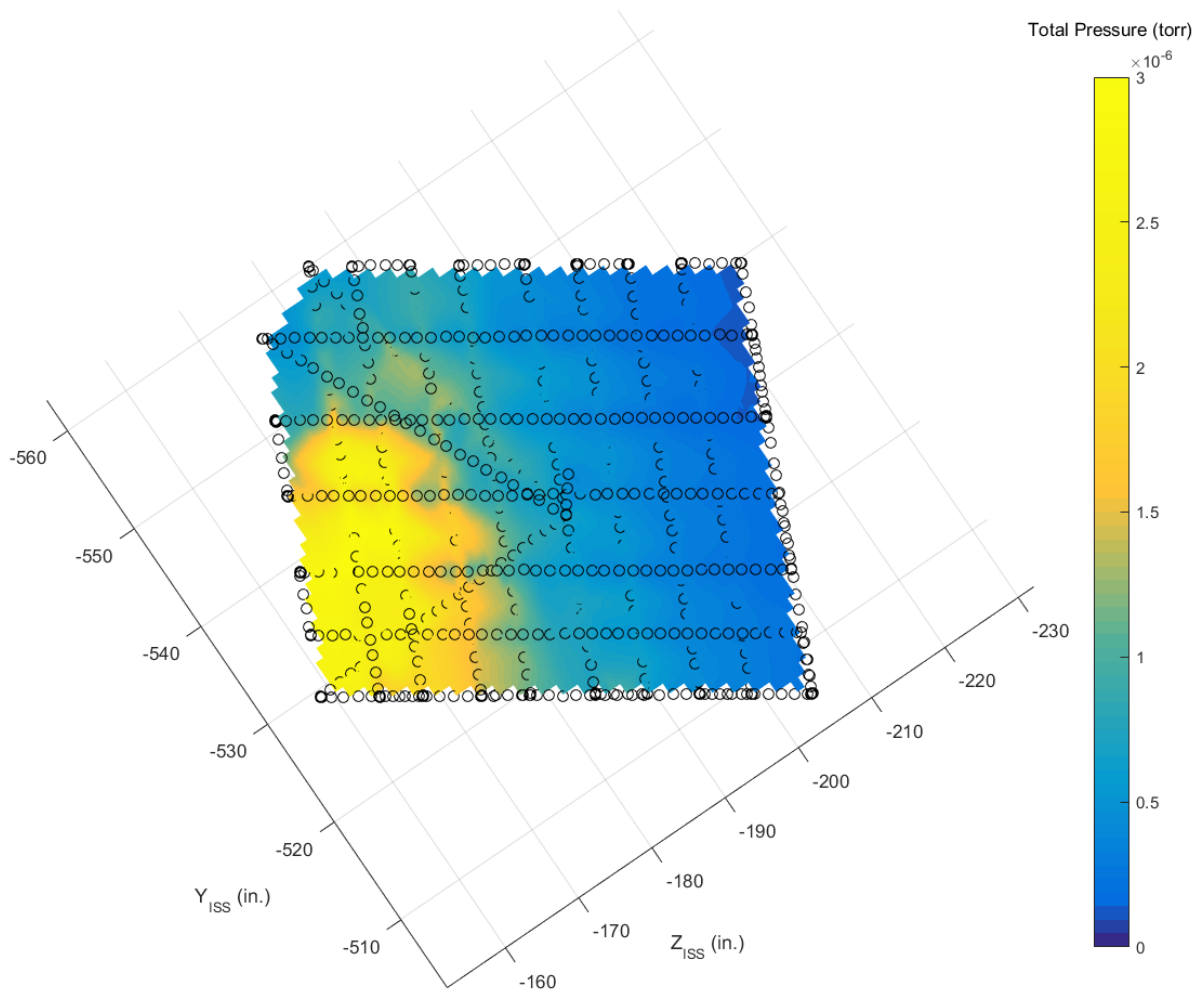
Focused RBVM 1 Inspection: Aft-Starboard (-X | +Y) Face

Aft-Starboard (-X / +Y) face

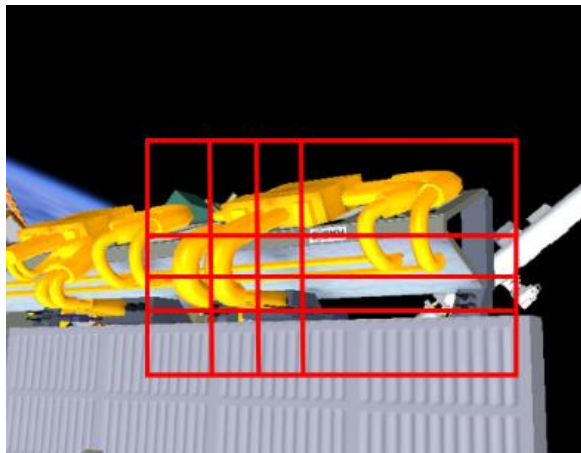
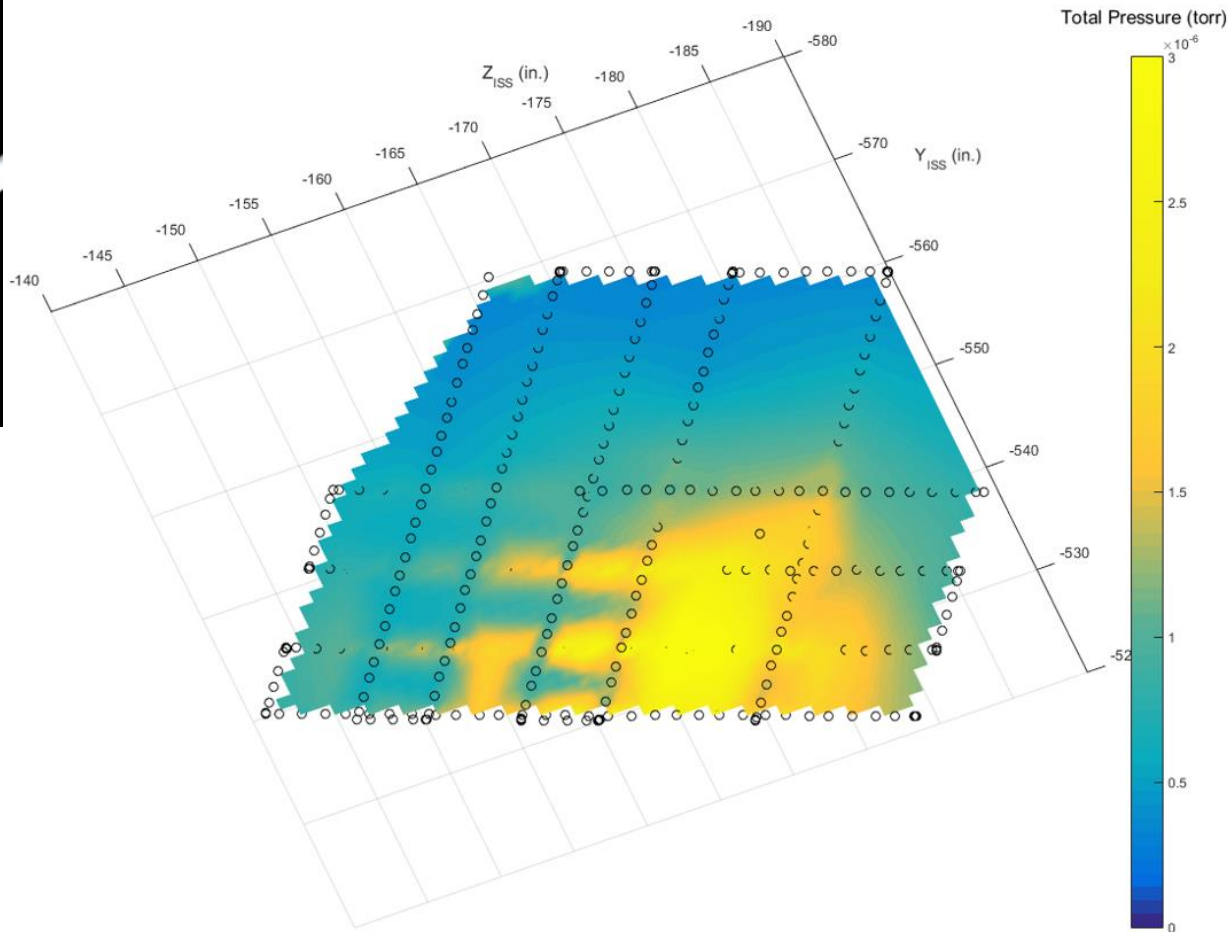
Focused RBVM 1 Inspection: Aft-Starboard (-X / +Y) Face

Aft-Starboard (-X / +Y) face

Expanded Scan

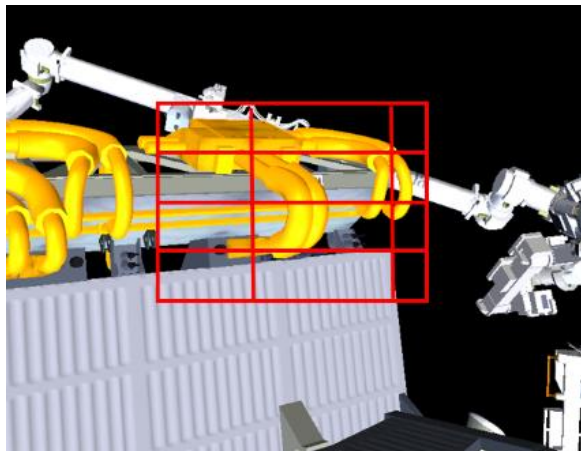
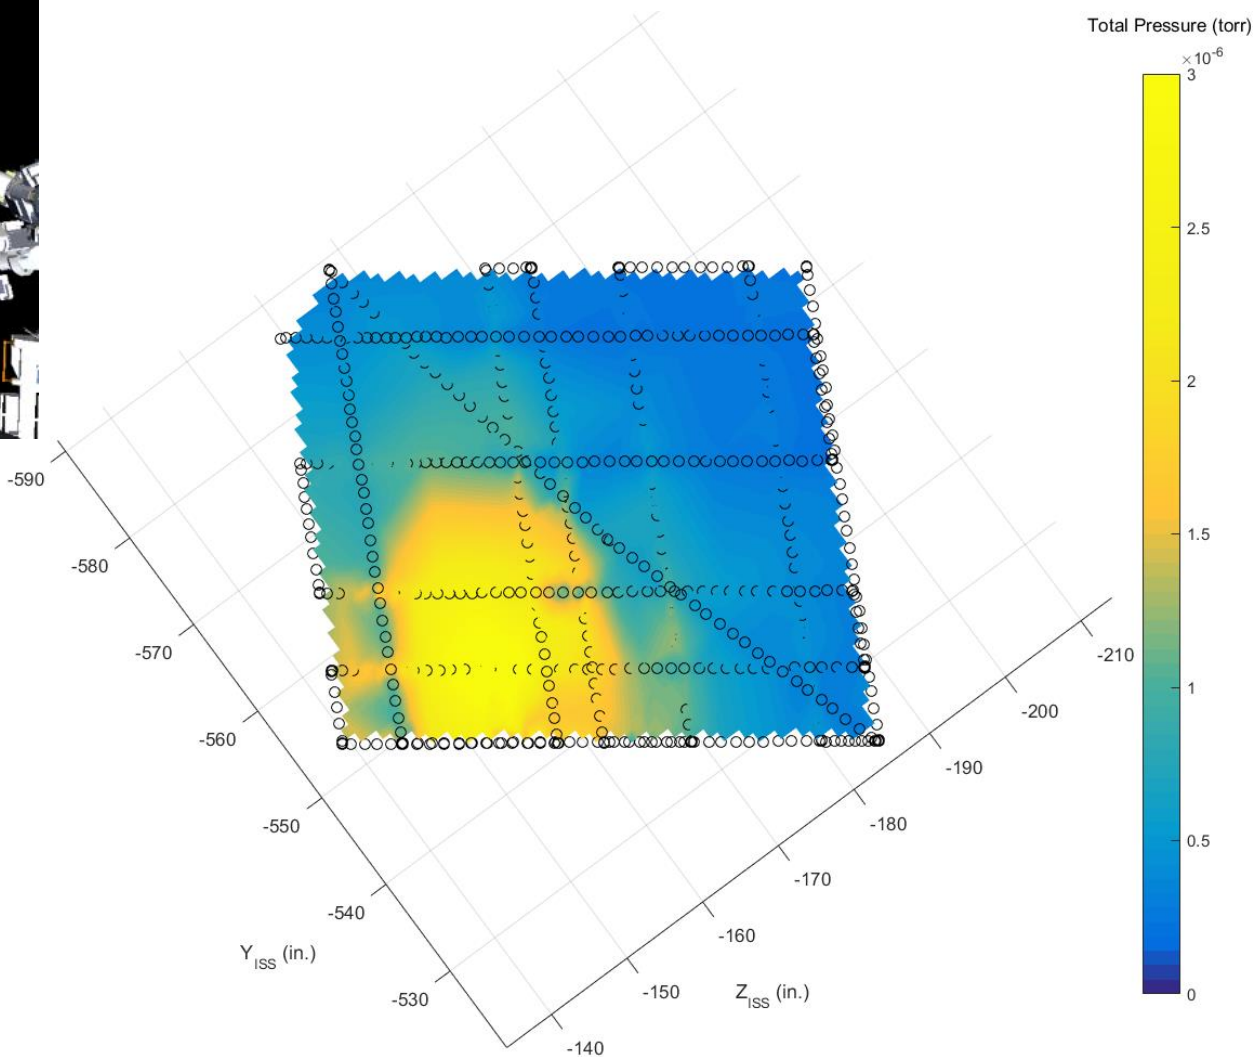
Focused RBVM 1 Inspection: Aft-Port (-X | -Y) Face

Aft-Port (-X / -Y) face

- ***RELL was successful in detecting and locating an ammonia leak during the on-orbit demonstration and additional inspection in February 2017.***
 - ***Potential leak site inspected by a crew member during an EVA in March 2017 and HD video showed small flakes originating from the coolant lines.***
 - ***Coolant lines isolated in April 2017 and subsequent monitoring of system pressures showed the leak had stopped.***
 - ***Radiator-side coolant line retrieved by EVA in March 2018 for inspection on the ground.***
- ***Grid scanning technique is effective and repeatable for locating leaks.***
 - ***Total pressure measurements using the ion gauge are useful in building contour maps of pressure.***
 - ***Need to be combined with RGA partial pressure measurement data to determine what is causing the differences in total pressure.***

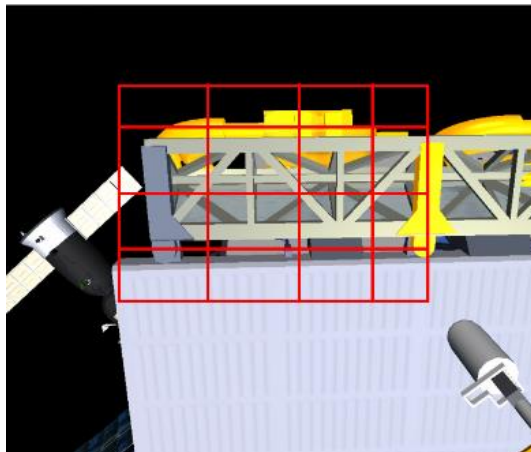
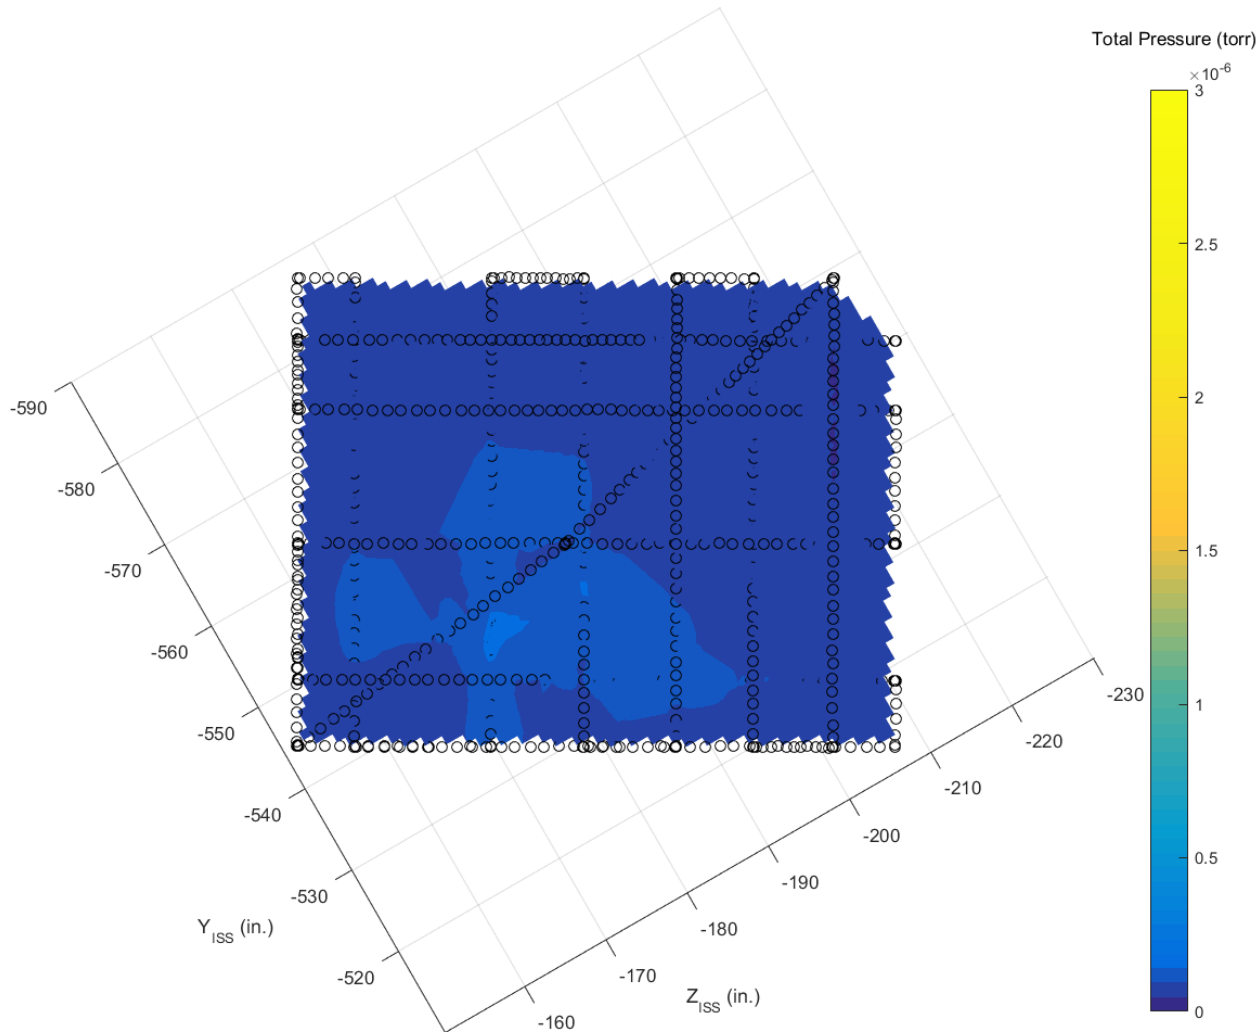
Focused RBVM 1 Inspection: "Back Side"

"Back side"

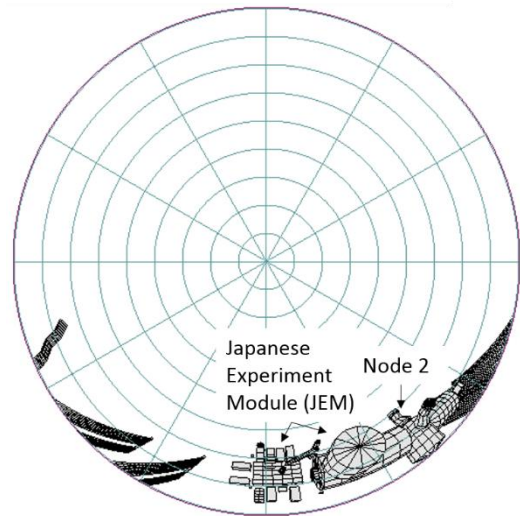
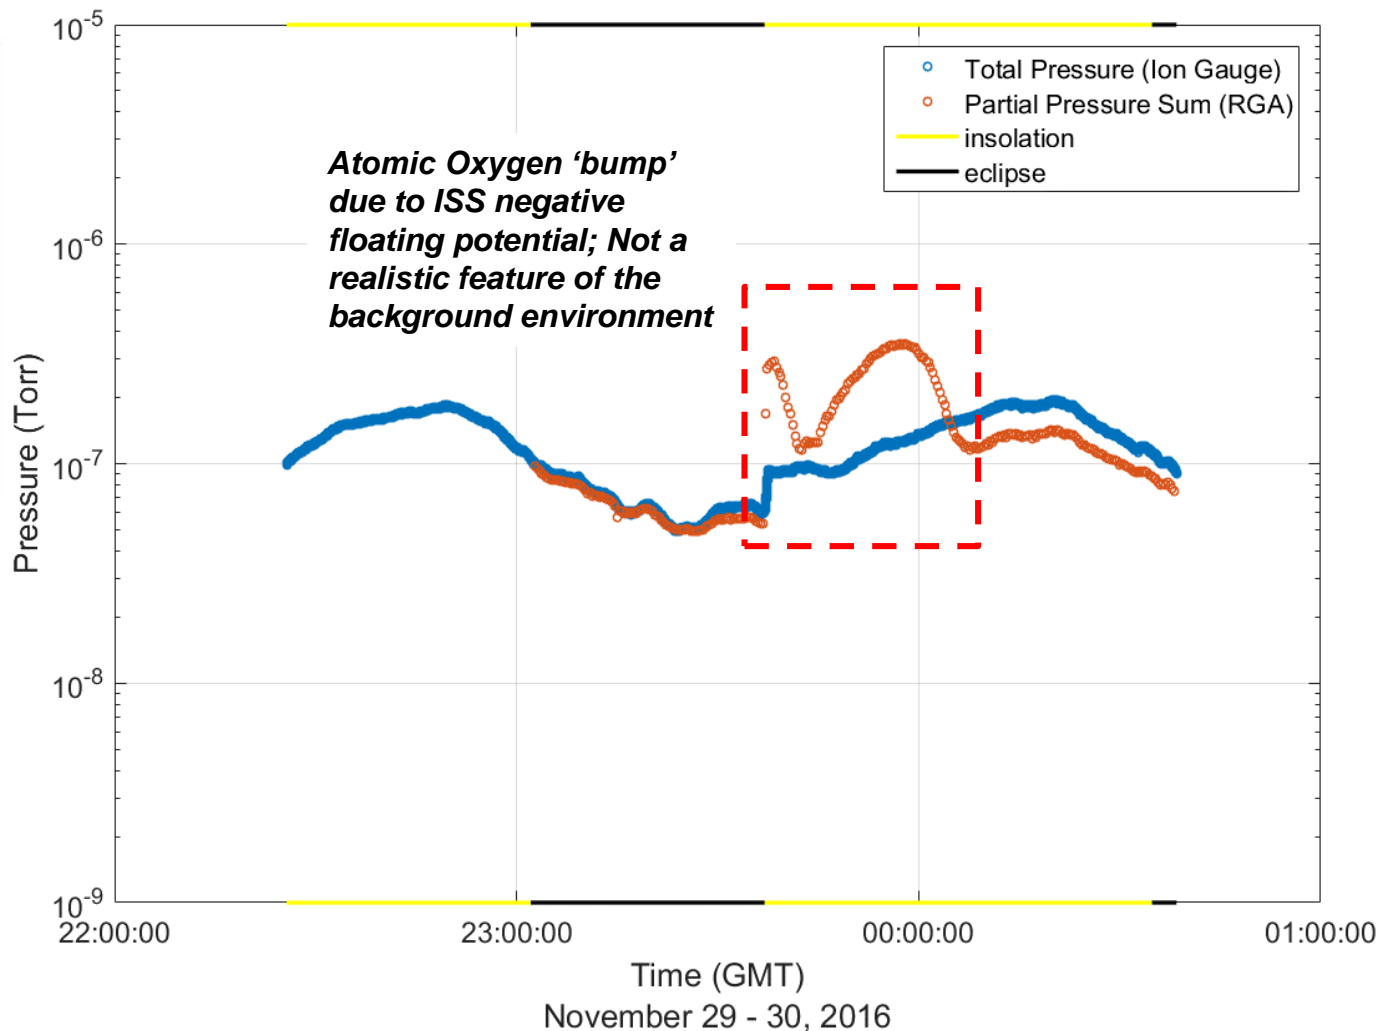
Background Scanning A: Ram (+X)

➤ **Sum of RELL RGA partial pressures includes AMU 3 to 50**
