A Screening Method Using Pulsed-Power Combined with Infrared Imaging to Detect Pattern Defects in Bulk Metal Foil or Thin Film Resistors

Jay Brusse

ASRC AS&D at NASA Goddard Space Flight Center

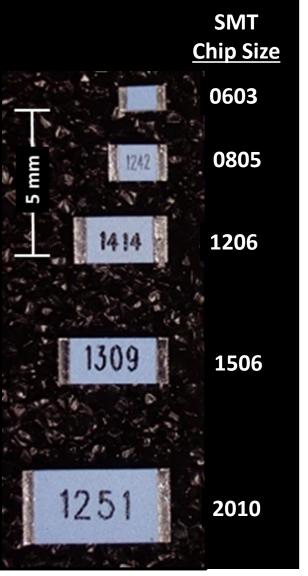
Basic Construction of a SMT Foil Resistor

- Resistor element is made from foil sheets of NiCr-based alloys
- Resistor gridline patterns are created by photolithography and electrochemical etching
- Resistor foil is adhesively-bonded to an alumina substrate
- Precise resistance values achieved by laser or mechanical cutting of combinations of "trim tabs" connected in parallel with resistor pattern segments of different values
- Various resistor termination options exist
- Polymeric and epoxy coatings protect the resistor element

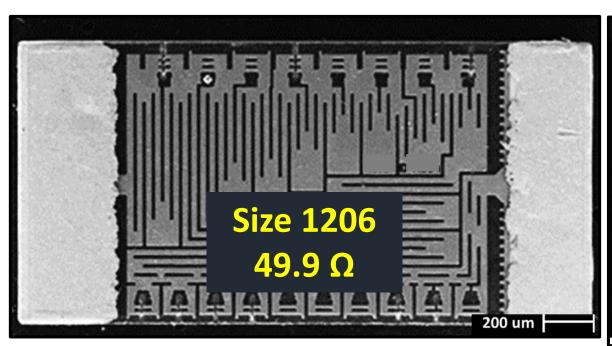
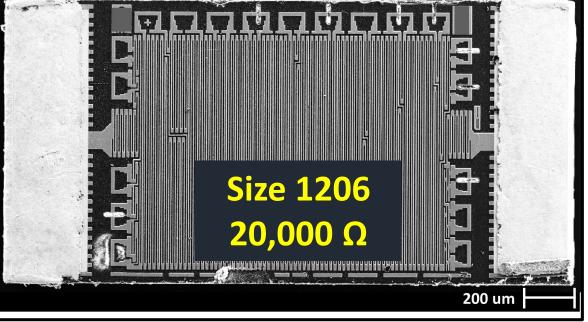
Foil Resistor Gridline Patterns

$$R = \frac{\rho * L}{A}$$

Low Resistance Values

- 1. Wider Foil Gridlines (e.g.,~ > 10 μm)
- 2. Thicker Foil (e.g., ~ 5 μm)
- 3. Shorter Path Lengths

3. Longer Path Lengths

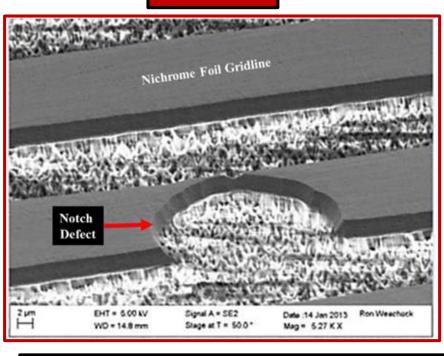
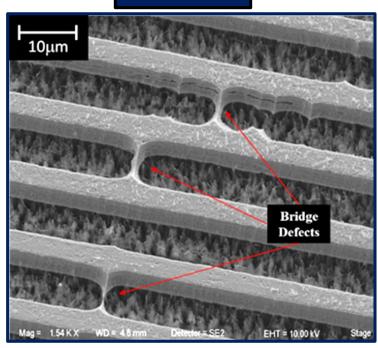
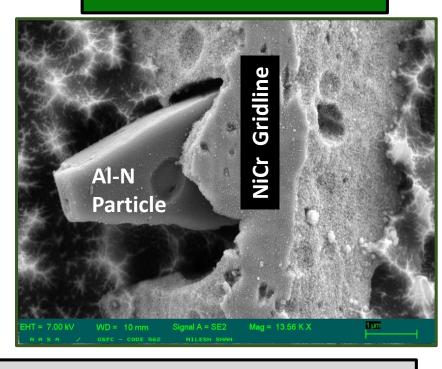
Foil Resistors Are Sometimes Produced with Localized Constriction Defects in the Gridline Pattern

Notches

Bridges

Embedded Particles

- 1. Constriction defects contribute directly to the final resistance value (e.g., bridges provide parallel resistor pathway).
- 2. Constriction defects are at risk of breaking due to thermomechanical fatigue fracture especially during power cycling
 - 1. Constrictions carry higher current density and develop localized 'hot spots' due to Joule heating
 - 2. Hot spots produce locally greater expansion of the NiCr foil
- 3. If a constriction defect fractures, then a positive resistance shift, including open circuit, will occur.

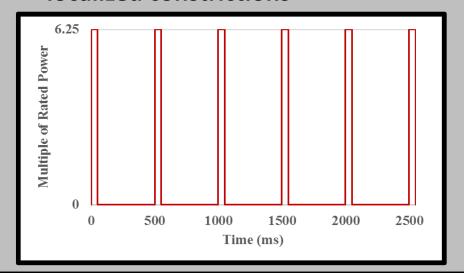
1. Apply pulsed-power to resistor

- 6.25x rated power ← same as STOL
- 50 ms, 10% duty cycle
- 1 or more pulses
- These conditions confine heating to the localized constrictions

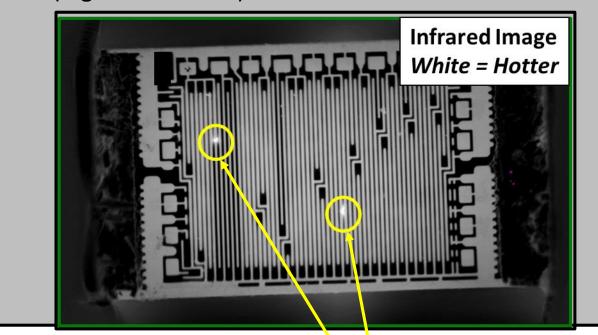
2. Examine resistor with high resolution infrared camera (e.g. FLIR SC8300)

- 3. Reject resistors with "hot spots"
 - Hot spots are indicative of constriction defects (e.g., notches, bridges, embedded particles)

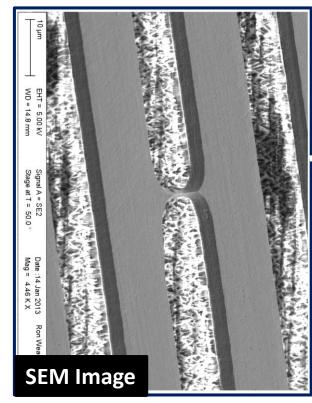
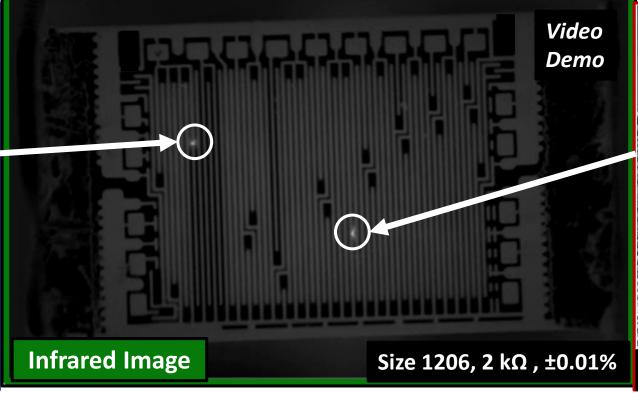
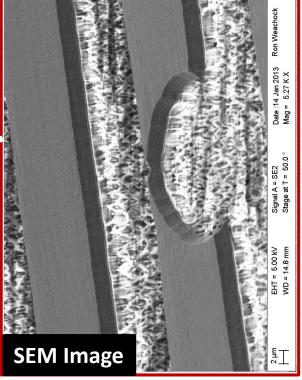
Demonstration of New Screening Method Using DPA Sample with Bridge and Notch Defects

Bridge Defect

Pulsed-Power 6.25x Rated Power 50ms On / 150ms Off

Notch Defect

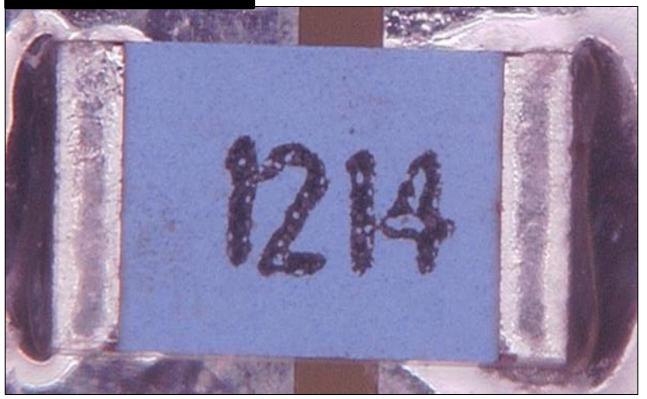
Optical Image

These Protective Coatings are "See Through" for Infrared Wavelengths of $3\mu m$ to $5\mu m$ Even With No Power Applied to the Resistor

Enables <u>Post-Procurement</u> Screening of SMT Foil Resistors

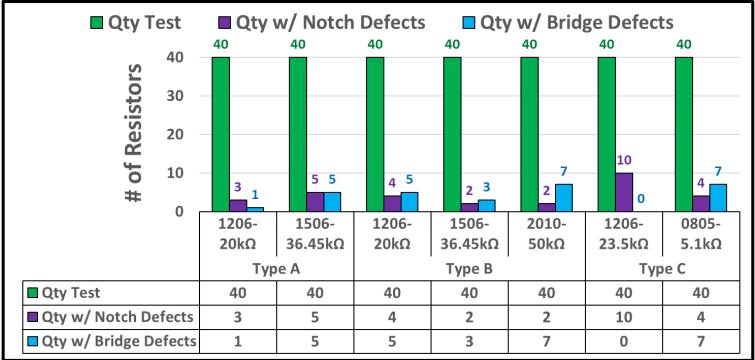
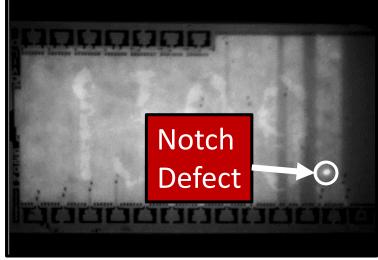
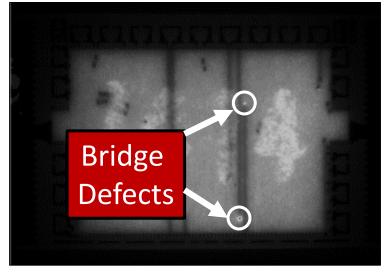
Results: Pre-Life Test Pulsed-Power Infrared Screening

Totals		
280 Tested		
30 with Notch Defects		
28 with Bridge Defects

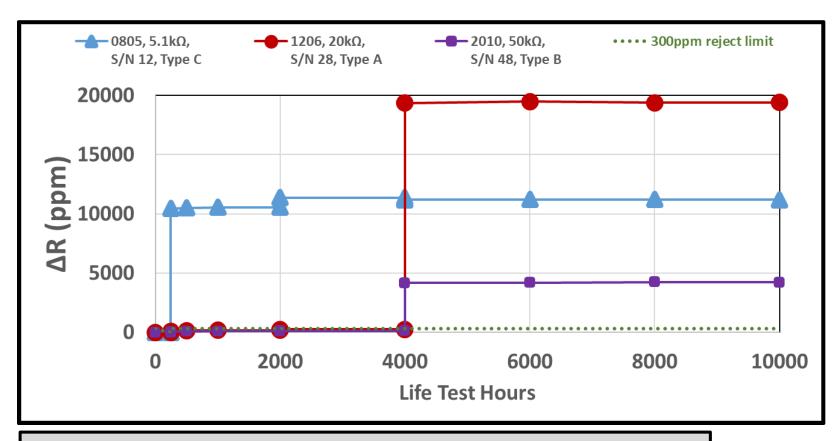
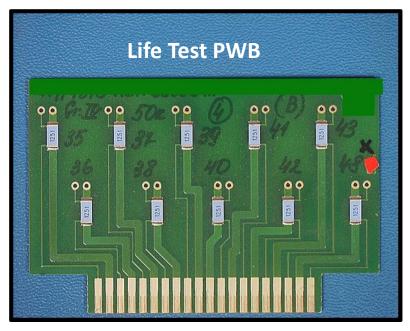
Results: 3 Life Test Failures (280 Resistors Tested)

Abrupt Positive Resistance Shift Failure Modes

* S/N 12 exhibits 2 distinct positive shifts during life test

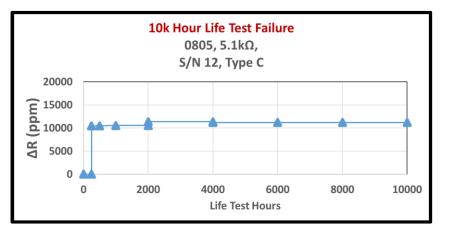
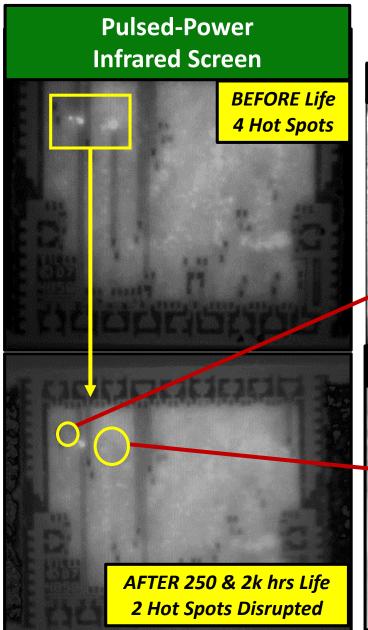
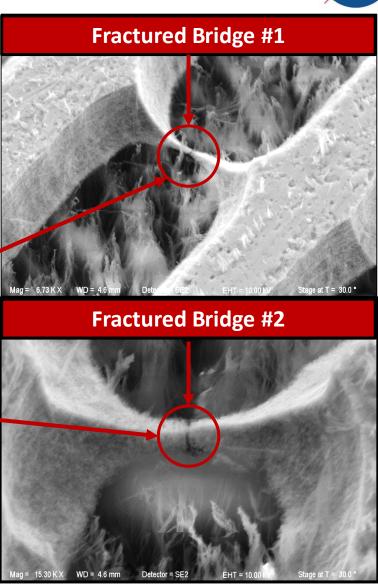
0805, 5.1kΩ, S/N 12, Type "C"

Two bridge defects fractured during life test causing total ΔR ~11000 ppm

Pulsed-Power Infrared Screen detected both bridge defects as 'hot spots' BEFORE Life Test

Two Positive Resistance Shifts During Life Test $\Delta R1 = +10440$ ppm @ 250 hrs; $\Delta R2 = +815$ ppm @ 2000 hrs

This Resistor Exhibited Two Abrupt Positive ΔR Shifts During Life Test. Both Shifts Were Caused by Thermomechanically-Induced Fatigue Fracture of Two Separate Foil Bridge Defects

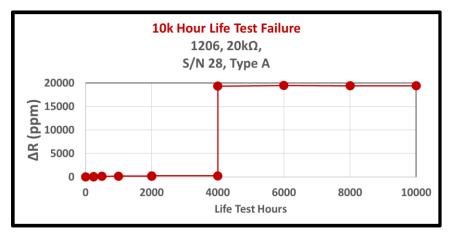
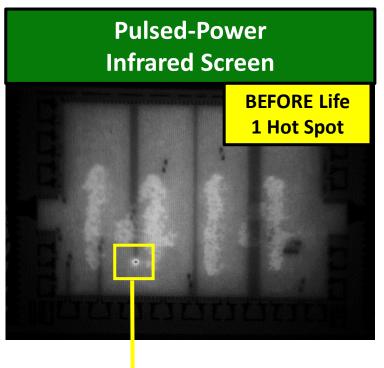
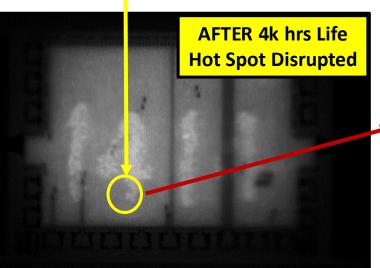
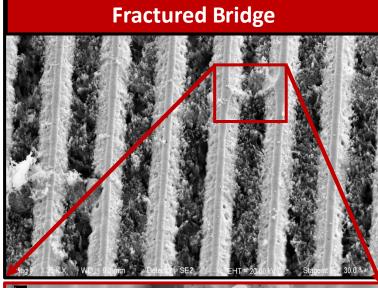
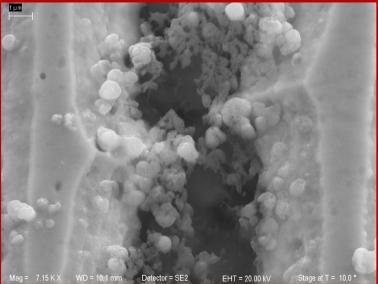
1206, 20kΩ, S/N 28, Type "A"

One bridge defect fractured during life test causing ΔR ~19400 ppm

Pulsed-Power Infrared Screen detected this bridge defect as a 'hot spot' BEFORE Life Test

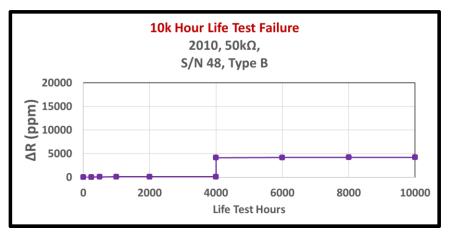
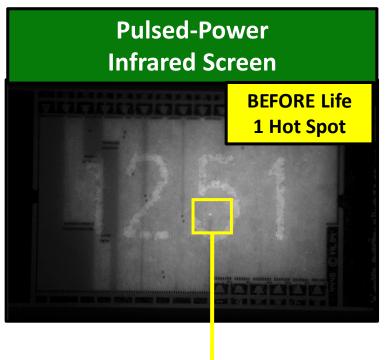
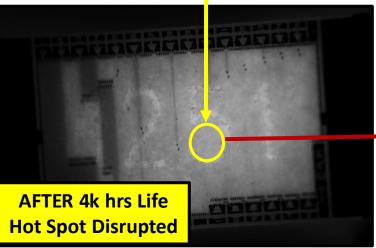
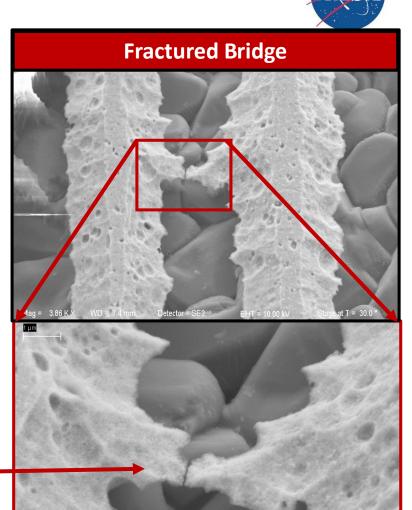
2010, 50kΩ, S/N 48, Type "B"

One bridge defect fractured during life test causing ΔR ~4200 ppm

Pulsed-Power Infrared Screen detected this bridge defect as a 'hot spot' BEFORE Life Test

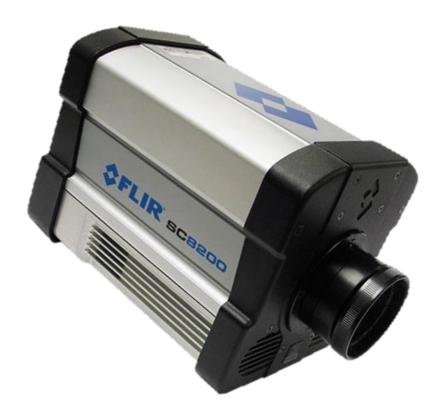
High Resolution Infrared Camera with 4x lens option *FLIR SC8200, SC8300 Series*

Parameter	Specification	
Detector	InSb	
Spectral Range	3 μm to 5 μm	
Measurement	-20°C to +350°C	
Temperature Range		
Field of View	~4.6mm x 5.6mm (> 1 million pixels)	
Resolution	~ 5 μm per pixel	
Focal Working Distance	~25mm	
Frame Capture Rate	>100 frames per second (fps)

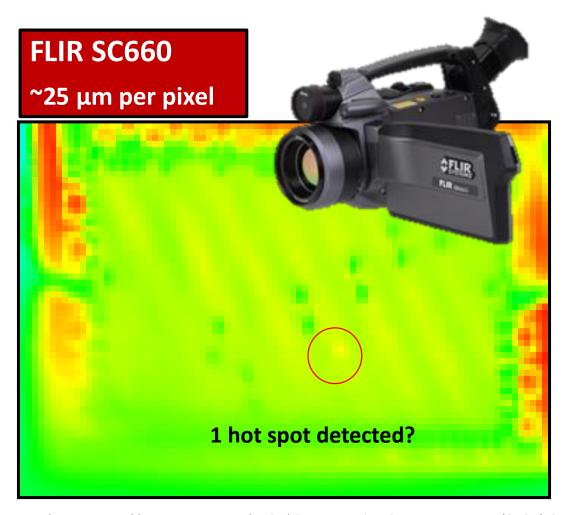
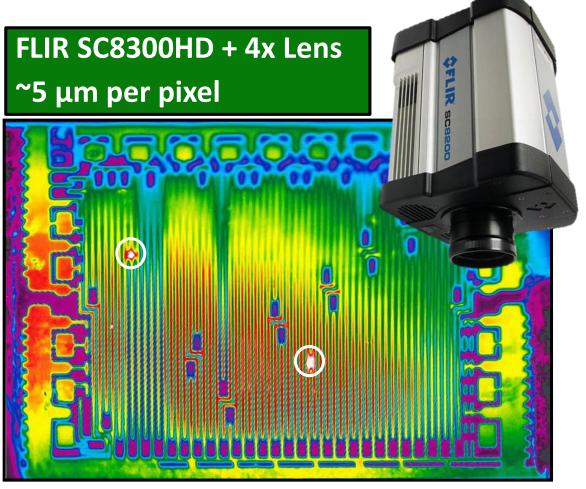
Comparison of Two Different Infrared Cameras

Inspecting the same resistor with 2 constriction defects while applying power pulses

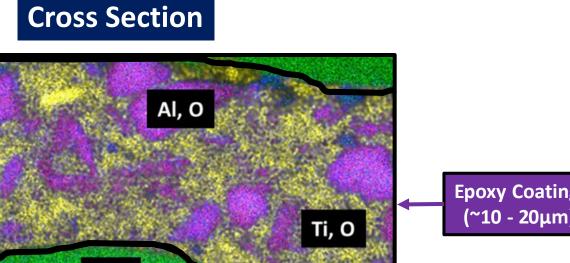
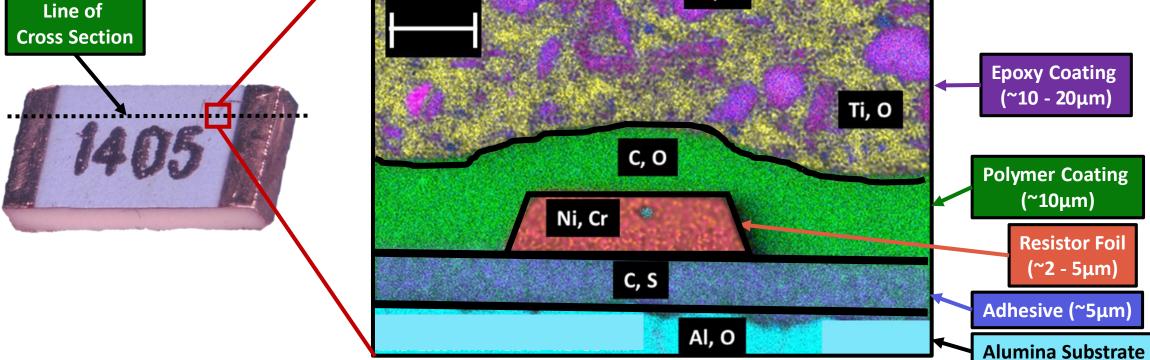
Basic Construction of a SMT Foil Resistor

Cross Section

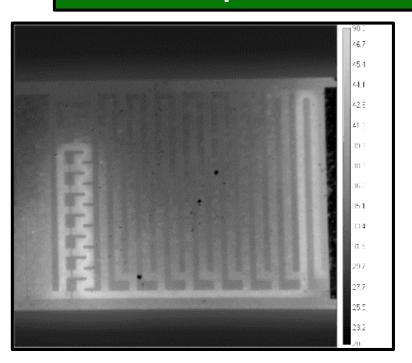
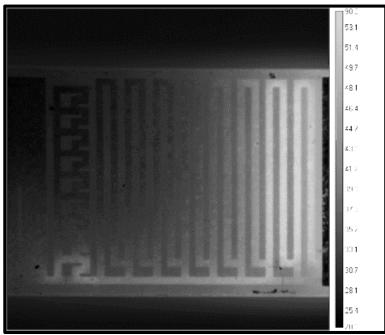
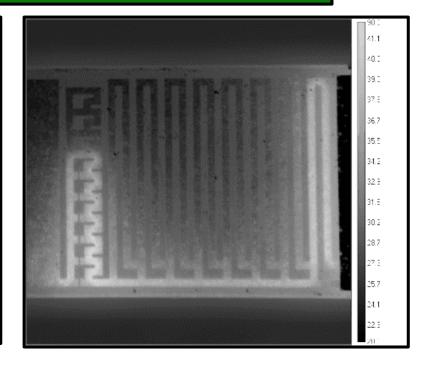
SMT Thin Film Resistors Inspected Using New Pulsed-Power Infrared Screening Method

Applying 6.25x Rated Power for 100 ms pulses; 10% duty cycle

Infrared Inspection Performed Without Removing Resistor Protective Coatings

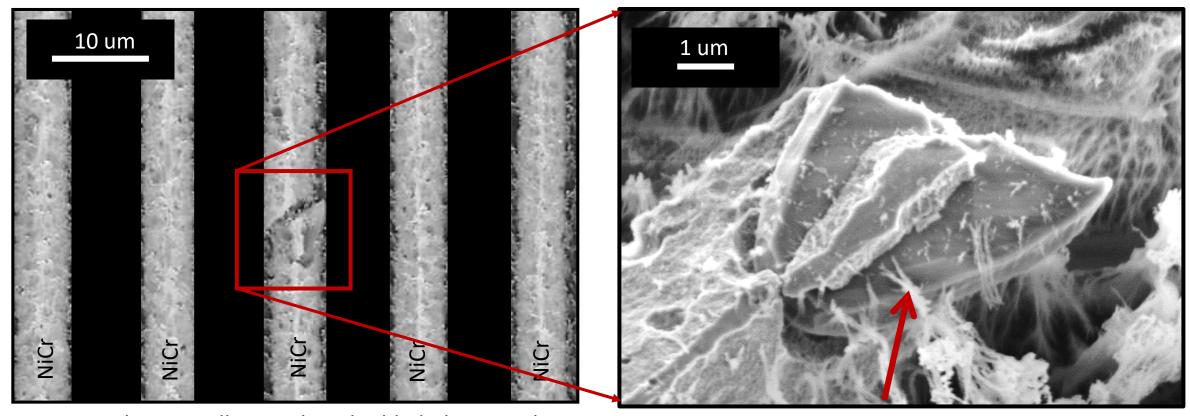
Embedded Al-N Particle in Foil Resistor Size 1206, 30 k Ω

Fractured NiCr Gridline With Embedded Al-N Particle

Aluminum Nitride Particle

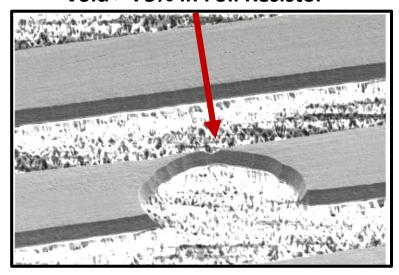
Void > 75% in Foil Resistor

Thin Film (MIL-PRF-55342)	Foil Resistors
Test Conditions	30x to 60x optical microso	copy prior to encapsulation
Sample Size	100% in-process screen	100% high reliability products only
Rejection Criteria	Voids > 50% nominal line width Bridges < 50% smallest line width	Voids > 75% nominal line width Bridges < 10% smallest line width
