NASA WG3 MMOD Protection Summary

37th Interagency Space Debris Coordination Committee (IADC)
6-10 May 2019

Summary of Meteoroid and Orbital Debris (MMOD) Protection Activities

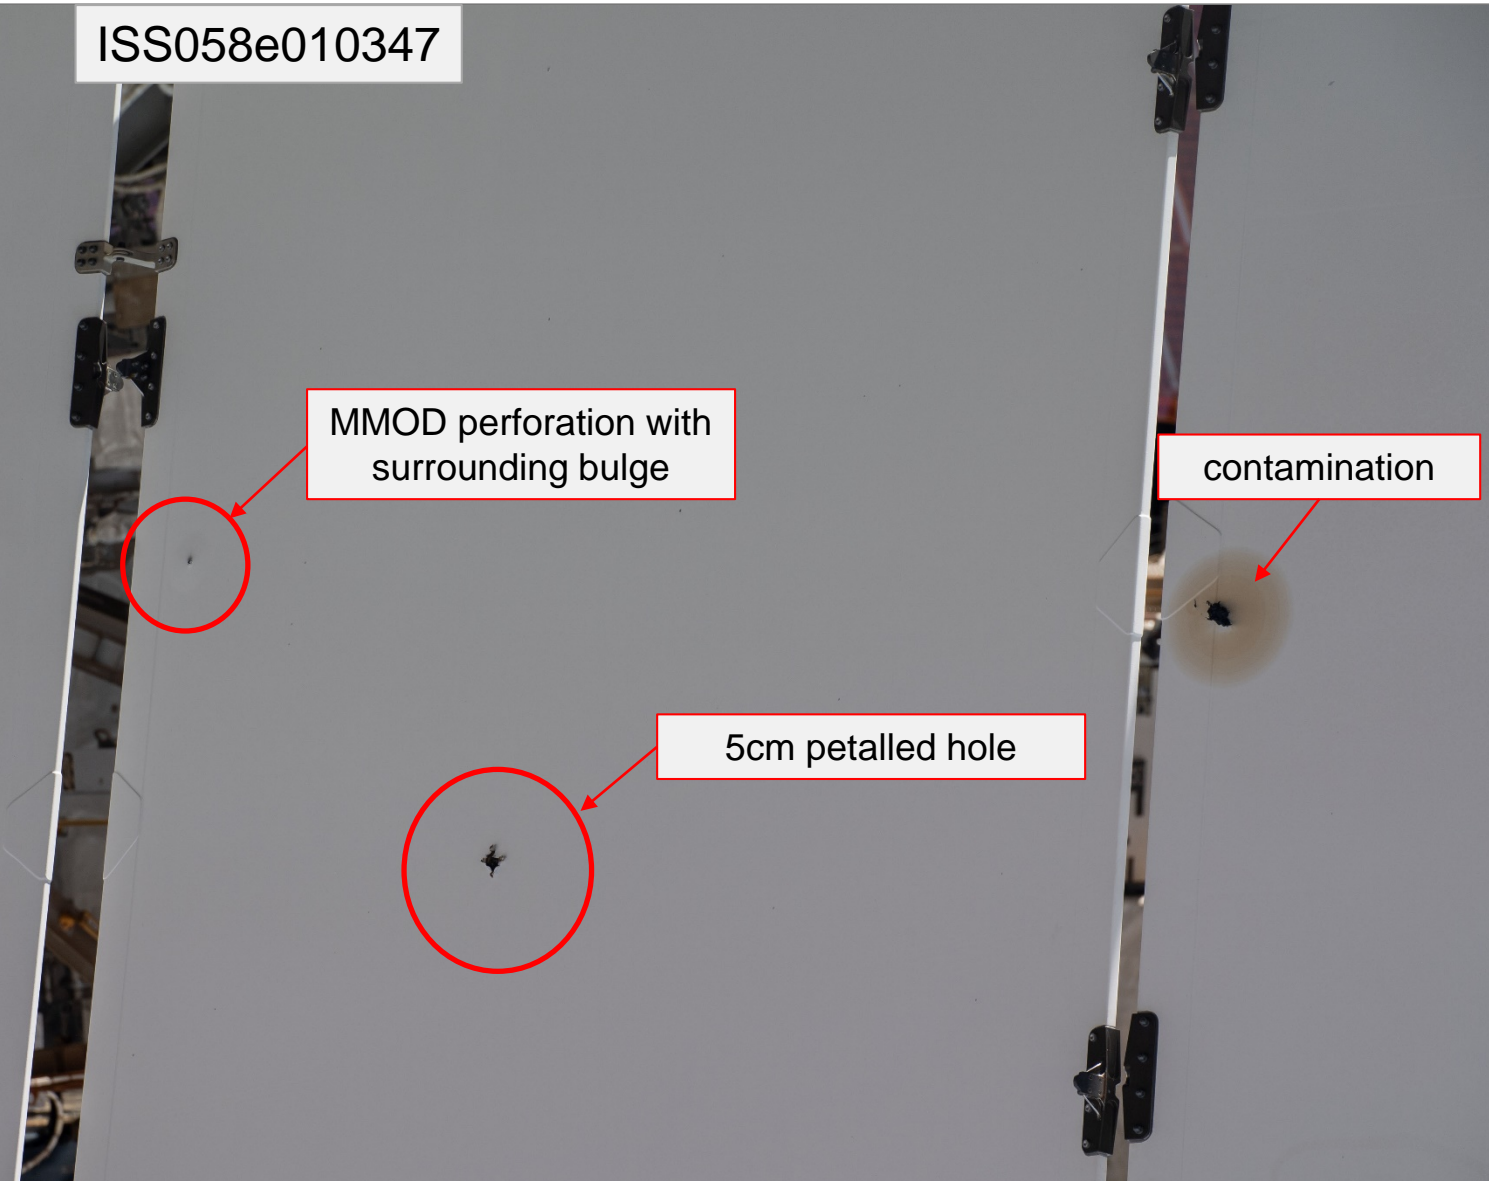
ISS058e010347

Space Station Radiator Panel

observed February 2019

MMOD perforation with
surrounding bulge

contamination

5cm petalled hole

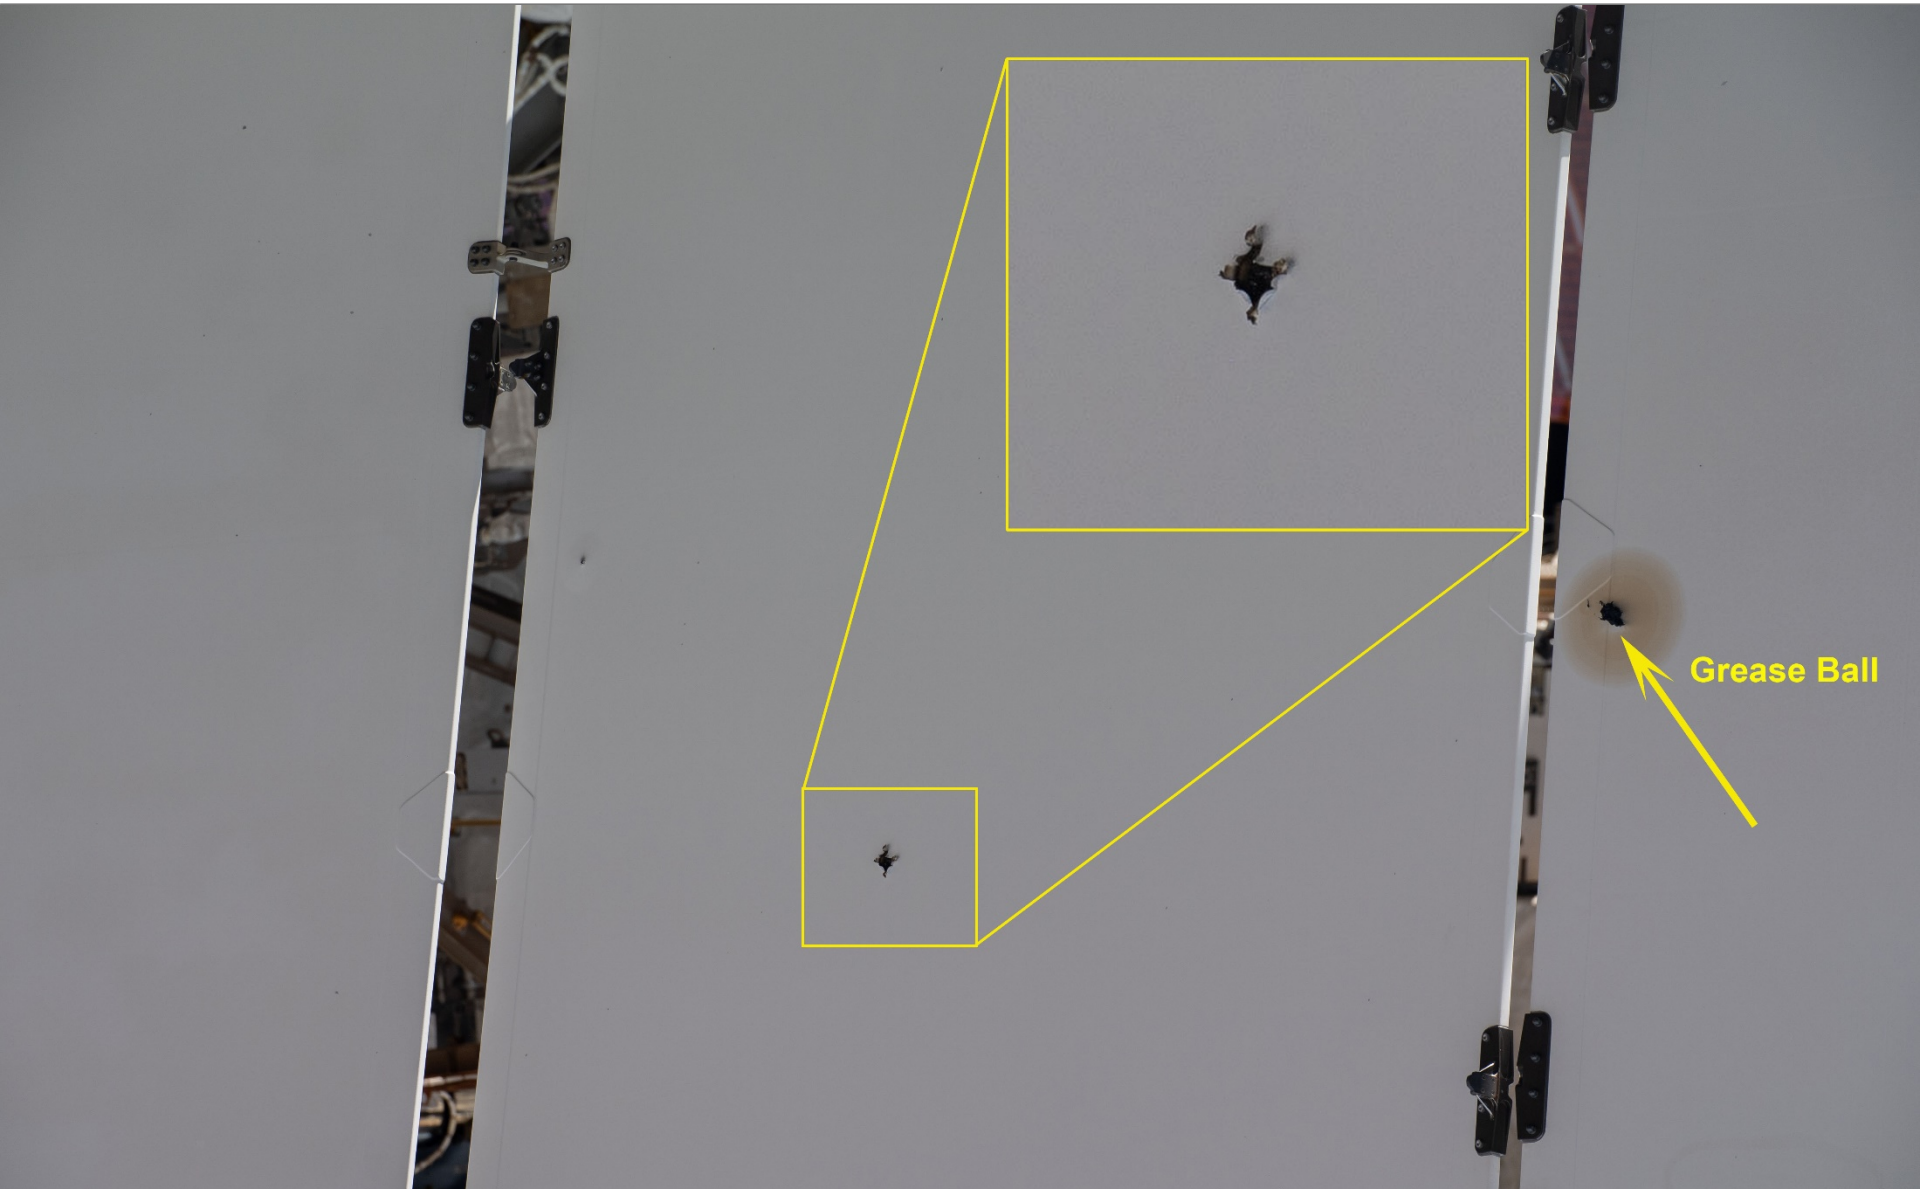
Space Station Radiator Panel

Grease Ball

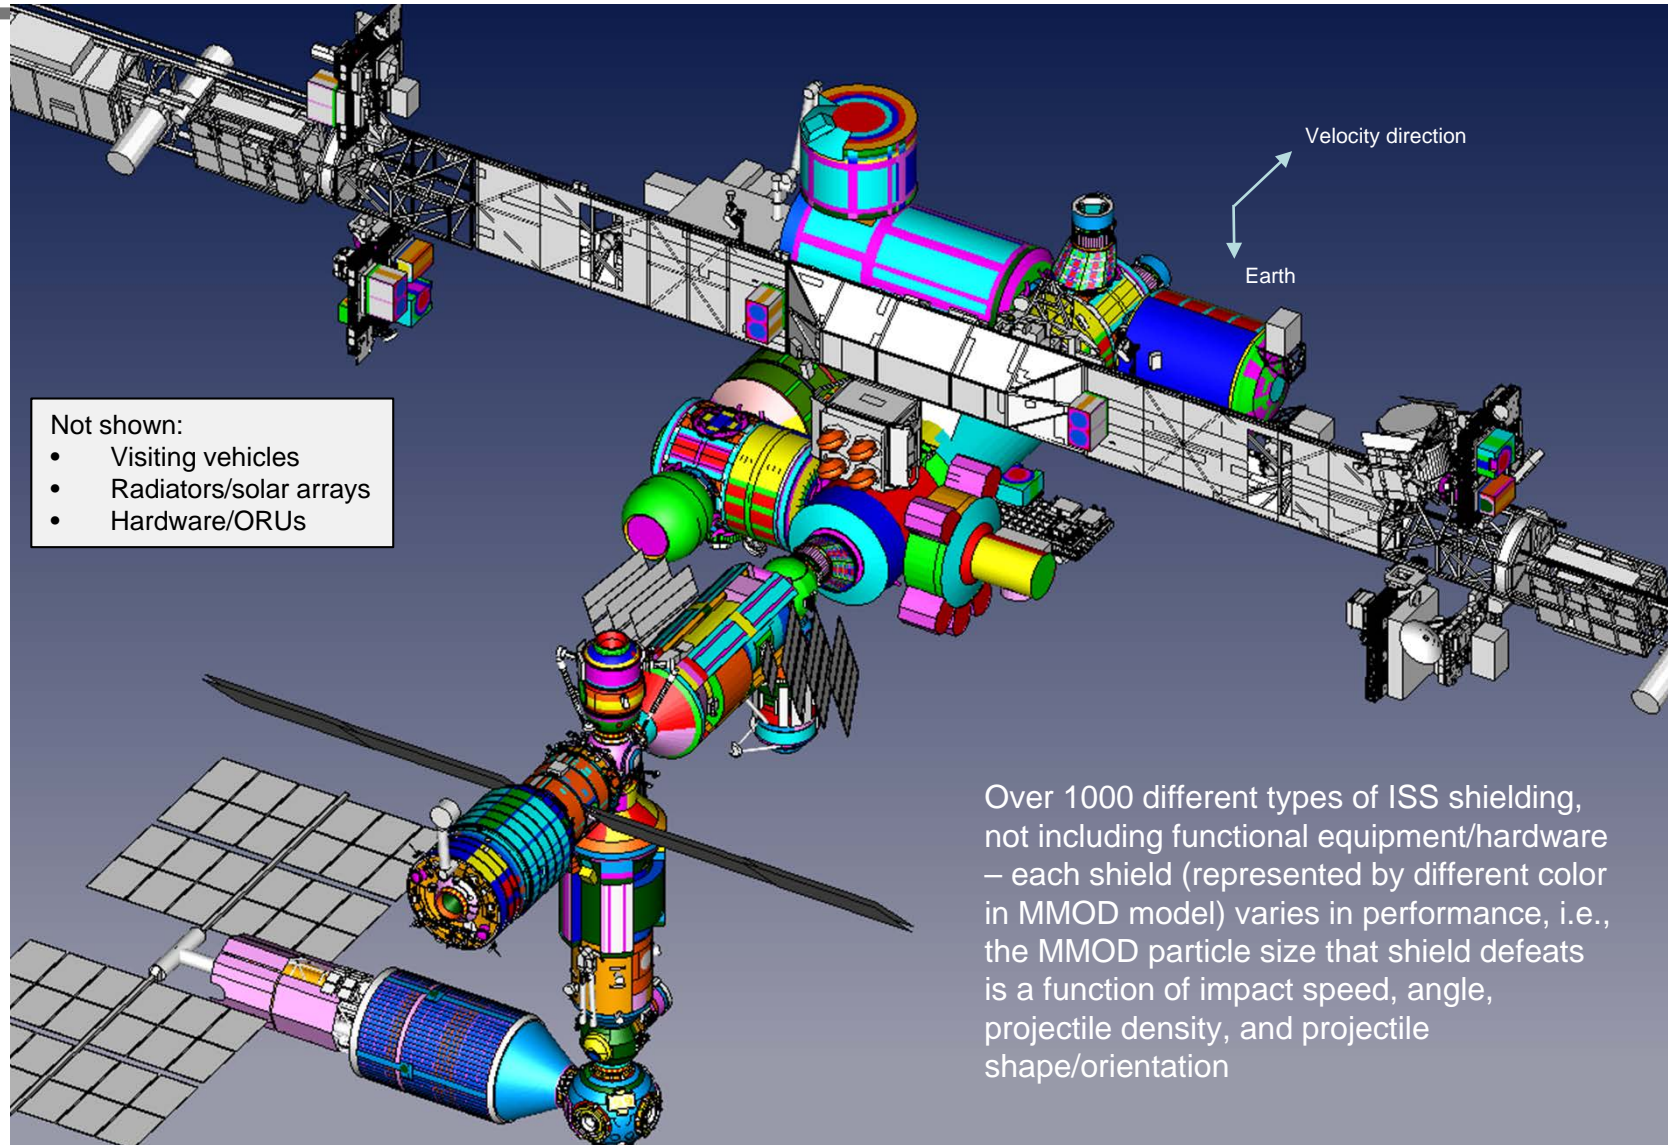
ISS *Bumper* finite element model

after addition of MLM, Russian Node, Science Power Module, and Bigelow Expandable
Activity Module (BEAM), and after PMM relocation
