Fatigue life and damage tolerance of postbuckled composite stiffened structures with indentation damage

Journal of Composite Materials

2018, Vol. 52(7) 931–943

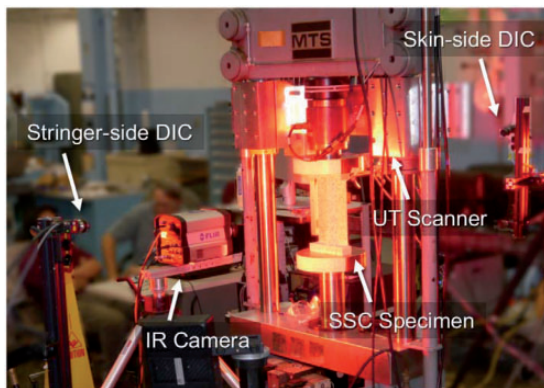
Figure 8. SSC specimen, load frame, and test instrumentation.

The tests were conducted using a uniaxial test frame and with instrumentation that allows a precise evaluation of the postbuckling response and damage. The test frame and the instrumentation shown in Figure 8 is the same as used in the previous test campaign conducted on SSC specimens with Teflon films and described in Dávila and Bisagni.¹⁶ The primary instrumentation consists of (i) two three-dimensional digital image correlation (VIC-3D) systems¹⁸ that are used to measure the postbuckling full-field deformations and strains on the skin and stringer sides of the specimen, (ii) an infrared camera for the passive thermal monitoring¹⁹ with a frame rate of 60 Hz that can track the position of a delamination front during fatigue cycling, and (iii) an in situ UT scanner²⁰ mounted on the load frame which is used to obtain detailed measurements of the damage. The digital image correlation system acquired images at a rate of 0.2 Hz, the infrared camera at 60 Hz,

and the UT scanner at selected intervals. Finally, two back-to-back pairs of strain gauges placed on the skin near the top of the specimen were used to ensure that the load introduction platen was properly aligned.

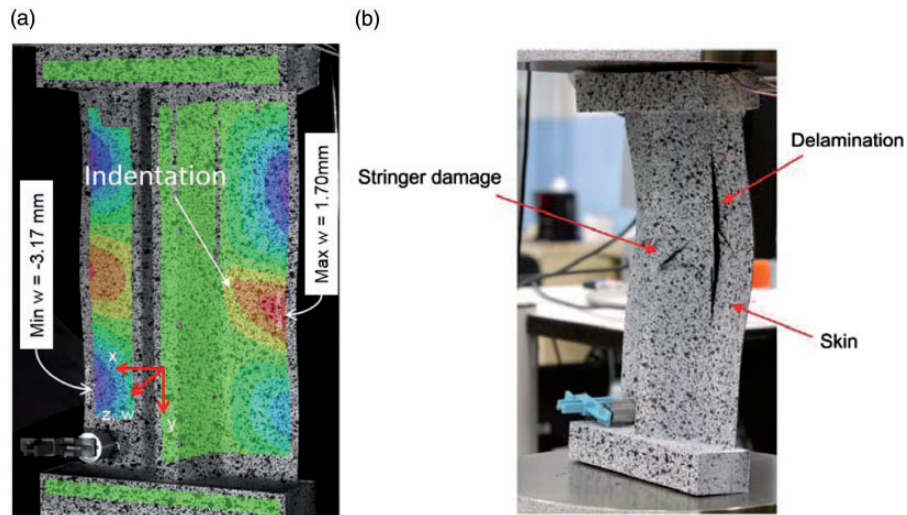
Figure 10. Fatigue and posttest assessment of specimen SSCS-1: (a) deformation at 96,000 cycles and (b) after collapse.

An image captured by the digital image correlation system on the skin side of a typical panel (SSCS-1) after 96,000 load cycles is shown in Figure 10(a). When subjected to a load of 31.1 kN, the maximum out-of-plane displacement is equal to 3.42 mm in the direction opposite to the stringer and 1.79 mm in the direction of the stringer. It can be observed that the deformation is similar to that for panel SSCS-2 but of opposite amplitude. Differences in the postbuckling response of two nominally identical specimens are common and attributable to small differences in the initial imperfections of the panels and, possibly, to minute differences in the alignment of the specimen in the test platens. Therefore, it is extremely difficult to predict the mode that will develop in a particular panel.

Specimen SSCS-1 failed suddenly at 117,506 cycles as a consequence of an unstable delamination between the skin and both stringer flanges. The posttest deformation is shown in Figure 10(b), where it can be observed that there is separation at the skin-stringer interface and crippling damage in the stringer.

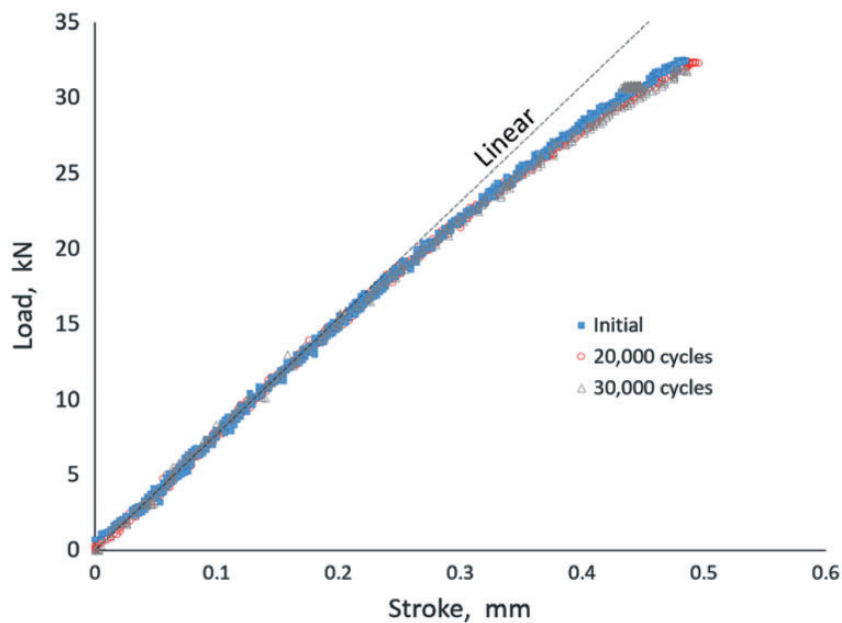
Figure 11. Quasi-static load-stroke curves at three stages of the fatigue life of specimen SSCS-5.

Quasi-static load-shortening curves for specimen SSCS-5 are shown in Figure 11, which is representative of what was observed for all specimens. It can be seen that the initial response is nearly identical to that at

20,000 and 30,000 cycles. Clearly, the global response of the SSC specimens retains a constant nonlinearity and is only mildly affected by the progression of fatigue damage. The specimen collapsed at 33,623 cycles.
