# Textile Material Lessons Learned During the Design and Qualification of the NASA Orion Capsule Parachute Assembly System

Brian P. Anderson<sup>1</sup>, Jared Daum<sup>2</sup>  
*NASA Johnson Space Center, Houston, TX, 77058, USA*

**The NASA Orion Capsule Parachute Assembly System (CPAS) development and qualification testing was completed in September 2018. Over the course of the airdrop and ground testing campaign, the team benefited from the ability to design, test, and adjust the design based on observations and inspection results. While the design team used the best knowledge available and attempted to utilize best practices, a number of lessons were learned that should be documented for consideration by future designers. This paper describes these lessons learned including the use of textile reefing loops, the importance of performing joint tests, the impact of using bight sleeves on parachute deployment, and a surprising number of design changes required in the CPAS system after the decision was made to change the suspension line braid to save system mass.**

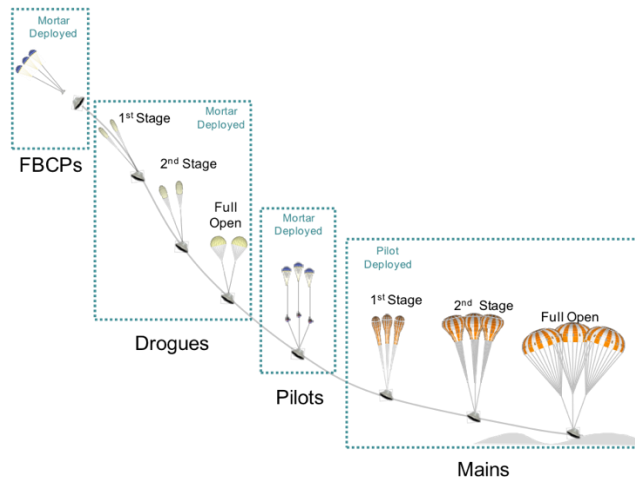
**Figure 1 Nominal CPAS concept of operations.**

The nominal NASA Orion parachute system developed by the Capsule Parachute Assembly System (CPAS) team is composed of three mortar-deployed Forward Bay Cover Parachutes (FBCPs), two mortar-deployed drogue parachutes, three mortar-deployed pilot parachutes, and three pilot-deployed main parachutes. The CPAS concept of operations for a nominal mission is depicted in Figure 1. As part of the development and certification of the parachute system, a total of 25 system air drop tests were conducted including 17 development tests and 8 qualification tests. This testing was carried out between September 2011 and September 2018. On average, one airdrop test was executed every 100 days. During development testing, the design of the system frequently evolved as data was reviewed and updates were made to make the system more reliable. Changes were made less frequently during the qualification testing phase. Many of the design updates related to the textile materials in the system and resulted in significant lessons learned. This paper describes a sampling of these lessons learned over the course of the entire CPAS test campaign.

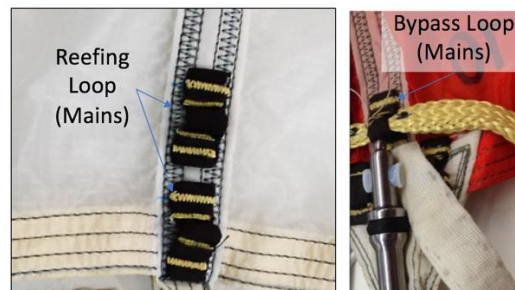
Figure 2 Main parachute reefing loops & bypass loop

The switch to textile reefing loops was made first on the main parachute design. As part of the CPAS airdrop test program, a pallet was used to extract the test article from the aircraft[3,4]. To ensure a safe landing for the pallet, "retired" CPAS main parachutes were used as pallet recovery parachutes. The benefit of using retired main parachutes for this purpose was that the team could make updates to the recovery parachutes to evaluate the appropriateness of proposed design changes to the flight system. The team incorporated textile reefing loops into the pallet recovery parachutes starting on CDT3-4. The textile reefing loops were incorporated into the flight main parachutes on CDT3-8. A figure showing textile reefing loops for the main parachute design is shown in Figure 2. At reefing line cutter locations, a bypass loop (also seen in Figure 2) is used to route the reefing line for the other reefing stage above the reefing line cutter. From CDT3-8 through the end of the qualification airdrop test program, only minor damage was noted on the main parachute reefing loops.

Figure 3 shows the drogue reefing loop design. The drogue reefing loops wrap around the radial, whereas the main reefing loops are attached to the inside of the radial (Figure 2). A bypass loop is used to route the other stage reefing line around the reefing line cutter. A cotton tie is used to hold the reefing line in place. The cotton tie pierces the reefing line and is tied around the reefing loop. See Figure 4. These cotton ties are also used on the main parachutes.

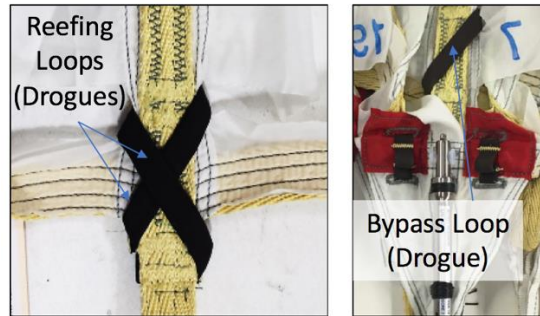
**Figure 3 Drogue parachute reefing loops & bypass loop**

During post-flight inspections of one of the two drogues used on the CQT4-6 airdrop test, it was noted that one of the drogue bypass reefing loops had failed. The cause of the failure appeared to be abrasion followed by a tensile failure of the few remaining fibers. Inspections indicated that the abrasion was caused by relative motion between the reefing line and bypass loop. Review of the test video showed the failure took place 7 seconds into the 8 second stage as evidenced by a parachute skirt shape change. A similar failure was also observed in the CQT4-8 airdrop test. During this test the failure took place between 5.1 and 5.8 seconds into the 8 second stage. There were no noticeable effects on parachute drag performance on either CQT4-6 or CQT4-8. While some reefing loop abrasion had been noted on previous drop tests, none of this damage had caused major concern because some abrasion to the reefing loops is expected once the reefing cutters fire and the reefing line is pulled through the reefing loops.

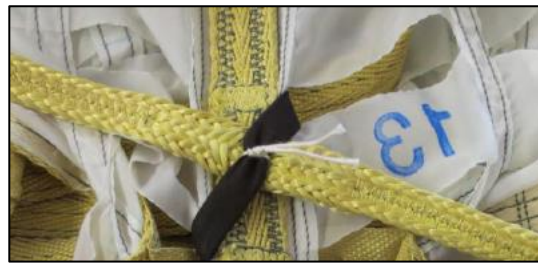
**Figure 4 Cotton tie at bypass loop**

The specific failure mode was determined to be migration of the reefing line to the corner of the reefing loop with subsequent sawing in the drop test vehicle wake. Analysis showed that it is likely that the cotton ties meant to hold the reefing line in the middle of the bypass loop failed prematurely. Then, due to the canopy shape and the direction of force on the reefing line, the reefing line was pulled down into the corner of the bypass loop. As illustrated in Figure 5, there is an angle formed due to the bypass that encourages the reefing line to migrate to the corner of the bypass loop. Ground testing showed that when the reefing line was in the corner of the bypass loop that it was very easy to saw through the loop, while sawing in the middle of the loop would not lead to loop failure.

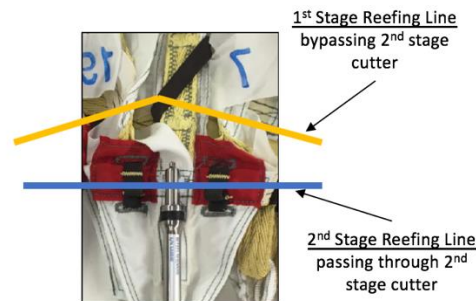
**Figure 5 Bypass loop angle illustration**

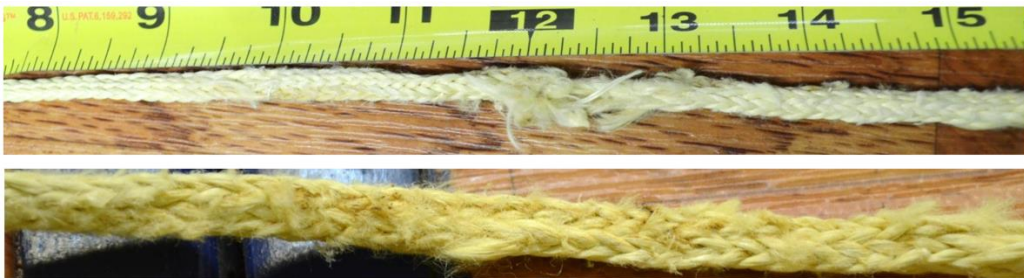
**Figure 6 Suspension line damage following CDT3-5**

During parachute inspections following the CDT3-5, it was noted that several main parachute suspension lines experienced unexpected damage. The damage appeared to be consistent with abrasion or snagging. The most severe damage was concentrated on 2 lines. Photographs representative of the damage are shown in Figure 6. This degree of suspension line damage had not been observed previously on CPAS development tests. Damage was also observed on two locking stow loops.

While the root cause was never positively identified, it was believed to have been caused by interaction between suspension lines and adjacent locking stow loops. During packing, it is possible that some of the suspension lines in one of the bights were inadvertently routed over an adjacent stow loop, as modeled in Figure 7. In order to prevent this from happening in the future, a design update was made to wrap the suspension line bights with a Spectra sleeve to prevent “stray” suspension lines from interacting with stow loops or other snag hazards. The bight sleeves were comprised of a single piece of rectangular Spectra fabric. During packing, the suspension lines were wrapped with the bight sleeve with a small amount of overlap before the bight was placed in the locking stow. These bight sleeves were only applied in locations that passed through a locking stow loop. The bight sleeves were intended to immediately release and

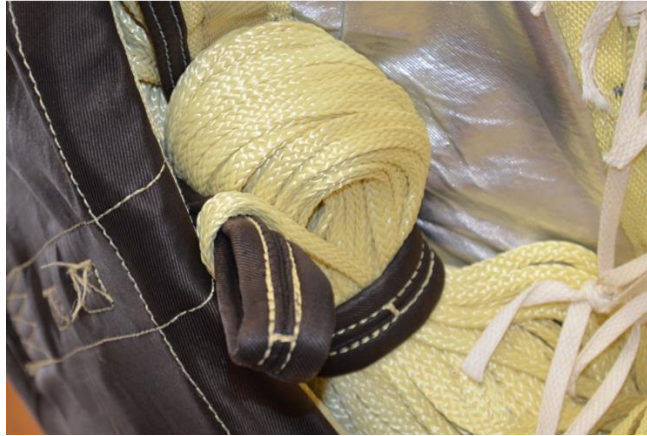
**Figure 7 Possible suspension line & locking stow interaction on CDT3-5**

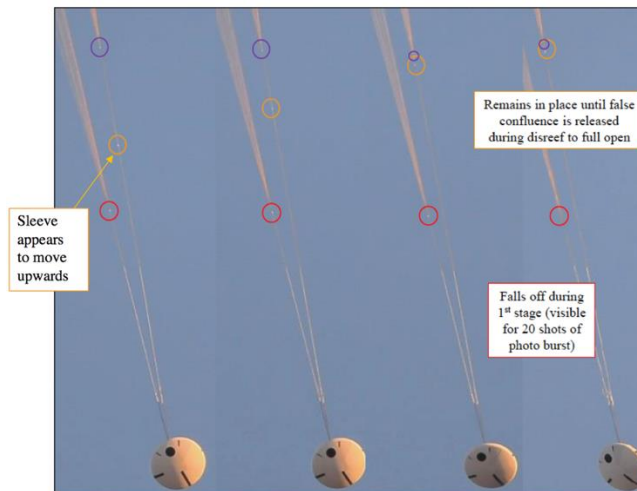
**Figure 8 Bight sleeve progression on CQT4-5. Circles highlight locations with bight sleeves present.**

During video reviews of main parachute deployment on CQT4-5, there were several “false confluences” identified. Figure 8 shows a series of photos as the drop test progressed. False confluences are locations where the suspension lines are restricted and the parachute is not allowed to attain its intended shape. Each of these false confluences were temporary in that the suspension lines eventually released and deployment and parachute staging were successful. Upon closer review of the video it was noted that the white Spectra bight sleeves were still present on the suspension lines throughout first stage. The bight sleeve was only able to release given the parting force induced from first stage disreef. While many of the sleeves released immediately upon deployment and could be observed flying away from the parachute, some of the sleeves remained on the suspension lines and were the cause of the false confluences. It was also noted that some of the sleeves migrated up the suspension lines. This caused concern given that it raised the possibility that migrating bight sleeves might combine and result in a stronger restriction. Ultimately, all bight sleeves did liberate. On CQT4-5 there was a slight temporary change in parachute performance that was attributed to the bight sleeves.

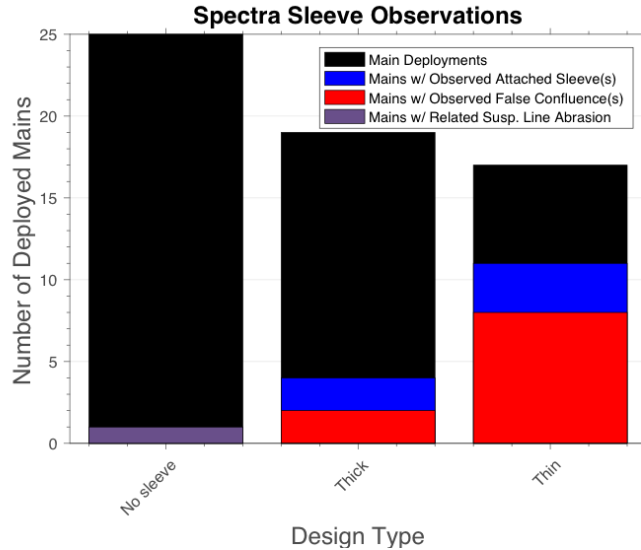
**Figure 9 Bight sleeve and false confluence experience**

Following the observations on CQT4-5, the team reviewed previous drop test videos again and noticed that false confluences were present on previous tests, but to a lesser extent. After reviewing all of the data it was noted that drop tests beginning with CDT3-17 (the last development test) through CQT4-6 (the sixth qualification test), were more likely to experience a false confluence. See Figure 9. As will be discussed in Section VII, on CDT3-17 the CPAS team implemented a new suspension line weave that resulted in smaller suspension lines. However, with the change to smaller suspension lines, the Spectra bight sleeve design was not modified accordingly. As such, the overlap of the Spectra wrap increased from approximately 2-inches with the old suspension lines to 4-inches with the new lines. It is believed that this is a key contributor to the increase in false confluence observations. Ground testing was conducted using bungee cords to simulate bight extraction through the stow loop. The testing showed that the bight sleeve material would roll over itself (similar to rolling a pair of socks) and bind. The resulting mass of material was somewhat difficult to unlock.

The false confluences caused by the bight sleeves were a cause of concern. A sustained confluence can cause a change to the geometry of the suspension lines and impact drag performance. In the worst case, a false confluence due to a bound-up bight sleeve(s) near the parachute skirt can result in the parachute failing to fully inflate, potentially causing loss of a main parachute. Ultimately, the team decided that the likelihood and consequence of sustained false confluences due to the Spectra sleeves was not acceptable for human flight. While one option was to re-size the Spectra sleeves to account for the smaller suspension lines, it was ultimately decided to remove the Spectra sleeves from the design altogether.

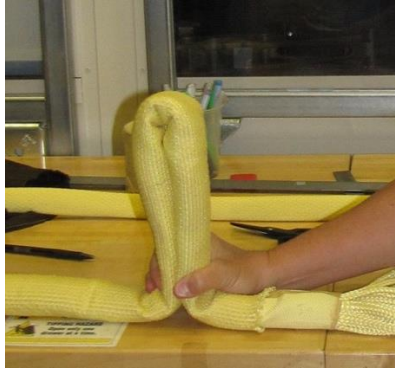
**Figure 10 All-textile riser flexibility**

Switching to an all-textile riser design resulted in a parachute system mass savings of just under 60 lbm. This number accounts for the riser and the riser attach fittings. Because the vehicle interface is different for a steel and textile riser, the vehicle attach structure (referred to as the “gusset”) was also redesigned and resulted in significant mass savings. A total estimated mass savings of 110 lbm can be attributed to design updates associated with the switch to textile risers and the associated gusset updates. In addition to these mass savings, parachute packing and integration into the spacecraft became much easier and much more repeatable. The stored energy in a secured steel riser was replaced by an all-textile design that can be placed in nearly any shape, as shown in Figure 10.

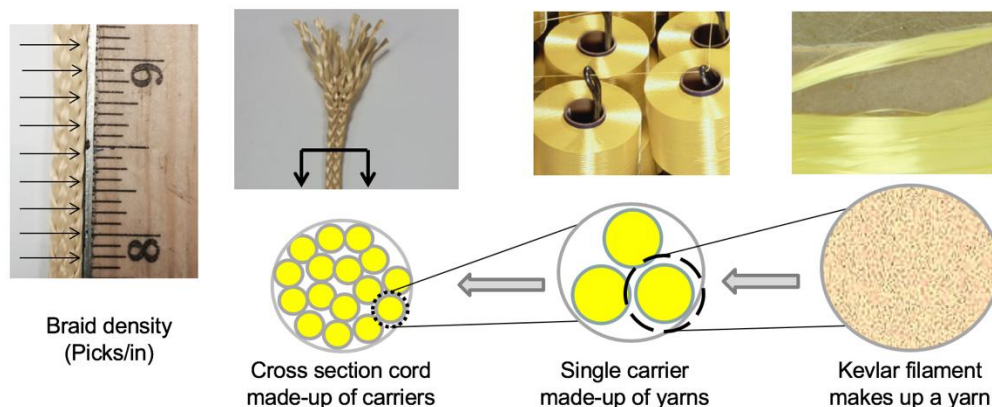
**Figure 11 Kevlar cord "anatomy"**

In communications with the suspension line cord vendor, it was found that a different Kevlar braid could be used to help make the parachute stronger. The new braid used a weave with fewer picks per inch, while the old braid had a higher weave density. See Figure 11 for an illustration of Kevlar cord makeup and braid density. The new material was higher strength and lighter than the existing material. The primary reason for the increase in strength is that the Kevlar fibers are more oriented in the loading direction. The cost and schedule for producing the new material was virtually identical to the old material. Joint testing was performed for all the parachute joints to ensure that the new material did not result in a substantial decrease in joint efficiency. Using the new material, the FBCP suspension line was changed from 1500 lb strength to 2250 lb strength with no mass impacts.

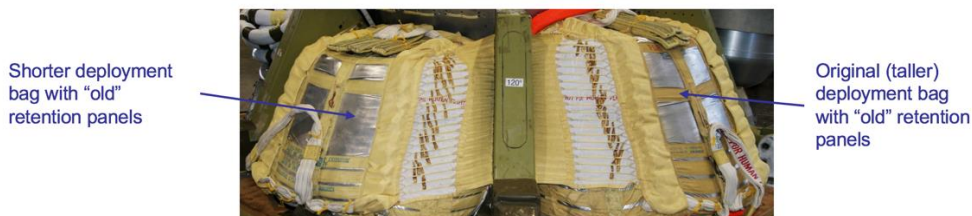
**Figure 12 Comparison of retention system with shorter and original main deployment bag**

In addition, because the main deployment bag was shorter, a redesign of the main parachute retention system was also required. The retention system is comprised of Kevlar panels that are hard mounted to the parachute compartment using fasteners in pre-determined hole locations. The panels then attach to the main deployment bag to hold the parachute in place until deployment. A parachute integration using the existing retention system panels with the new, shorter deployment bag showed that the retention panels were not oriented properly (see Figure 12). The retention panels were re-sized.
