Orion Capsule Parachute Assembly System (CPAS) Main and Drogue Canopy Instrumentation

Jared S. Daum¹

NASA Johnson Space Center, Houston, Texas, 77059

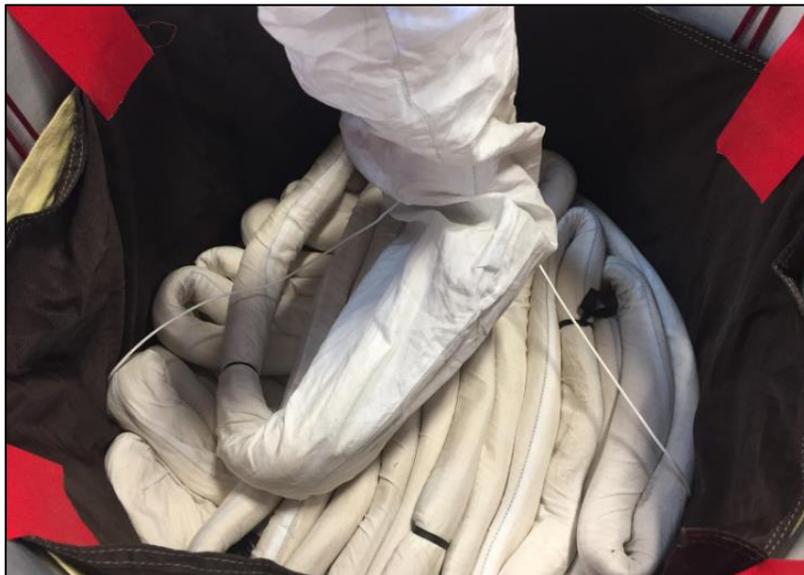
Fig. 5 Sensor activation lanyard in Drogue parachute.

The activation method for the RLCES was designed for minimal impact to the qualification parachutes. Flight-like packing and integration of the Main and mortar-deployed Drogue parachutes, along with snag hazard concerns, required the activation method be completely self-contained inside the deployment bag. Additionally, it was desired to activate the sensors as early as possible in the deployment so that the system could boot up and begin collecting data as early as possible. This required a length of the Spectra activation lanyard to be pulled past parachute material. Simulator lanyards (with no sensors) were installed in the qualification Main and Drogue parachutes on CQT4-5 (Cluster Qualification Test), as seen in the Drogue in Fig. 5. The primary test objectives were to observe any damage

to the qualification assets that could be attributed to the lanyards and to verify that the lanyard pull method would not result in broken lanyards or any other conditions that would prevent sensor activation.

All 8 simulator lanyards performed as expected. The entire length of installed lanyard remained fixed to the attach point at post-test inspection. Additionally, there was no indication of friction burns or other damage to the qualification asset. This provided confidence that the sensors could be activated without impacting the qualification parachutes.

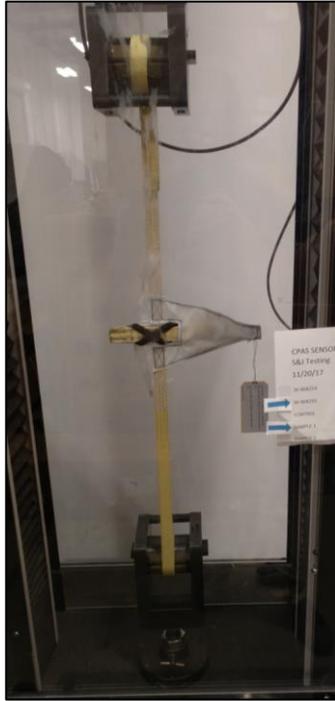
Fig. 6 Sensor pocket seam and joint testing.

Stitching, knotting, joining, or otherwise affecting raw textile materials can degrade the ultimate strength of that material. Introduction of the RLCEs into the canopies required the addition of custom pockets which were sewn into the parachute. Testing was required to demonstrate that joining the pocket materials to the parachute structural grid did not significantly degrade the structural capability of the parachute. Since these pockets are slightly different from the flight cutter pockets (located on the outside of the canopy), samples were pull tested, as seen in Fig. 6, and results showed that the addition of the pockets did not significantly degrade the parachutes.
