The International Space Station (ISS) Port 1 (P1) External Active Thermal Control System (EATCS) Ammonia Leak

*Darnell T. Cowan, Timothy A. Bond and Jordan L. Metcalf
NASA Lyndon B. Johnson Space Center (JSC)*

49th International Conference on Environmental Systems

ICES-2019-31

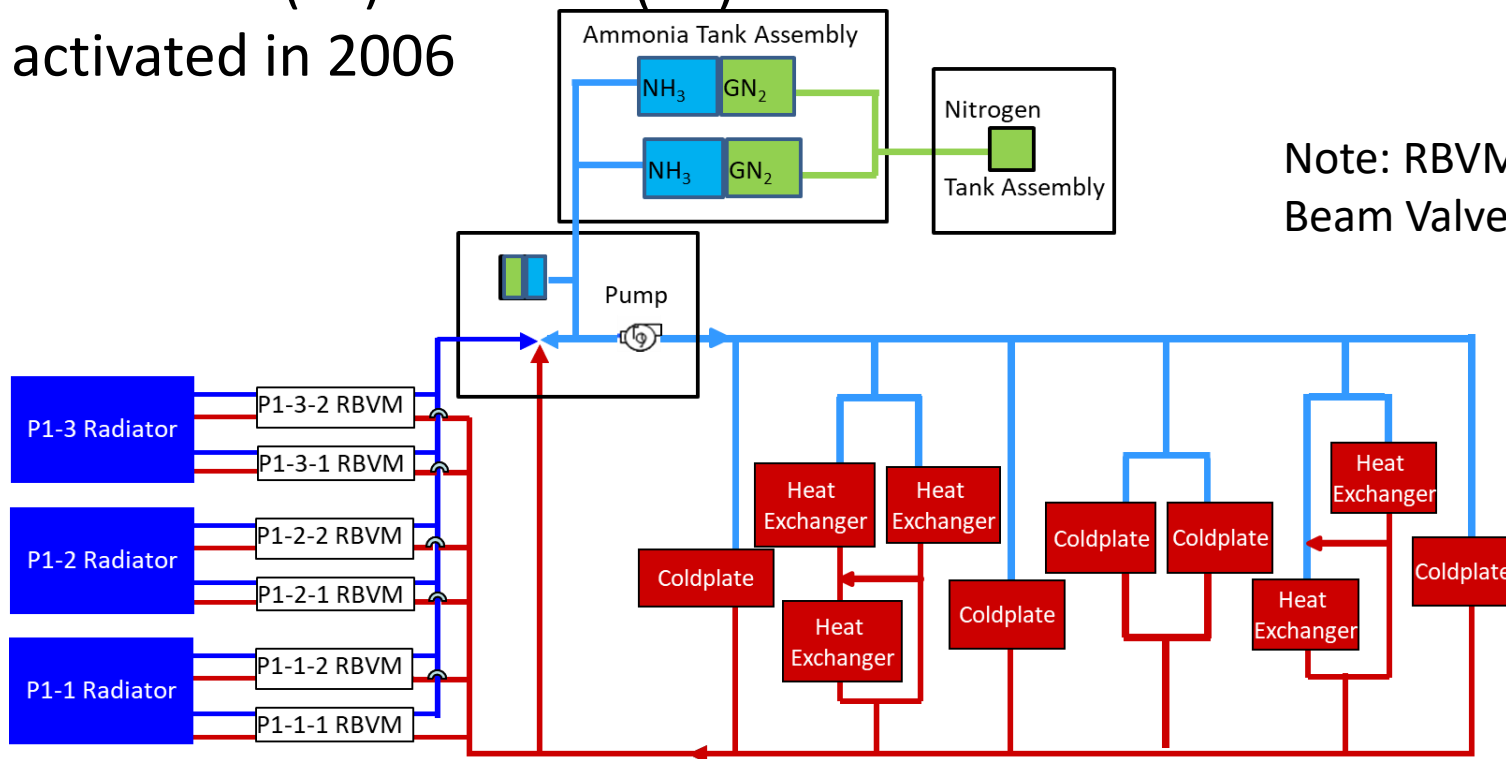
- EATCS - closed loop single phase system (two redundant loops)
- Mechanically pumps liquid ammonia to cool avionics, payloads and electronic equipment onboard the ISS
- Starboard (S1) and Port (P1) EATCS were launched in 2002, and activated in 2006

Note: RBVM= Radiator Beam Valve Module

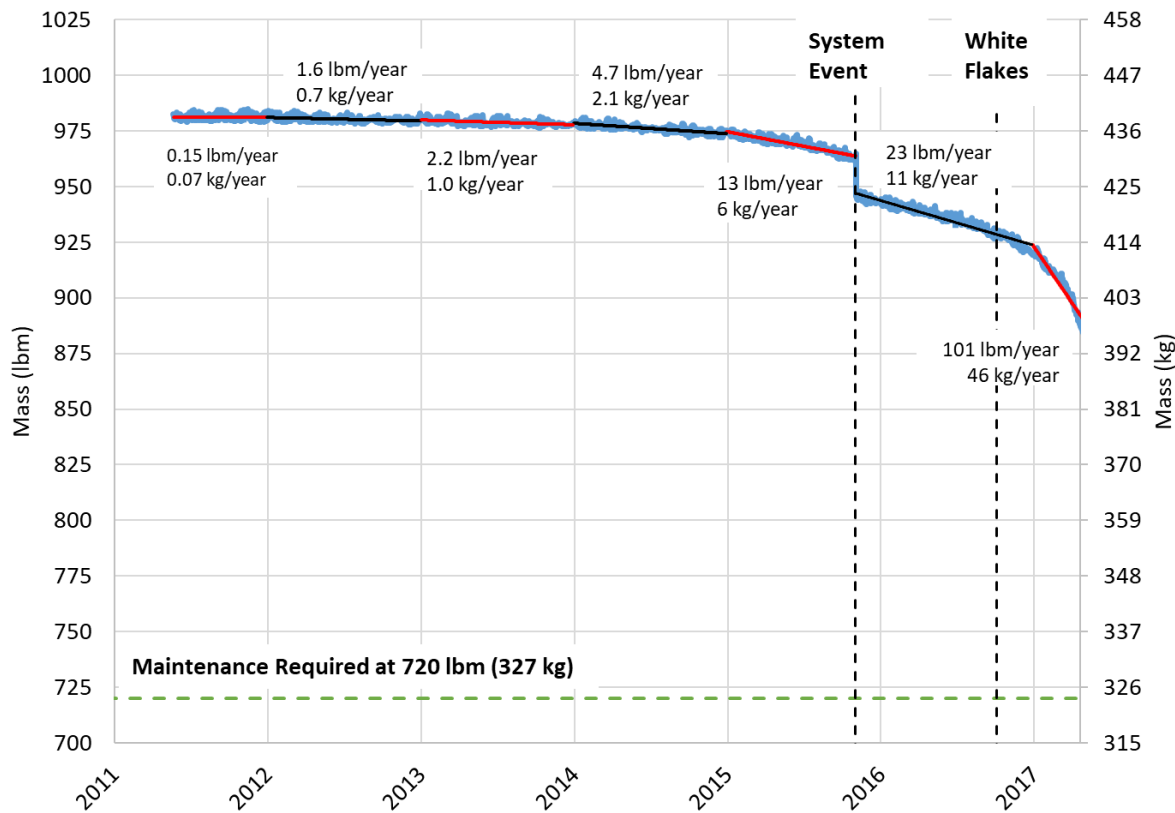
- The Problem: P1 EATCS -detected a coolant inventory decay in 2012,leak began to accelerate
- Cause/Location: Unknown at the time

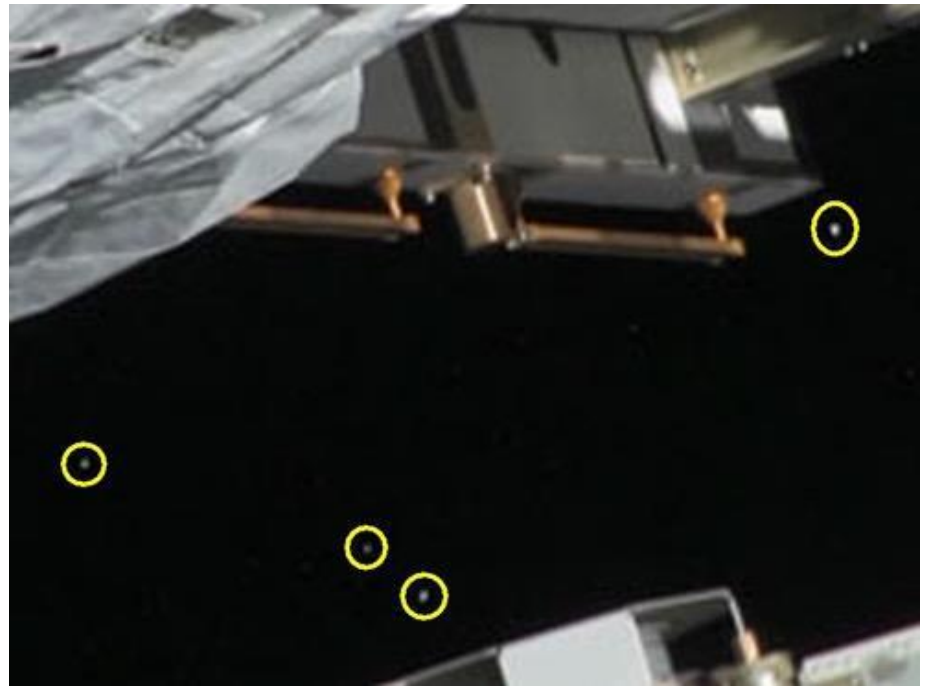
- In early 2016, began observing mysterious “white flakes”, on the P1 external high definition cameras as the leak rate approached 30 lbm/year (13.6 kg/year)
- Uncertain if related to ammonia leak, what else could they be?
- Leaks that produce visible particles or flakes typically thought to be > 50 lbm/day
- Flakes were sporadically seen moving across camera field of view seeming to come from a common location
- Lack of depth perception made it difficult to estimate possible originating locations

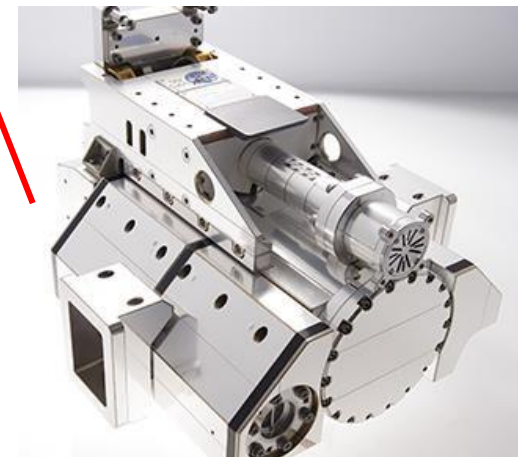
RELL Unit

- Detect molecules up to 100 atomic mass units (amu)
- Measure pressures from standard atmosphere to $\sim E^{-12}$ torr
- Cold Cathode Ion Gauge measures total pressure
- Residual Gas Analyzer (mass spec) measures partial pressure of range of amu
- Pressure measurements are directional in space environment

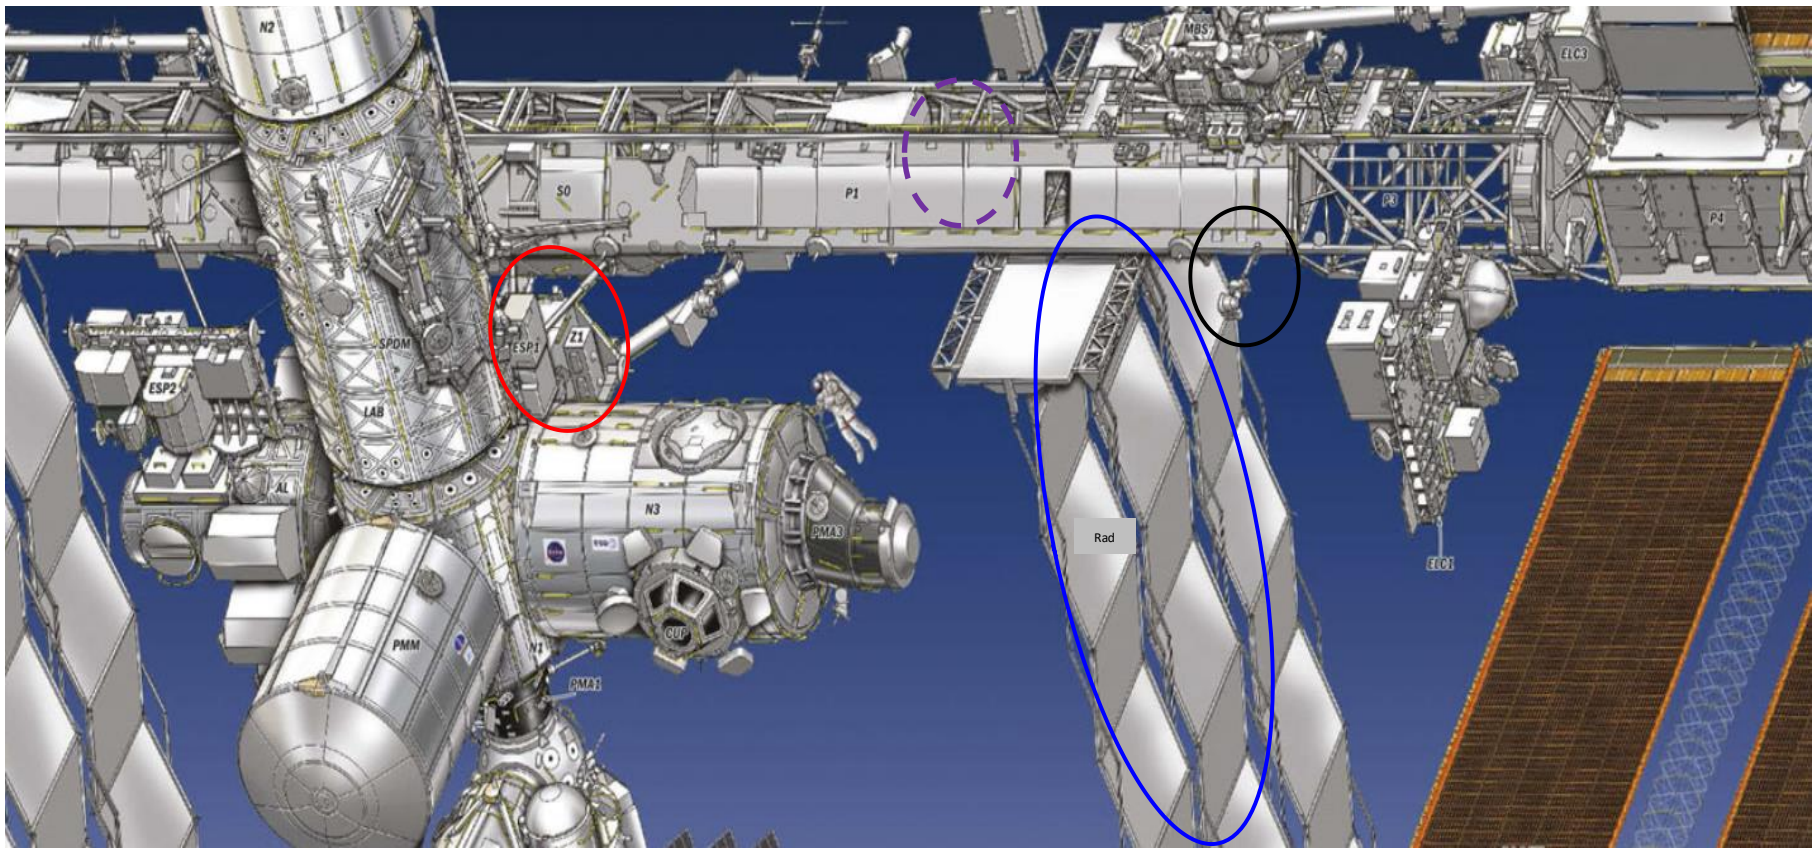
Possible White Flakes Sources Locations

- P1 EATCS Radiators circled in blue, Z1 (decommissioned) and a spare Pump Flow Control Subassembly (PFCS) circled in red, P1 EHDC circled in black, ATA behind structure (dotted purple)

- Demonstration Scans
 - ISS background (natural atmosphere, ISS vents and outgassing)
 - Pressures measured $\sim E^{-12}$ to E^{-8} torr
- P1 EATCS leak and white flake scans
 - Z1, PFCS, ATA
 - No significant ammonia signature present ($\sim E^{-8}$ to E^{-7} torr)
 - P1 EATCS Radiator Beam Valve Modules (RBVM)
 - **Significant ammonia signature pressure**

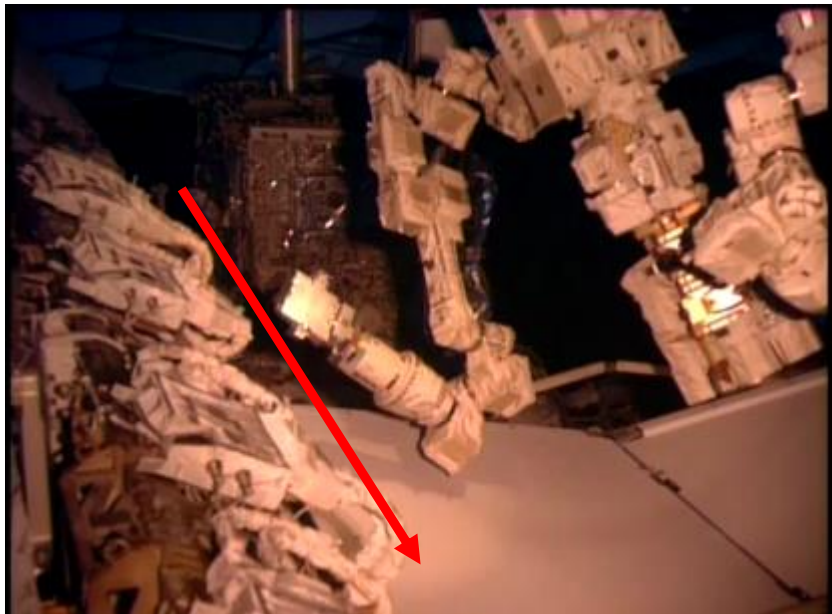
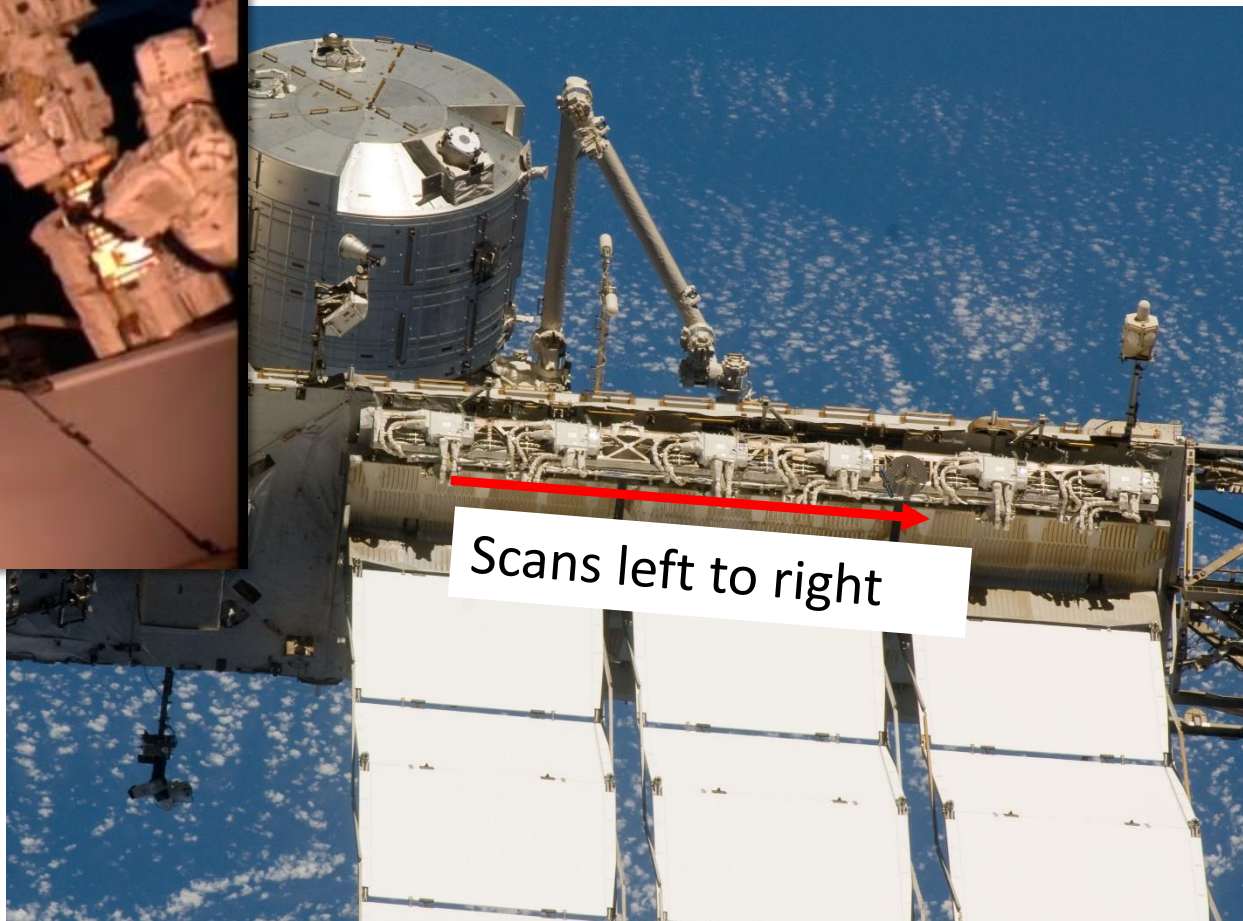
RELL Scan Locations

- P1 ISS EATCS Radiator Beam Valve Modules

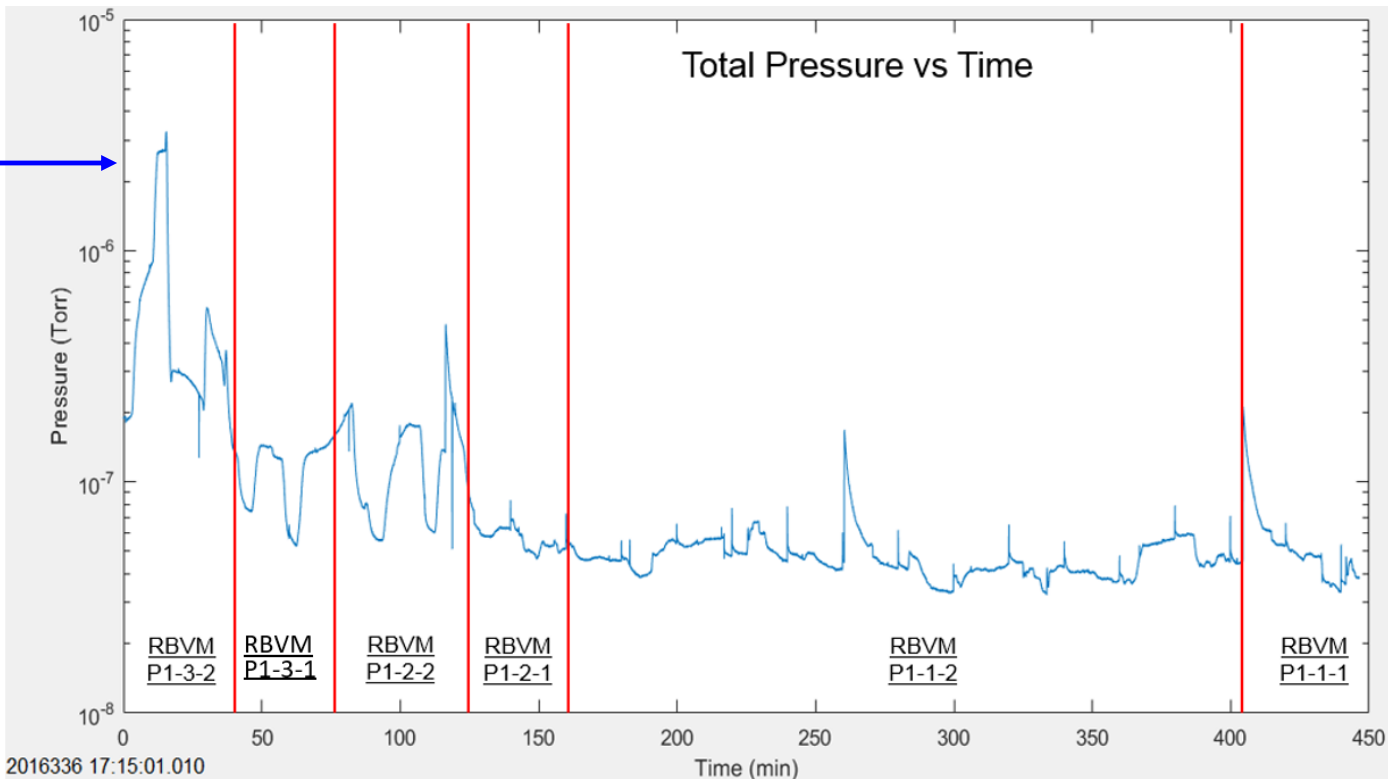
- Noticed total pressure spike at P1-3-2 RBVM on order of $\sim 5E^{-5}$ torr
- Low levels of ammonia around other RBVM $\sim 5E^{-7}$ torr
- Partial pressure from RGA correlated with ammonia

Scan
Direction →

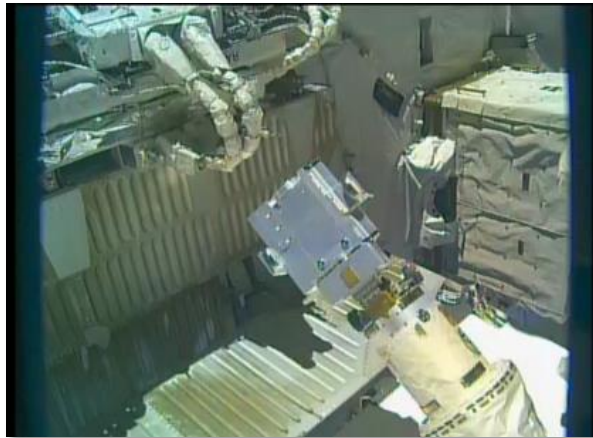
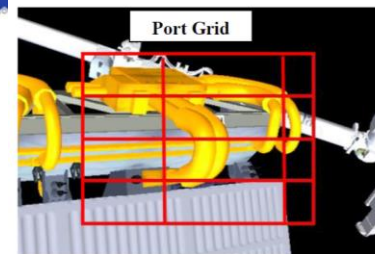
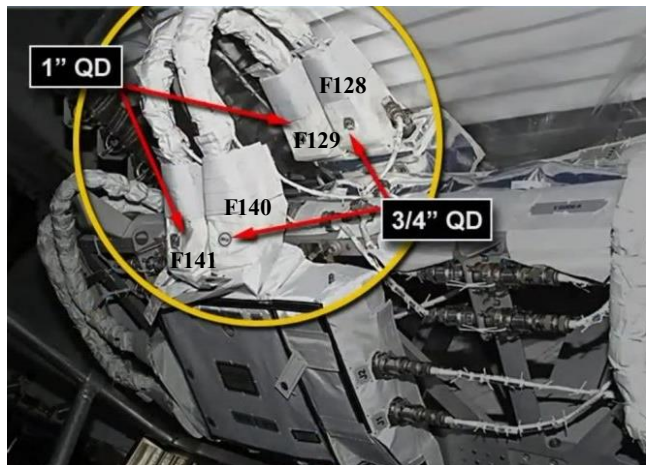
Focused RELL Scans – P1-3-2 RBVM

Highest Pressures @ P1-3-2 RBVM to the radiator jumper hoses, and the hard lines underneath them

Pressures E^{-5} torr \sim 50 lbm/year (22.6 kg/year)

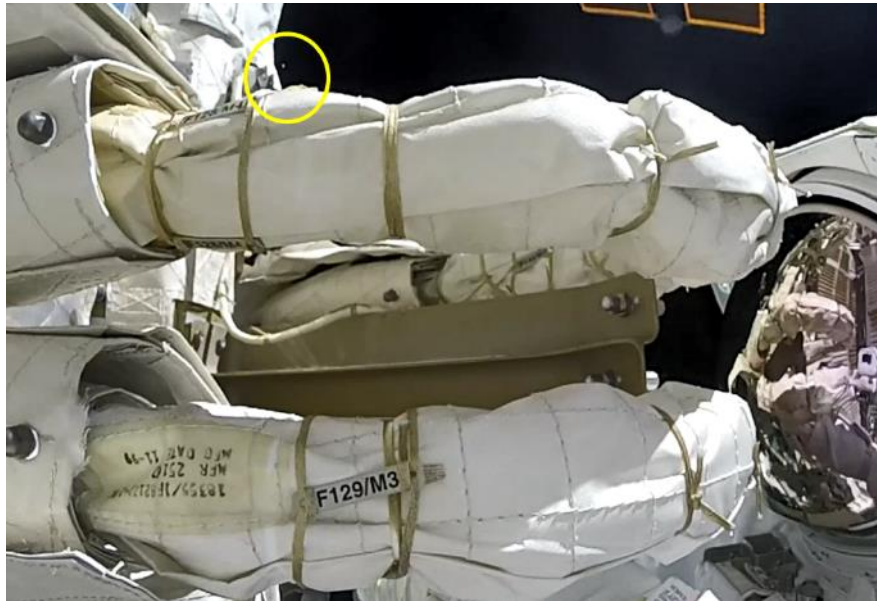
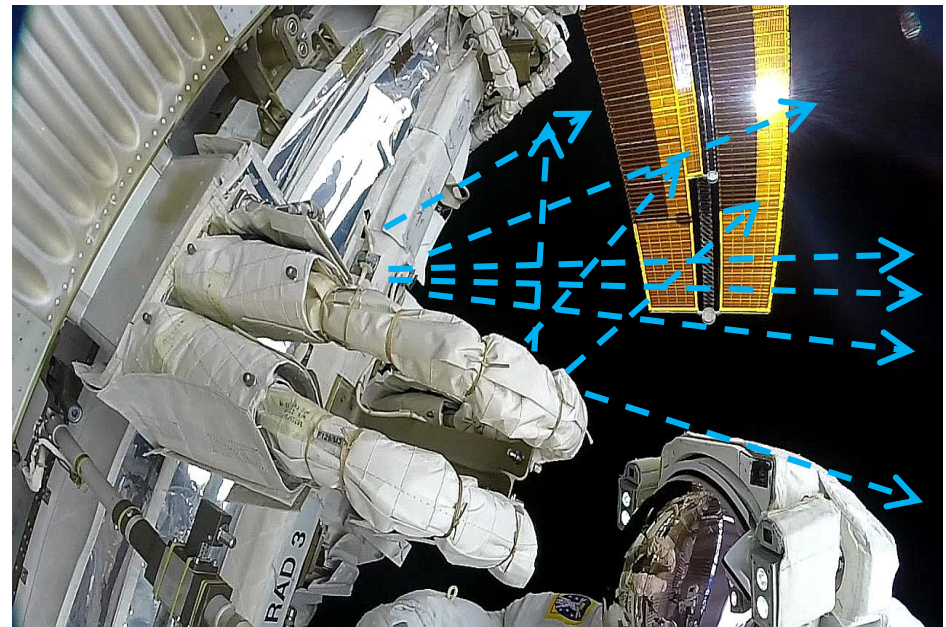
Extravehicular Activity (EVA) Jumper Inspection

- Inspections of the RBVM jumpers hoses and system lines performed during an EVA in March 2017
- Nothing noteworthy observed from the crew
- Post EVA review, multiple white flakes seen from EVA GoPro video

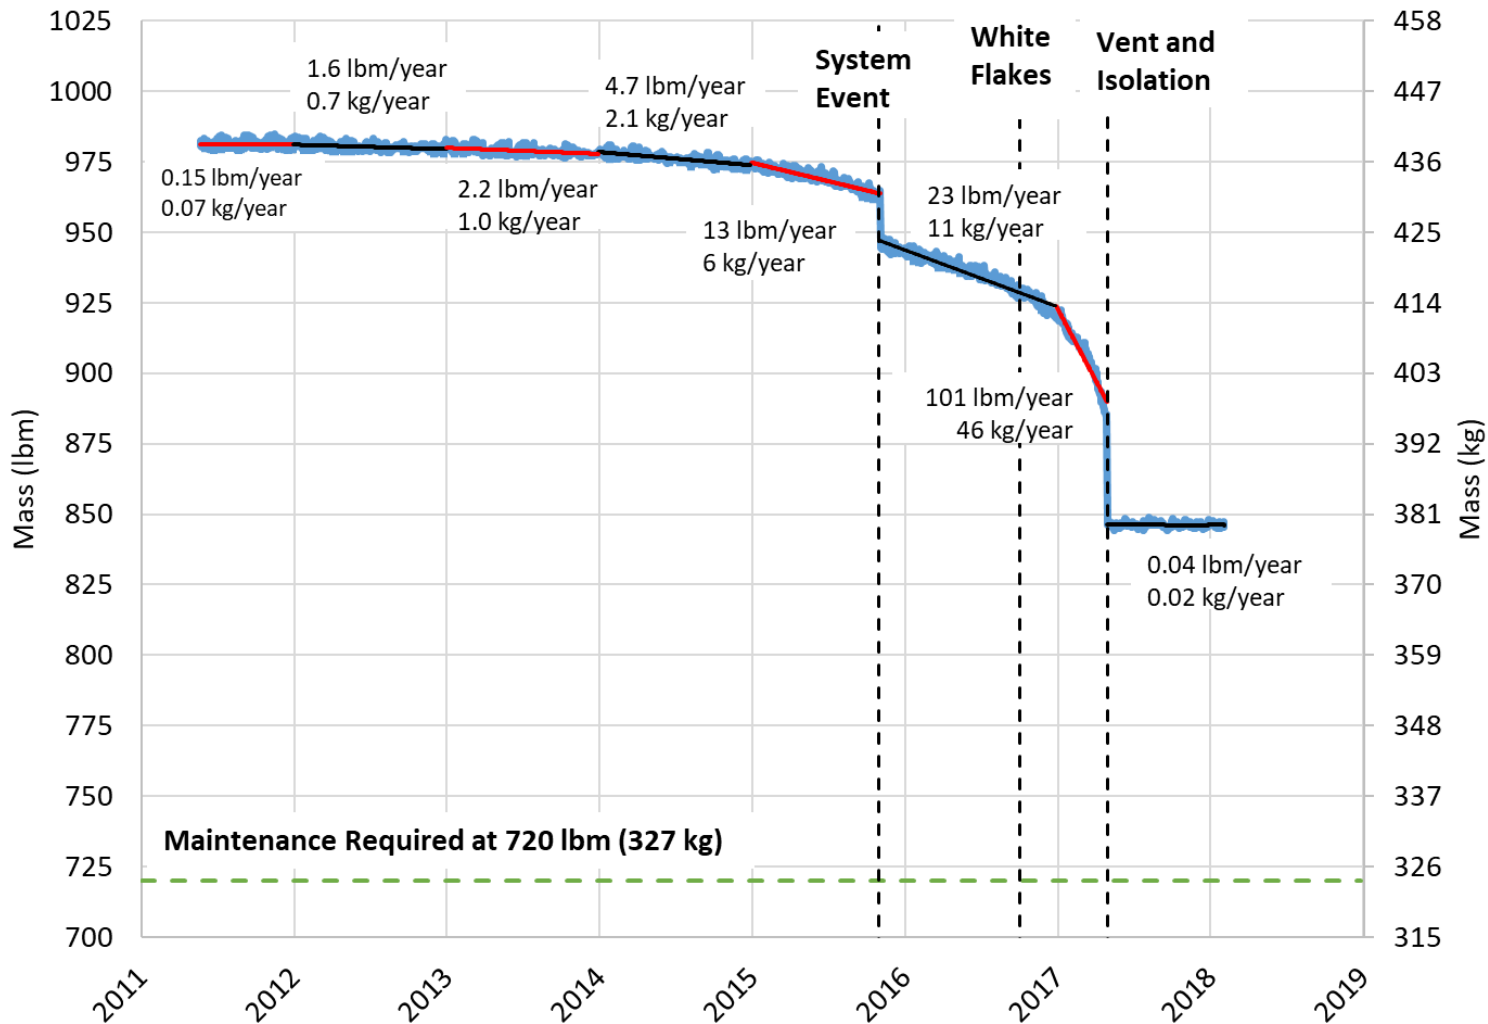
Leak Stopped

- Following the EVA in May 2017, ground command remotely closed the RBVM to the P1-3 radiator; isolating that flow path
- Ammonia was vented to space, stopping the leak
- White flakes have not been observed since and subsequent mass plots show the leak stopped

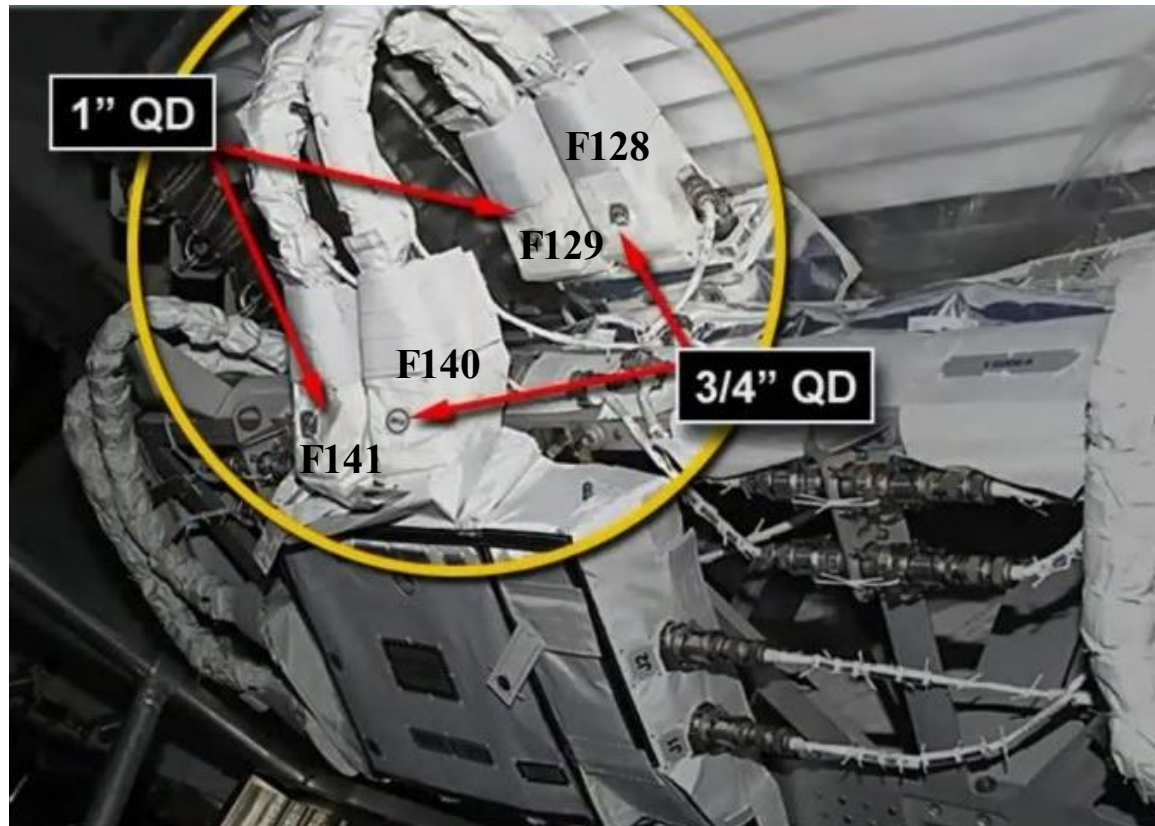
- Most likely leak source - RBVM jumper hoses rather than the hard lines underneath them
- ISS Program agreed to remove the RBVM hoses and returned them to the ground for investigation
- Hoses removed during an EVA in March 2018, and return to the ground in May 2018

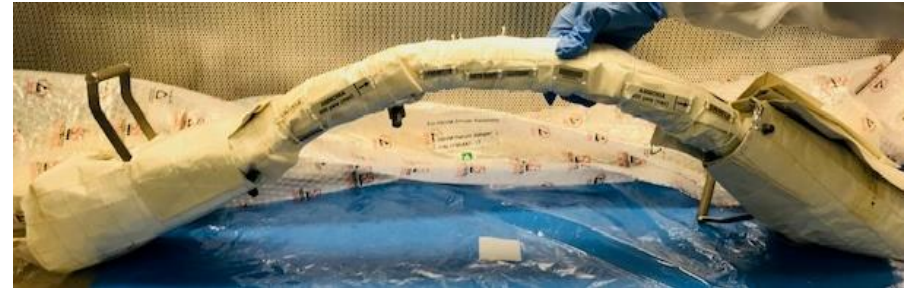
Jumper Assembly

- 1" supply and 3/4th return hose
- Each hose contains two female Quick Disconnects (QD)
- Each QD contains multiple seals
- Some seals are not visible without significant QD disassembly

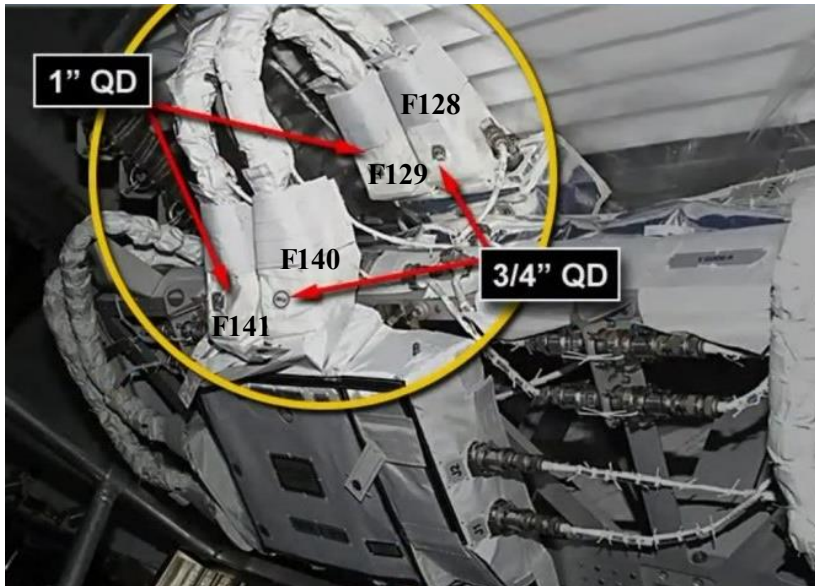
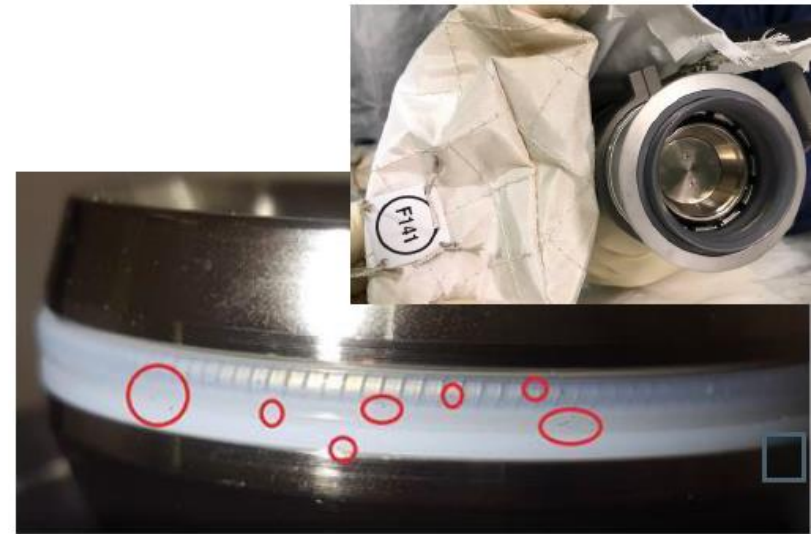
F141 QD secondary seal

- Inspection shows the 1" supply hose looked good
- Barely failed Leakage requirement of 1 E^{-4} sccs of Helium at 500 psia (3447 kPa)
- Considered acceptable to be reused "as is", and returned to the ISS in April 2019

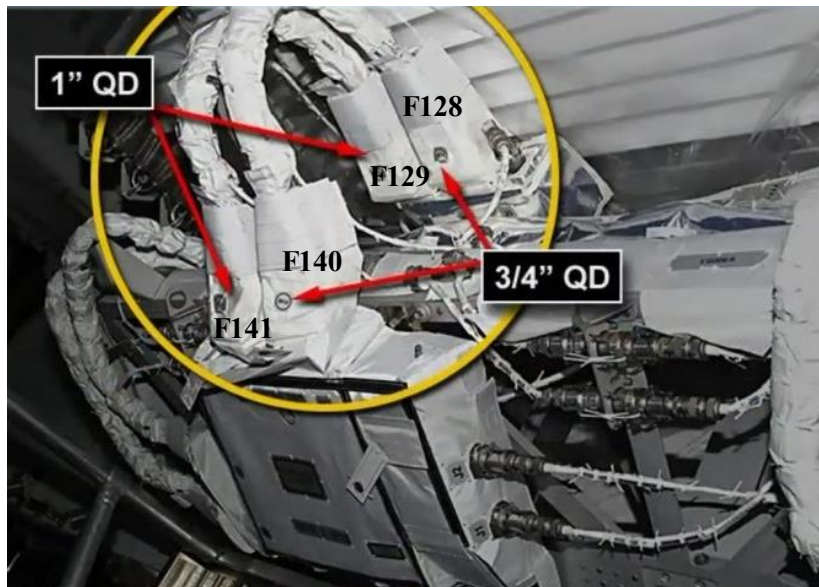
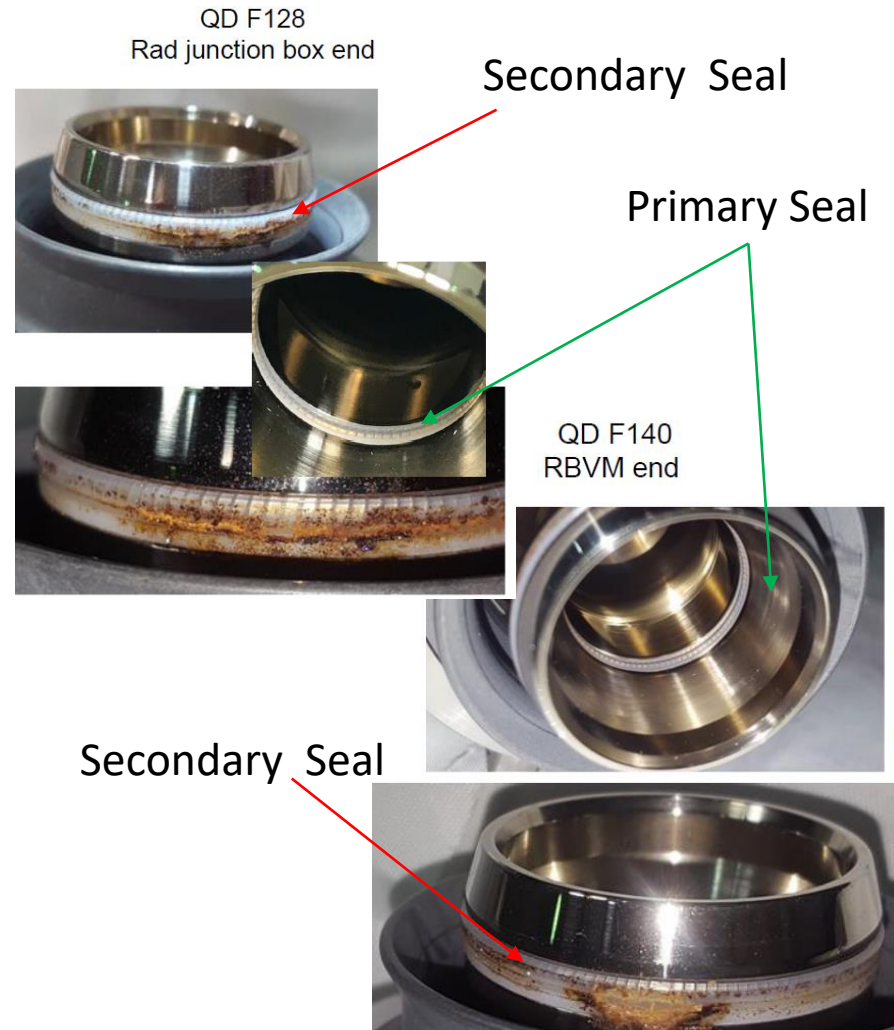
- The 3/4" return hose – not so good
- QD F140 failed the leakage requirement at $2.8E^{-3}$ sccs of Helium at 500psia (3447 kPa)
- QD F128 failed the leakage requirement at 1.91 sccs of Helium at 500 psia (3447 kPa)

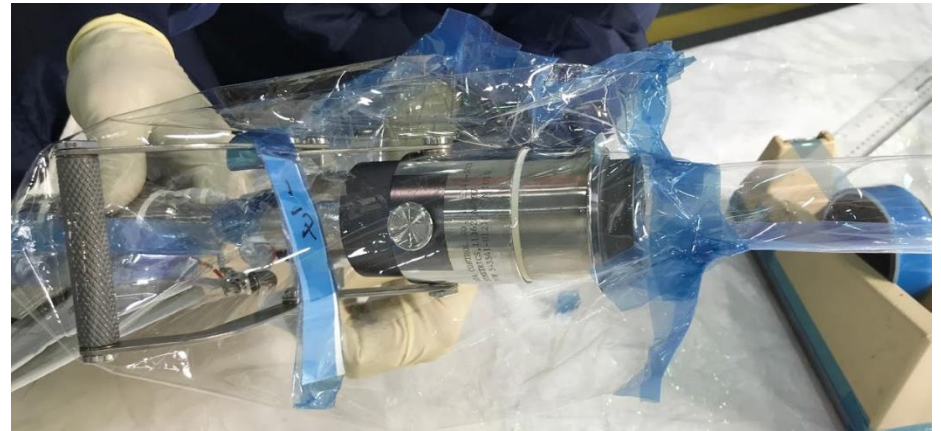
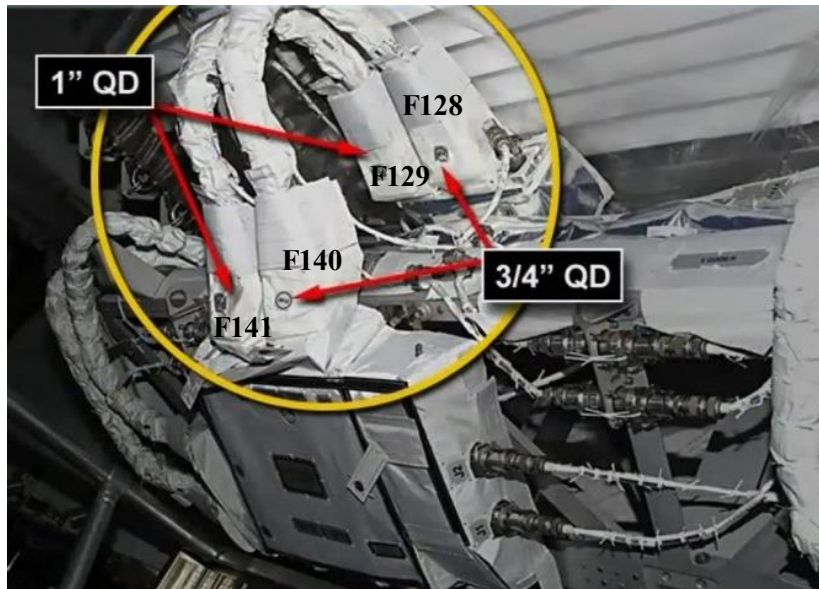
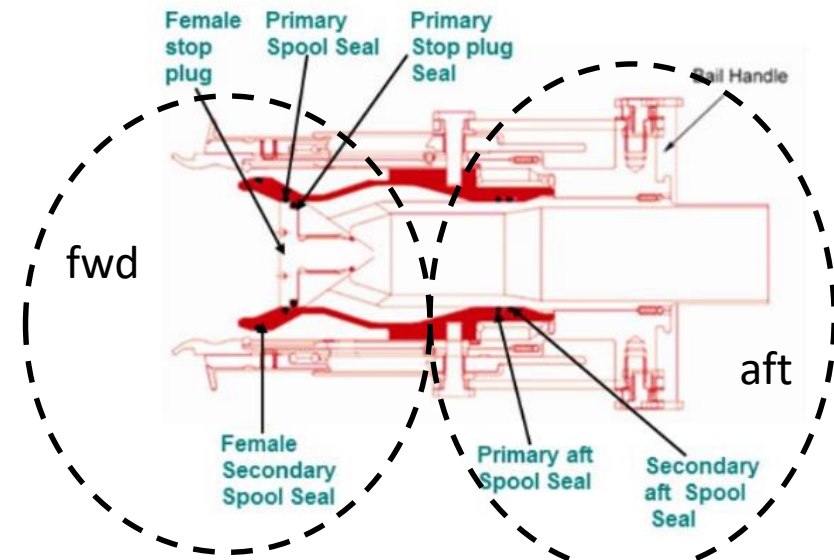
- Forward half QD F128 failed the leakage requirement at **2.2E-1 sccs** of Helium at 500 psia (3447 kPa)
- Aft half failed at **0.5 sccs** of Helium @ 500 psia (3447 kPa)
- QDs removed for additional TT&E
- New QDs installed, hose assembly launched to the ISS in April 2019

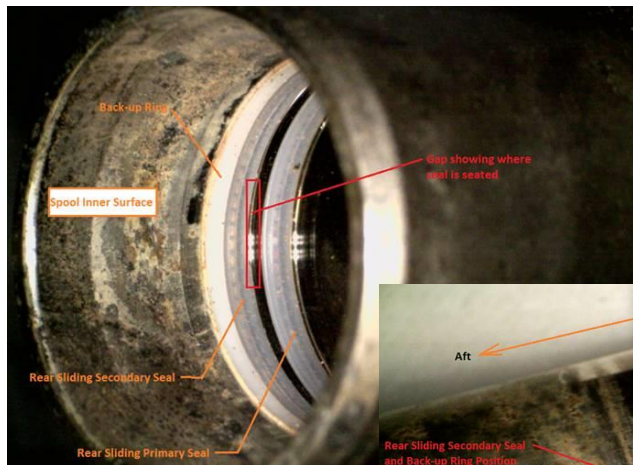
QD F128
Spool

- Appears aft spool seals of QD F128 were responsible for the majority of the P1 EATCS leak
- Further analysis of the deposits and examination of surfaces is planned in the near future

- The ISS P1 EATCS had a slowly increasing ammonia leak, and white flakes were observed from the ISS video cameras
- RELL narrowed down the source of the leak to the P1-3-2 RBVM supply and return jumper hoses
- Hoses and radiator flow paths were isolated, and vented of ammonia; stopping the leak
- White flakes have not been observed since
- Hoses returned to the ground, refurbished and relaunched to ISS
- Leak source – aft seals in QD F128 (radiator end) on the ¾” return hose
- Further evaluation in work
