NASA/TM—2019–220135

Electron Beam Welding of Pure Tungsten Hex Cans for Nuclear Thermal Propulsion Engines

*Z.S. Courtright and K.M. Benensky
Marshall Space Flight Center, Huntsville, Alabama*

June 2019

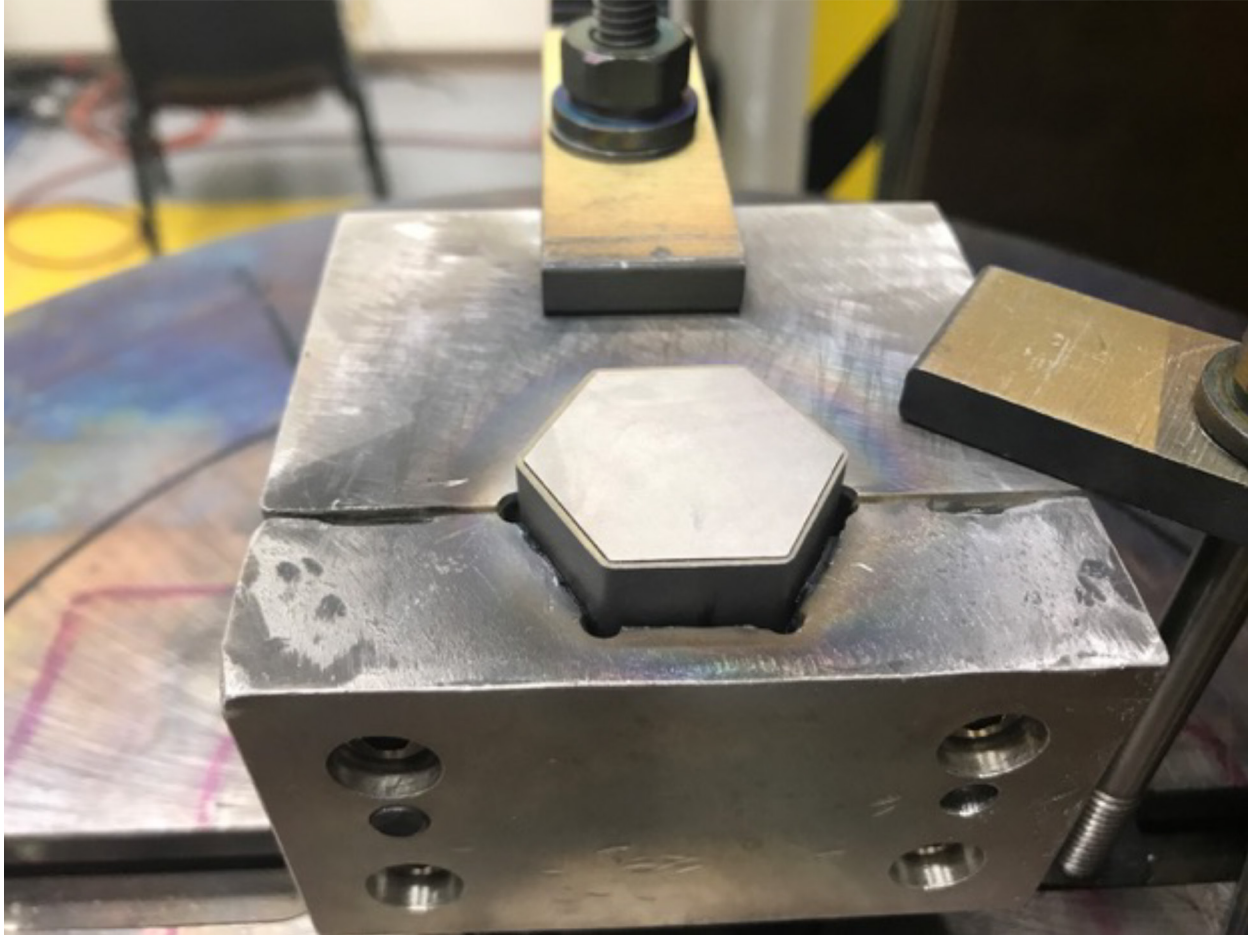
Figure 1. Image of EBW_Hex8 assembled in the EBW fixture prior to welding.

Following machining and labeling of each hex can assembly, each sample was wiped with acetone just prior to being set up in the EBW fixture. Each of the nine weld samples was welded with EBW in the setup shown in figure 1. The beginning samples used parameters similar to those developed with the flat plate welds. Those parameters were quickly established as inadequate, due to holes and cracks observed with visual inspection, so parameter development continued throughout all nine samples. Each sample had a variation in parameters compared to the last sample. This meant the experiment could only focus on parameter development rather than repeatability of an EBW.

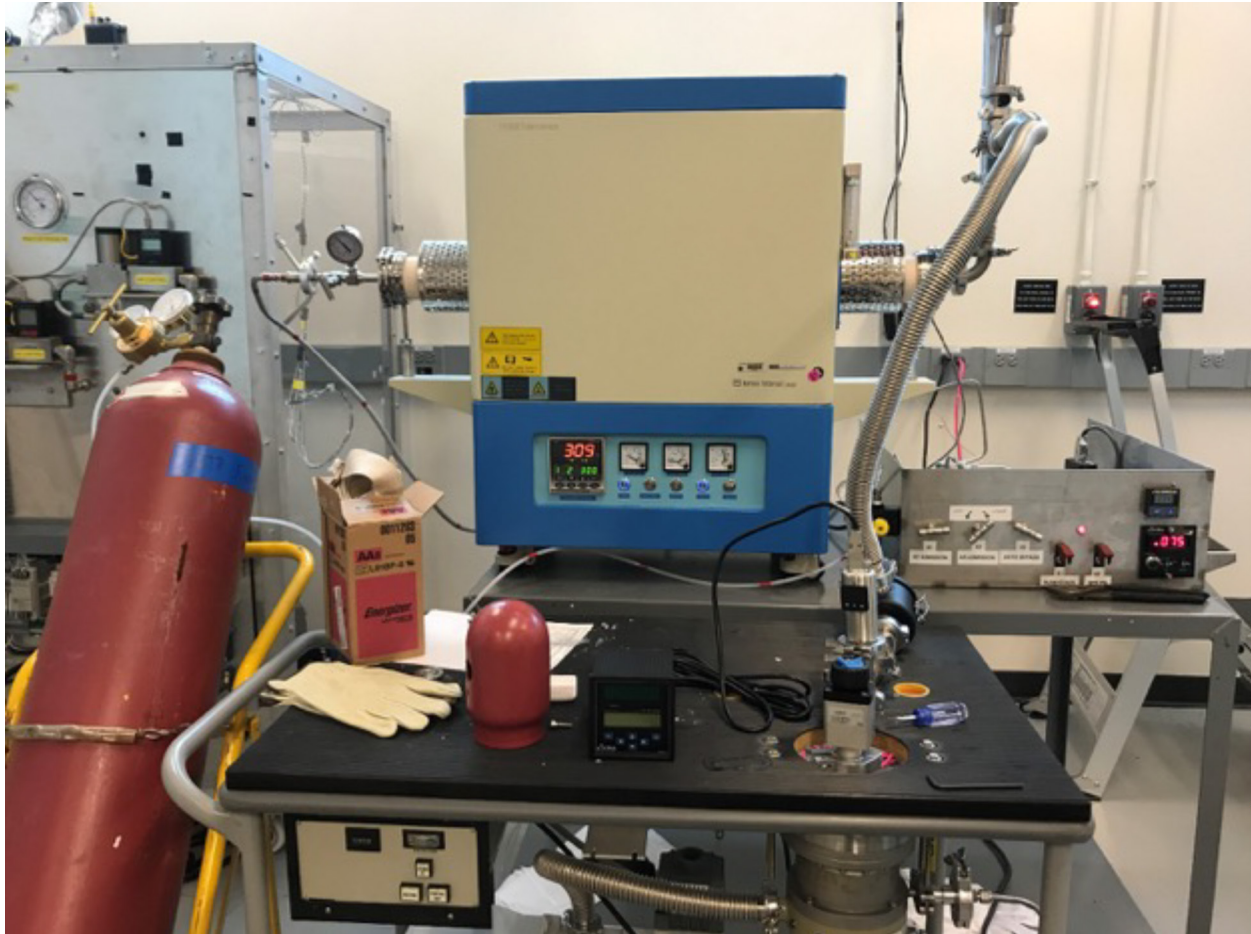
Figure 2. Oven used for PWHT of all pure tungsten hex cans.

The 'insulator box' was then transported by the welding engineer to an induction furnace for PWHT at 1400 °C, shown in figure 2. The induction furnace was then opened and the sample was inserted into the center of the furnace prior to following the furnace startup procedures to complete the PWHT.⁴ This PWHT lasted for up to 6 hours.

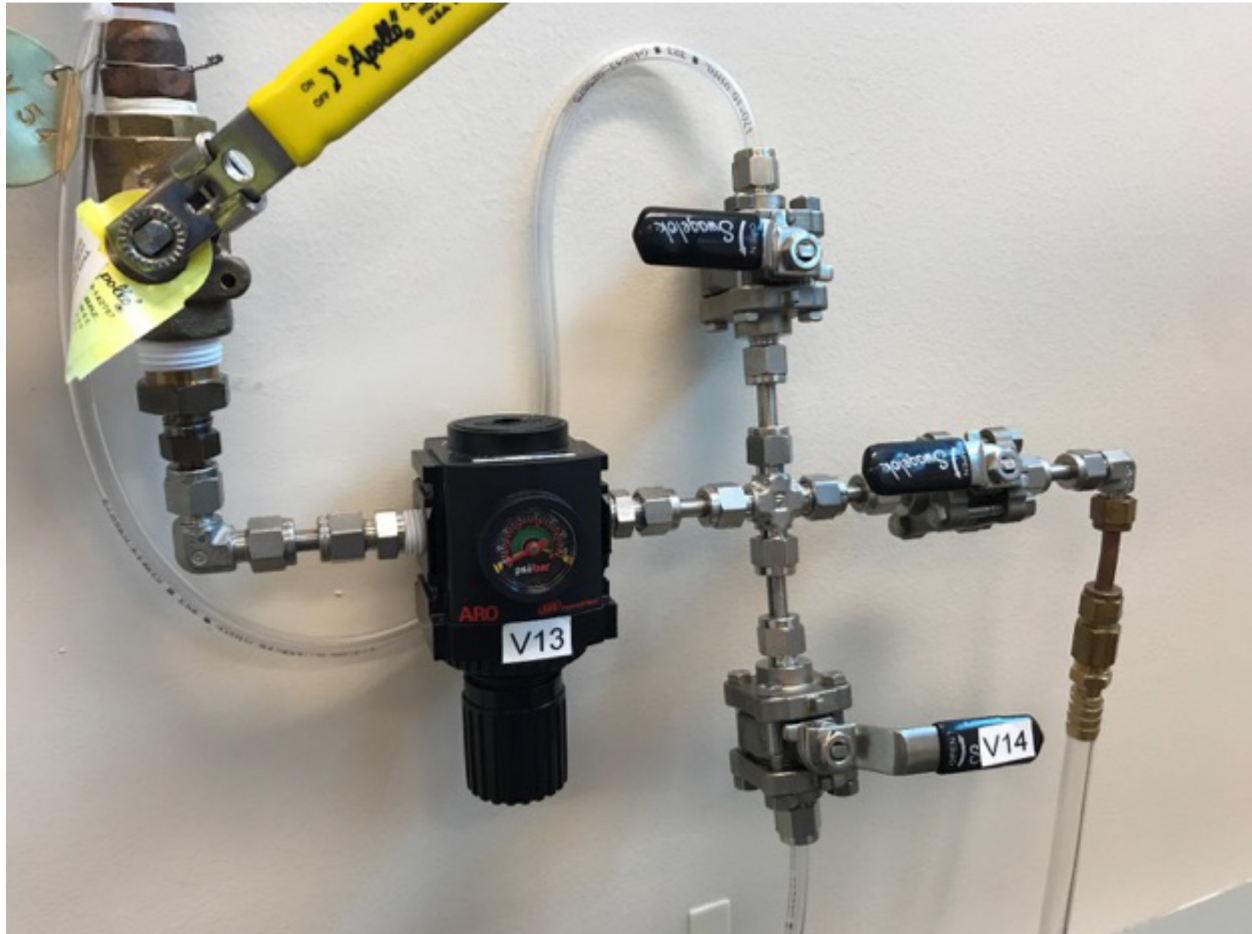
Figure 3. Regulator setup for pressure testing of the pure tungsten hex cans.

The following business day the sample was removed from the induction furnace and prepared for pressure testing. To prepare for pressure testing, an aluminum insert was made to fit into the open end of the hex can. This aluminum insert had a barbed fitting on one end that could easily be inserted into an air hose attached to a regulator. The regulator setup is shown in figure 3 and the aluminum insert, attached to EBW_Hex8, is shown in figure 4. Multiple methods were used to ensure that the fitting and hex can had an airtight fit-up. Initial pressure tests used teflon tape and electrical tape to attempt to create an airtight fit-up. This technique was not satisfactory. Instead, a low melting point polymer was applied to the insert/hex can interface by heating the polymer with a heat gun and spreading it across the interface. Once the polymer cooled, the sample was ready for pressure testing. Pressure testing was done by using air pressure on the inside of the weld joint while the outside of the weld joint was submerged in water.

It was found that the pressure regulator only became accurate above 5 psi. Therefore, all pressures held under 5 psi were subject to debate and weld parameters had to be repeated to ensure proof of a hermetic seal. The initial pressure testing was done by slowly opening the regulator valve to allow up to 5 psi of pressure to impinge upon the weld root. It was recorded if no bubbles were seen at this point. Then the regulator was opened to a point where 10 psi and then 20 psi was impinging upon the weld root. The formation of bubbles and the location that they came from within the sample was then recorded.

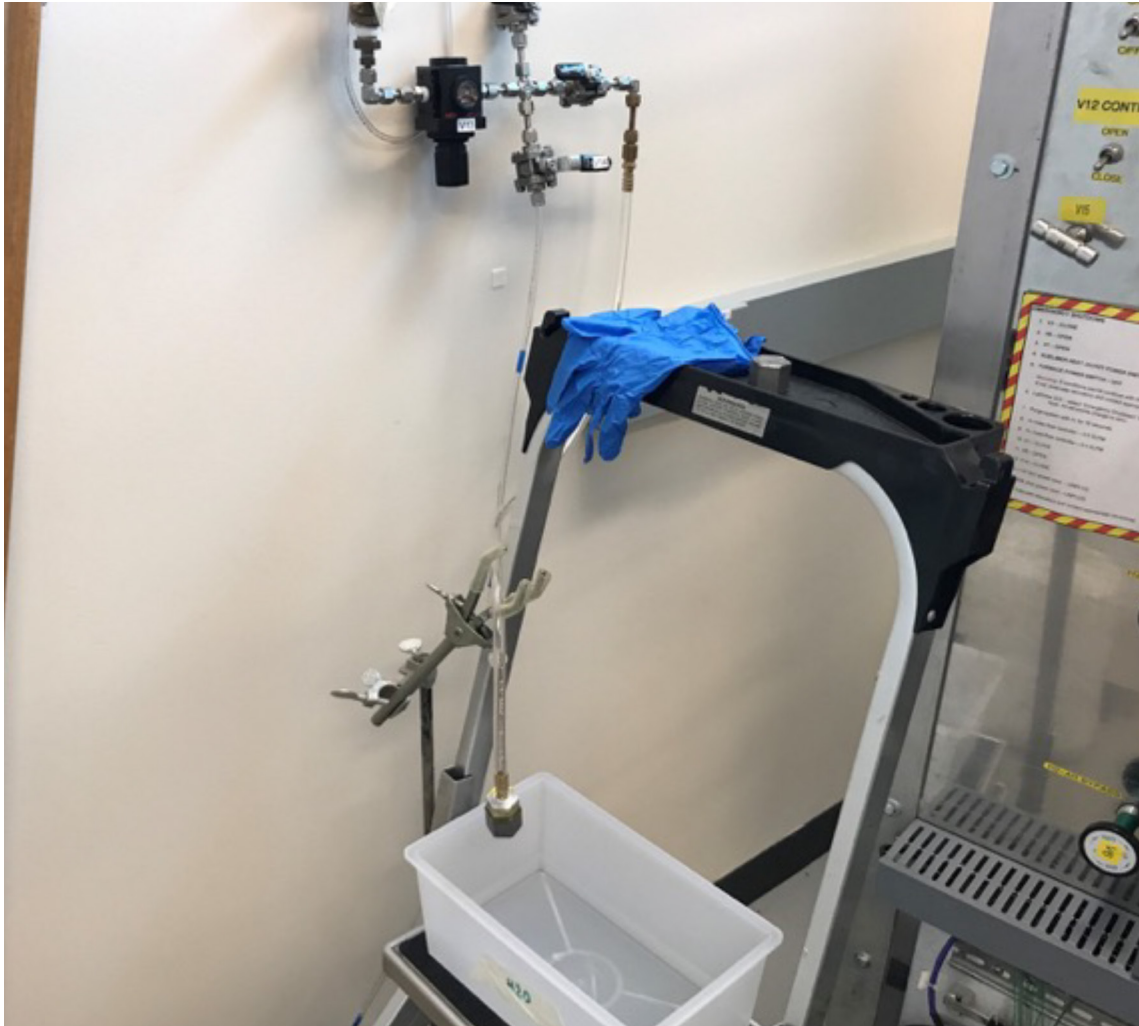
Figure 4. Pressure test setup with EBW_Hex8 attached to the pressure hose and aluminum hex fitting.

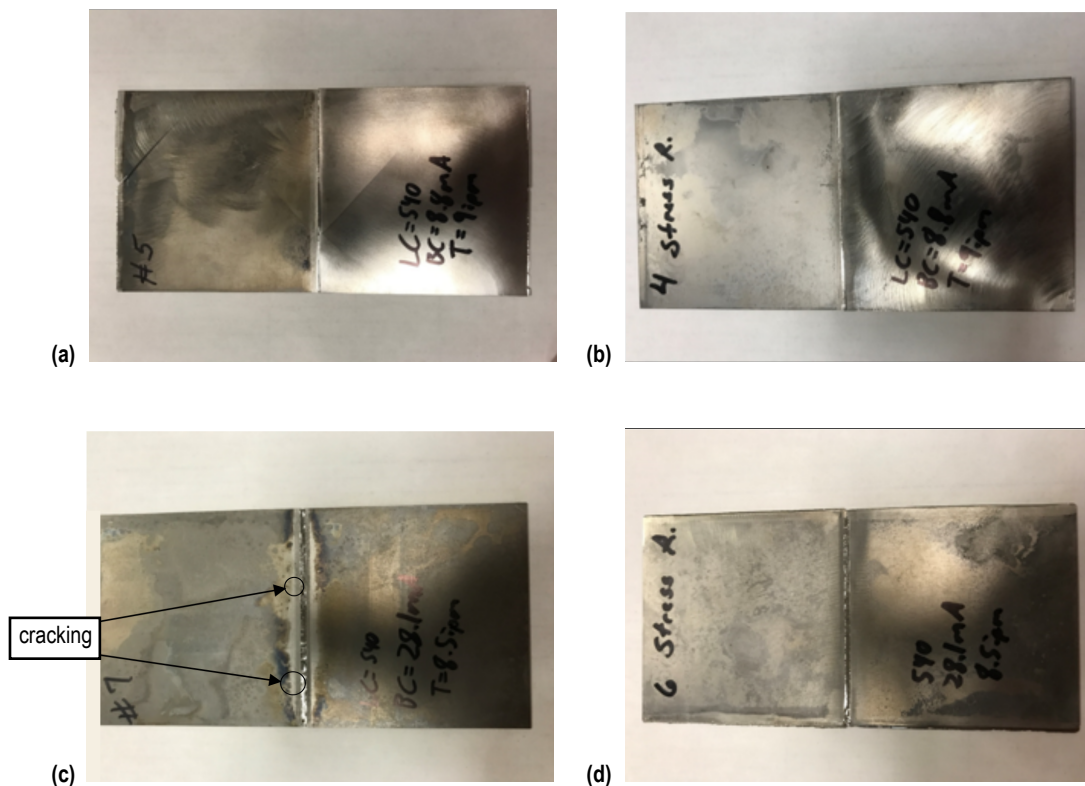
Figure 5. Images of electron beam butt welds on thin, pure tungsten plates: (a) 0.01-in tungsten with no PWHT, (b) 0.01-in tungsten with PWHT, (c) 0.03-in tungsten with no PWHT, and (d) 0.03-in tungsten with PWHT.

As evidenced by figure 5, both the 0.01- and 0.03-in-thick tungsten plates exhibited cracking when no PWHT was used. The cracking was much more evident in the thinner of the plates as shown in figure 5(a).

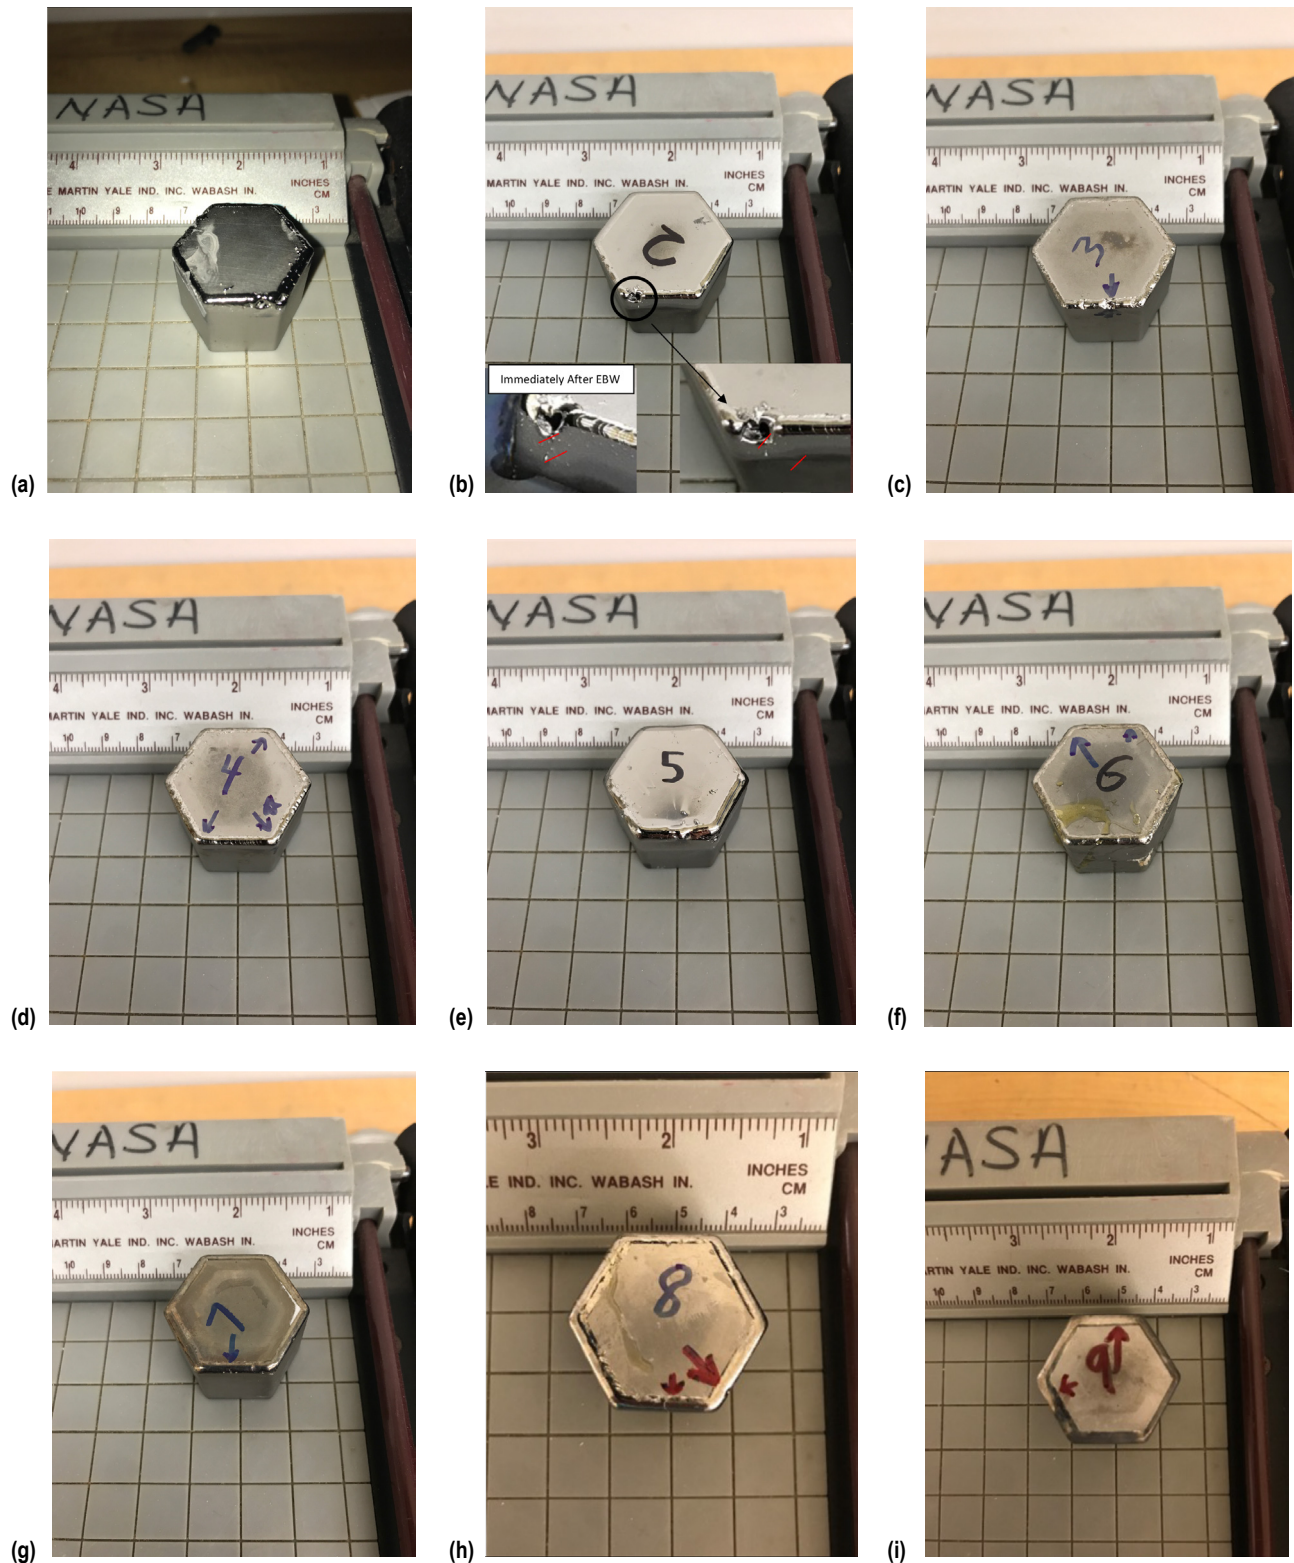
Figure 6. Images of all nine pure tungsten hex can samples: (a) EBW_Hex1, (b) EBW_Hex2, (c) EBW_Hex3, (d) EBW_Hex4, (e) EBW_Hex5, (f) EBW_Hex6, (g) EBW_Hex7, (h) EBW_Hex8, and (i) EBW_Hex9.

EBW_Hex1, shown in figure 6(a), was made using a hex can with a machining defect along the joint interface. The defect was small and located on one of the corners of the hexagon. Issues with the weld path program led to a need to run the preheat pass three times to ensure that the path would run evenly across the weld joint interface. The heat input of the weld was too high and resulted in burn-through which is easily observed in the side wall of the hex can shown in figure 6(a). The holes were located both on the straight portions and on the corners of the hexagonal weld joint, indicating that the machining defect on the joint interface on the hex can was not the only portion of the weld interface subject to burn-through. The holes were all located on the side wall rather than on top of the hex can, which may have been caused by excessive focus of the electron beam on the outer edge of the weld joint or due to the fact that the hexagon was made from plasma-sprayed tungsten and the hex cap was made from a solid tungsten sheet. Although holes were present, a PWHT was still performed to ensure that the PWHT cycle was correct. PWHT was done in a hydrogen atmosphere after the furnace chamber was purged with argon to reduce oxygen levels to prevent oxidation. After the PWHT, a visual inspection was performed and found no evidence of cracking. This indicated that residual stresses were relieved evenly during the PWHT so brittle fracture did not occur.

The initial weld pass for EBW_Hex2, shown in figure 6(b), was too hot and resulted in immediate burn-through causing an emergency stop in the weld after 1 s. After this, another six attempts were made to seal the hole, none of which were successful. The second attempt used a lower beam current than the first and was aborted halfway through the weld cycle because it generated a large amount of surface porosity. The third attempt used a much lower beam current than the first attempt and a higher focus current which helped to partially defocus the beam. This attempt went along the full weld path and the heat input was too low to fully melt the weld joint. The fourth attempt used a beam current 1 mA higher than the third attempt and improved surface appearance in the entire weld aside from the initial burn-through. Attempts five and six also improved surface appearance and attempt seven closed all surface porosity but was unsuccessful in closing the burn-through. No PWHT was done for this sample because it exhibited a large burn-through hole, thus inhibiting it from holding pressure. Cracks propagating from the hole and one of the corners of the weld became visible after the sixth weld attempt and were likely due to excessive heat input causing a thermal gradient which led to high residual stresses along the corners of the weld and along the burn-through defect. These cracks grew and others, which were not observed during visual inspection, appeared over the course of a week and may be attributed to the lack of PWHT. An example of this is shown in the images on the bottom of figure 6(b). The image on the left was taken immediately after welding and the crack was present but had not propagated well into the side wall. The image on the right is a magnification of the overall image and was taken days after welding had been completed. This image showed greater propagation of the crack into the sidewall. Visual inspection 1 week after welding showed many more cracks and greater crack lengths than visual inspection immediately after welding. Photographic images were not optimal for showing the length, number, and size of cracks.

The weld parameters developed from the final weld pass in EBW_Hex2 were used to weld EBW_Hex3. EBW_Hex3, shown in figure 6(c), used a preheat pass, weld pass, and cosmetic pass. The cosmetic pass used the same parameters as the weld pass. After the weld, no holes or cracks were visible so a PWHT was performed. After the PWHT, a pressure test was performed using the pressure test setup shown in figure 4. As soon as the pressure was raised above 0 psi, bubbles began to release from the surface of the weld joint. The bubbles came from one weld defect along the weld path that was located on one of the sides rather than on one of the corners of the hex can. This defect location is indicated with a blue arrow in figure 6(c), and appears to be surface porosity caused by a low weld heat input.

EBW_Hex4, shown in figure 6(d), was made with a slightly hotter weld pass than EBW_Hex3. After welding, the surface had some minor spatter and a few divots were located in the weld. Then, a PWHT was performed prior to pressure testing. One of the divots, located on one of the corners, leaked during pressure testing. This divot is identified by a blue arrow with a star next to it in figure 6(d). Then, as the pressure was increased to 10 psi, two more leaks appeared, both of which also came from corners. These two leaks are identified in figure 6(d) by the two blue arrows with no star next to them. The two worst leaks came from the corners where surface divots existed and became worse due to the propagation of cracks upon pressure testing. (Prior to pressure testing, no cracks were evident.)

Similar to EBW_Hex2, the initial parameters used for EBW_Hex5 resulted in immediate burn-through at the beginning of the weld. This sample, shown in figure 6(e), was then used as a test sample to see if high heat input could seal the hole. Each attempt to seal the hole was run at a higher heat input than the previous attempt. After eight unsuccessful attempts, a preheat pass was run to redistribute the thermal stresses from the previous passes. Next, an attempt was made to fill the hole with a small piece of tungsten and another weld pass was run with a beam current of 23 mA. The small tungsten piece was melted in place but did not fully seal the hole. The heat from the repeated cosmetic passes greater than 24 mA led to significant sidewall cracking (propagating from the large hole and the corners of the hex can). The formation of these holes and cracks led to a reassessment of the welding procedure. It was then decided that a rotating beam pattern may help distribute heat evenly, resulting in a better weld appearance. The rotating beam pattern parameters, used on EBW_Hex6, were used on all of the remaining weld samples. No PWHT was done on this weld because the through-hole was not fully filled and extensive cracking was present.

EBW_Hex6, shown in figure 6(f), used the new beam parameters of beam pattern 5, frequency of 20, x amplitude of 5, y amplitude of 5, and rotation of 5. This weld incorporated, in chronological order, a preheat run, a hot preweld pass, a weld pass, a rerun at the preheat parameters, a cosmetic pass, and finally another pass with the preheat parameters. The use of a preheat pass between the weld pass and cosmetic pass and after the full weld sequence was to avoid the formation of high residual stresses and prevent cracking during the weld sequence. The preweld pass, first used in this weld sample, was added to slightly melt the weld joint so heat distribution during the weld pass would be more uniform. This was also added to potentially increase the ductility of the weld to prevent cracking.⁷ During PWHT, the lack of a visible hydrogen flame in the burn stack of the induction furnace caused the welding engineer to decide to use argon as the inert atmosphere in the furnace rather than hydrogen. This is believed to have no effect on weld stress relief.

EBW_Hex7, shown in figure 6(g), used a preweld pass to increase ductility like EBW_Hex6. This resulted in a more uniform weld but surface porosity was still observed. Also, since the weld path involves some overlap of the start and stop points, along a corner, a small region of the weld joint had higher heat input than the rest of the weld. This resulted in a slight divot in that region, which did not leak during pressure testing. Although this spot did not leak during pressure testing, it is still a region subject to stress concentration and therefore, in future experiments, the welding engineer suggests that this overlap region be located along one of the flat edges, rather than the corner, to help eliminate the formation of a high stress concentration. Since surface porosity was small, a PWHT was performed on this sample in an argon atmosphere like EBW_Hex6. Upon initial pressure testing of this sample, a surface pore in the weld on one of the sides of the hex can

began to leak. The location of this leak is indicated in figure 6(g) by a blue arrow. The leak began as soon as pressure was added and bubbling became rapid once a pressure of 20 psi was achieved. The only difference between this sample and sample 6 was a hotter weld pass. The surface porosity may have been a function of a machining defect or the weld parameters themselves. The preheat pass parameters were used to run an interpass both after the weld pass and cosmetic pass to help relieve residual stresses.

EBW_Hex8, shown in figure 6(h), used preheat and interpass weld cycles to maintain an even temperature gradient throughout the weld to prevent cracking caused by high stress concentrations during stress relaxation. Two very small porosity surface defects were observed in this sample (smaller defects than any of the previous samples) and surface defects did not appear to penetrate through the thickness of the weld. The preheat pass parameters were used to run an interpass both after the weld pass and cosmetic pass. After PWHT, pressure testing caused the sample to leak from two points in the weld surface: (1) A surface pore and (2) along the weld in a region where the weld bead appeared slightly cold or displayed some sort of temperature gradient; this region fizzled rather than bubbled. The region where fizzling occurred may have been attributed to microcracking. This sample, along with EBW_Hex6, exhibited the least amount of bubbling upon pressure testing.

EBW_Hex9, shown in figure 6(i), was initially planned to repeat parameters from EBW_Hex8 while only increasing the weld pass to 26 mA. An issue with the EBW machine caused the electron beam to shut off when the 26 mA weld pass was attempted. A preheat pass was rerun prior to attempting the weld pass a second time, and the problem persisted. This was attempted another two times at 25 and 24 mA and, in all cases, the electron beam shut off almost immediately after it turned on. It was then decided to run another interpass at the preheat parameters before putting the unwelded sample in an electrode drying oven at 121.1 °C. The sample was stored for 1 week while the EBW machine was fixed and tested on scrap tungsten to ensure that it functioned properly. Then, the weld cycle was attempted again, starting with a preheat pass and continuing directly into the weld pass at 26 mA. The orientation of the hex can was flipped so the region where the weld started was different than it was 1 week earlier. Next, an interpass weld at the preheat parameters was run, followed by a cosmetic pass at 24 mA, another interpass, and a final cosmetic pass at 25 mA. This final cosmetic pass was used because porosity was present after the initial cosmetic pass and it eliminated the porosity. Lastly, another interpass was run to relieve residual stresses and was followed shortly by the PWHT cycle used on the other samples. At some point between the final interpass and the end of the PWHT cycle, two sidewall cracks propagated from the weld. Both of these propagated from a straight portion of the weld and did not originate at any of the corners. Both cracks leaked during pressure testing. This led to the conclusion that the final cosmetic pass increased the heat input enough to cause brittle fracture due to higher residual stress and the brittle nature of tungsten.³⁻⁵ The results of this weld sample are subject to debate because of the 1-week gap in the weld cycle. Table 1 shows a basic form of the weld schedule used for EBW_Hex6 through EBW_Hex9. These weld schedules were subject to any aforementioned changes made during the welding process.

While these two factors made it difficult to produce a leak-tight weld, the visual weld quality clearly improved from EBW_Hex1 to EBW_Hex9. This is evident in figure 6 because EBW_Hex1–5 all had multiple surface defects that were large and EBW_Hex1, 2, and 5 all had through-thickness porosity easily observed in figure 6. EBW_Hex6–9 also had visual defects but they were small and it was not obvious that they penetrated through the thickness of the welds.

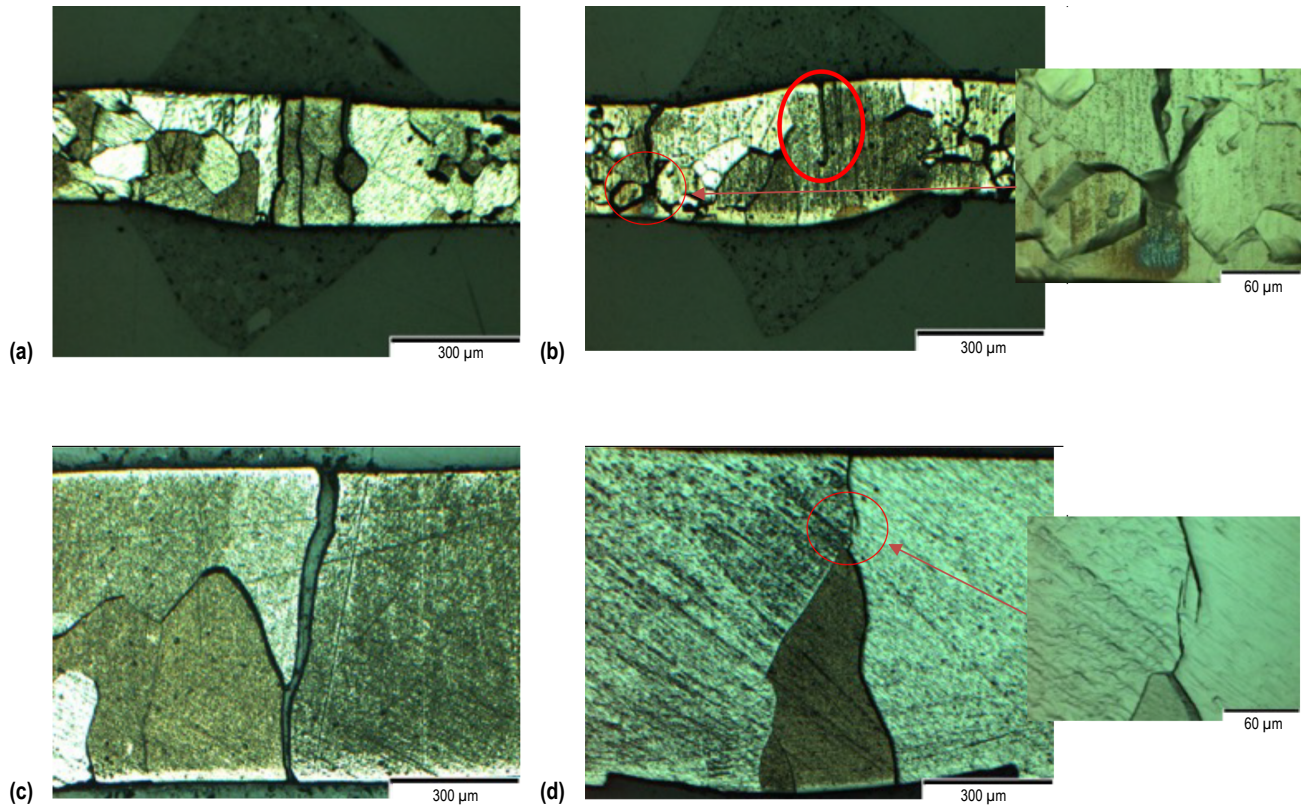
Figure 7. Images of metallography for EBWs joining pure tungsten plate: (a) 0.01-in sample without PWHT showing multiple through-thickness cracks, (b) 0.01-in sample with PWHT showing cracks with increased tortuosity, (c) 0.03-in sample without PWHT showing through-thickness crack, and (d) 0.03-in sample with PWHT showing cracks that did not propagate through-thickness.

Following PWHT, the eight total plate welds were etched and mounted for metallographic analysis and a brief overview of the metallurgical results is shown in figure 7.

Images of metallography from the flat plate samples shown in figure 7 reaffirm that the PWHT helped to reduce through-thickness cracking. The only variation between the samples shown in figure 7(a) and (c) and figure 7(b) and (d) is that the images shown in figure 7(b) and (d) were PWHT at 1037.78 °C within 1 hour after welding commenced. The metallurgical images in figure 7 all show some sort of intergranular cracking and large grain sizes. The samples with no PWHT displayed through-thickness cracks, as shown in figure 7(c) where the crack clearly propagated through the plate and opened up slightly, while the samples with PWHT showed cracks which arrested prior to propagating through the full thickness of the weld. Figure 7(d) displays a 0.03-in sample with a crack that propagated towards an intersection with another crack and, when observed more closely, the crack is not 100% continuous through the thickness of the plate. The 0.01-in samples shown in figure 7(a) and (b) also displayed a variation in the propagation of

cracks through the full thickness of the weld. The image in figure 6(b) shows multiple regions where cracks formed without propagating through the weld completely while the image in figure 6(a) shows multiple through-thickness cracks. This helps indicate that PWHT helped to arrest cracks and prevented through-thickness cracking.

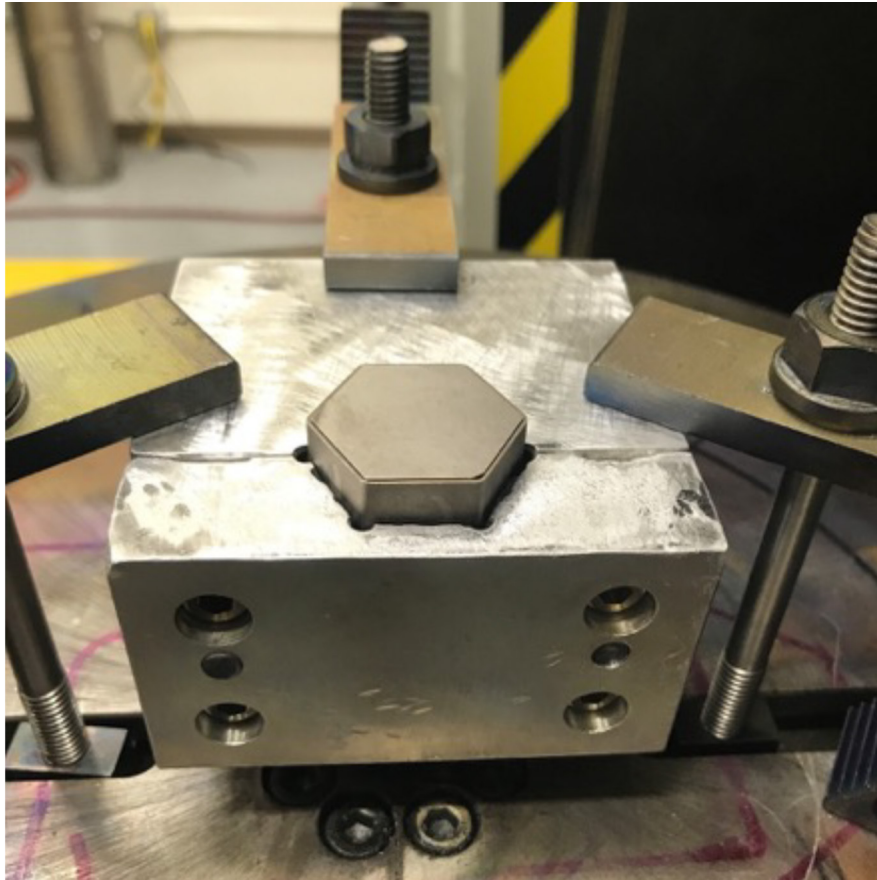
Figure 9. Weld fixture (with EBW_Hex6 in place prior to welding).

Figures in the appendix show the weld fixture (fig. 9), the EBW machine (fig. 10), the EBW machine operators interface (fig. 11), the pressure hose and aluminum hex fitting (fig. 12), the tube furnace (fig. 13), extent of cracking in the hex can side wall (fig. 14), schematic of hex can/pressure fitting (fig. 15), and the type of heat gun used (fig. 16).

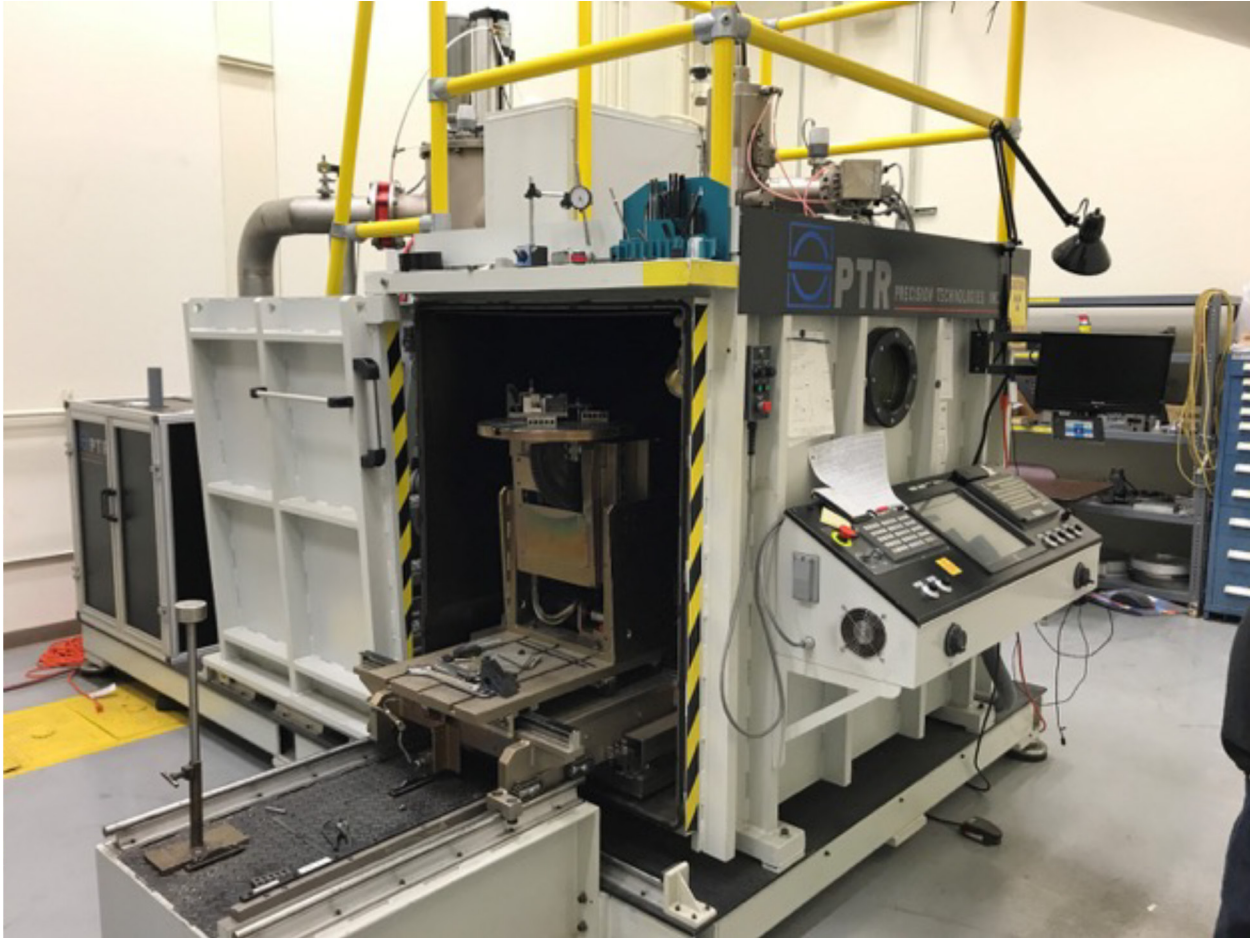
Figure 10. EBW machine used to weld both pure tungsten plates and pure tungsten hex cans.

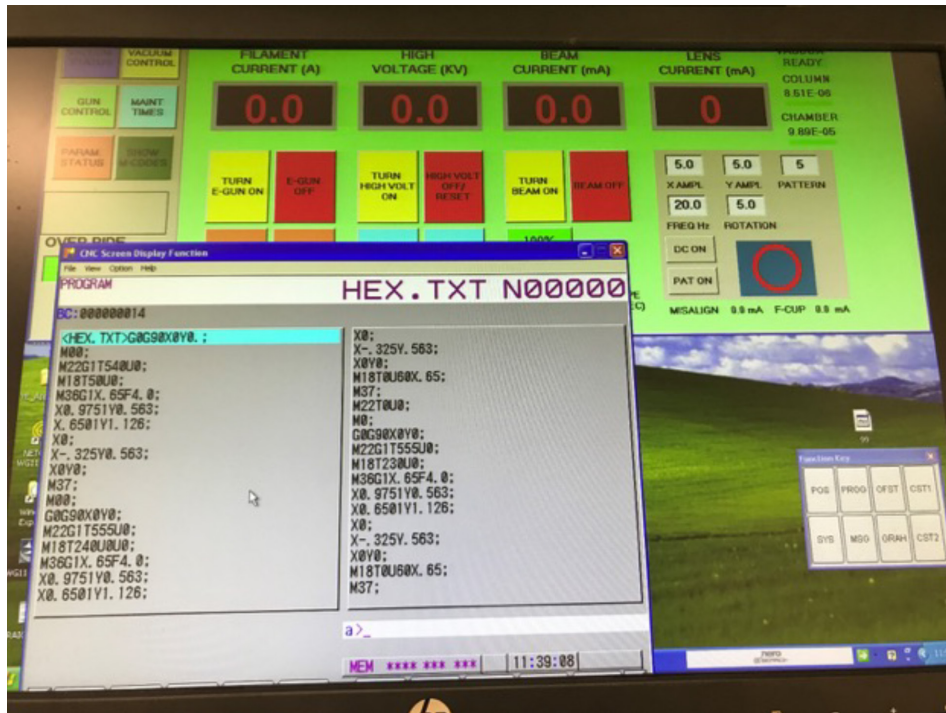
Figure 11. EBW machine operators interface.

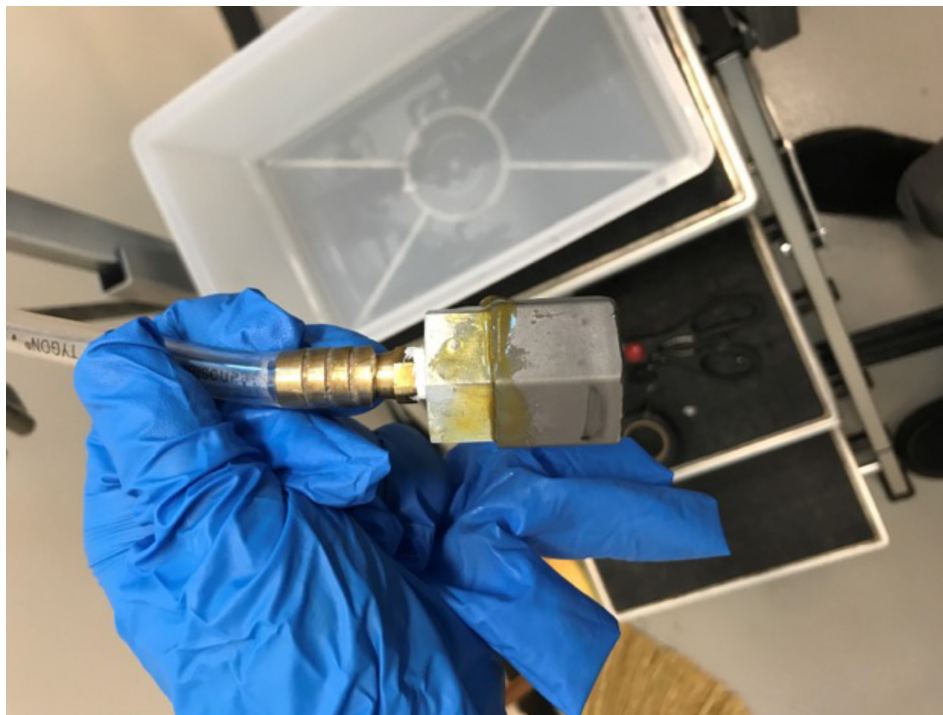
Figure 12. Pressure hose and aluminum hex fitting designed to pressurize the EBW tungsten weld. Polymer binder applied using a heat gun to make the interface leak tight.

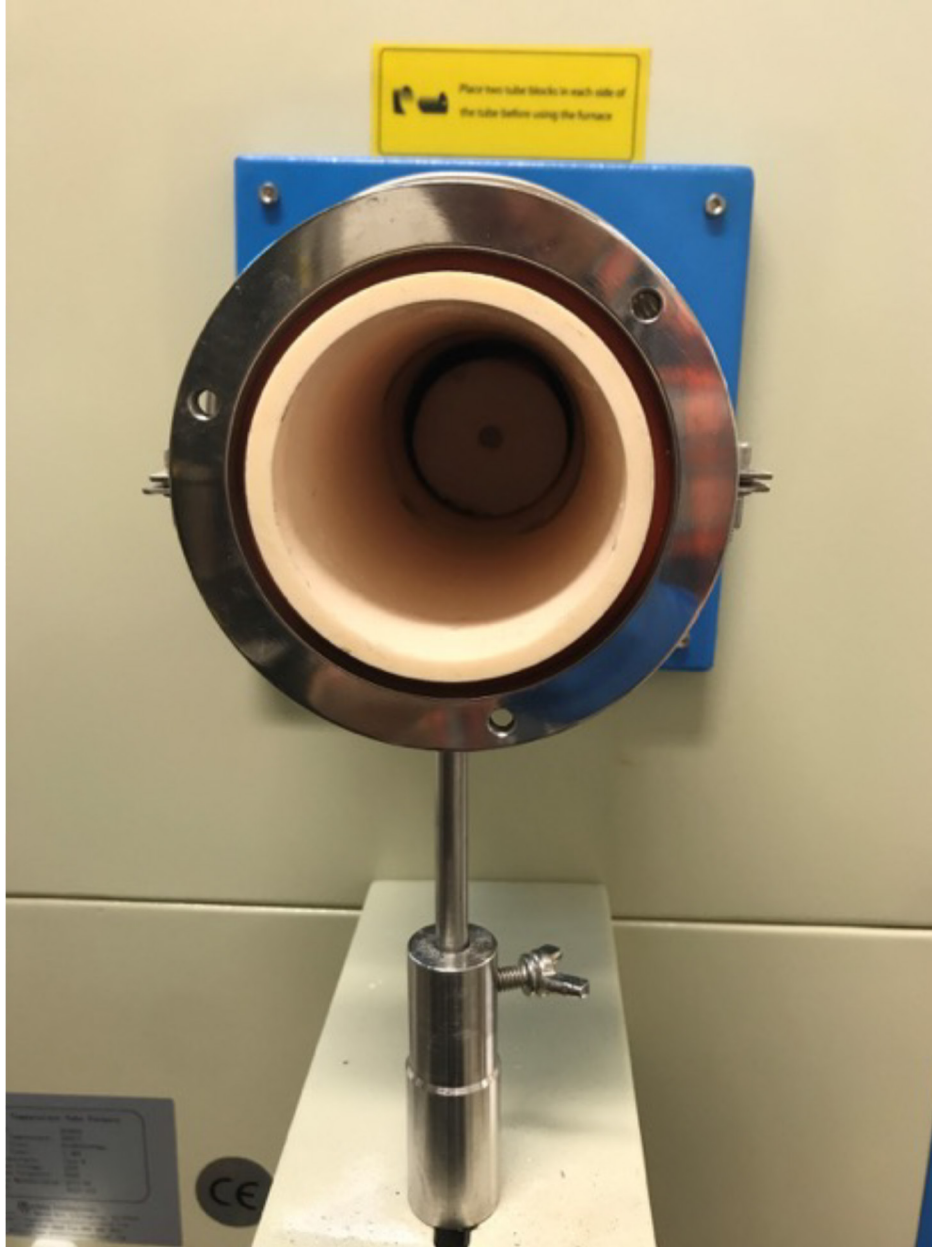
Figure 13. Tube furnace used to PWHT tungsten hex cans.

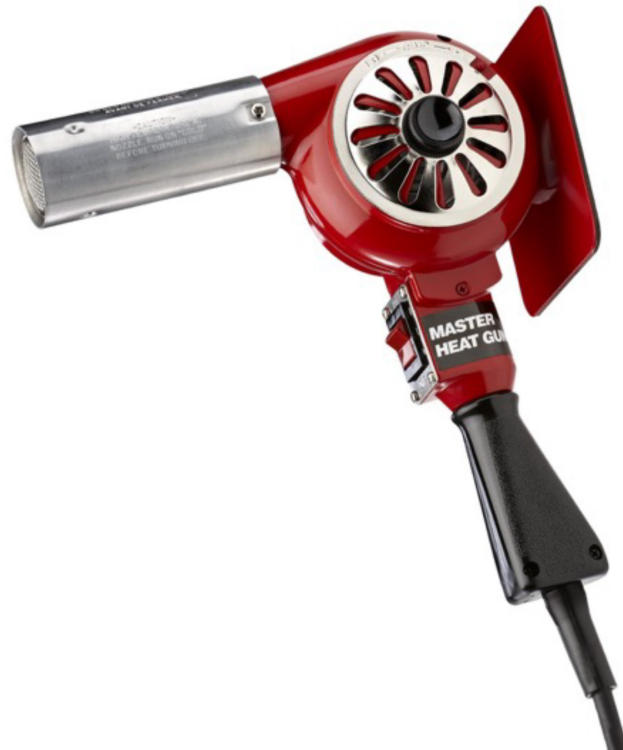
Figure 16. Heat gun used to heat polymer for pressure testing.
