Material Characterization of Additively Manufactured Titanium Parts for an Environmental Control and Life Support System in Space Flight Hardware

Environmental Control and Life Support System (ECLSS) Pressure Control Pump Assembly (PCPA)

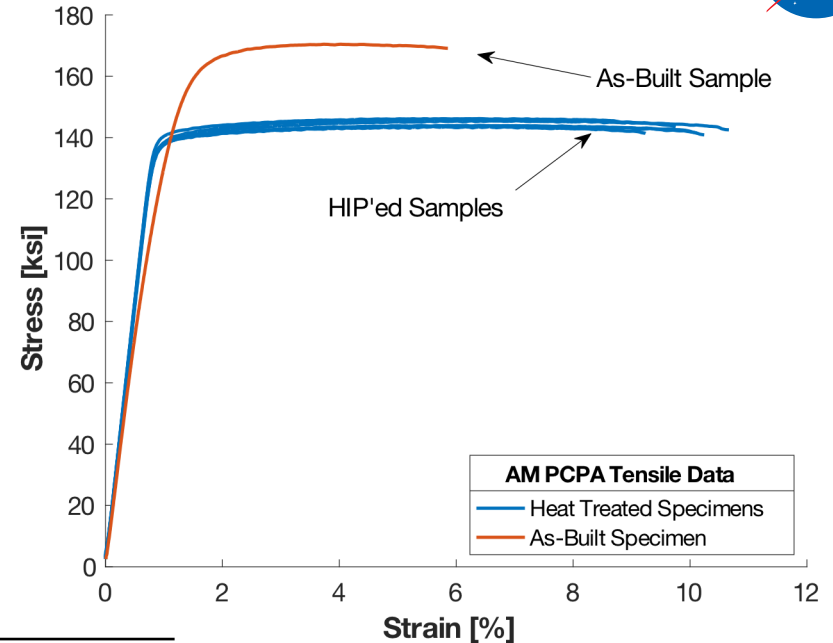
- Samples Tested to ASTM E8/E8M
- HIP Samples showed reduced tensile and yield strength comparable to traditional Ti64
- Fracture elongation, while improved by the HIP procedure still does not meet traditional values

Specimen ID	Tensile Stress [ksi]	Yield Stress [ksi]	Inelastic Strain [%]	Modulus of Elasticity	Fracture Elongation [%]	Reduction of Area [%]
Heat Treated ^a	145.0	138.5	8.8	17.1 ^b	9.8	10.6
As-Built	170.6	140.5	4.7	15.2 ^b	5.8	5.4

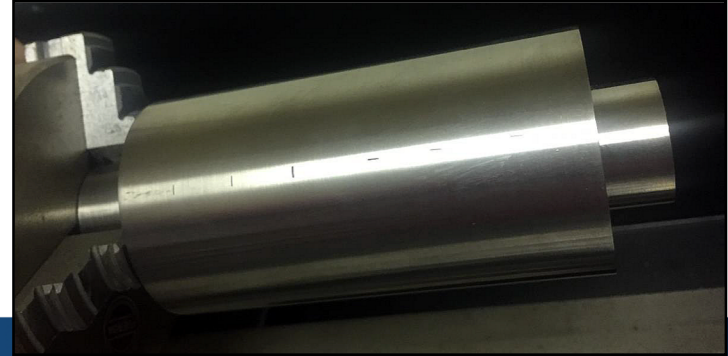
- Samples were produced in a low cycle fatigue geometry
 - Analogue samples were produced of wrought Ti64 to ensure acceptable alignment and temperature rise
- AM samples were machined to a final finish of RMS 8
- AM samples inspected by eddy current (calibrated to a 0.080”L x 0.010”D notch specimen)
 - No crack-like indications noted

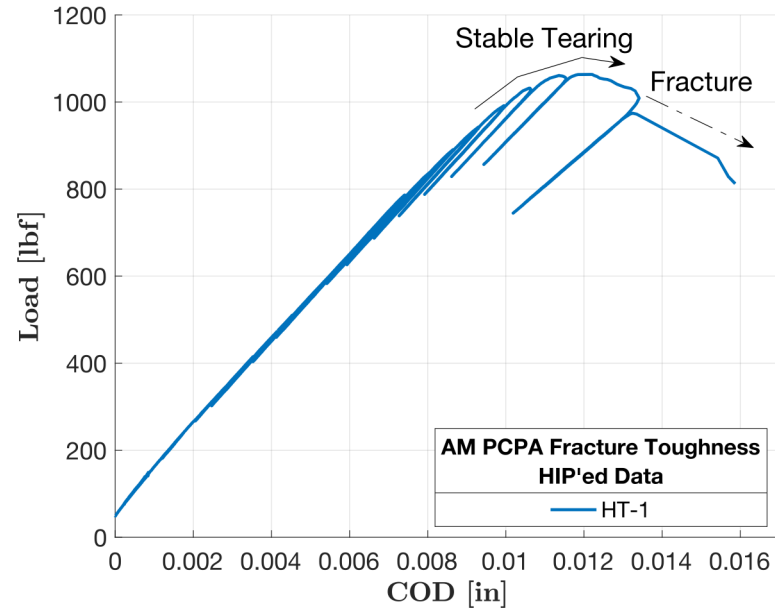
- Load-Crack Opening Displacement Curve with Compliance Unloading Cycles
- Stable tearing followed by fracture instability in the final load response

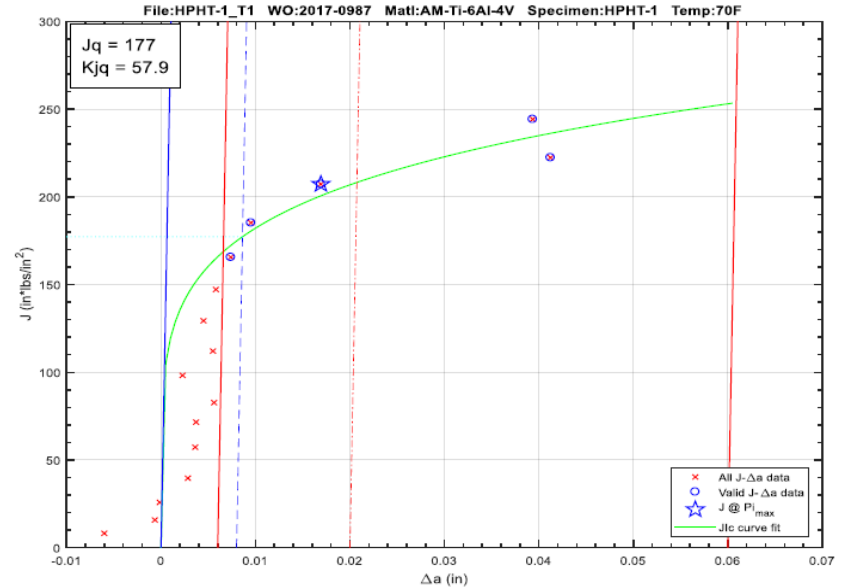
- ASTM E 1820 Evaluation
- Test did not produce a J_{Ic} value due to lack of well defined crack extension and R-curve regression curve fit invalidity
- Rising R-curve behavior reflecting stable tearing capability
- Fracture instability occurred after stable tearing.
- $J_q = 177$ in-lb/in²
- $K_{Jq} = 57.9$ ksi $\sqrt{\text{in}}$

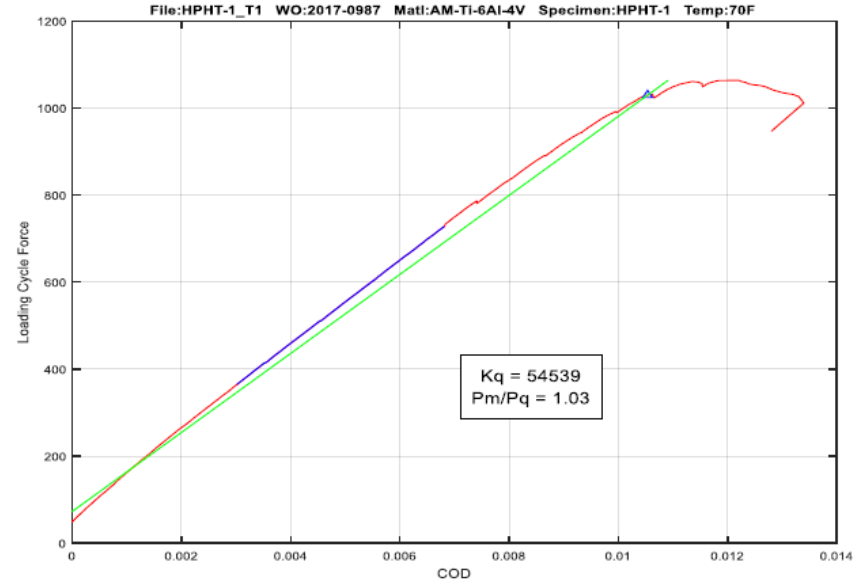
- ASTM E 399 Evaluation
- Test did not produce a K_{Ic} value due to sample ligament size.
- $(Kq/\sigma_{YS})^2 = 0.171$ in
- Required ligament = 0.42 in
- Actual ligament = 0.36 in
- The extended COD capability after P_q suggests some stable tearing capability
- $Kq = 54.5$ ksi $\sqrt{\text{in}}$
- $Kq \approx KJq$

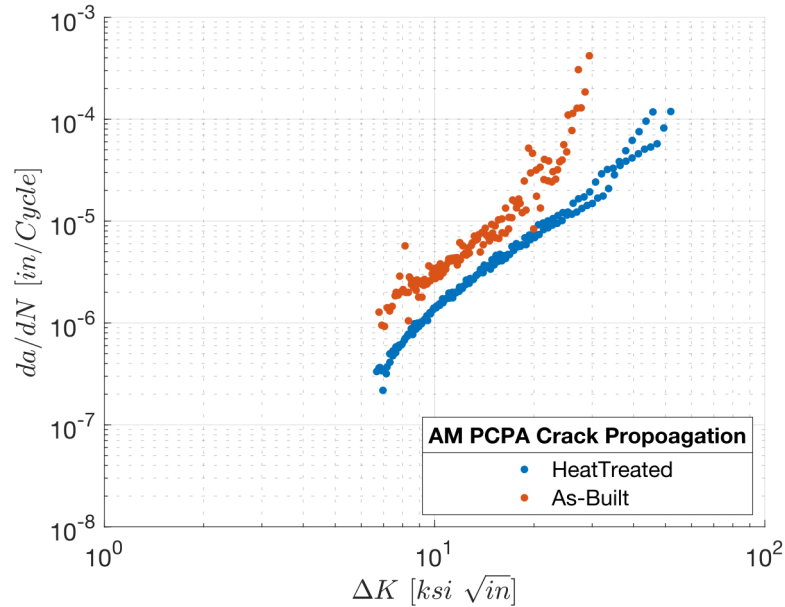
- As built material exhibits more scatter vs heat treated material
- As built material instability consistent with estimated fracture toughness
- Evaluation of crack growth rate at additional R-ratios recommended to establish mean stress effects
