Robotic Refueling Mission 3: Cryogenic Demonstration Subsystem Operations

Rob Boyle¹, Susan Breon¹, Matt Francom¹, Hudson DeLee¹, John Francis¹, Shuvo Mustafi¹,
Pete Barfknecht¹, Jill McGuire¹, Angela Krenn², Greg Zimmerli³ and Dan Hauser³

¹ NASA Goddard Space Flight Center

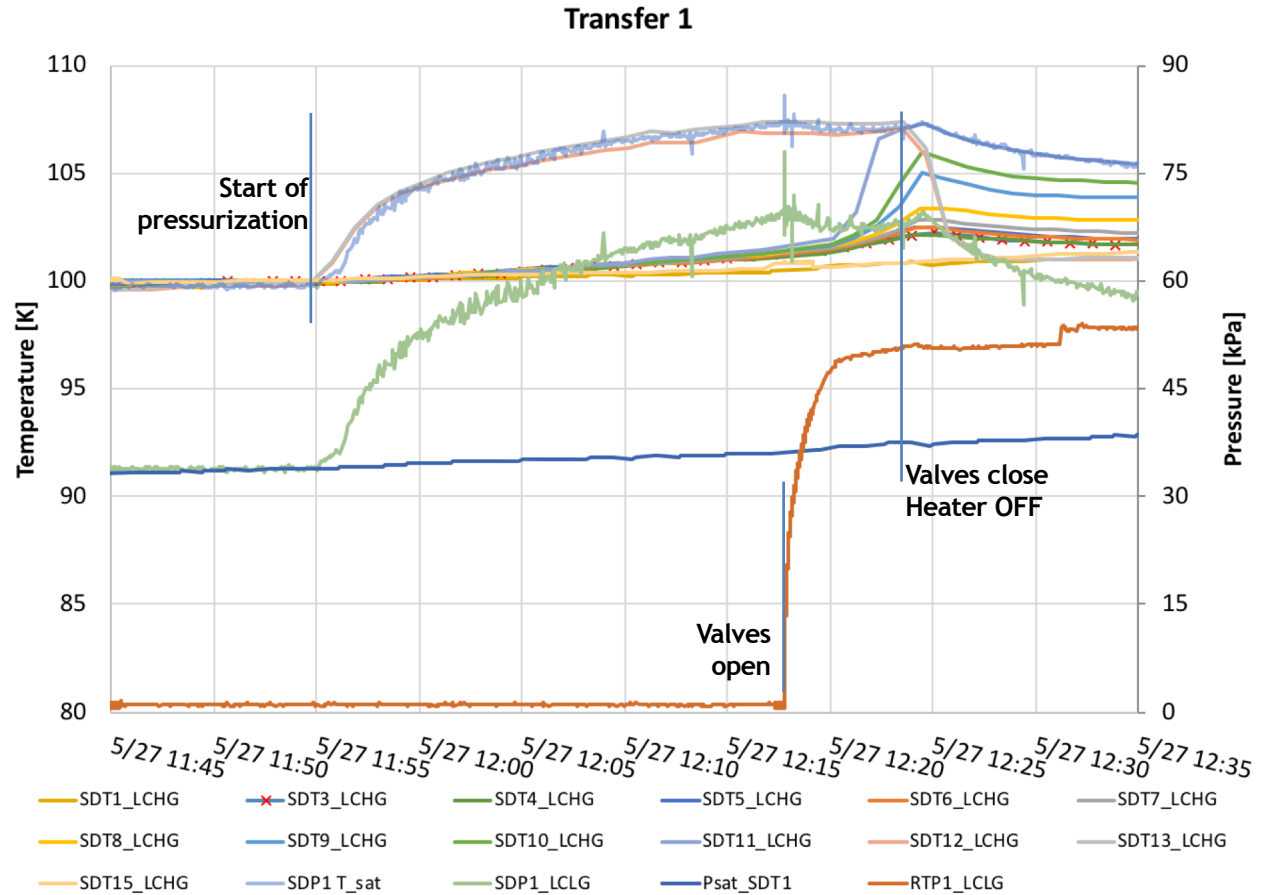
Transfer 1 - successful

- SDP1: 70 kPa at start of transfer
- RTP1 came up to 50 kPa and stabilized
- Liquid from SD was cold enough to absorb transfer line heat, and arrive in RD with saturation pressure ~15 kPa below delivery pressure

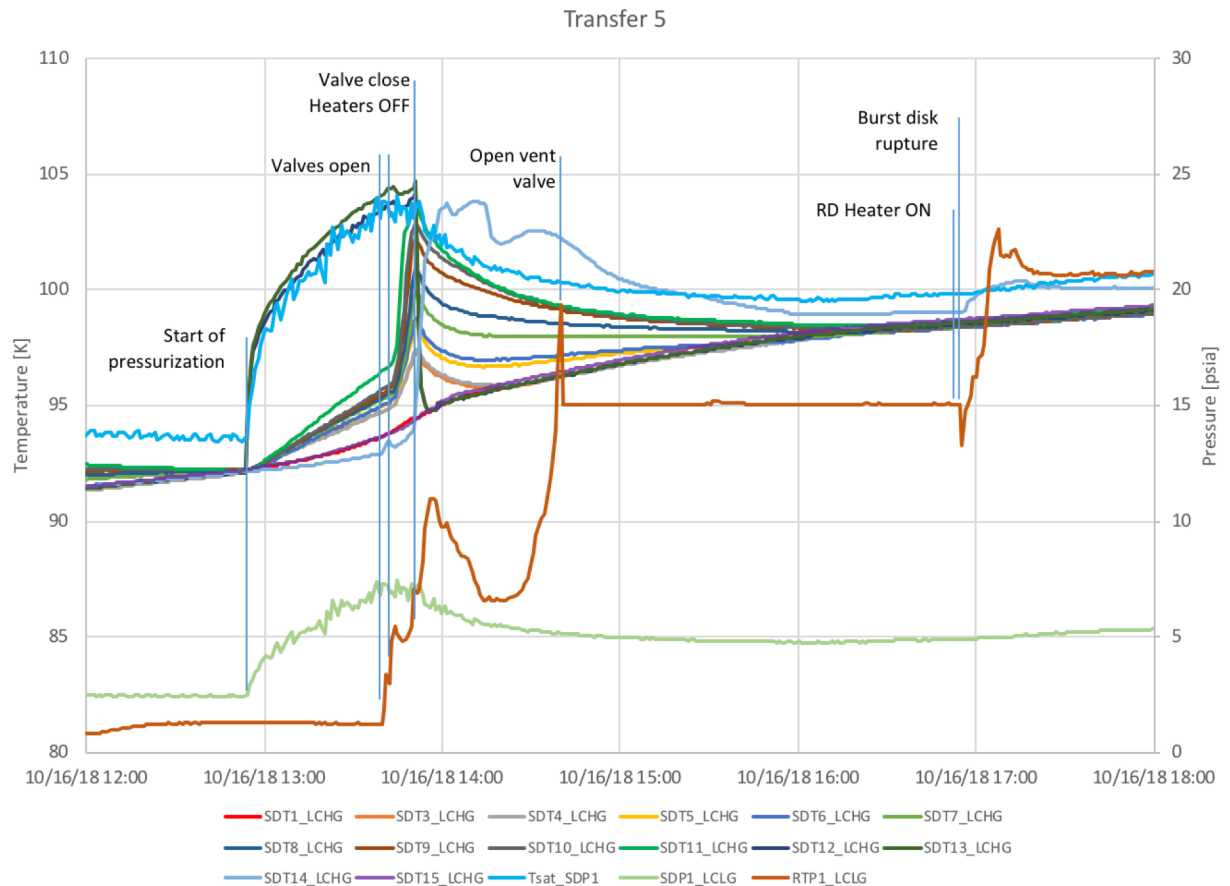
Transfer 5 – too successful

- Tank liquid locked at end of transfer, cryocooler successfully densified the fluid
- RD cryocooler controlled pressure, until it was turned off to evaporate RD contents
- RD tank liquid locked again, vent valve successfully alleviated pressure rise
- RD tank heater was turned on to evaporate RD contents, caused expansion faster than vent valve could accommodate
- At least one BD on tank ruptured into vacuum space, but outer BD's were left intact
- Cryo team did not recognize criticality of liquid lock, and did not recognize compromised vacuum space

- Expanding liquid contacted the (warmish) lid
 - High vent line impedance allowed tank pressure to exceed set point for inner burst disks
- Burst disk had released into vacuum jacket, but had not ruptured the outer burst disk
- Compromised vacuum jacket on RD allowed high heat load, but ops team did not recognize the symptoms
- Loss of vacuum jacket was only recognized two days later

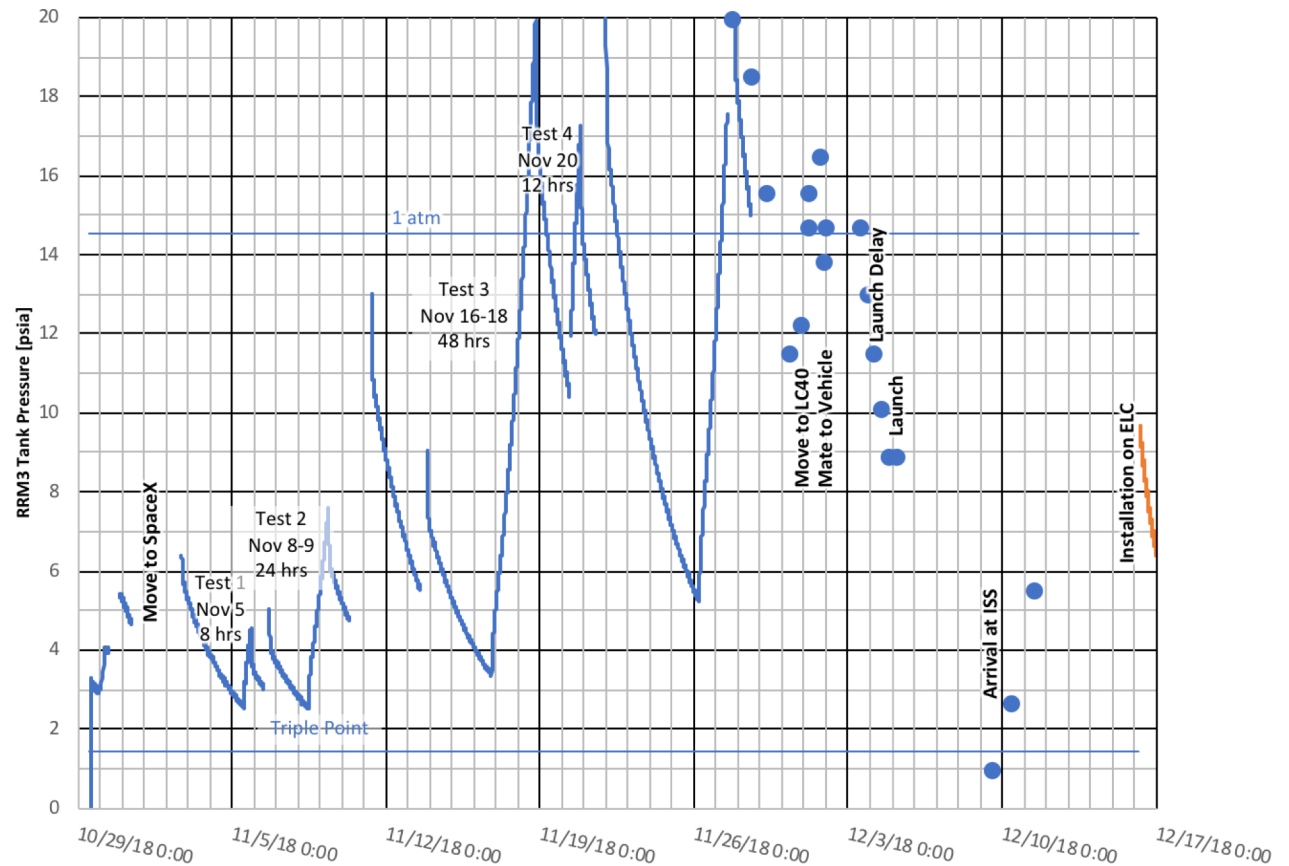
RRM3 Source Dewar Launch Campaign Pressure History

- Move to SpaceX Oct 30
- SpaceX interface allowed monitoring of basic telemetry through launch campaign
- Power (GSE or vehicle) available with mandatory gaps ≤ 24 hours
- Operations at SpaceX facilities were closely controlled, but were negotiable
- Last touch T -60hrs

- Launch on CRS-16 Dec 5 13:16 EST

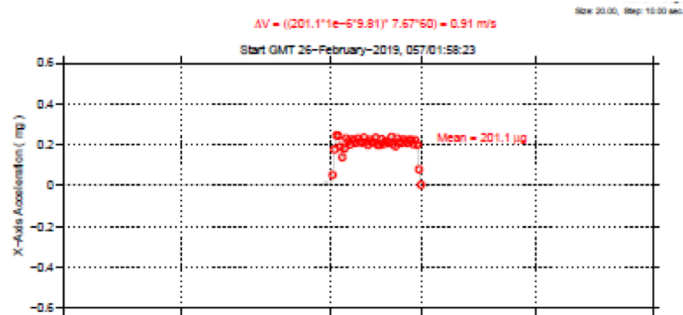
Fig. 3: Interval average of SAMS 121f03 sensor data shows Progress 71P reboost. MODIFIED MARCH 1, 2019

- Re-boost of the ISS with cryocooler running showed very little reaction, but with cryocooler off, the liquid de-stratified at $\sim 200 \mu\text{g}$

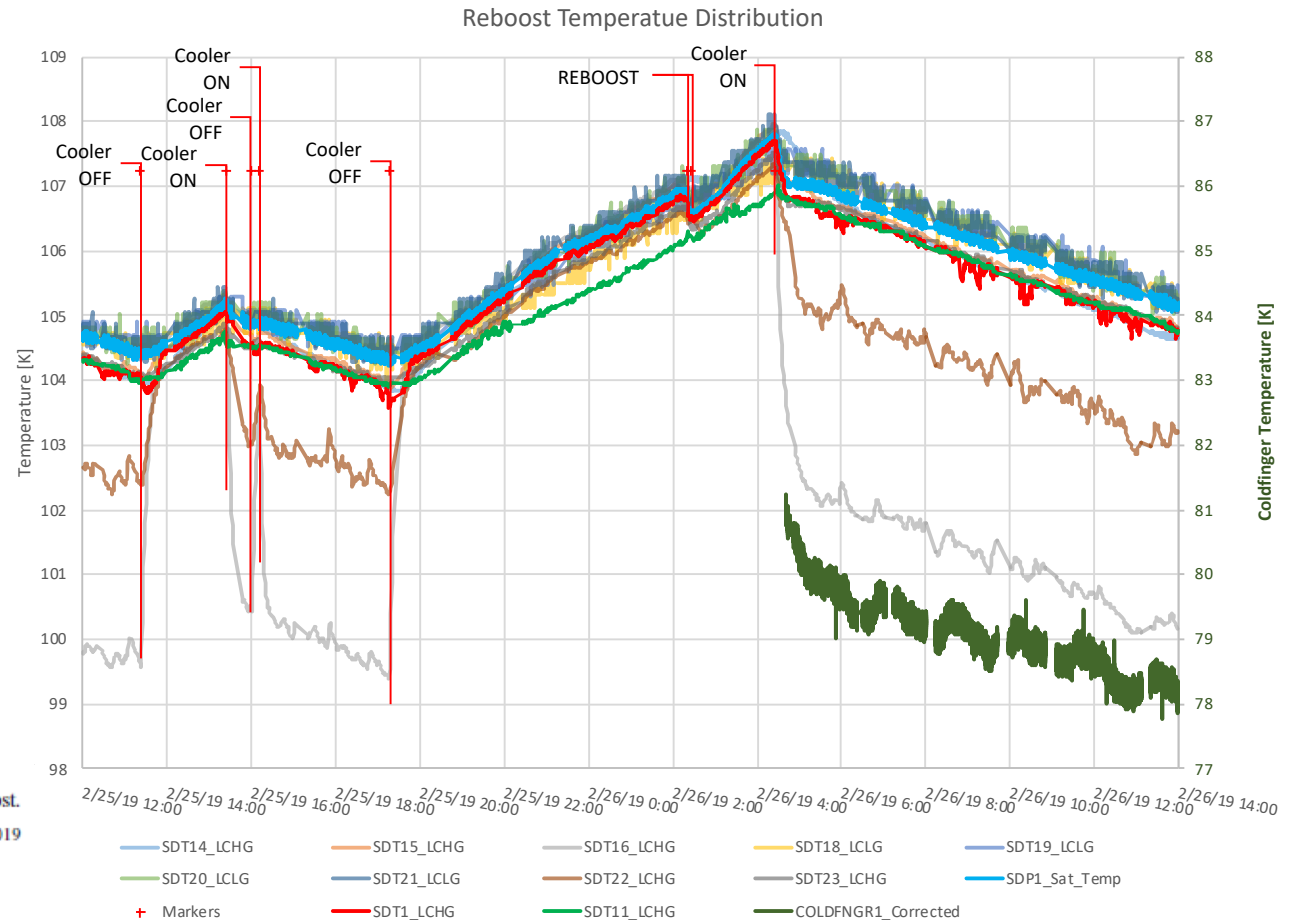
Reboost – tank surface sensors

- Sensors in the middle of the sensor array showed high variability during pressurization (cooler OFF) prior to reboost event
- SDT1 at the bottom of the sensor array showed high variability during cooldown (cooler ON) before and after reboost

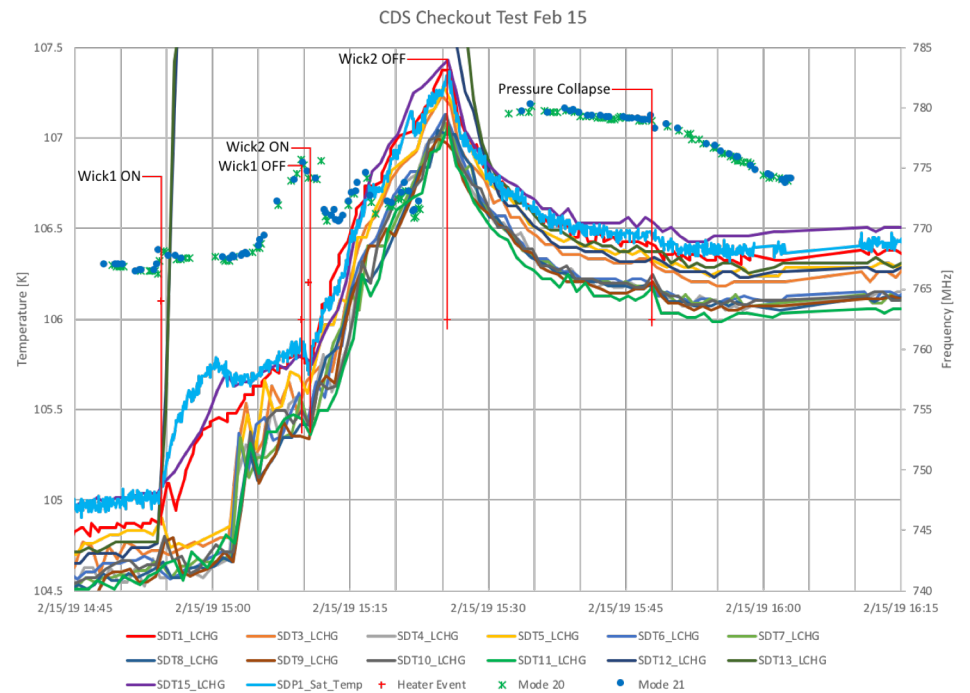
Wick pressurization – CDS checkout

- In CDS checkout test Feb 15, RFMG seems to show redistribution of fluid inside tank

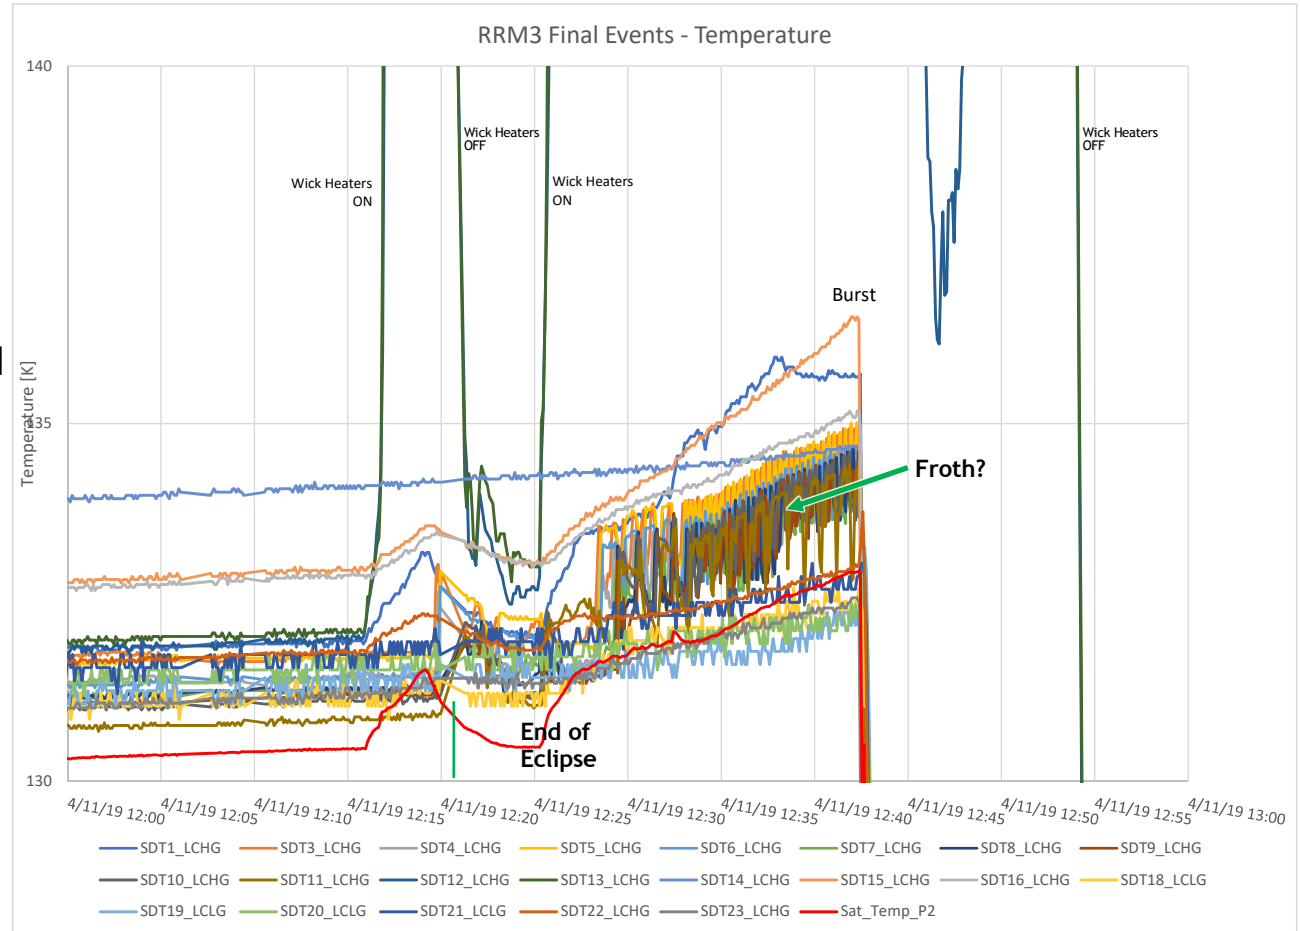
Wick pressurization – final ops

- Wick heaters ran as high as 265 K
 - Previous events operated at saturation temp
- Initial pressurization was very rapid (local heating), then slowed down (more like global heating)
- Frothing in the central cone?

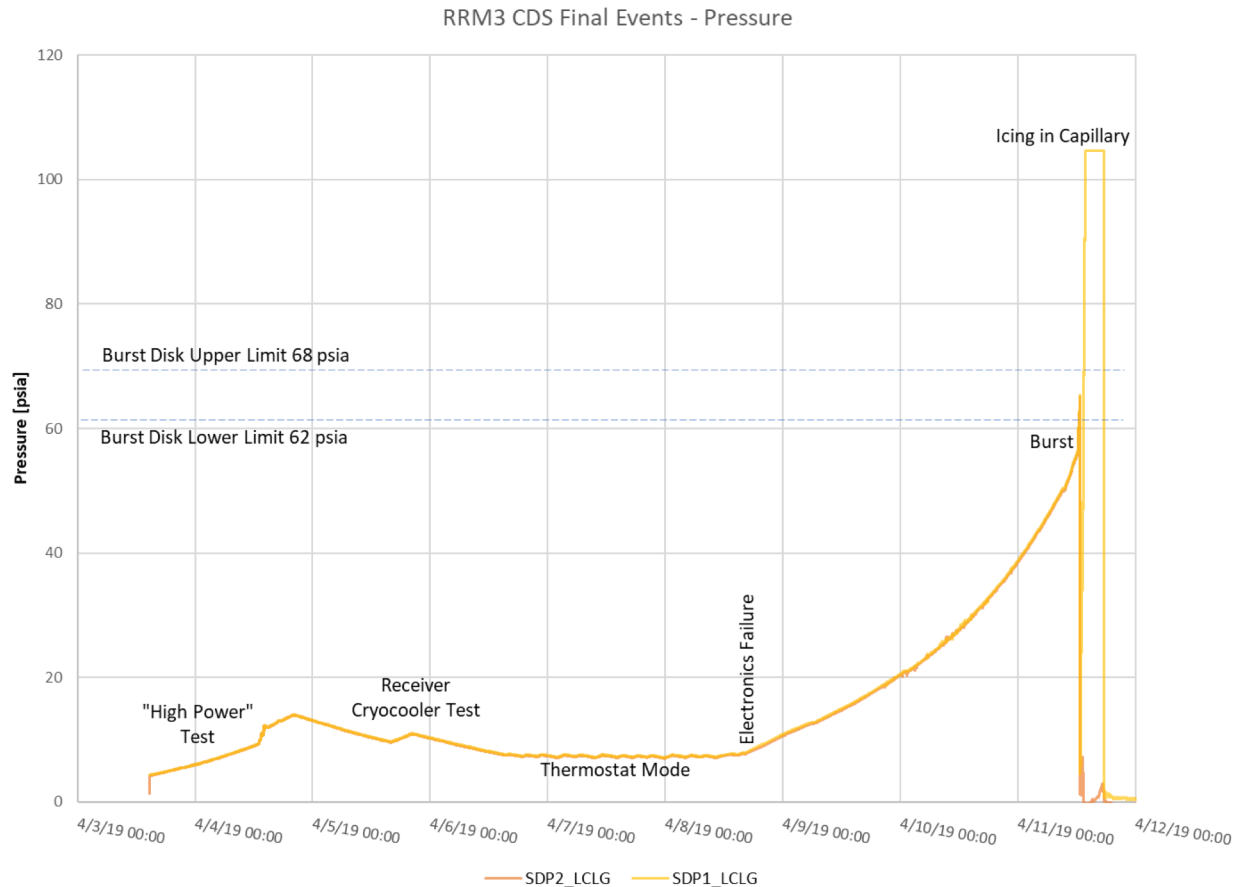
Loss of Cryocooler Function

- Payload power glitch April 8 at 1200 GMT
- Cryocooler power restored at 1742, circuit breaker trip at 1749
 - Circuit breaker could be reset if cryocooler was held OFF
- Electrical fault isolated to cryocooler output circuits
 - Not recoverable
- Burst disk projected to activate 4/11 – 4/12
- ISS requested coordinated operation to mitigate disruption of ISS activities
 - Use wick heaters to instigate burst disk rupture

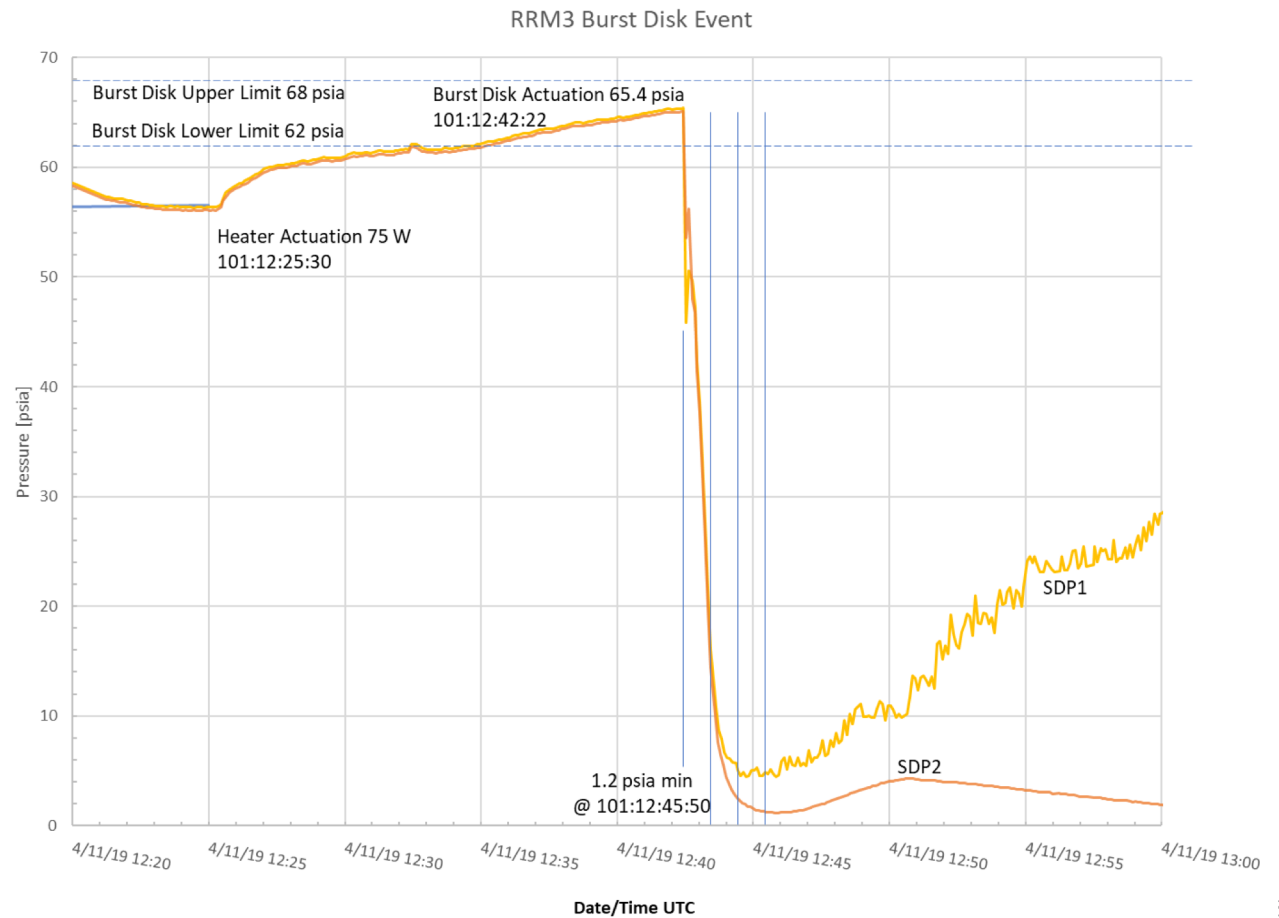
Burst disk rupture

- Heater operation was coordinated with ISS operations
- Blowdown to 5 psi took approx 90 seconds
- SDP1 re-pressurized to > 100 psia
 - Capillary to pressure sensor had plugged with methane ice

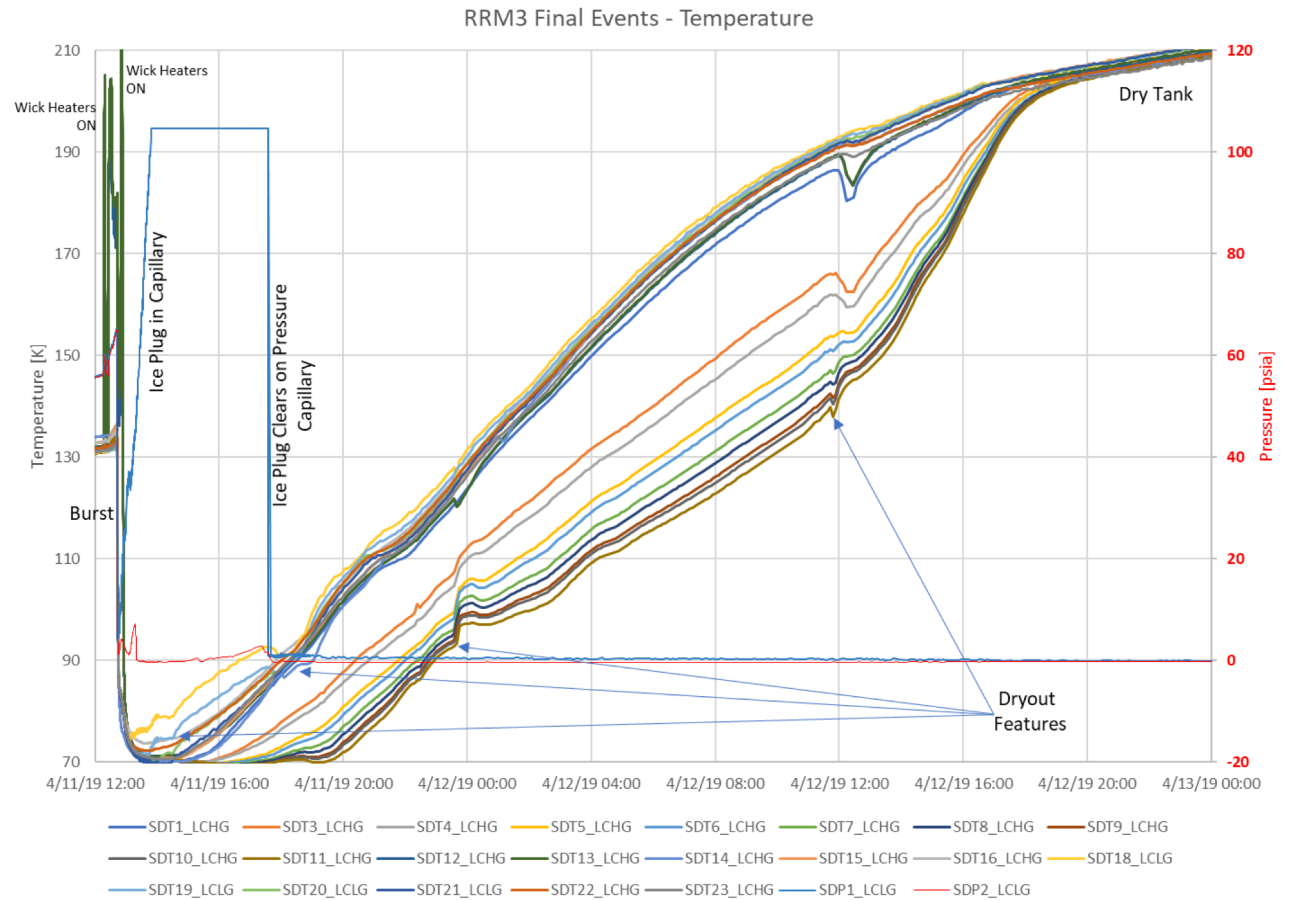
Dryout

- Features in dryout are probably associated with impurities in cryogen
