NASA/TM—2019–220134

The Effect of Hole Quality on the Bearing Strength of Carbon Fiber Laminates

A.T. Nettles

Marshall Space Flight Center, Huntsville, Alabama

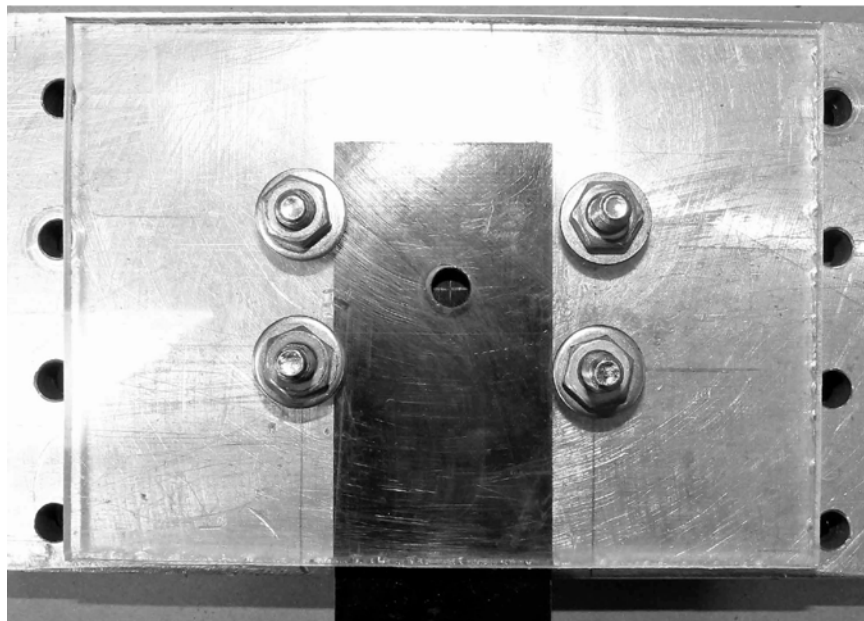
Figure 1. Jig used to drill best holes.

In this study, holes of four different qualities were evaluated. For convenience, these four levels of hole quality from worst to best will be referred to as: (1) bad, (2) medium, (3) good, and (4) best. The bad holes were made with a twist drill rotating at a relatively slow speed and forced through the laminate at a fast rate. No backing plate was used for these. The medium holes were made with a four-flute, square-end mill rotating at a slow speed and fed at a fast rate with a backing plate. The good holes were made with a high-quality, six-flute, square, diamond-coated end mill rotating at a fast speed and fed very slowly through the laminate. No backing plate was used. This quality hole was intended to mimic field drilling conditions where sometimes a backing plate cannot be used due to inaccessibility. The best holes were made using the aforementioned high-quality end mill and a special jig made to prevent delamination pull-up and backface breakout. A photograph of this fixture is shown in figure 1, and a schematic side view is shown in figure 2. The top PLEXIGLAS® plate was tightened down onto the specimen to sandwich the specimen between the upper Plexiglas and lower aluminum base. A sacrificial piece of carbon/epoxy was placed directly under the specimen to help prevent fiber breakout. Photographs of the bits used are shown in figure 3. The visual appearance of these four hole qualities, along with a thermography image of each, is shown in figure 4.

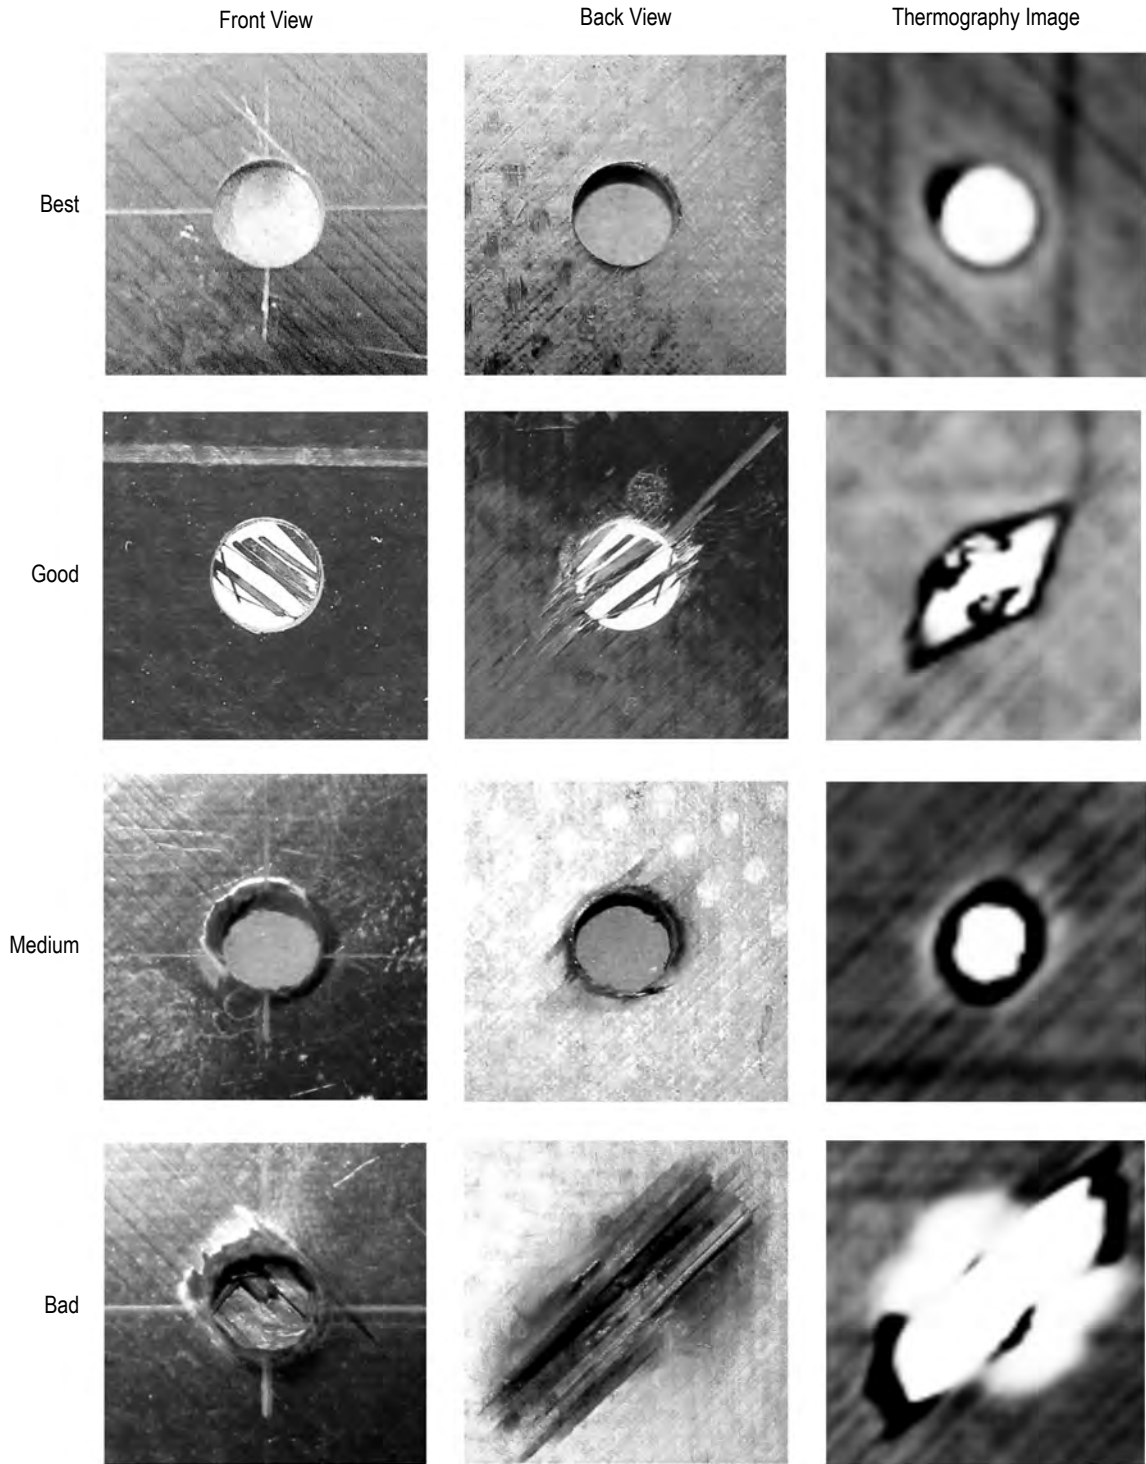
Figure 4. Photographs and thermography images of the four hole qualities used.

If fiber breakout on the exit side of the hole is present, it can be seen from the front view of the hole (the good and bad specimens in fig. 4), which had no backing plate. In addition, the thermography images will be elongated as seen in figure 4. The medium and bad holes showed clear visual indications of fiber pull-up as is evidenced by the cross-sectional photomicrographs seen in figure 5. It is apparent that a simple visual examination can ascertain the quality of a hole, and a simple nondestructive evaluation technique, such as thermography, can give quite detailed information about the hole quality.

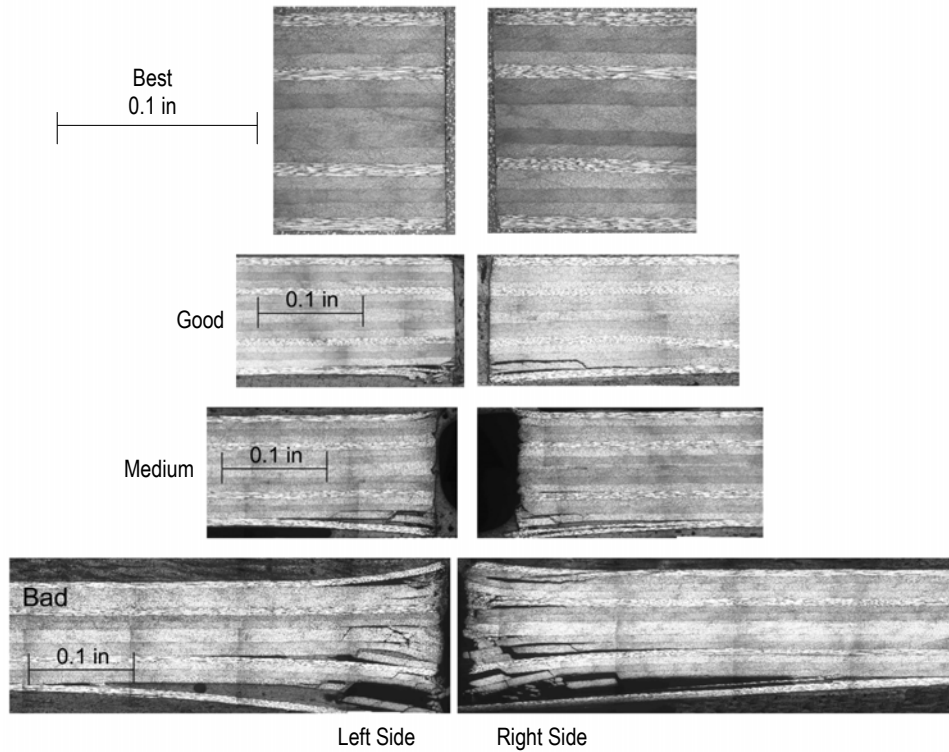
Figure 5. Cross-sectional micrographs of the four hole qualities used in this study.

Cross-sectional photomicrographs of the four hole qualities are shown in figure 5. The specimens were sectioned through the center of the holes in the direction of the outermost fibers (+45°). To save space, the actual holes are cropped out of the picture, and only the material on either side is shown.

Figure 10 shows cross-sectional views of the damage in the specimen shown in figure 9. If these are compared to figure 5, before the first load drop occurs, the hole already is as damaged as the worst drilling technique used, thus the best quality of hole quickly becomes one of poor quality, thus the lack of criticality in how well the hold was initially machined into the laminate.

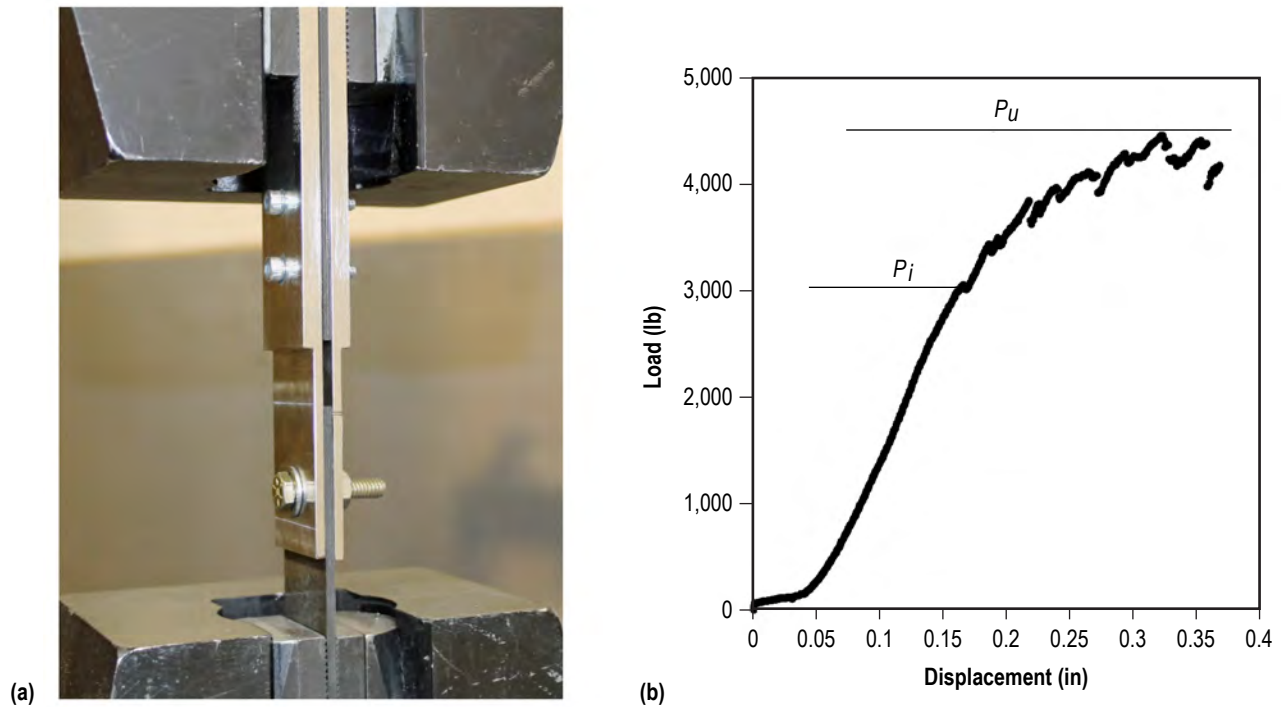
Figure 6. Bearing test used in this study: (a) Photograph and (b) typical load-displacement curve.

ASTM D5961 Procedure A, double shear in tension. The holes in the specimen measured $0.245 +0.001/-0.000$, and the bolt diameter measured $0.245 +0.000/-0.001$, giving a light interference fit. The bolts were torqued at 25 in•lb as suggested in reference 6. A photograph of a specimen undergoing a bearing test, along with a typical load-displacement plot, are shown in figure 6. It should be noted that the displacement values presented in this study are simply crosshead displacement and do not represent the true elongation of the hole due to compliance within the system. The displacement values presented are not used in this study in any calculations, thus a more precise measurement of hole elongation was not attempted. This study focused on two areas of the load-displacement curve: (1) the initial load drop (denoted as P_i), which may be of interest to applications in which small displacements of the bolted part may be critical, and (2) the ultimate load (denoted as P_u), which is of interest if the goal of the bolted joint is to simply have the part not fall off the vehicle. In this study, the initial load drop was defined to be at least 1% of the load at which the drop began. The two values used for bearing strength are shown on the load-displacement plot in figure 6. Both of these values will be reported throughout this Technical Memorandum for completeness.

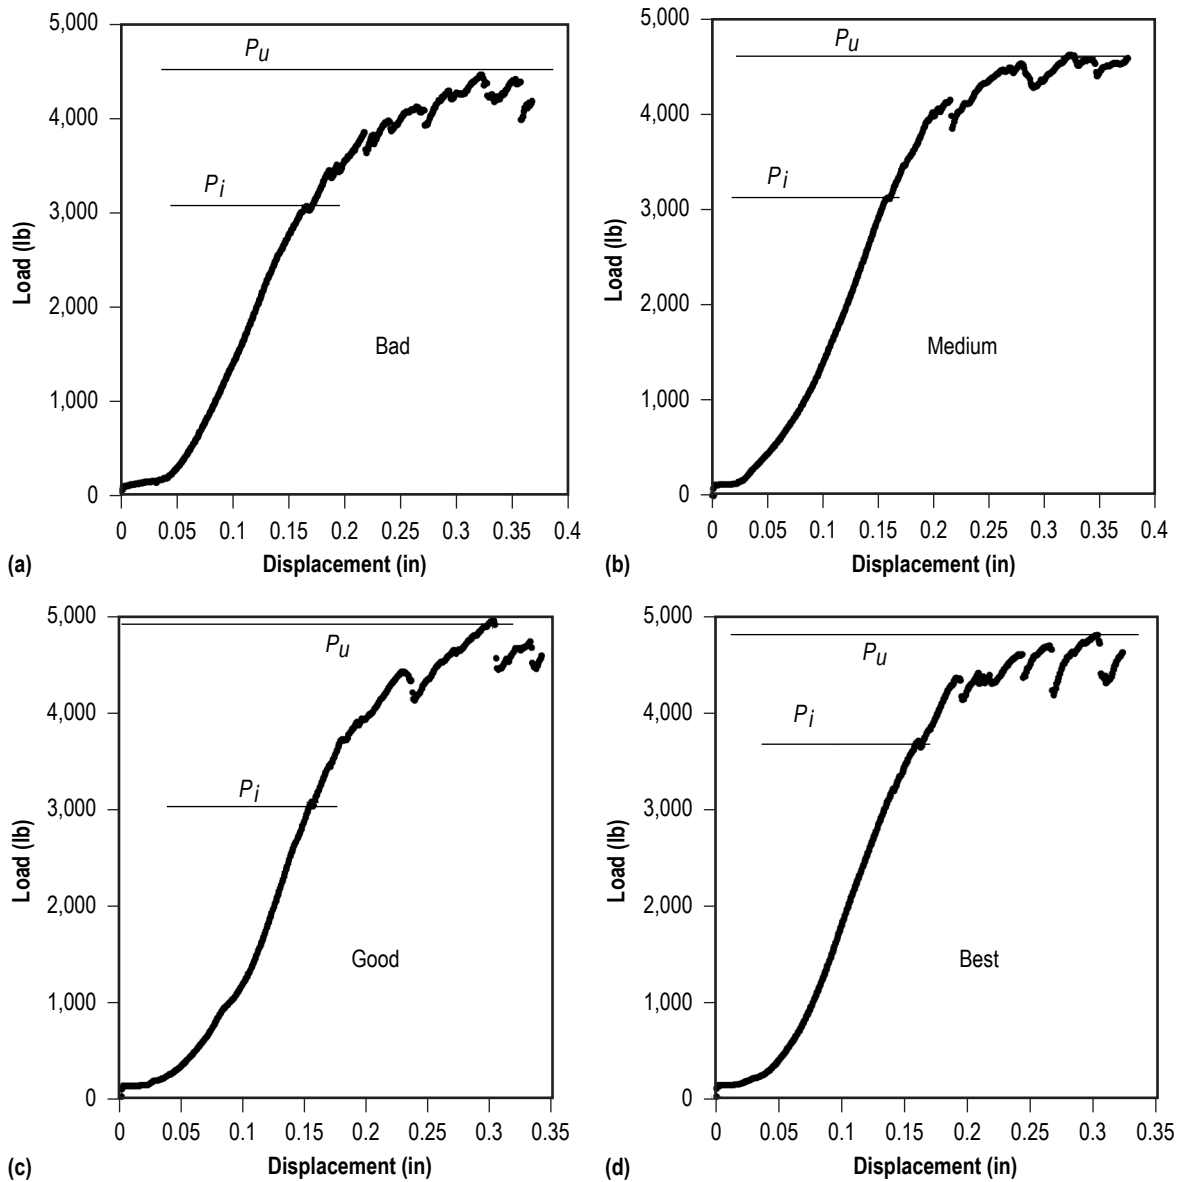
Figure 7. Typical load-displacement curves for the four levels of hole quality examined: (a) Bad, (b) medium, (c) good, and (d) best.

A typical load-displacement curve for each of the four quality holes is shown in figure 7. The data are shown in table 1 for all of the specimens tested. The average load at which initial load drop occurred and the ultimate bearing load is shown in the bar chart in figure 8 for a visual representation of the results.

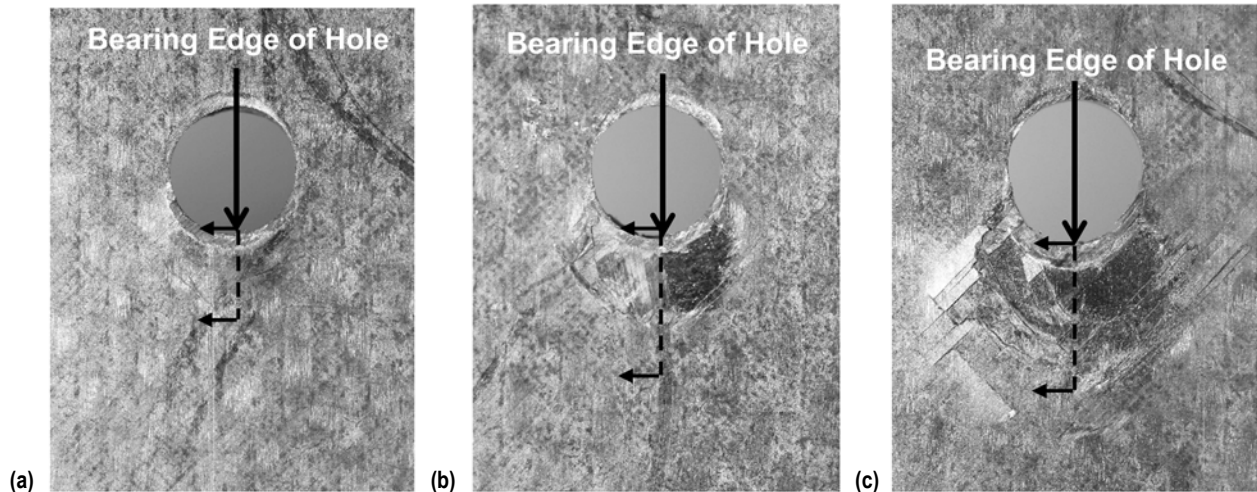
Figure 9. Progression of damage of a best-quality hole from: (a) before initial load drop, (b) after initial load drop, and (c) after maximum load has been reached.

By examining what happens to a hole during a bearing test, one can see why the quality of the hole is of little importance to the ultimate bearing strength of a composite laminate. As a hole is loaded in the bearing by the bolt, the hole elongates in an elastic fashion, during which some form of initial damage occurs. Depending on minor factors, such as clamp-up force, uneven loading in a row of bolted holes, slight angle of bolt, etc., this initial damage can begin at a relatively small load and not even be detectable on a load-displacement plot. Figure 9(a) shows a hole of best quality that has been loaded to the point where audible sounds were heard but before a load drop was noted on the load versus displacement curve, (b) at the time of the first noted load drop, and (c) after the maximum load had been reached. Dashed lines show a view of cross-sections shown in figure 10.
