The International Space Station (ISS) Port 1 (P1) External Active Thermal Control System (EATCS) Ammonia Leak

Darnell T. Cowan¹, Timothy A. Bond² and Jordan L. Metcalf³
NASA Lyndon B. Johnson Space Center, Houston, TX, 77058

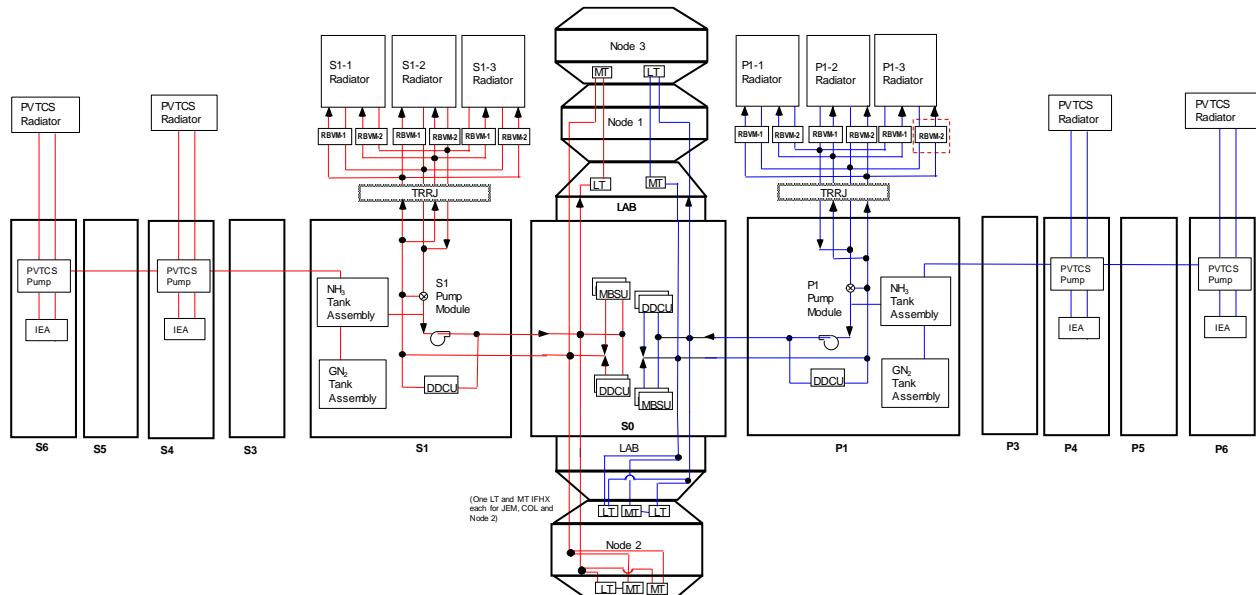
Figure 2. S1 and P1 EATCS simplified schematic.

Each of the two EATCS¹ loops contain a Pump Module, an ATA, a Nitrogen Tank Assembly (NTA), three deployable radiators, multiple coldplates and heat exchangers, as shown the simplified schematic of Figure 2. Each Pump Module circulates liquid ammonia at a constant flowrate to a network of coldplates, heat exchangers, and radiators. The ATA consists of two pressure vessels filled with liquid ammonia and gaseous nitrogen separated by a collapsible bellows to provide system compliance and supply ammonia to the EATCS. The NTA is connected to the ATA and contains a volume of high-pressure nitrogen gas used to regulate the pressure in the EATCS. Ammonia

supplied to the coldplates and heat exchangers collects heat, which is transferred to the three deployable radiators and rejected to space.

square in figure 2. This pressure was two orders of magnitude larger than the natural background scans. This RBVM is one of six located near the three radiator panels on the port side of ISS. P1-3-2 refers specifically to the third radiator on the port side, flowpath number two.

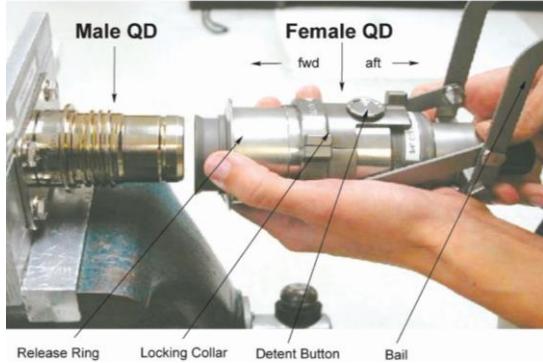
Figure 3. Male and Female Quick Disconnects
leaks in both mated and demated conditions.

Each deployable radiator contains 2 parallel flow paths and each flow path is connected to a Radiator Beam Valve Module (RBVM). The RBVM controls ammonia flow to radiators including the ability to vent ammonia from a flowpath or isolate flow. The ATA, NTA, pump, deployable radiators, RBVM and the heat exchangers are Orbital Replacement Units (ORU). This means they have the capability of being replaced on-orbit by the crew during an EVA. The plumbing in the EATCS consists of hard tubing and flexible jumpers. Fluid Quick Disconnects (QD) are attached to each ORU to enable connection and disconnection (see figure 3), and flexible jumpers and hard tubing are used to connect them together. Each Fluid QD contains seals to secure the connection and to prevent ammonia

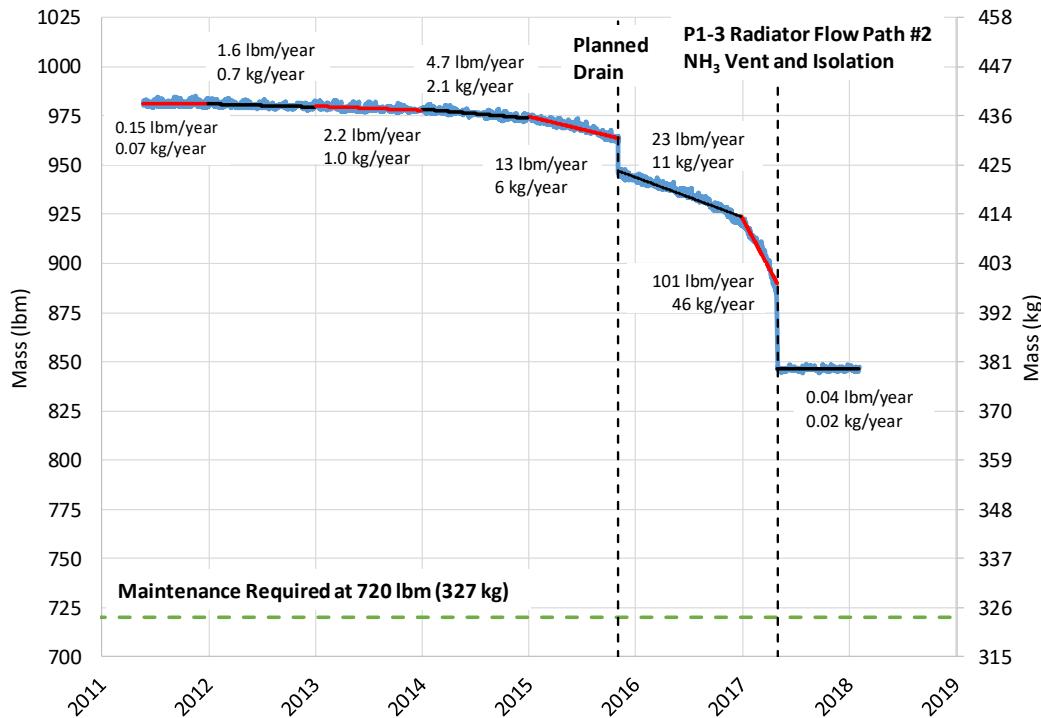
Figure 4. P1 EATCS Mass Decay over Time.

The calculated system mass oscillates due to the ammonia property assumptions made for certain volumes of the EATCS. This makes small system changes (i.e. leaks) less apparent, and the teams have to look at long term trends to provide a more accurate story of leak rates. Only long term trends (i.e. months to years) are of significance with this technique, not near term changes. Furthermore, planned system changes that add or remove significant amounts of ammonia create a discontinuity as shown in a system maintenance event in Figure 4. The planned drain event illustrated restarts the calculation after the discontinuity.

The rate of ammonia leakage was initially not a concern since it was below the EATCS leakage requirement of 7 lbm/year (3.2 kg/year). Experience has shown that leakage in the 0.5 to 1.5 lbm/year range has been typical of a tight system on ISS. The leak in P1 was tracked at a very low rate for several years before it began to accelerate, eventually trending towards exponential behavior. In 2016, ground controllers at NASA's Mission Control Center began observing "white flakes", as shown in Figure 5, from the P1 External High Definition Camera (EHDC) as the leak rate approached 30 lbm/year (13.6 kg/year). The P1 EHDC is capable of recording High Definition (HD) video outside the ISS. Pressurized liquid ammonia appears to be white and flaky when exposed to a vacuum.

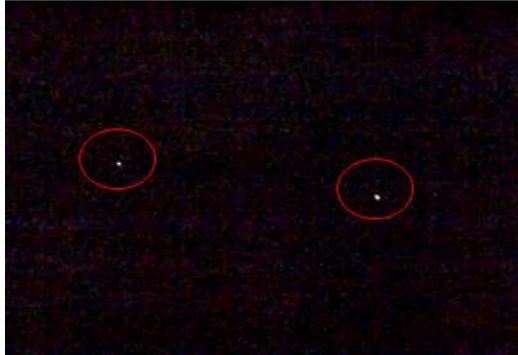
Figure 5. Photo taken from the P1 EHDC pointed to space. "White Flakes" circled in red.

Though this is the first ammonia leak observed in an EATCS, it is the second ammonia leak of this type in the history of the ISS. The first ammonia leak on the ISS was from the Photovoltaic Thermal Control System (PVTCS) Channel 2B. PVTCS collects and removes heat from each solar array power channel on ISS and rejects that heat to space through four separate radiators. Based on the PVTCS Channel 2B history², the ammonia leak rate that was visible to cameras and crew was at a much larger rate of approximately 1000 lbm/year (454 kg/year). Earlier analysis and laboratory testing of ammonia behavior had shown that, to be visible, a leak rate much larger than seen on P1 would be required. Therefore, the frequency and amount of white flakes recorded since the first observation until the leak stopped was too low and sporadic to conclude definitively that they were associated with the P1 EATCS leak. Understanding the size and geometry of the white

flakes could help conclude if they were ammonia or not. However, this could not be accomplished since the background of the images for all the white flakes was deep space and the images lack depth perception.

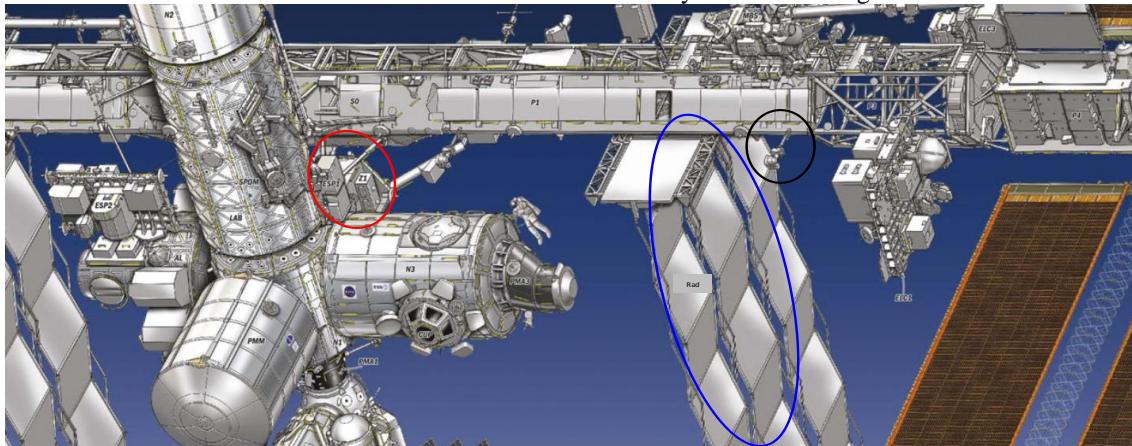
While watching the white flakes through the P1 EHDC, they appeared to be originating from the P1 EATCS as they moved across the screen. However, one of the spare Pump Flow Control Subassembly (PFCS) and a decommissioned ammonia system, Z1, were in the same direction of the P1 EATCS relative to the camera, as shown in Figure 6. Both the spare PFCS and Z1 contain ammonia and could be contributors to the white flakes if the ammonia in those systems began leaking to space. At the time, NASA was unable to rule out those locations as suspects since there was a lack of telemetry insight into their ammonia inventory. Thus, the P1 EATCS, the spare PFCS located on the ISS US Laboratory Module and Z1 located on top of ISS Node 1 could be the source of the white flakes. Ultimately, it could not be determined at the time of the white flakes where they were emanating from.

Figure 6. Location of the P1 EATCS Radiators circled in blue, Z1 and the PFCS circled in red, P1 EHDC circled in black

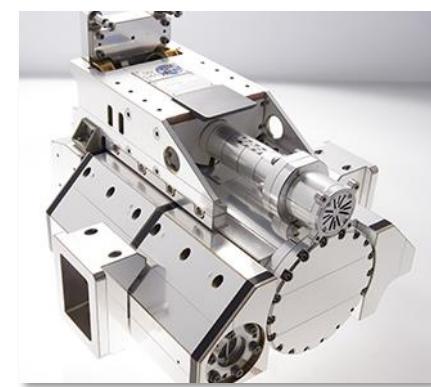
that can be used in conjunction with the ISS Robotic capabilities to remotely detect various gases and measure their pressures in a vacuum, as shown in Figure 7. RELL consists of a Residual Gas Analyzer and a Cold Cathode Ion Gauge and is capable of detecting molecules up to 100 atomic mass units (amu). RELL can measure pressures from standard atmosphere to as low as $1E^{-12}$ torr, and was certified to be able to detect ammonia leaks³ from $1E^{-3}$ lbm/year ($4.5E^4$ kg/year) to $1E^4$ lbm/year ($8E^3$ kg/year). A flight ready RELL unit is shown in Figure 8.

Figure 8. RELL.

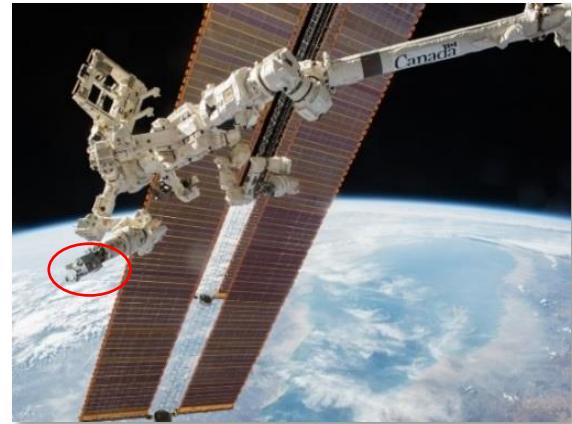
Figure 7. RELL (circled in red) attached to the ISS Robotic Arm in December 2016.

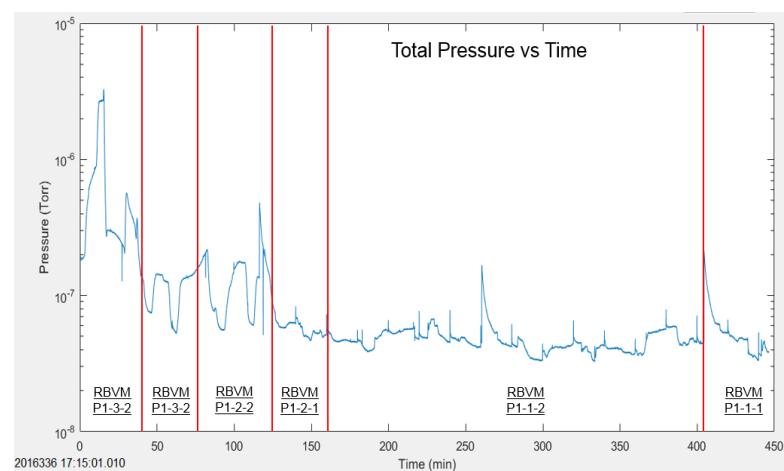
RELL detected significant pressure readings around the P1 EATCS. The spare PFCS and Z1 pressure readings were low and in the same order of magnitude as what was measured during the natural background scans. Though not entirely conclusive, these results increased the team's confidence that the white flakes were ammonia which had originated from the P1 EATCS. RELL proceeded to scan locations around the P1 EATCS that the teams thought could be possible sources of the ammonia leak. This included the Pump Module, the ATA and the three radiators. The highest pressure readings were around the P1-3 radiator, and a more close up scan measured similar pressures of ammonia in the area of the P1-3-2 RBVM, as shown in Figure 9 also in the dotted

Figure 9. Total pressure versus time of all scans performed on the RBVM on the P1-1, P1-2 and P1-3 Radiators.

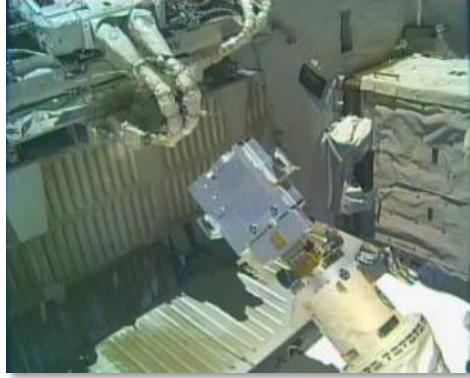
Figure 10. RELL scanning the P1-3 RBVM #2 Flexible Jumper Hose Assemblies.

Because of the success of the first round of remote RELL scanning, scans were again performed in the area of the P1-3-2 RBVM in February 2017, as shown in Figure 10. This included the P1-3-2 RBVM itself, the supply and return flexible jumper hose assemblies that connect the RBVM to the P1-3 radiator, and the supply and return ammonia hard-lines leading up to the RBVM that are underneath the jumper hose assemblies. Figure 11 graphically shows the RELL scanning grid and a visualization of the pressures measured using contour maps. The contour map was colored on a range from blue to yellow, with yellow corresponding to higher pressures and blue corresponding to lower pressures.

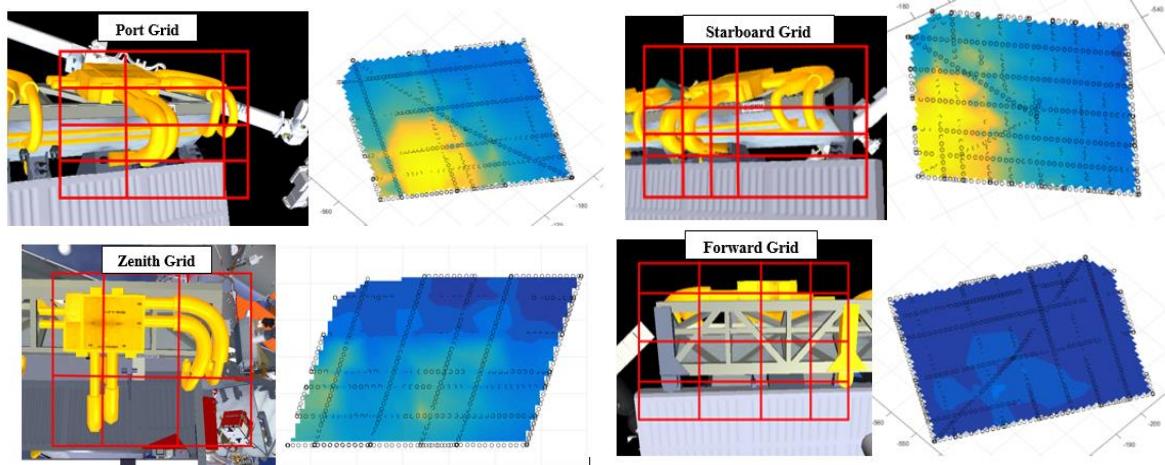
The port and starboard grids showed the highest pressure in the area of the supply and return jumper hose assemblies. However, directly underneath those two jumper hoses are supply and return ammonia hardlines coming to and from the system. Having hardware that is in close proximity or overlapping provides an additional layer

Figure 11. Pressure contour maps for each of the grid scans performed in February 2017

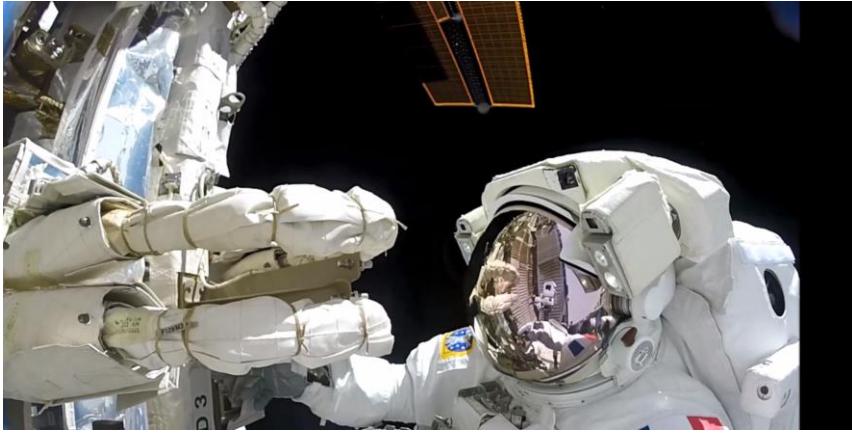
Figure 12. A screenshot from the EVA GoPo during the inspection of the P1-3-2 RBVM Supply and Return Flexible Jumpers.

During the EVA, no white flakes were reported by the crew, nor were there any other signs that implicated either of the two flexible jumper hose assemblies over the ammonia lines underneath them. Figure 12 is a screenshot of the footage taken during the EVA from the GoPro Camera. However, after further review of the GoPro HD video following the completion of the EVA, the teams observed multiple tiny white flakes emanating directly from one of the two hose assemblies. This was the final piece of evidence to have high confidence that the leak and the source of the white flakes was indeed from one of the two jumper hose assemblies.

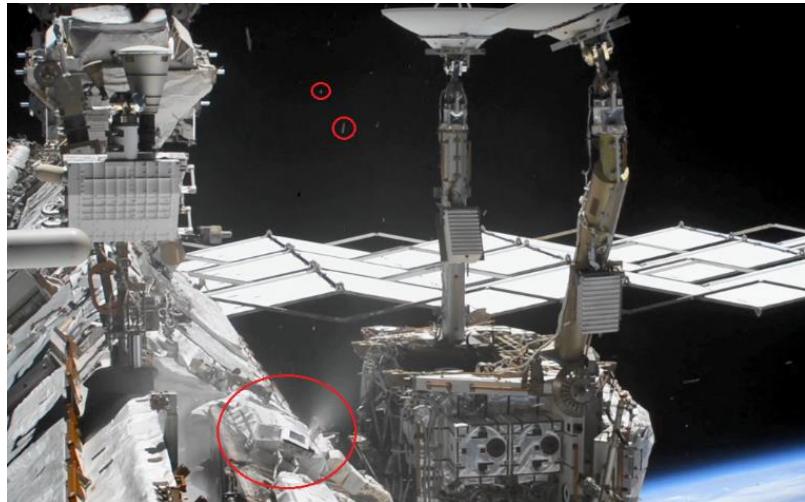
An ammonia venting analysis was performed to determine the amount of time the P1-3-2 RBVM would need to remain in the vent position to ensure all the ammonia was evacuated⁵. The results concluded that the RBVM should remain in the vent position for no less than one hour, but the teams recommended to leave it in the vent position for no less than 24 hours for conservatism. The ammonia venting operation occurred in May 2017. Figure 13 is a screenshot of the video recorded from the ammonia venting operation. The actual time that the RBVM remained in the vent position was around 22 hours before it was closed. The vast majority of ammonia quantity vented in the first 15 minutes.

Figure 13. Ammonia vent of the P1-3 Radiator Flow Path #2. Ammonia particles and the RBVM are circled in red.

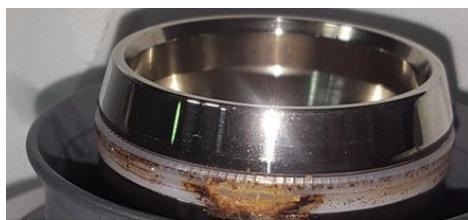
The first step in the TT&E was to conduct a visual survey of the two flexible jumper hose assemblies. For the supply hose assembly, there were no signs of structural issues for the jumper hose itself. The two QDs on each end of the supply hose assembly appeared almost pristine, as shown in Figure 15. However, this cannot be said for the return flexible jumper hose assembly. Though no structural issues were observed for the jumper hose itself, there was noticeable brown colored residue found on the secondary spool seals on both QDs, as shown in Figure 16. This was observed on the visible exposed seals, however the aft primary and secondary spool seals located on the aft end of each QD cannot be observed without disassembly.

A sample of the residue was taken and sent to a Materials and Processes (M&P) lab where detailed examination could be conducted. Lab results revealed the material consisted of non-volatile residue (NVR) which included silicone grease classified as polydimethylsiloxane, and many other compounds typically found in NVR for systems of this nature. While the ammonia used in the EATCS is certified to a 99.998% purity, the amount of NVR found in the sample was consistent with the amount that is allowed in ammonia. When ammonia leaks through seals or other interfaces into the vacuum of space and changes phases from liquid to gas, the NVR is typically left behind at the leak site. The larger quantity of residue found in these QDs indicated the possibility of their role in the P1 EATCS leak, but were not a conclusive indicator of the prime leak site.

Figure 16. Return Hose Assembly QD Forward Secondary Seal.

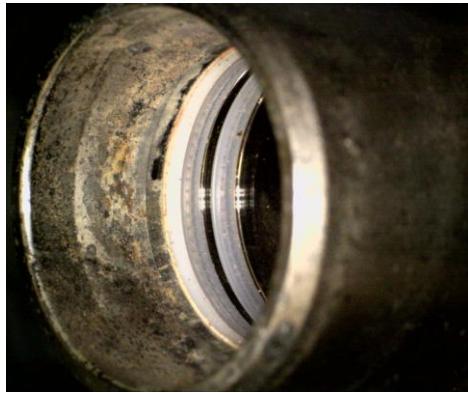
Figure 17. Return Flexible Jumper Assembly QD Aft Spool Seals.

Disassembly of the failed QDs took place with the help of the hardware vendor in March 2019, and initial indications are that the suspect aft spool seals were indeed responsible for the majority of the leakage experienced on ISS. A significant quantity of brown deposits, as shown in figure 17, were seen just down-stream of the enclosed aft seals and further analysis of the deposits and examination of surfaces

To regain full capacity of the P1 EATCS radiator heat rejection system on ISS, it was highly desired to obtain replacement hose assemblies and get them relaunched to ISS sooner rather than later. The ISS Program approved the refurbishment of both jumper assemblies that were returned from ISS. For the supply hose assembly, refurbishment was fairly straightforward since it was basically in pristine condition and only needed retest and leakage verification prior to relaunch to the ISS. For the return path jumper hose, the QDs from both ends were removed and replaced with new QDs, but the jumper hose itself was cleared to be reused as-is. Both refurbished hoses were launched in April 2019 and are planned to be reinstalled via EVA in 2020. Assuming reinstallation goes well and no additional problems are experienced, it is hoped that this will regain the use of the additional cooling capacity of the P1-3-2 radiator flow path.

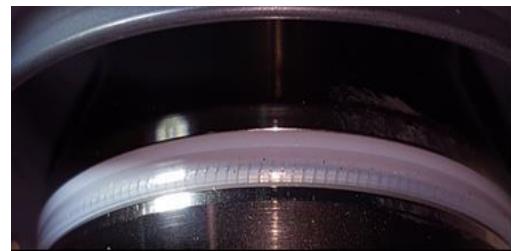
Figure 15. Supply Hose Assembly QD Forward Secondary Seal.
