The International Space Station (ISS) Port 1 (P1) External Active Thermal Control System (EATCS) Ammonia Leak

Darnell T. Cowan, Timothy A. Bond
and Jordan L. Metcalf
NASA Lyndon B. Johnson Space
Center (JSC)

Thermal & Fluids Analysis Workshop
TFAWS 2019
August 26-30, 2019
NASA Langley Research Center
Hampton, VA

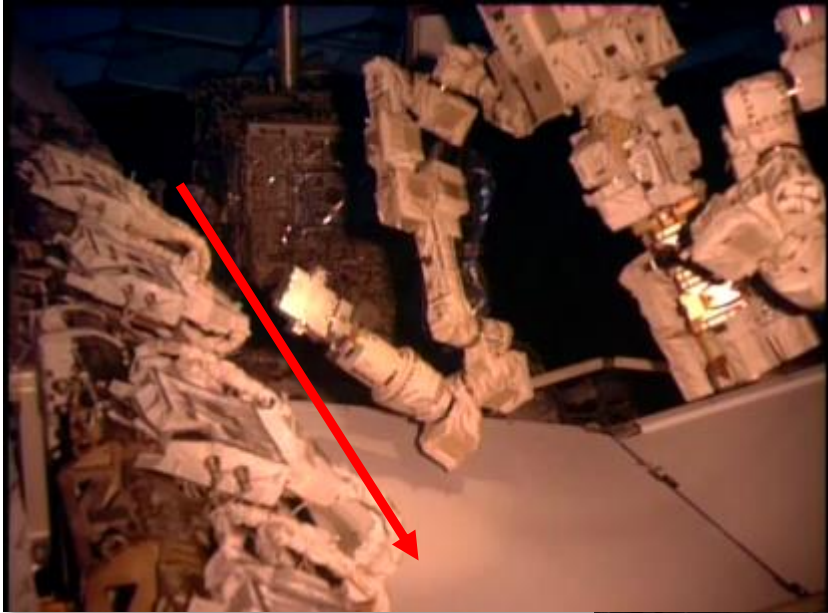
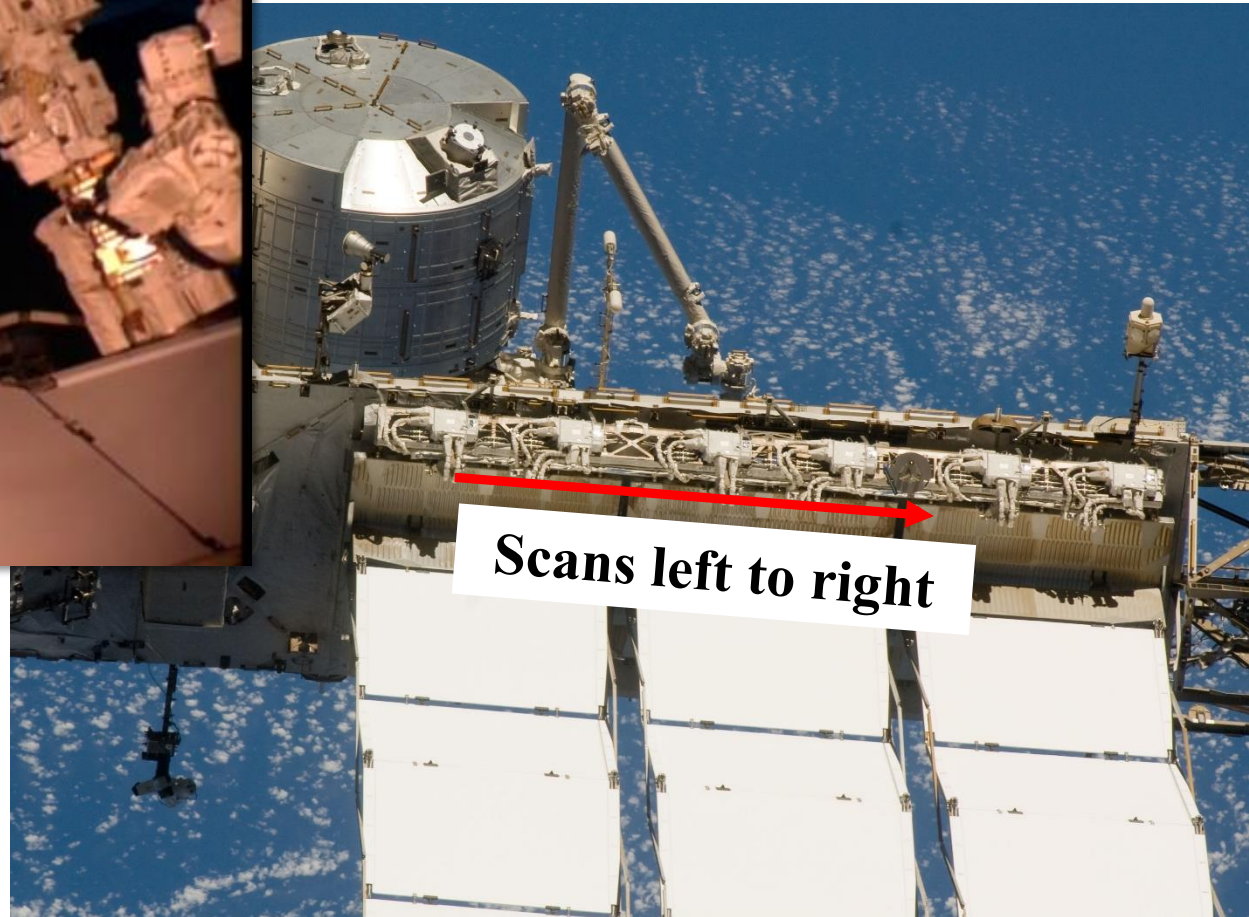
- P1 ISS EATCS Radiator Beam Valve Modules

- Noticed total pressure spike at P1-3-2 RBVM on order of $\sim 5E-5$ torr
- Low levels of ammonia around other RBVM $\sim 5E-7$ torr
- Partial pressure from RGA correlated with ammonia

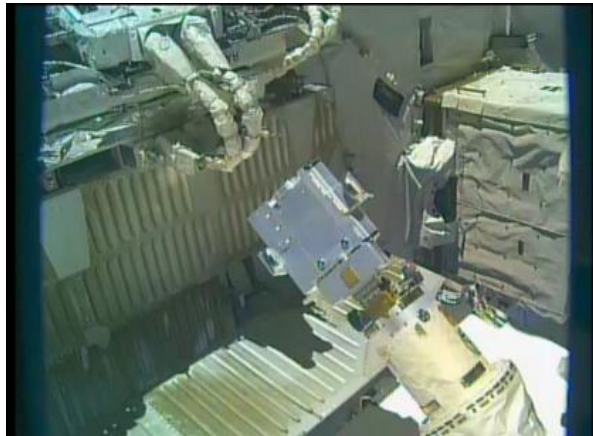
Highest Pressures @ P1-3-2 RBVM to the radiator jumper hoses, and the hard lines underneath

Pressures E-5 torr ~ 50 lbm/year (22.6 kg/year)

- Inspections of the RBVM jumpers hoses and system lines performed during an EVA in March 2017
- Nothing noteworthy observed from the crew
- Post EVA review, multiple white flakes seen from EVA GoPro video

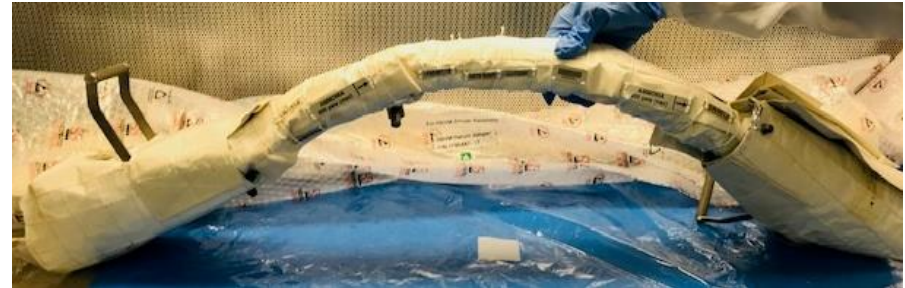
Female QD

- 1" supply and 3/4th return hose
- Each hose contains two female Quick Disconnects (QD)
- Each QD contains multiple seals
- Some seals are not visible without significant QD disassembly

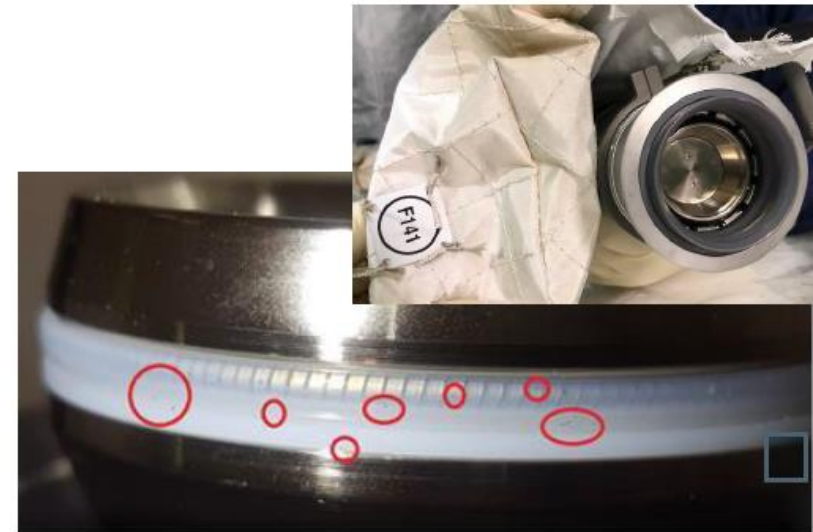
F141 QD secondary seal

- Inspection shows the 1" supply hose looked good
- Barely failed Leakage requirement of 1 E-4 sccs of Helium at 500 psia (3447 kPa)
- Considered acceptable to be reused "as is", and returned to the ISS in April 2019

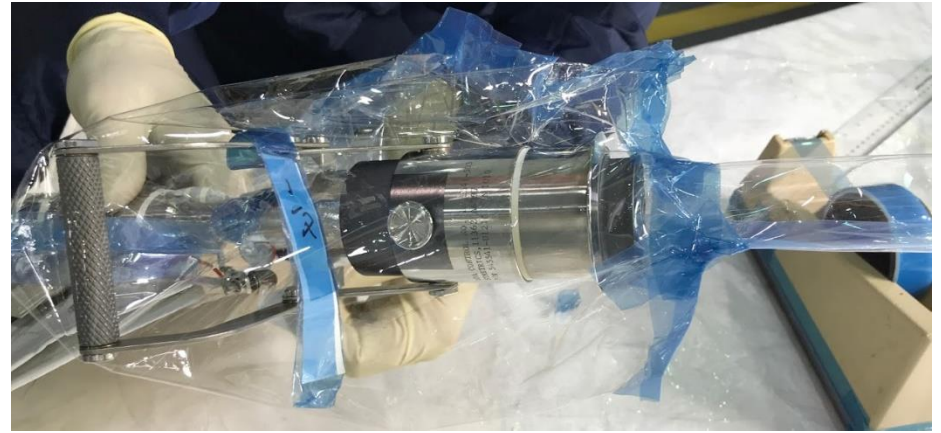
- Forward half QD F128 failed the leakage requirement at $2.2E-1$ sccs of Helium at 500 psia (3447 kPa)
- Aft half failed at 0.5 sccs of Helium @ 500 psia (3447 kPa)
- QDs removed for additional TT&E
- New QDs installed, hose assembly launched to the ISS in April 2019

- Appears aft spool seals of QD F128 were responsible for the majority of the P1 EATCS leak
- Further analysis of the deposits and examination of surfaces is planned in the near future
