Post-test Microstructural Analysis of Particle Impact-Tested Wrought Inconel, Additively Manufactured Inconel and Wrought Monel Targets

Ngozi C. Ochoa¹
Jonathan M. Tylka

*¹Materials Engineer Co-op, Jacobs Technology Test2 Contract
NASA Johnson Space Center White Sands Test Facility
P.O. Box 20, Las Cruces, NM 880042*

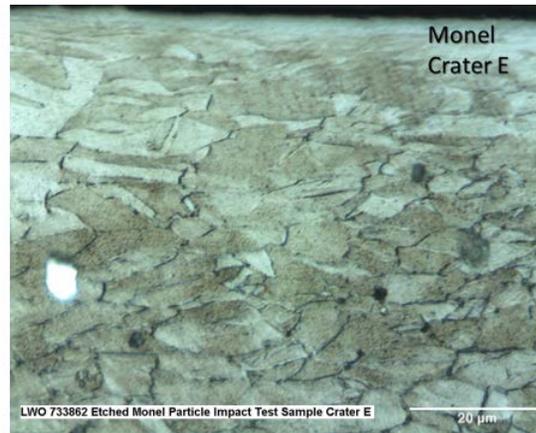
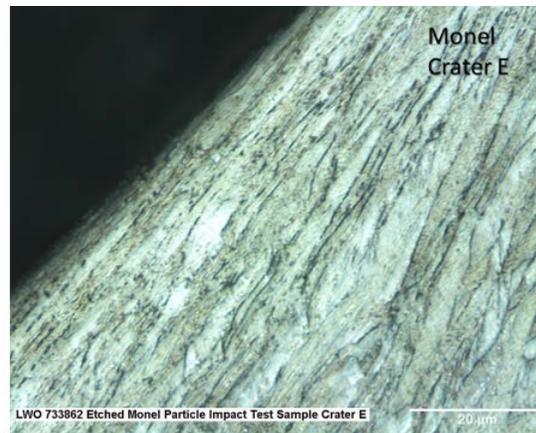
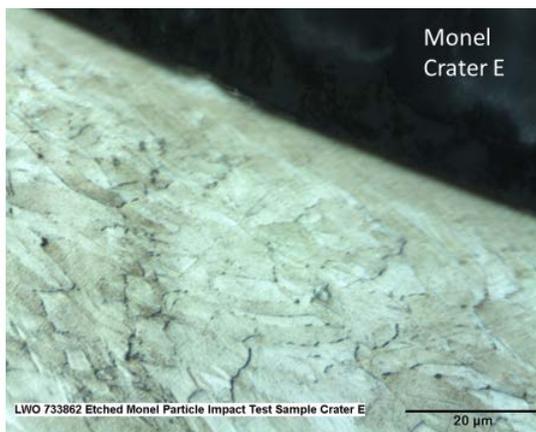
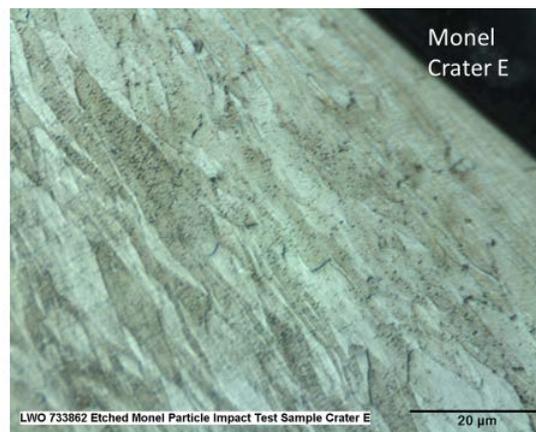
FIG. 20 – Monel 400 particle impact test target microstructure adjacent to (a)-(b) Crater E floor, (c)-(f) Crater E walls.

For the Monel sample, an elongated grain structure was observed along the surface edge adjacent to the crater interface except for at the crater floor, where a more equiaxed grain structure was apparent. A microstructural gradient was present along the crater edge. At the crater floor, a microstructure of slightly elongated grains transformed into a more equiaxed, fragmented grain structure. Moving away from the crater floor, evidence of deformation increased as well-defined, elongated grains were more apparent.
