Completion of the Long Duration Wear Test of the NASA HERMeS Hall Thruster

Jason D. Frieman¹, Hani Kamhawi², Jon Mackey³, Thomas Haag⁴, Peter Y. Peterson⁵, and Daniel A. Herman⁶
NASA Glenn Research Center, Cleveland, OH, 44135, USA

The NASA Hall Effect Rocket with Magnetic Shielding (HERMeS) 12.5-kW Hall thruster has been the subject of extensive technology maturation by NASA GRC and JPL in preparation for development into a flight propulsion system. As part of this effort, a series of wear tests have been conducted to identify erosion phenomena and the accompanying failure modes as well as to validate service-life models for magnetically-shielded thrusters. This work presents a summary of the results obtained during the Long Duration Wear Test (LDWT), which was the third in this wear test series. The LDWT accumulated approximately 3,570 hours of operation and had the overall goal to identify and correct design or facility issues prior to the flight qualification campaign. Thruster performance, stability, and plume properties were invariant throughout the duration of the LDWT and consistent with measurements acquired during previous HERMeS performance and wear characterizations.

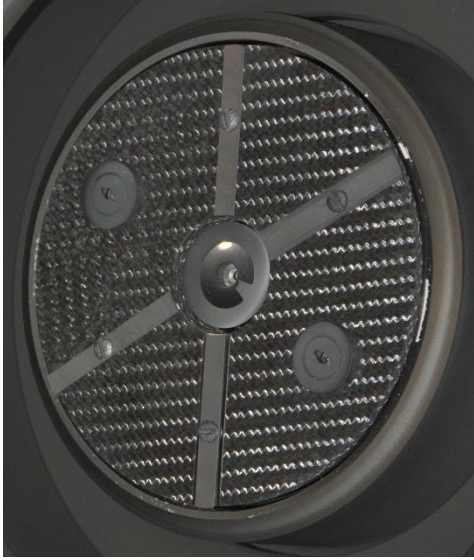
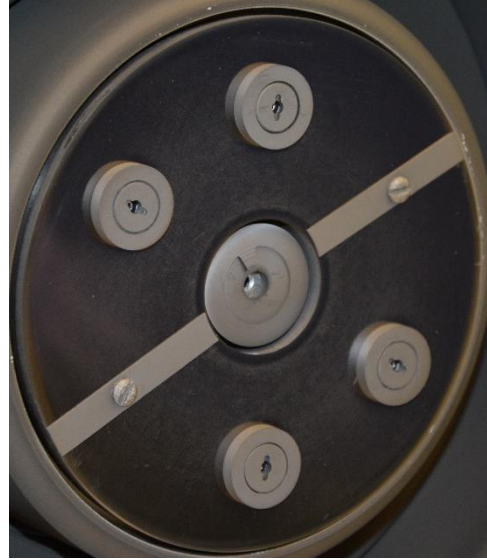
Fig. 5 IFPC configurations used during Segments (a) V and (b) VI of the TDU-3 LDWT.

The IFPC configuration used during Segment V of the LDWT is shown in Fig. 5(a). The IFPC is made of a carbon-carbon composite instead of the graphite used for the other LDWT segments. Identical masks to those used during the other LDWT segments were installed at the 12 o'clock and 8 o'clock positions while a pair of bushings were installed at the 4 and 10 o'clock positions [7]. Similar to the approach taken with the molybdenum strips during the SDWT, two grooves were incorporated into the C-C IFPC to accommodate a pair of graphite inserts [4]. These inserts were installed in the grooves and laid flush with the downstream surface of the IFPC. In order to investigate the impact of surface finish on IFPC erosion, the insert installed at the 6 o'clock position was polished before installation whereas

the one at the 2 o'clock position was not. Unfortunately, the small size of the inserts relative to the masks precluded obtaining measurements of insert wear following Segment V. The IFPC configuration used during Segment VI of the LDWT is shown in Fig. 5(b). This configuration is identical to that used during Segments I-IV of the LDWT and is detailed in Ref. [7].

The keeper configuration used during the TDU-3 LDWT is shown in Fig. 5(b). The keeper was made of graphite and had the downstream surface polished prior to installation. A graphite ring was affixed to the outer edge of the downstream keeper face. This ring increased the diameter of the keeper to match the AEPS design and provided a masked reference surface for keeper erosion measurements. A small tab was also included as part of the mask, which protruded radially inwards towards the cathode orifice. This tab enabled an assessment of the radial variation in erosion rates across the keeper face. A new keeper was installed prior to the start of Segment V. It was re-used for Segment VI, but the mask was rotated prior to the start of that segment to expose a new region of polished graphite. This enabled direct measurements of the keeper wear for both segments.

Another possibility is that the apparent azimuthal variation is an artifact introduced by the orientation of the mask. As shown in Fig. 5(a), the radial tab was placed at approximately the four o'clock location during Segments V and VI of the LDWT. The side of the tab on which net deposition was observed was therefore approximately horizontal during these segments and faced the ceiling of the facility. Since the top of the facility contains numerous backscatter sources (e.g., pumps, carbon paneling, etc.), the observed net deposition could also be due to a flux of carbon from these sources with a preferential downward angle. However, the keeper mask was oriented with the tab at the 12 o'clock location during Segment I. Thus, although it is a plausible explanation for the net deposition observed during Segments V-VI, this preferential downward flux of carbon cannot explain the azimuthal variation shown in Fig. 13. Taken together, this suggests that the azimuthal velocity component of eroding ions is important for understanding HERMeS cathode keeper wear.

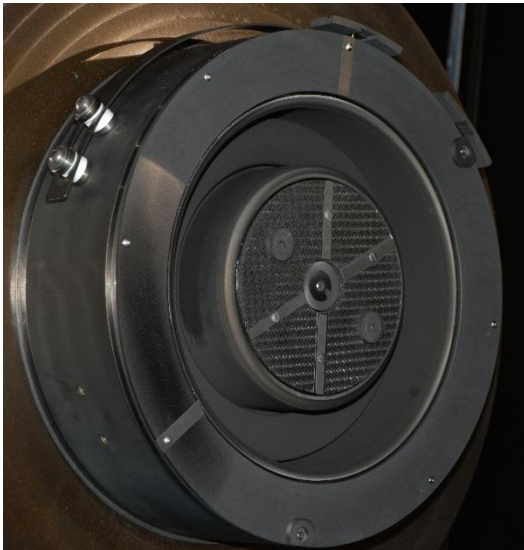
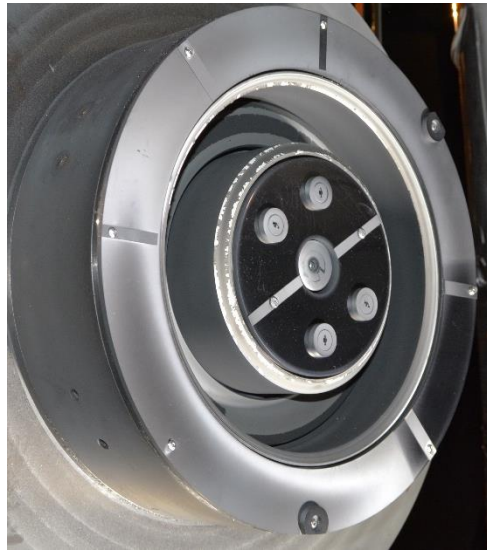
Fig. 6 OFPC configurations used during Segments (a) V and (b) VI of the TDU-3 LDWT.

The OFPC used during Segment V of the LDWT is shown in Fig. 6(a). The OFPC was made of graphite and had the region between 7 and 10 o'clock polished pre-test. Two masks were installed at the 12 o'clock and 9 o'clock positions. These masks and OFPC configuration were identical to those used during the SDWT and previous LDWT segments [4, 7].

Segment VI reused the graphite OFPC from Segment IV [7]. As shown in Fig. 6(b), the 3 to 4 o'clock region of this OFPC was polished pre-test. Two masks were installed over the polished region at the 3 and 4 o'clock positions. An additional mask was installed over the unpolished region of OFPC at the 10 o'clock position. It is important to note that this is the only pole cover used during the LDWT to undergo re-polishing between test segments and that the mask at 10 o'clock was installed over a region of the pole cover that was never polished.

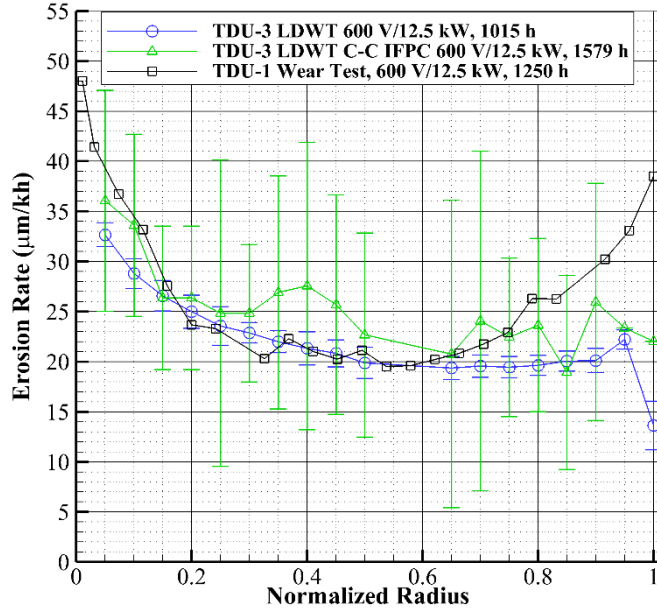
Fig. 10 IFPC erosion rates measured using a C-C IFPC during Segment V of the TDU-3 LDWT.

The average erosion rate of the C-C IFPC used during Segment V of the TDU-3 LDWT is shown in Fig. 10 along with comparable results acquired with graphite covers during the TDU-1 wear test and Segment I of the LDWT. In Fig. 10, a normalized radius of 0 corresponds to the edge of the IFPC closest to the cathode whereas a radius of 1 corresponds to the edge closest to the discharge channel. The truncation of the LDWT data near the inner IFPC edge is due to the fact that the employed masks only covered approximately 95% of the IFPC.

Overall, the erosion rates of the C-C IFPC are azimuthally symmetric and match those obtained with graphite pole covers to within the experimental uncertainty. The larger uncertainty associated with the C-C IFPC measurements is primarily due to the woven construction of the C-C composite. This weave results in increased surface roughness and the presence of surface features (e.g., gaps) equal in dimension to the steps introduced by erosion that are not present in the polished graphite covers. Despite these changes, the measurements indicate that the average erosion rates of the C-C IFPC match those of graphite pole covers.

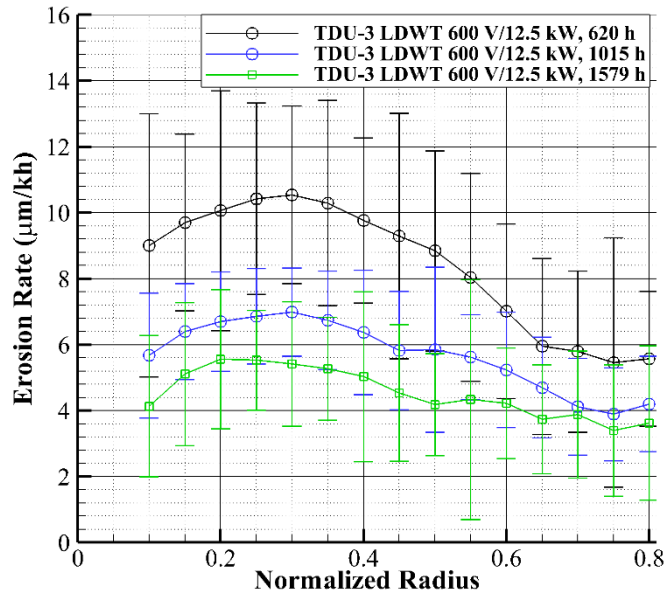
Fig. 11 OFPC erosion rates measured at RFC 5 during the LDWT.

Figure 11 shows the OFPC erosion rates measured during the LDWT as a function of normalized OFPC radius. In Fig. 11, a normalized radius of 0 corresponds to the edge of the OFPC closest to the discharge channel whereas a radius of 1 corresponds to the outer edge of the thruster. The truncation of the data near the inner edge is due to the fact that the employed masks do not cover the entire width of the OFPC. Near the outer edge, the mask fastener interfered with the unexposed reference surface, thus precluding data analysis in this region.

Consistent with IFPC measurements presented in previous work, the mean OFPC erosion rates measured at RFC 5 show an apparent decrease with operating time [3, 7]. Specifically, the radially-averaged erosion rates decreased by approximately 46% between the measurements taken after 600 hours and 1579 hours of operation. However, unlike with the IFPC, this decrease is within the uncertainty of the measurement.

Previous work has suggested that this observed decrease in erosion rates over time is actually caused by changes in pole cover surface finish during operation [7]. Specifically, although polished pre-test, the graphite pole covers have been observed to roughen after plasma exposure. Once roughened, the results in Fig. 11, suggest that the erosion rates of the OFPC decrease.

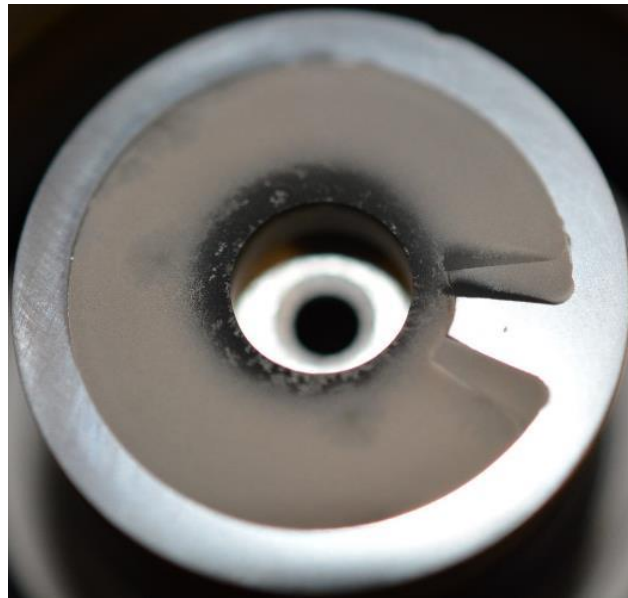
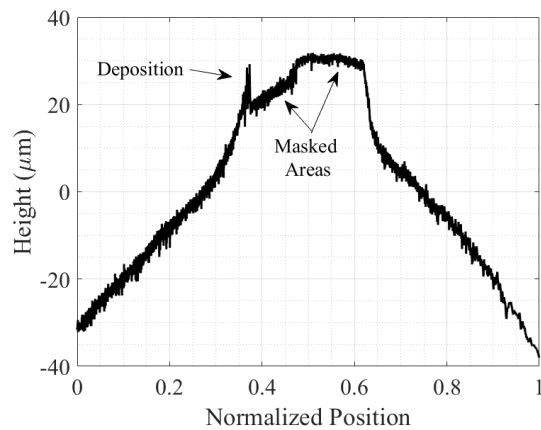
Fig. 12 A (a) photograph, (b) 3D surface scan, and (c) profile of deposition observed on the keeper after Segment VI of the LDWT.

Two features of note were observed during the keeper wear assessment performed after Segment VI. First, net deposition with a thickness of approximately $1\ \mu\text{m}$ was observed around the keeper orifice. This deposition is shown by the dark ring surrounding the orifice in Fig. 12(a) and the rough peaks in the 3D surface scan of the near-orifice region in Fig. 12(b). This is quite different from the net erosion observed at all other radii, but it does match observations made during the TDU-1 wear test.

A region of net deposition was also observed on one side of the radial tab that protruded inwards from the keeper mask. This deposition is shown by the dark triangular region near the unexposed keeper region at the 3 o'clock position in Fig. 12(a). Evidence of deposition is also visible in the azimuthal profile extracted from this region and shown in Fig. 12(c). Specifically, the hill adjacent to the leftmost masked region represents the net deposition observed during Segment V of the LDWT. The two heights visible in the masked region of the profile in Fig. 12(c) were caused by the rotation of the keeper mask between Segments V and VI. Specifically, the lower region corresponds to the keeper region masked for Segment V and exposed for Segment VI, whereas the higher region was masked for both segments. This height change obfuscates the measurement of the deposition that occurred during Segment VI, even though a second dark region is visible adjacent to the masked region in Fig. 12(a).

It is important to note that deposition was only visible on one side of the keeper mask. One possibility is that this was due to azimuthal variation in the process driving keeper erosion. Further evidence of this is shown in Fig. 13, which depicts a sample keeper profile obtained at the end of Segment I of the LDWT. Although a clearly defined step between the masked and unmasked keeper regions is visible to the right of the masked region, almost no step is detectible on the left side of the masked region. This is different from profiles acquired on the IFPC, which have nearly identical steps on both sides of the mask. However, it does match the trends observed during the SDWT [4].
