Experimental Study on Mitigation of Lifetime-Limiting Dielectric Cracking in Extreme Temperature 4H-SiC JFET Integrated Circuits

D. J. Spry¹, P. G. Neudeck¹, and C. W. Chang²

1 NASA Glenn Research Center, 21000 Brookpark Road, M.S. 77-1,
Cleveland, OH 44135 USA

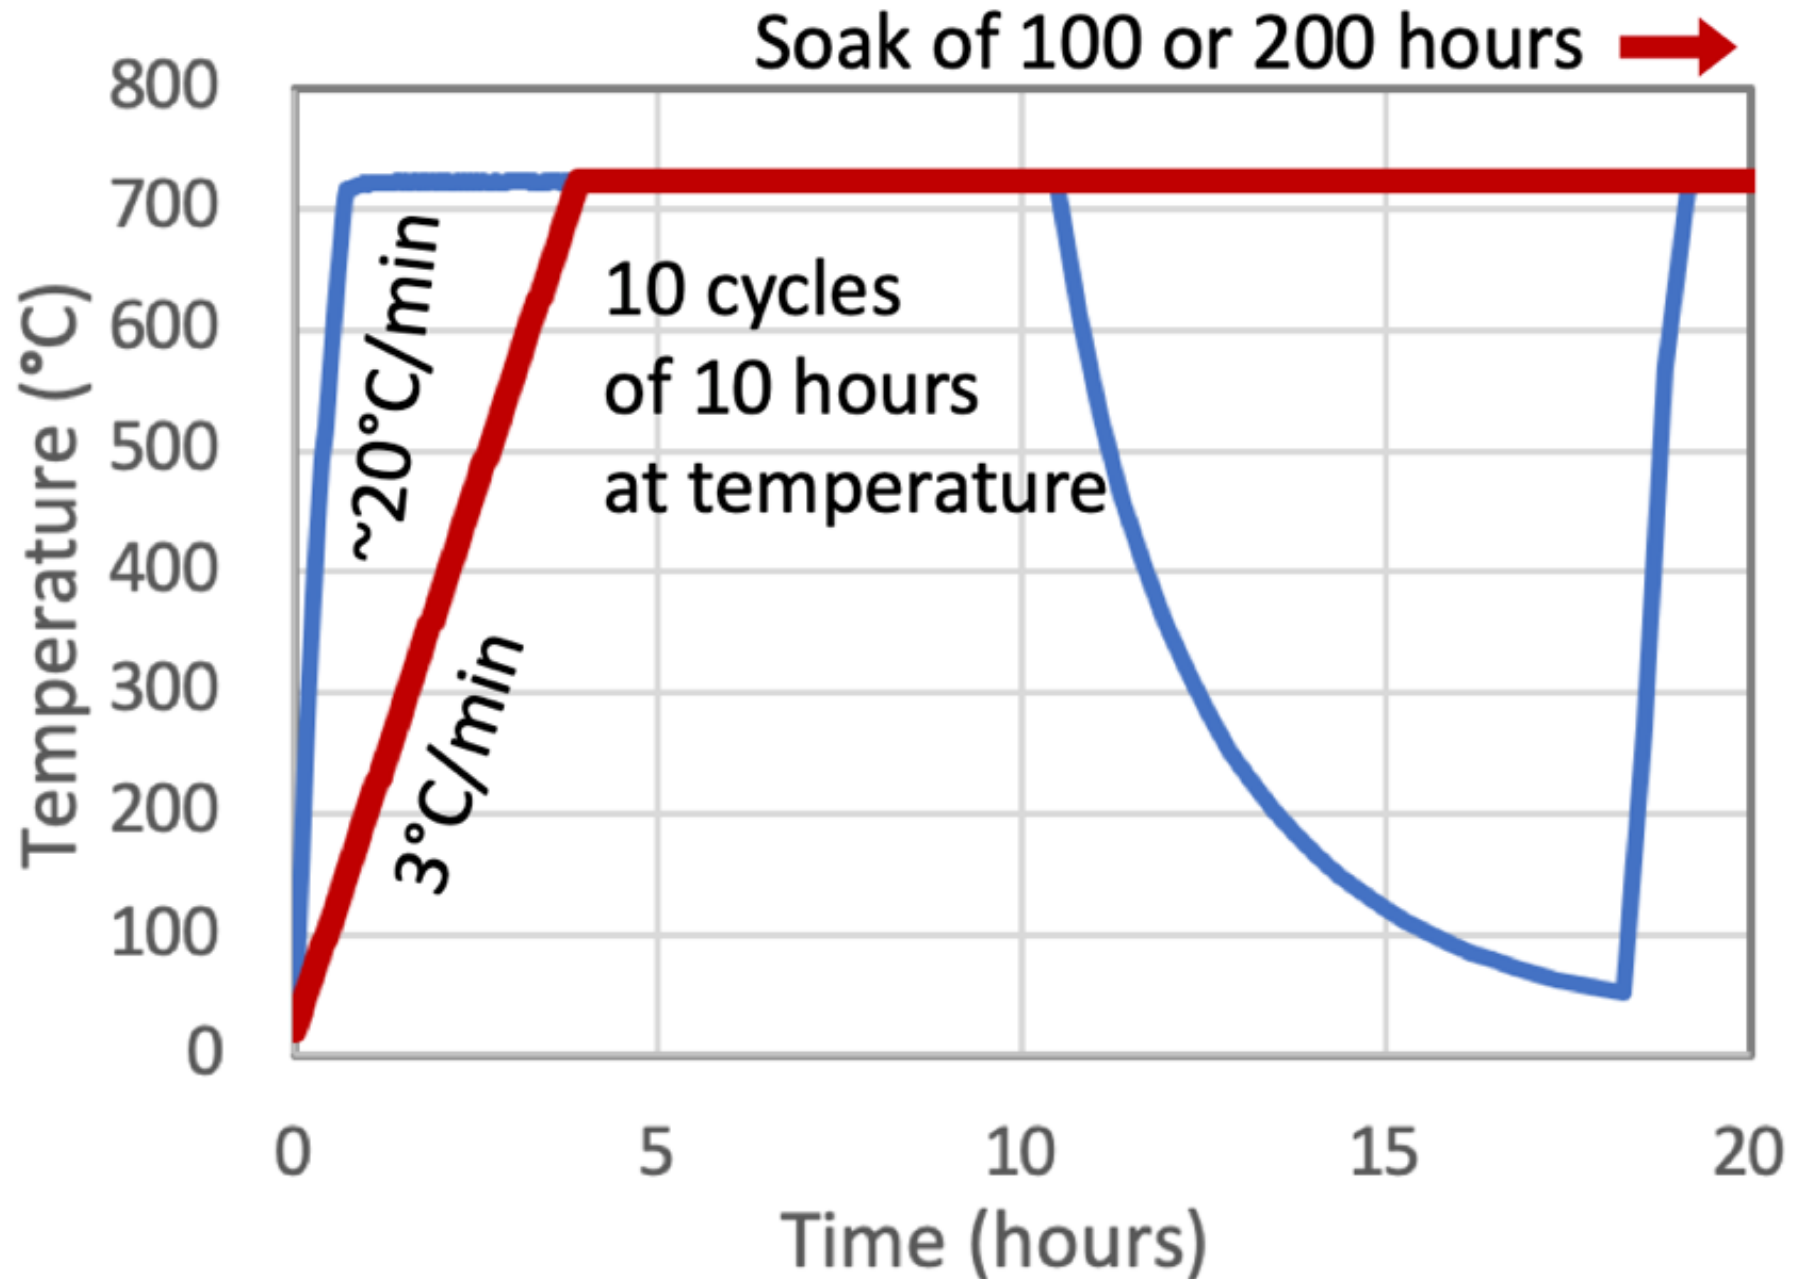
10 cycles 10 hrs. / 100hrs. / 200hrs.
500, 600, 720, and 800 °C
