Root Cause Classification of Breakup Events 1961-2018

P. Anz-Meador⁽¹⁾

⁽¹⁾Jacobs, NASA Johnson Space Center, Mail Code XI5-9E, 2101 NASA Parkway, Houston, TX 77058, USA
Phillip.d.anz-meador@nasa.gov

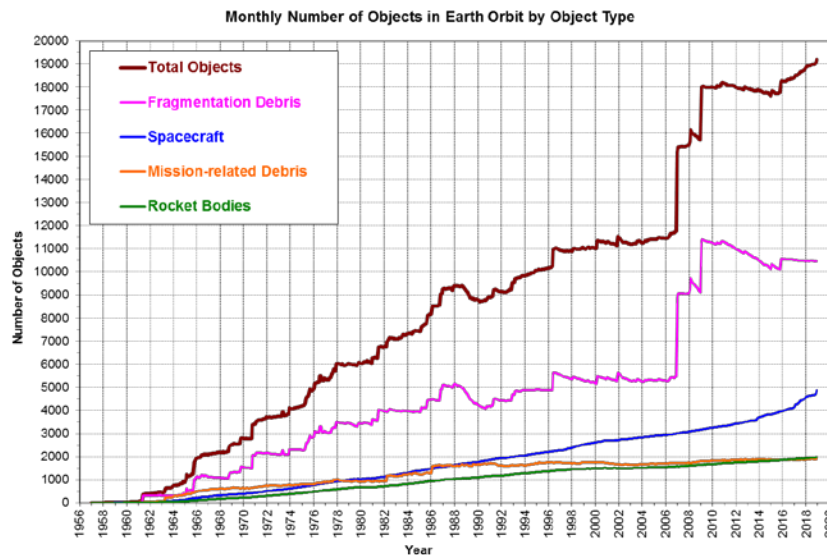
Fig. 1. The growth of debris populations over time. Major breakups show sudden “jumps” at the date of breakup.

Figure 1 shows the growth over time in the number of catalogued objects, including debris. Note that for the purposes of this chart, debris objects that were identified and catalogued by the U.S. Combined Space Operations Center (CSPOC) some length of time after the breakup (even years later) were “back filled” to the time of breakup. Large breakups show “jumps” in number, with a gradual decay as the debris are gradually removed from the environment due to atmospheric drag.

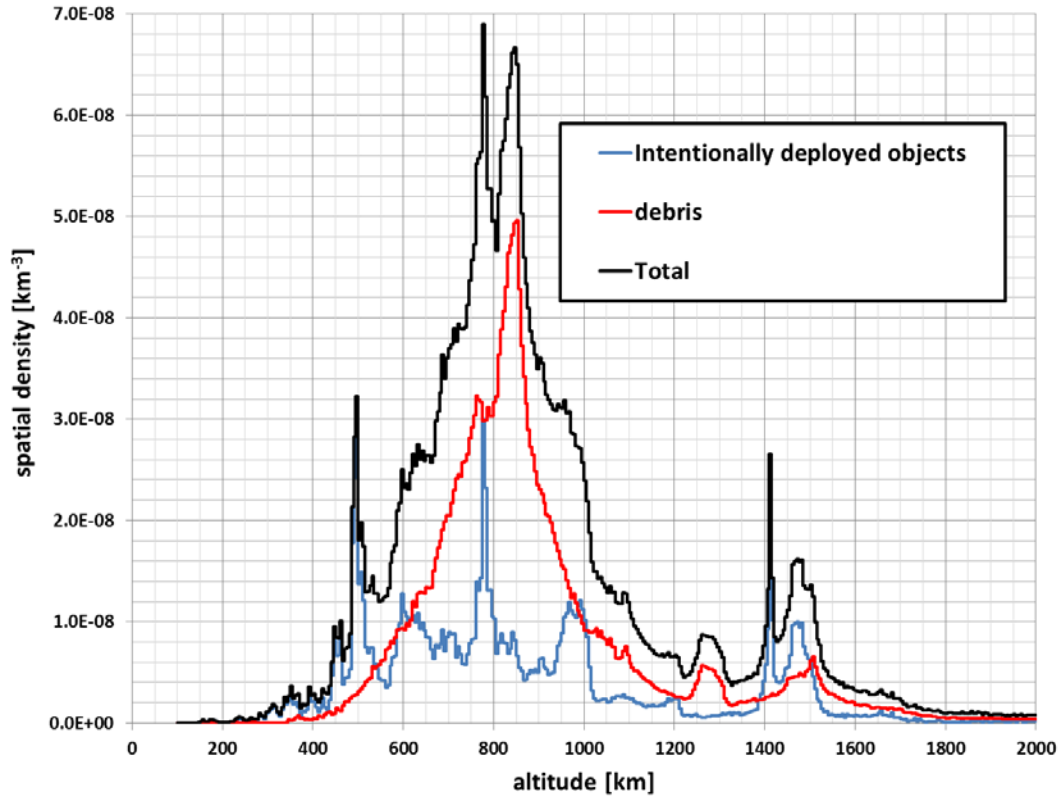
Fig. 2. The relative population of debris and intact objects at various altitudes. From about 600 km to 1400 km altitude, debris is the major contributor to the population of tracked objects (> 10 cm in size).

Another way to understand the debris distribution is to plot it as a function of altitude. Figure 2 shows this distribution of trackable objects, using the concept of spatial density – where the volume is a spherical shell around the Earth – and the number is weighted by the fraction of time the orbiting object spends at each altitude. Debris dominates the orbit population between about 600 km and 1400 km altitude.

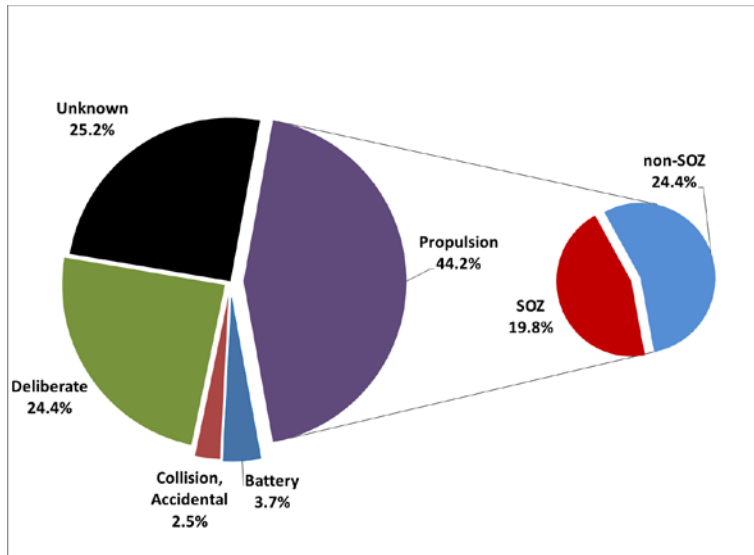
Fig. 3. This pie chart shows a proportion of various historical on-orbit breakup causes. The largest category of breakups is due to propulsion-related events, although a significant fraction of these is due to a single type of rocket body – the Russian SOZ units. Most of the deliberate events were intentional self-destruction of Russian military satellites before the 1990s. Note the significant fraction of breakups where the root cause was never uniquely identified.

Using the HOOSF data, it is possible to accrue statistics on the causes of the various breakups, as shown in Fig. 3. Note that a largest category of (known) breakups consists of propulsion-related explosions. However, nearly half of those are due to explosions of a single type of rocket body – the Russian SOZ (*Sistema Obespecheniya Zapuska*) units from Proton 4th stage ullage motors. Cause – in isolation – however, is insufficient to understand the temporal behavior of orbital debris generation, as technology, practices, and operations evolve over time. Figure 4 presents Fig. 3’s events over time.

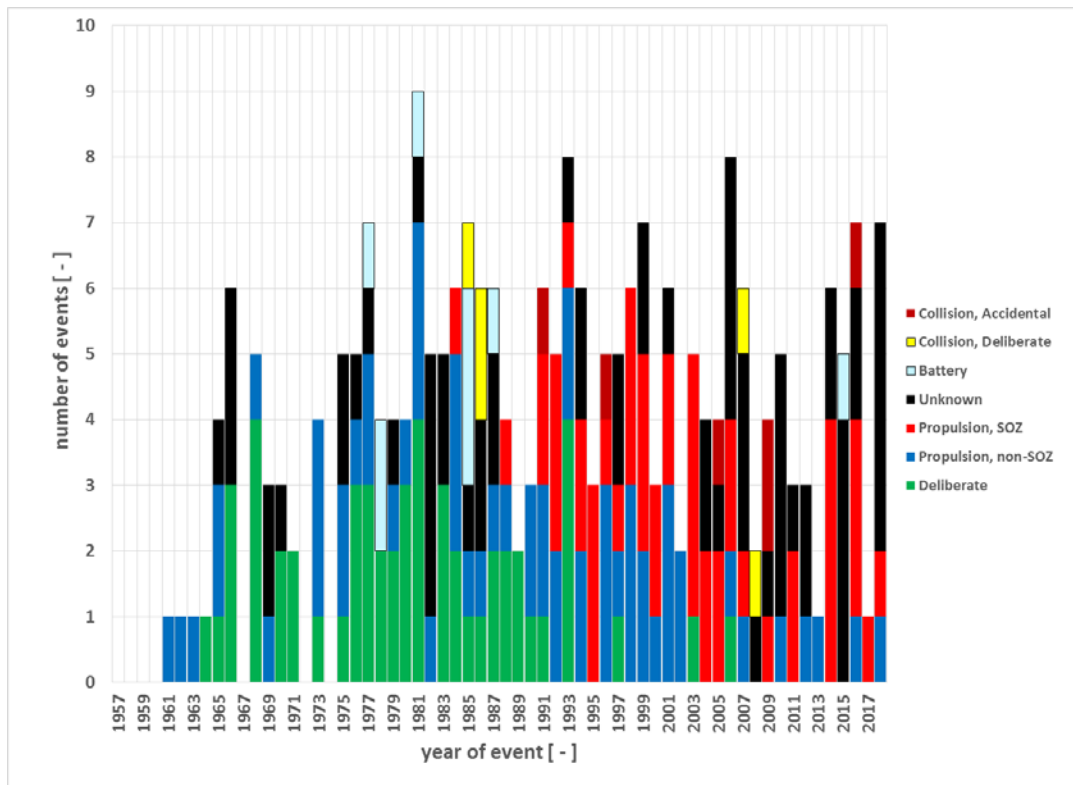
Fig. 4. Cause attribution by time. The largest category of breakups is due to propulsion-related events, although a significant fraction of these is due to a single type of rocket body – the Russian SOZ units. Most of the deliberate events were intentional self-destruction of Russian military satellites before the 1990s. Note the significant fraction of breakups where the root cause was never uniquely identified.

Figure 4 clearly identifies several salient features of debris production. Most of the deliberate breakups are due to a number of Soviet military satellite self-destruct events before the 1990s. These were motivated by payload recovery concerns (*i.e.*, payloads whose recovery within the Soviet Union was uncertain were destroyed on-orbit), apparent end-of-mission activities, or loss of signal. No deliberate explosions have occurred in the last decade. Rather, this category has been supplanted in its entirety by a lone battery-related breakup, propulsion-related explosive breakups (including those of SOZ units), and accidental collisions. Failures due to causes unknown remain a major contributor to the overall yearly totals over the last decade.

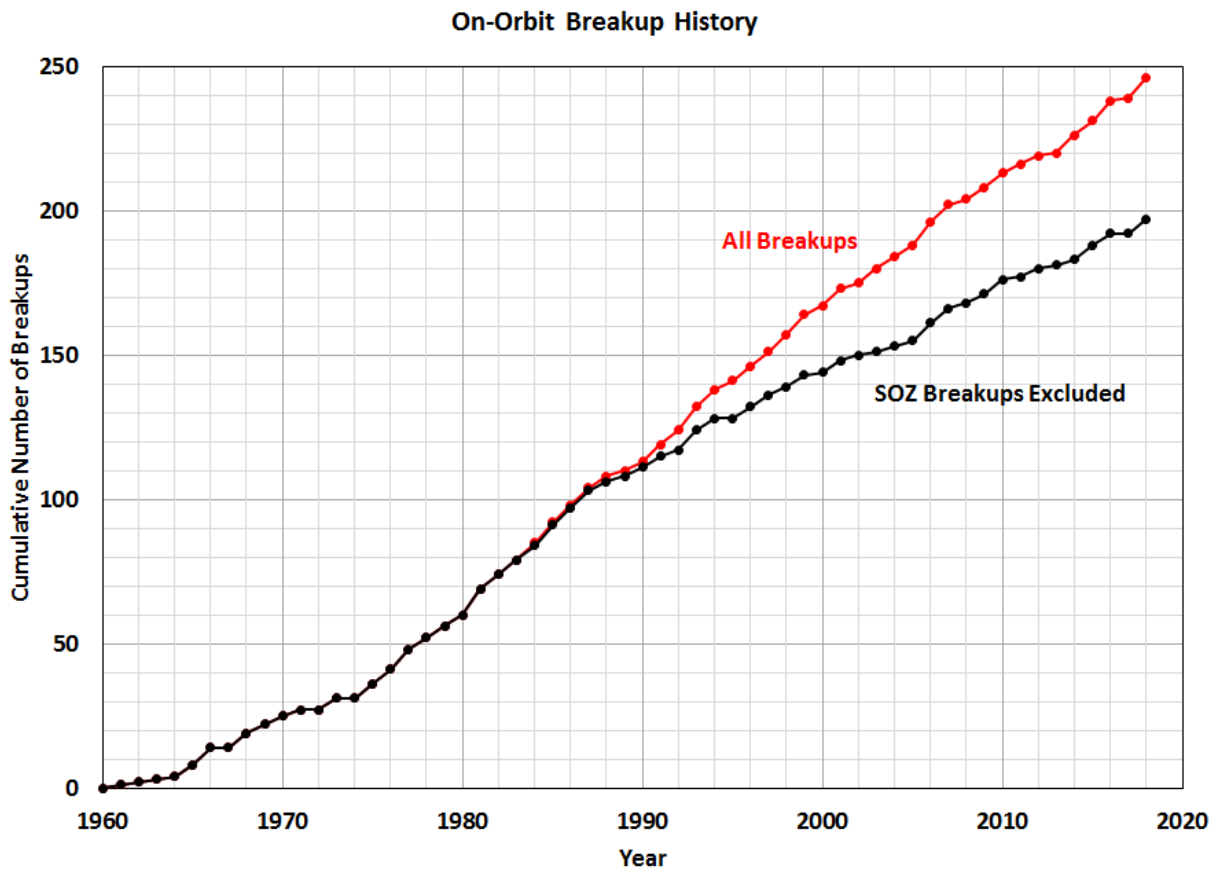
Fig. 5. Here, the data from Fig. 3 is plotted as a cumulative distribution, this time both with and without the SOZ breakups included. Note that ongoing SOZ breakups mask a noticeable reduction in explosion rates of other satellites beginning in the late 1980s. This is the time when widespread mitigation measures were implemented on a regular basis. Because the SOZ units are a “grandfathered” system (see text), they exhibit a similar slope to the steeper pre-mitigation fragmentations of the 1970s and 1980s.

It is important to note that the SOZ statistics mask the history of other types of breakups. Figure 5 shows the breakup history from Fig. 3, but in a cumulative form, plotted both with and without the SOZ breakups. In the curve without the SOZ breakups, there is a noticeable change in slope in the late 1980s that corresponds to the beginning of widespread mitigation activities, primarily due to efforts by NASA and other agencies to educate the space community and implement mitigation standard practices. In essence, the SOZ units were a “grandfathered” system with known issues, but where no mitigation changes were made. Despite the reduction in fragmentation rate due to mitigation practices, fragmentations continue, albeit at a reduced rate. When a satellite or upper stage shows a pattern of fragmentation, changes are typically made to correct the problem for future launches. However, new systems or updates of older systems are continually being deployed, which sometimes introduce new failure modes that must be remedied.

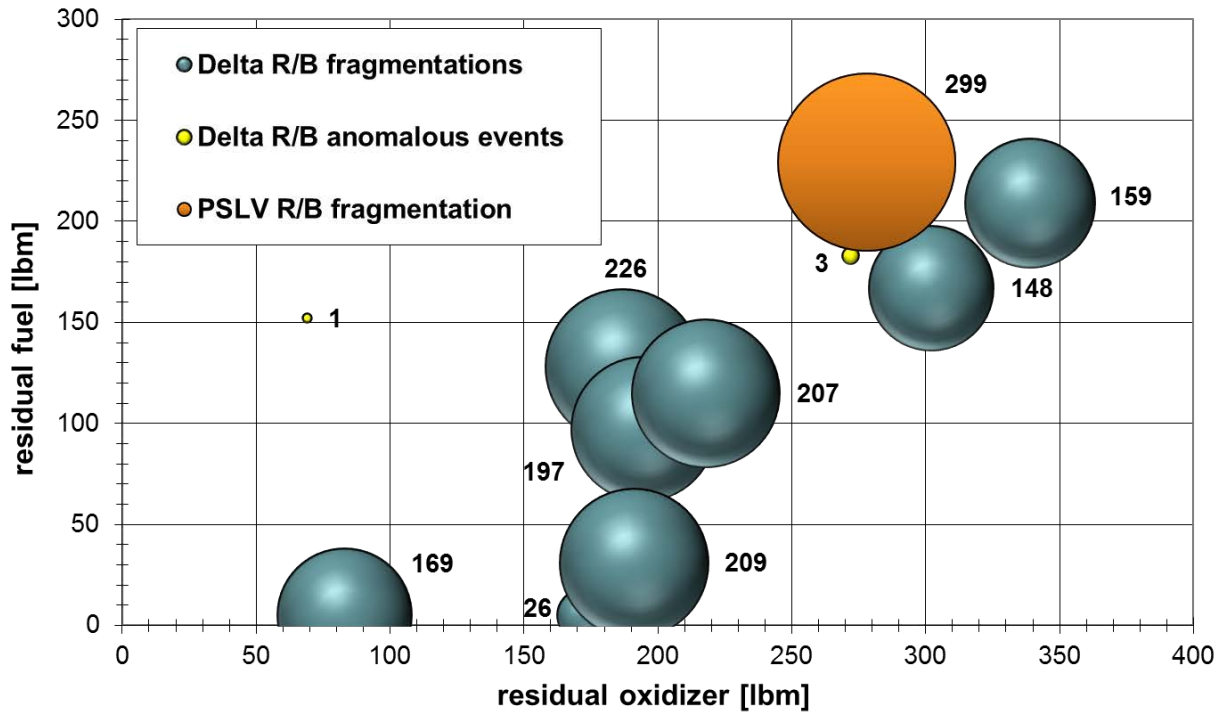
Cataloged Debris as a function of Residual Propellants

Fig. 6. The relative number of tracked debris of several explosions (shown graphically as size of the circles) as a function of both residual fuel and oxidizer. The low correlation between cloud size and amount of remaining propellants suggests a very inefficient explosion process.

The next case study concerns the U.S. Delta and Delta II second stages. The first identified fragmentation of this rocket body was Delta 62 in November 1973, and many more major LEO events followed. The manufacturer examined all available data, including estimates of the residual propellants on each stage [3], and concluded the breakups were caused by a mixing of the residual hypergolic propellants due to breaching of the common bulkhead, leading to an inefficient explosion. Studies by the NASA Orbital Debris Program Office and imaging by German radar of the Landsat 2 rocket body confirmed that large hulks remained in orbit after the breakups, corroborating the hypothesis of inefficient explosions. Figure 6 shows the debris cloud sizes of the Delta breakups (and one Indian Polar Satellite Launch Vehicle [PSLV] breakup) as a function of remaining fuel and oxidizer. The low correlation of debris cloud size to available energy also argues for inefficient mixing of the propellants in an explosion.

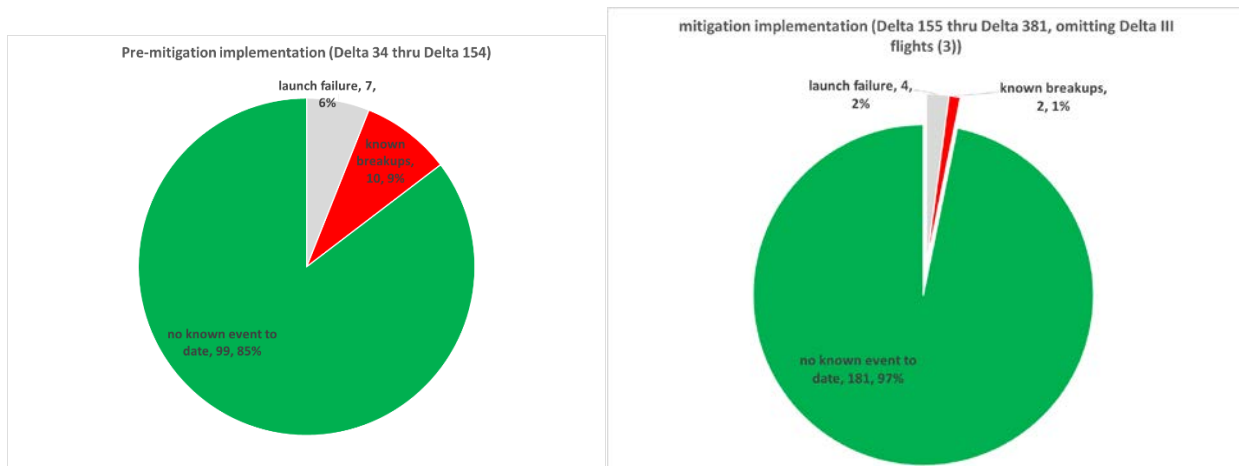
Fig. 7. Breakup events pre- (left) and post-implementation (right) of mitigation standard practices.

While no single cause fits all the historical Delta second stage fragmentation data, the highest-likelihood attribution is to mixing of hypergolic propellants through a breach in the common bulkhead separating the fuel and oxidizer tanks. With this attribution, now-standard mitigation practices were introduced with the launch of Delta 155 in August 1981. These practices consist of disabling the range safety ordnance and burning remaining propellants to depletion during a payload evasive burn or, expending propellants by starting the main engine and holding propellant valves open for one minute and venting the nitrogen-gas ullage jets for five minutes. Figures 7 and 8 illustrate the effect of mitigation procedures upon the second stage.

Prior to this mitigation-driven operational procedure, Delta flights 34–154 inclusive experienced 10 known breakups, for a 9% rate. Afterwards, Delta flights 155–381 inclusive (but omitting three flights of the Delta III model) experienced only two known breakups, for a 1% rate. However, noting the number of debris cataloged in the pre- and post-mitigation operational regimes, pre-mitigation flights produced 1786 (98.13% of the total cataloged) debris while post-mitigation flights produced only 34 (1.87% of the total cataloged). Further, examining debris remaining on-orbit as of 4 July 2018, the information cut-off date of the 15th edition of the NASA “History of On-orbit Satellite Fragmentations,” 1073 (99.814% of remaining cataloged debris) pre-mitigation flight debris remain, versus only two (0.186%) for post-mitigation Delta fragmentation events. The significantly different nature of the post-mitigation events argues strongly that, indeed, the operational procedures for stage passivation introduced with Delta 155 resulted in a complete success in addressing the highest likelihood fragmentation scenario.

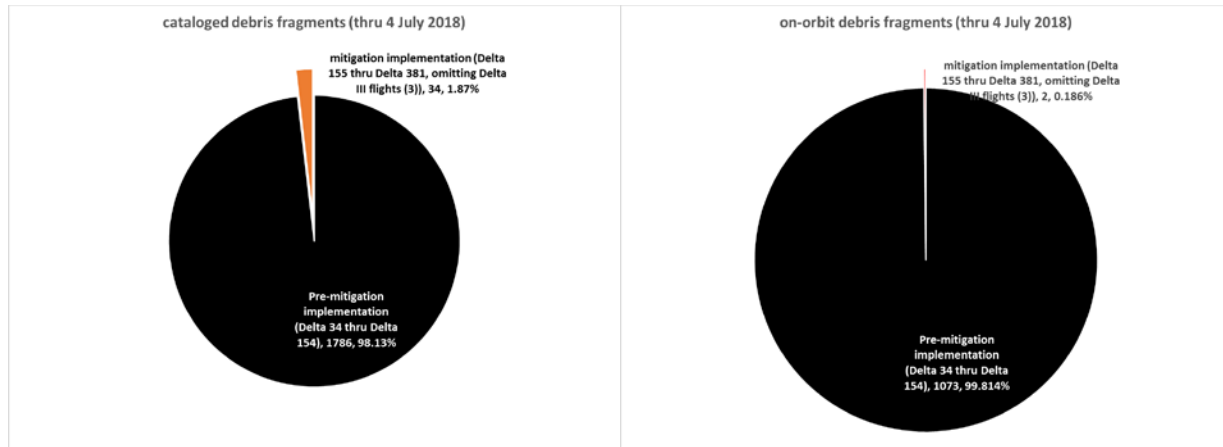
Fig. 8. Pre- (black) and post-implementation (orange) debris cataloged (left) and on-orbit (right).

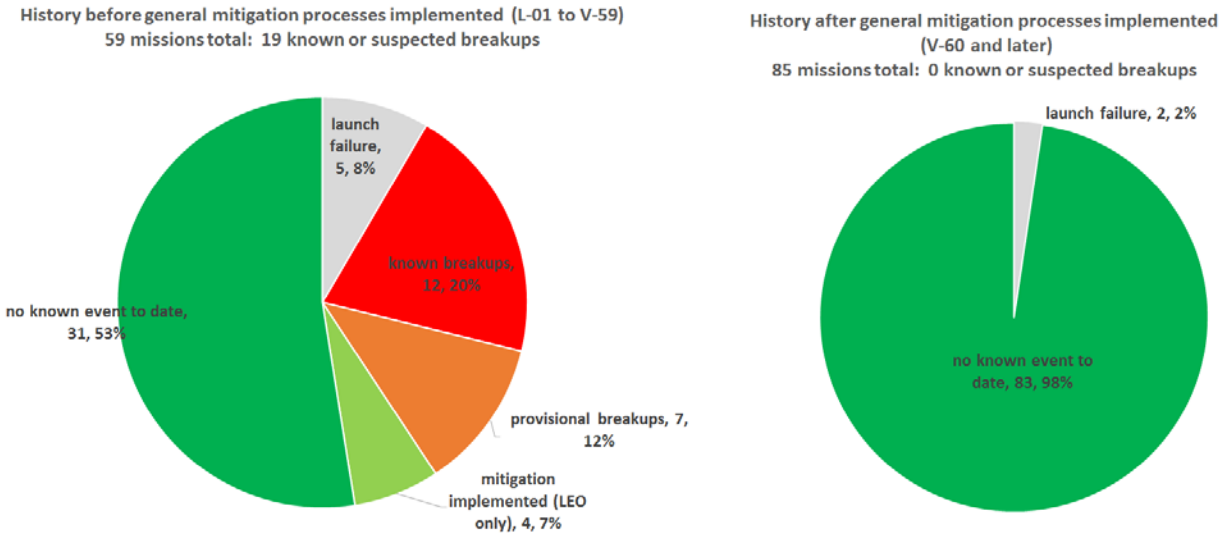
Fig. 9. The proportion of observed or suspected Ariane fragmentations that occurred before and after mitigation procedures were generally implemented. When LEO mitigation was implemented (left chart), no more explosions occurred, and when general mitigation procedures were implemented in all flights (right chart), no more on-orbit explosions occurred.

The manufacturer examined the available data, and was able to exclude causes due to battery explosions, accidental initiation of range-safety explosives, a mechanical breakup due to venting-imparted spin, or electrostatic discharge. Possible root causes included a common bulkhead reversal due to hydrogen or oxygen tank leakage, or rupture of the hydrogen tank due to structural fatigue induced by the orbit day/night thermal cycle. Mitigation practices were first introduced for the launch of SPOT-2 in 1989 (flight V36). These procedures consisted of vehicle reorientation after final payload separation, followed by irreversible opening of the oxygen vent valve [4, 5]. After a “proper time lag,” the pressure release valve on the hydrogen tank was opened irreversibly. Figure 9 graphically shows the effects of mitigation procedures on the rate of explosions.
