NASA/TM–2020-220568/Volume II/Part 2

Nondestructive Evaluation (NDE) Methods and Capabilities Handbook

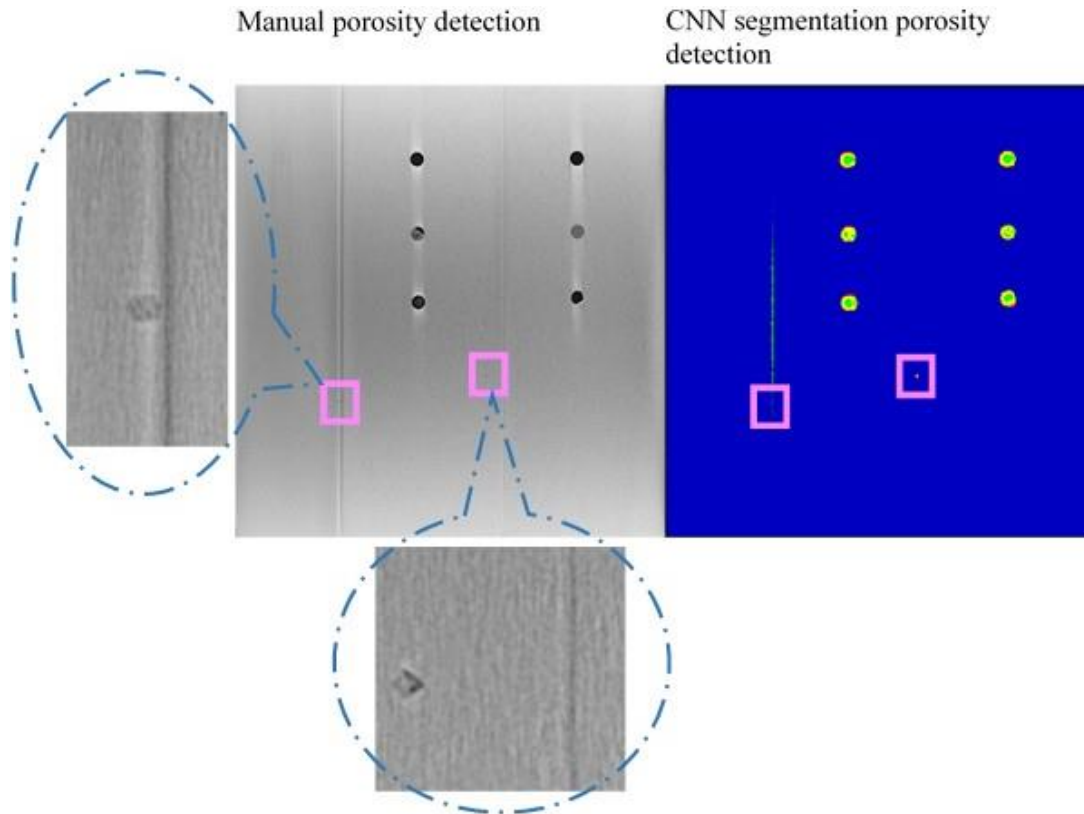
Figure E.2-8. (Left) Manual porosity detection of Y-normal slice showing two locations of porosity. (Right) Porosity detection by CNN Segmentation of same slice.

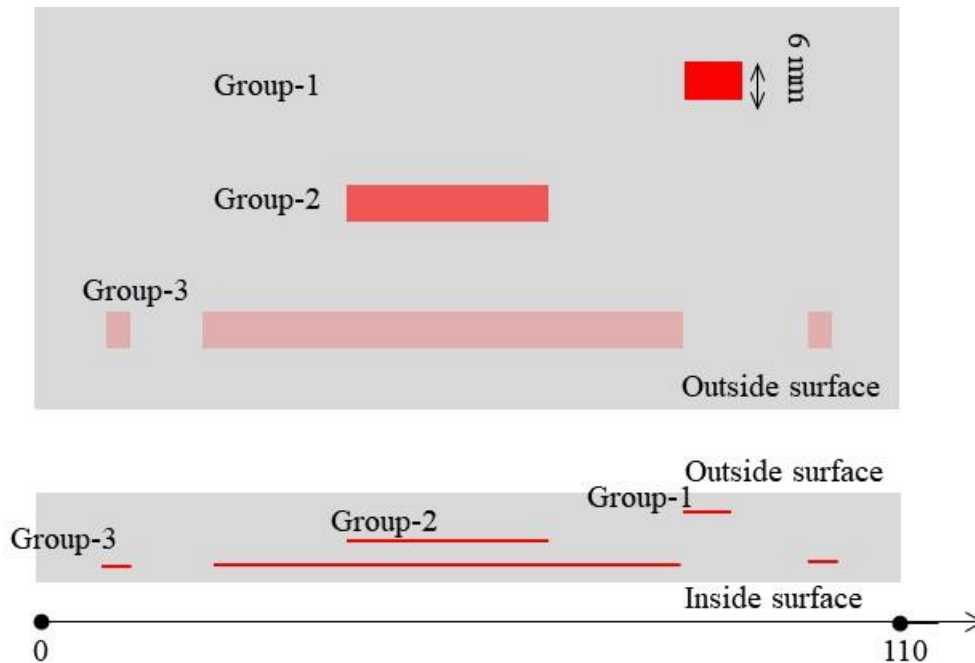
Figure E.19-10. Inspection summary of identified defects.

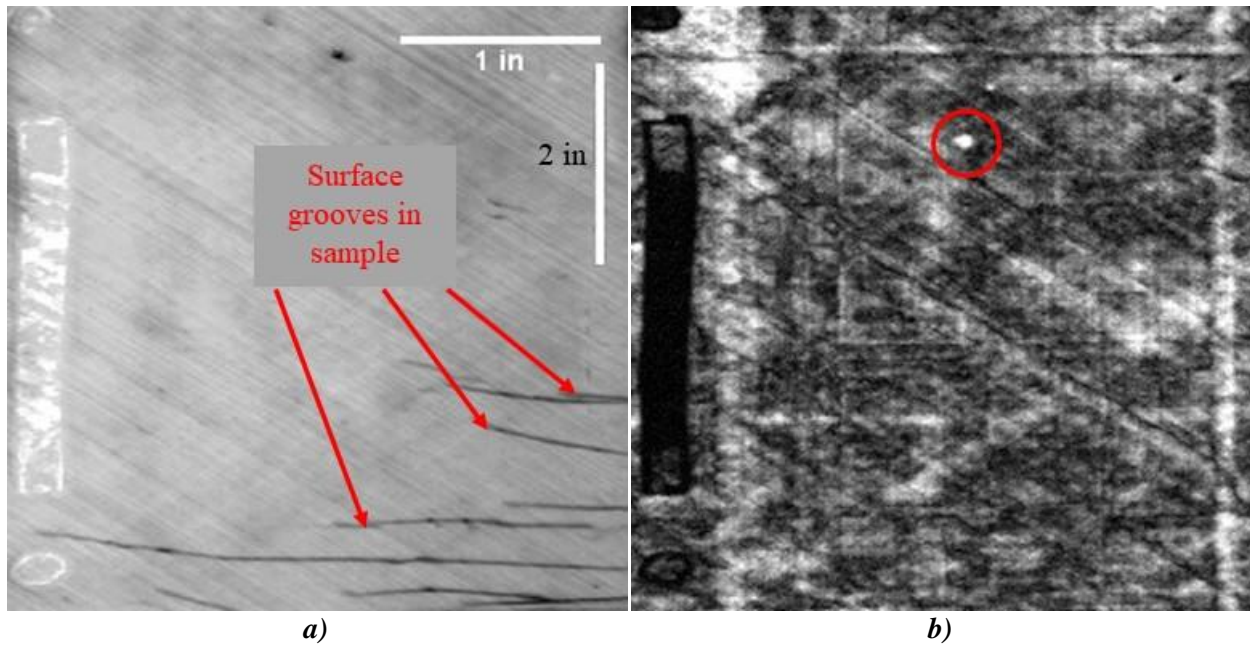
Figure E.20-3. (a) Surface flaws and (b) near surface void

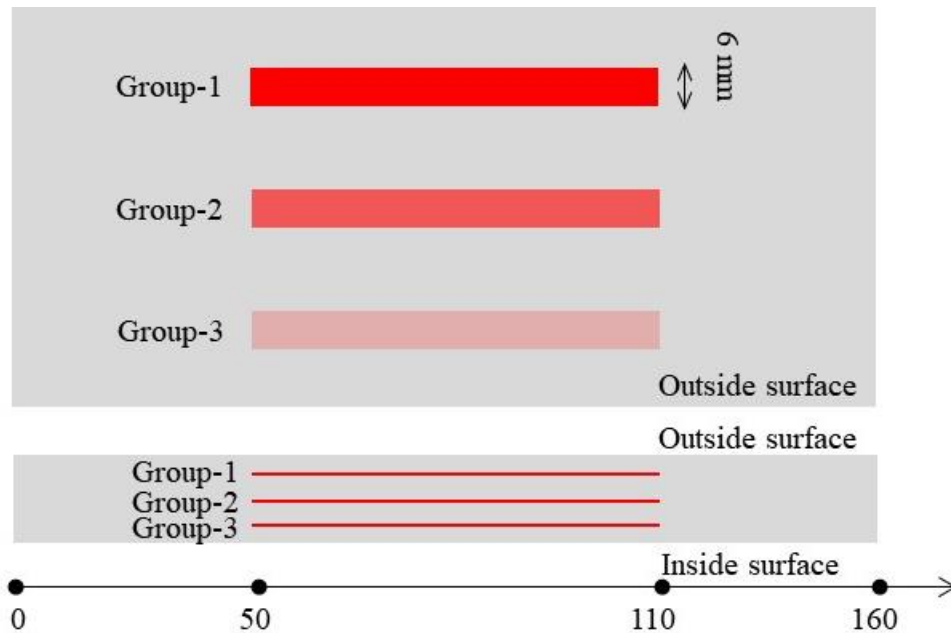
Figure E.20-13. Inspection summary of identified defects.
