Impact Damage Tolerance of Composite Laminates with Through-the-Thickness Stitches

Vipul Ranatunga¹, Savannah N. Minor²
Air Force Research Laboratory, Wright Patterson AFB, 45433, USA

Dawn Jegley³
NASA Langley Research Center, Hampton, VA 23681, USA

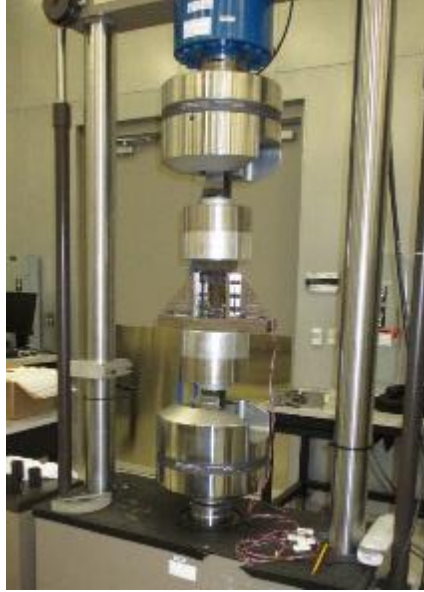
Fig. 7 CAI test specimen in hydraulic test frame.

Instructions in ASTM D7137-12 standard [4] were followed to prepare the specimens for CAI testing, maintaining the specified dimensional tolerance, parallelism, perpendicularity, and surface roughness requirements. Specimens were tested using a standard compression test fixture, as shown in Figure 7, following ASTM D7137-12 [4]. Four strain gages placed on the opposite faces and aligned in the longitudinal direction were used to prevent premature bending or buckling during the compression loading. The strains measured on the opposite faces of the specimen were required to be within 10% of each other in order to prevent specimen bending and subsequent premature failure. To prepare the specimen for compression test, a compressive force up to 10% of the anticipated ultimate failure load was applied and strain gage measurements were recorded, then the compressive force on the specimen was reduced to 156 N (35 lbf). Percentage bending at the maximum load was calculated according to ASTM D7137-12 [4] and corrective measures were taken to align the fixture, test specimen, and the loading platens to avoid the onset of specimen instability.

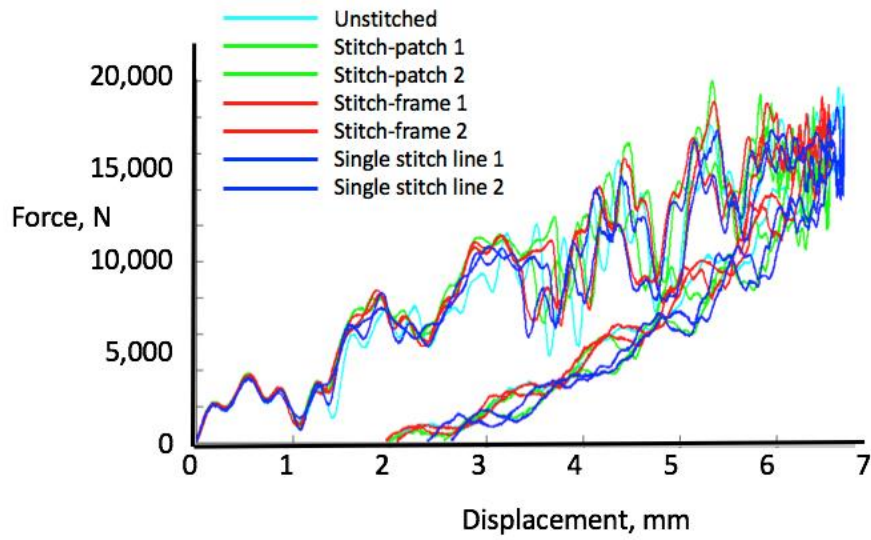
Fig. 10 Impact force vs impactor displacement for 60 J impacts.

The load vs displacement response shown in Figure 10 displays a considerable difference in loading and unloading curves, attributed to the energy dissipation as delamination and other forms of damage. However, The maximum measured force was only slightly greater for the 80 J impacts than for the 60 J impacts, at 22,000 N. Furthermore, the response is nearly identical for all the specimens until the sudden drop of stiffness, regardless of reinforcement pattern deployed in each specimen. The largest total displacement was recorded in unstitched specimens and those with the single stitch line. Identical specimens were studied under 80 J impacts and a similar pattern of load-time history (Figure 11) and load-displacement (Figure 12) behavior were recorded. The load-time history was similar between different types of stitch patterns at the higher impact energy compared to the specimens impacted with 60 J.

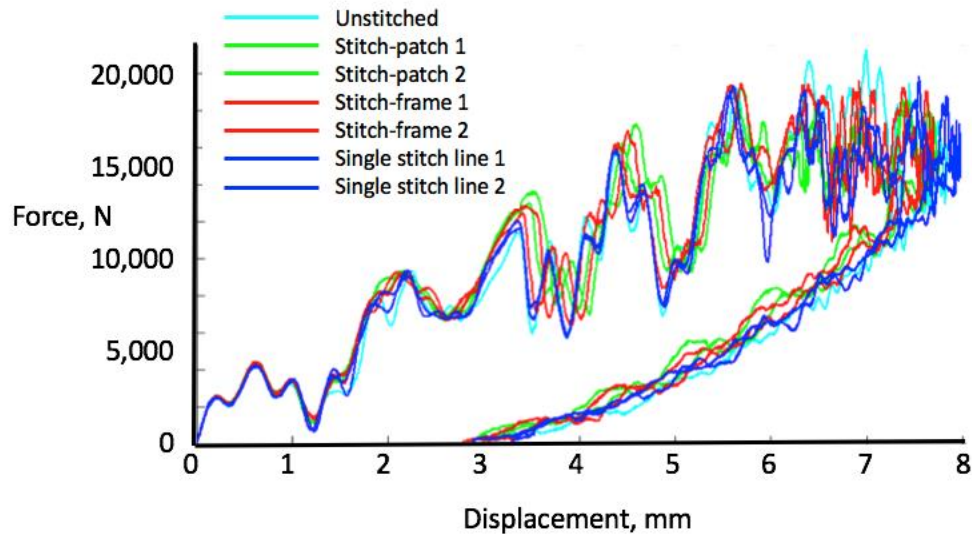
Fig. 12 Impact force vs impactor displacement for 80 J impacts.

The results for one unstitched specimen and two specimens with each stitch pattern at each energy level are shown in Figures 9-12. The results for specimens with no stitching are shown in light blue. The results for stitch-patch, stitch-frame, and single stitch line patterns are shown in green, red, and dark blue, respectively.

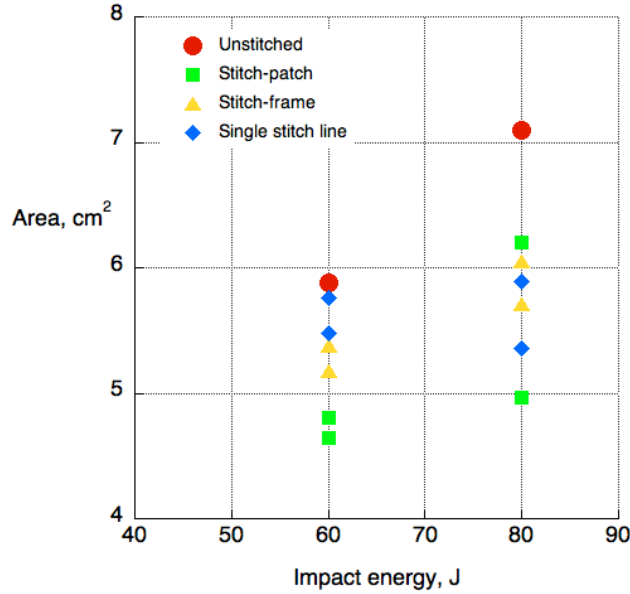
Fig. 13 Comparison of delamination damage size after impact for stitched and unstitched specimens.

Post-impact results are shown in Figures 13-15. The results for specimens with no stitching are shown in red; stitch-patch, stitch-frame, and single stitch line are shown in green, yellow, and dark blue, respectively. The projected area of delamination estimated from the ultrasonic C-scans are compared at two energy levels in Figure 13 to see whether the spread of delamination is affected by the patterns of reinforcement used to contain damage. As expected, the unreinforced specimens have the maximum spread of delamination damage, while the stitch-patch possesses the least delamination spread. For the 60 J impacts, the delamination area for the stitch-patch is approximately 75% of the size of delamination for the unstitched specimen. For the 80 J impacts, the delamination area for the stitch-patch and single stitch line is approximately 50% of the size of delamination for the unstitched specimen. Unlike the delamination spread at 60 J, the higher energy impact at 80 J tends to have similar delamination spread for all the reinforcement patterns. Furthermore, the delamination spread with unstitched specimens is significantly larger than for the stitched specimens at 80 J compared to 60 J impacts.

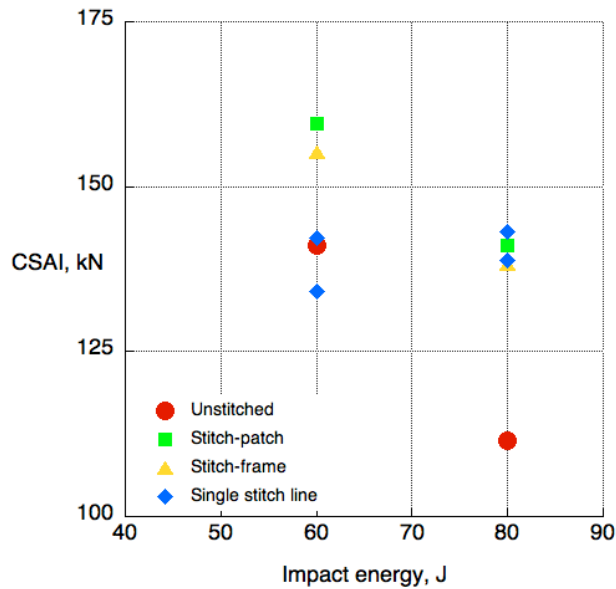
Fig. 14 Comparison of static compression strength after impact for stitched and unstitched specimens.

The value of compression strength after impact (CSAI) reflects a similar response under 60 J impacts as for delamination spread. As shown in Figure 14, the stitch-patch has the highest CSAI while unreinforced and single stitch line specimens have the lowest CSAI. For 80 J impact, there is little difference among the results for the different stitch patterns while the unreinforced specimens have a CSAI approximately 70% of the stitched specimens. Note that the stitch-frame symbol is largely hidden by the other data points for the 80 J impact.

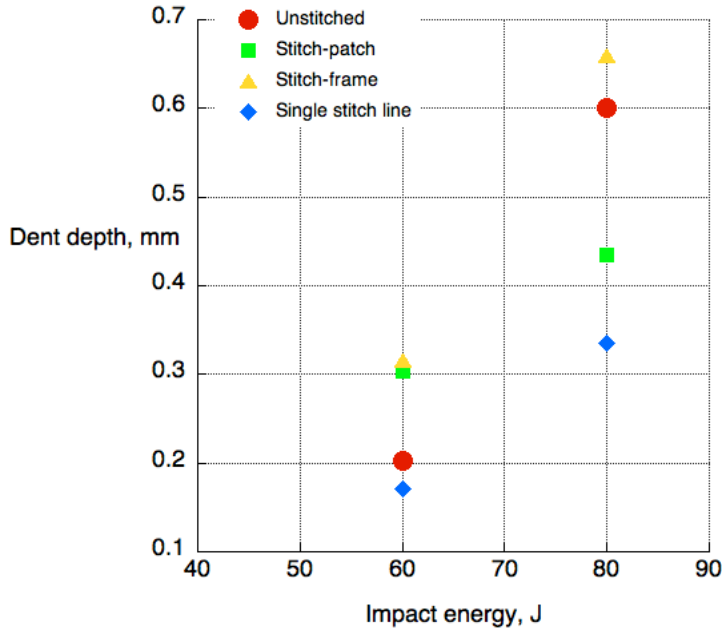
Fig. 15 Comparison of dent depth after impact for stitched and unstitched specimens.

The localized damage under the impactor, measured from the projected average dent-depth profile, did not produce a consistent outcome. As shown in Figure 15, the single stitch line has, on average, the least dent depth under the impactor at both energy levels while the stitch-frame has the greatest dent depth. The average single value of dent depth plotted on Figure 15 is not consistent with the size of localized damage under the impactor. A contributing factor to the apparent lack of consistency in these results could be the noise found in the surface measurements themselves.

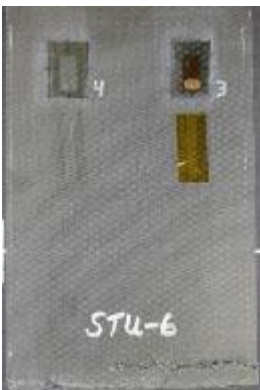
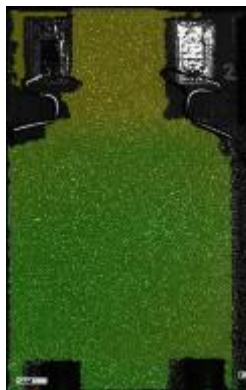
a) Back surface damage

b) DIC images immediately before and after failure

Fig. 16 Failure patterns of a typical unstitched, unimpacted specimen.

Failures on the back surface and DIC images of out-of-plane deformation immediately before and after failure of specimens subjected to compression testing are shown in Figures 16-20 to compare the modes of failure in the presence of different reinforcements patterns. Unstitched specimens without impact damage failed at the bottom of the specimen as shown in Figure 16 (a). The failure occurred at this location because the supporting vertical knife edges of the compression test fixture leaves a small gap at the top and bottom of the specimen, allowing a local out-of-plane displacement at the bottom corners, resulting in a local stress concentration which triggered failure near this unsupported gap. DIC images prior to failure show minimal out-of-plane deformation while the post-test image shows a noticeable out-of-plane deformation with failure at the bottom of the specimen.

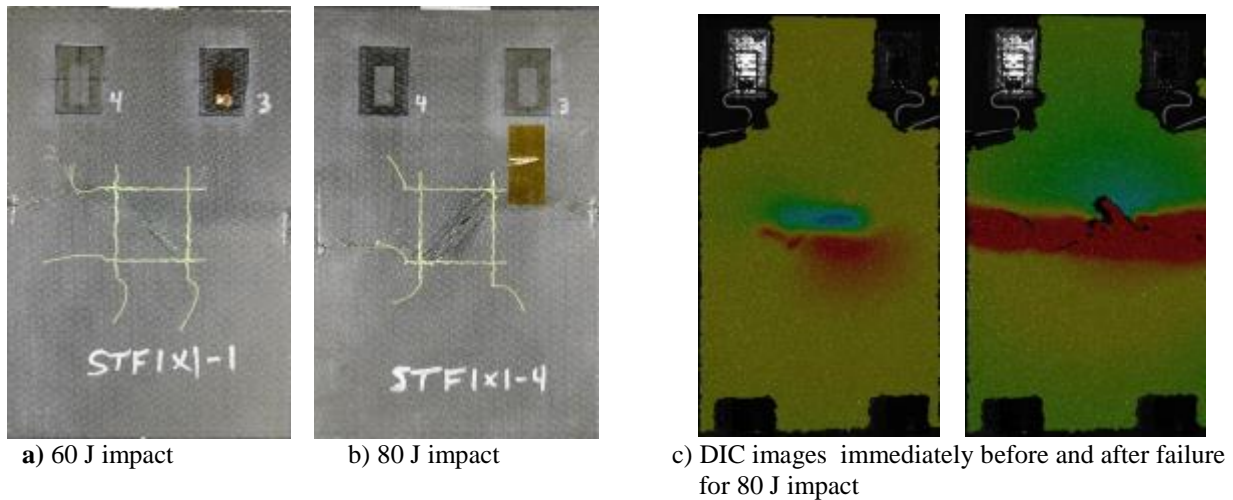
Fig. 20 Failure of typical single line stitched impacted specimen.

Significant back-splitting and fiber breakage was observed in specimens with a single stitch line, as shown in Figures 20 (a) and (b). The failure initiated from the diagonal corners of the specimen and propagated to the sides of the test article, displaying a different failure pattern compared to the two other stitch patterns. The DIC images in Figure 20 (c) shows the displacement pattern of a specimen subjected to 80 J impact. An outward and inward displacement field above and below the damage site, respectively, was observed prior to the failure. A significant outward displacement field above the failure line was observed immediately after the sudden failure. Somewhat different failure patterns were observed between the duplicates of 60 J and 80 J impacts and these are not included in this paper but will be evaluated more thoroughly at a later date.
