# Impact of Advanced Synoptics and Simplified Checklists during Aircraft Systems Failures

A human-in-the-loop test was conducted in NASA Langley’s Integration Flight Deck B-737-800 simulator to evaluate advanced synoptic pages with simplified interactive electronic checklists as an IAS for routine air carrier flight operations and in response to aircraft system failures. Twelve U.S. airline crews flew various normal and non-normal procedures and their actions and performance were recorded in response to failures. These data are fundamental to and critical for the design and development of future increasingly autonomous systems that can better support the human in the cockpit. Synoptic pages and electronic checklists significantly improved pilot responses to non-normal scenarios, but implementation of these aids and other intelligent assistants have barriers to implementation (e.g., certification cost) that must be overcome.

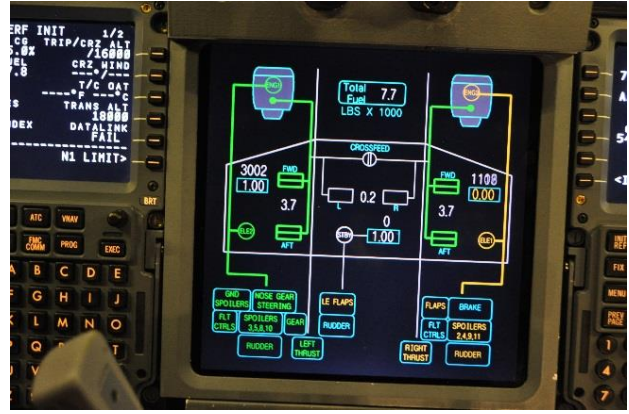
Figure 3. Fuel Synoptic Page with Hydraulic Failure Shown on Lower Display Unit

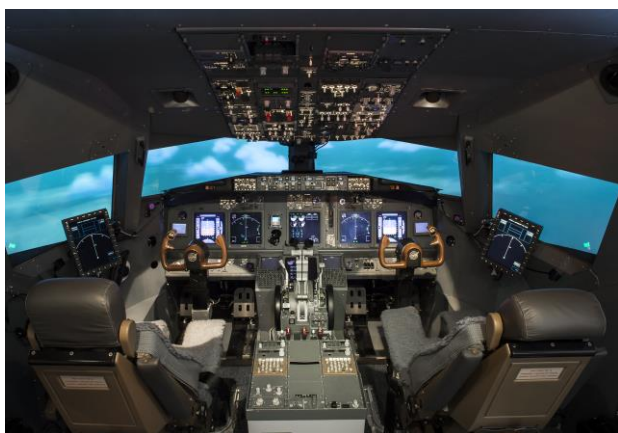
The experiment was conducted in the NASA Langley Research Center (LaRC) Integration Flight Deck (IFD) simulator, Fig. 5. The study was conducted in full motion with the IFD articulated on top of a hexapod hydraulic motion system. The IFD simulator cab is populated with flight instrumentation, including the overhead subsystem panels, to replicate a B-737-800. This facility incorporates fully functioning pilot controls with representative force feel and a stick shaker system, a flight management system, and 6 representative flight displays (2 PFDs, 2 NDs, EICAS display and lower system display). EFB displays are installed outboard on each pilot's side and were used to display interactive ECLs to the crew. A collimated out-the-window scene is produced by an Evans and Sutherland Image Generator graphics system providing approximately 200 degree horizontal by 40 degree vertical field-of-view at 26 pixels per degree.

Figure 5. Integration Flight Deck Simulator

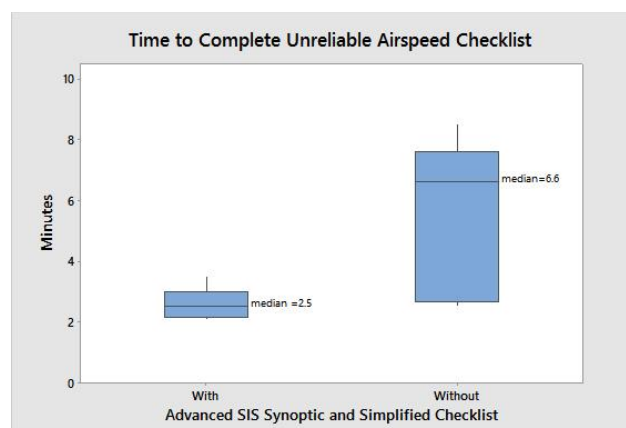
As discussed, the checklist usage for Blocked Pitot Tube condition was problematic because the first annunciation, IAS DISAGREE, points to a checklist with the only action “Refer to the unreliable airspeed checklist”, which required crews to manually find the Unreliable Airspeed checklist. Fig. 6 shows a box plot of the time to complete hydraulic system B checklist and Fig. 7 shows a box plot of the time to complete unreliable airspeed checklist.

Comparing checklist usage with and without advanced synoptic and simplified checklists, an ANOVA revealed significant differences for time-to-complete Unreliable Airspeed Checklist ( $F(1,10) = 8.81$ ,  $p = 0.014$ ). Crews completed this checklist significantly earlier when using the advanced synoptic page with simplified checklist ( $M = 2.5$  min) compared to conventional ECLs without synoptic ( $M = 6.6$  min).

Figure 7. Time to Complete Unreliable Airspeed Checklist
