# Progress in Autonomous Inspections using Collaborative Robots

K. Elliott Cramer, Joshua Brown & Daniel Perey  
Nondestructive Evaluation Sciences Branch  
NASA Langley Research Center

Presented to:  
2019 ASNT Research Conference

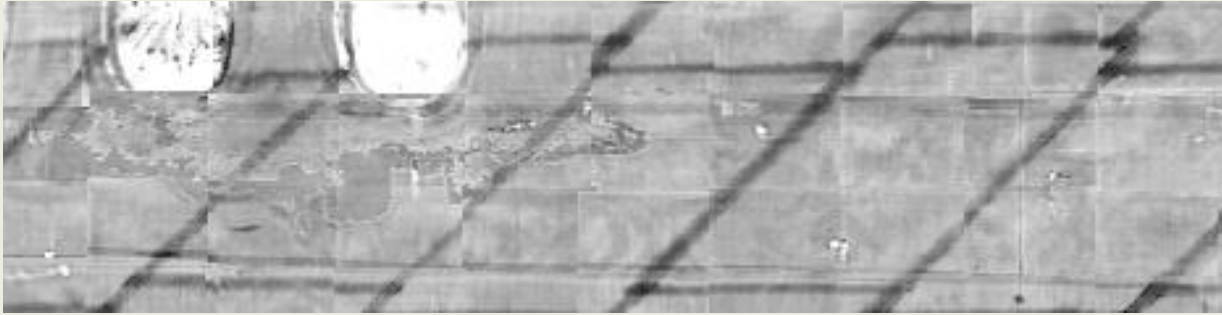
Flash Inspection (Full Temporal Processing)

Results similar to flash thermography  
with improved inspection speeds:  
2X+ faster than robotic flash  
thermography  
10X+ faster than manual flash  
thermography

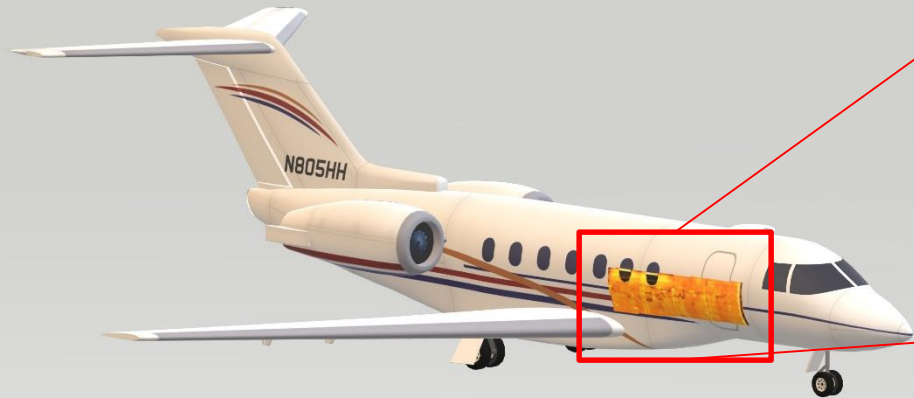
# Results on Hawker 4000 Fuselage Section

Processed Data accurately registered to a model of the “as manufactured” structure
