Lessons Learned from Recent Space Flight Assessments

James P. Smith¹, Kenneth R. Hamm Jr.², Kauser S. Imtiaz³ and Ivatury S. Raju⁴
NASA Langley Research Center, Hampton, Virginia

ABSTRACT

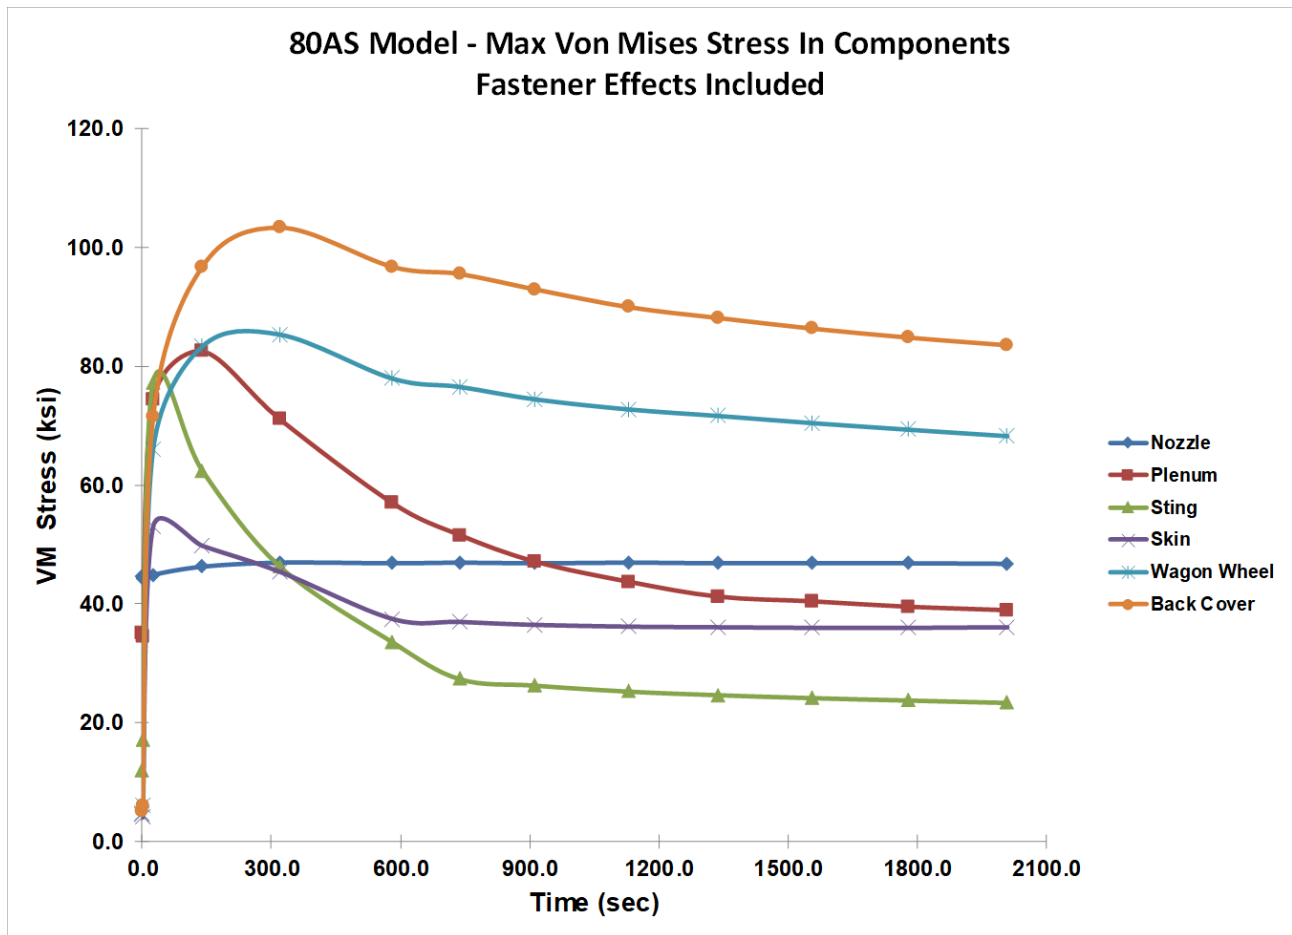
Figure 9. Stress Effects Resulting from Thermal Transients

The simulation now allowed the model to gradually heat from the inside, following the heating/cooling cycles. Thermal strain now developed between structural parts. These more accurate results showed an increase in loads and stresses in the components of the test article, especially at joints, due to pressure effects combined with transient flow of heat. Stress levels were significantly higher in the first 3-4 transient cycles than had been predicted by steady state analyses, as is shown in Figure 9 and Table 2⁸. Figure 9 illustrates the peaking of stress in the early heating/cooling cycles resulting from thermal transient behavior.

Margins, which originally had shown positive, were now negative in many locations. However, much of the hardware was already fabricated - a result of starting manufacturing based on the results of the earlier steady state analysis. Test schedules in the ARC wind tunnel were set and did not allow sufficient time for hardware re-design or re-manufacture.

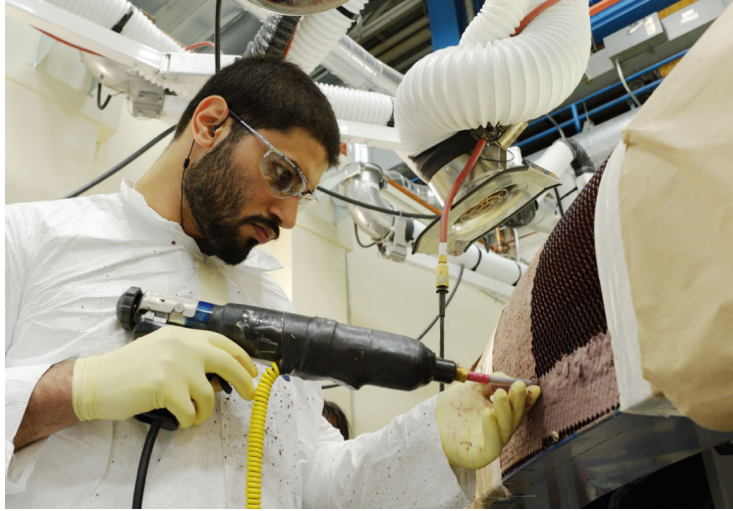
Figure 11. Manual injection process implemented on Orion EFT-1 heat shield
(<https://www.nasa.gov/content/partnerships-make-missions-possible>)

By comparison, some five decades later, the heat shield fabrication on the Orion MPCV followed many of the same processes. The manual injection process, shown in Figure 11, was largely unchanged. This manual process involved injecting over 300,000 individual cells by hand to create a rough form of the ablative heat shield followed by non-destructive evaluation using X-ray.

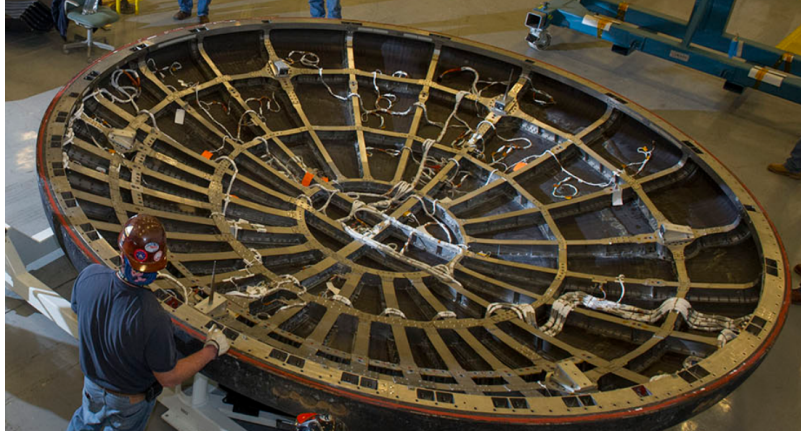
Figure 12. Orion Heatshield Substructure

- Apollo used a stainless steel plate and honeycomb substructure⁹ whereas Orion used a composite substructure with a titanium backbone¹⁰ (Figure 12)
- Material constituents used in the Apollo era Avcoat mixture were no longer available in the Orion era due to modern environmental regulations
- Differences in how requirements were levied, such as the use of average material properties during Apollo and A-basis properties for Orion and how design factors were levied on the thermally induced loads
- Apollo's heat shield diameter was 154 inches compared to Orion's diameter of 198 inches¹⁰

The difference in structural design has certain implications for the thermo-mechanical response of the heat shield system. The mechanical stiffness of the Apollo steel sheet and honeycomb design is significantly different from Orion's quasi-isotropic composite laminate and titanium backbone system. The Apollo system provides for repeatable mechanical response (i.e., essentially isotropic-like bending response), but the circumferentially and radially stiffened Orion system allows for local bending between stiffeners.

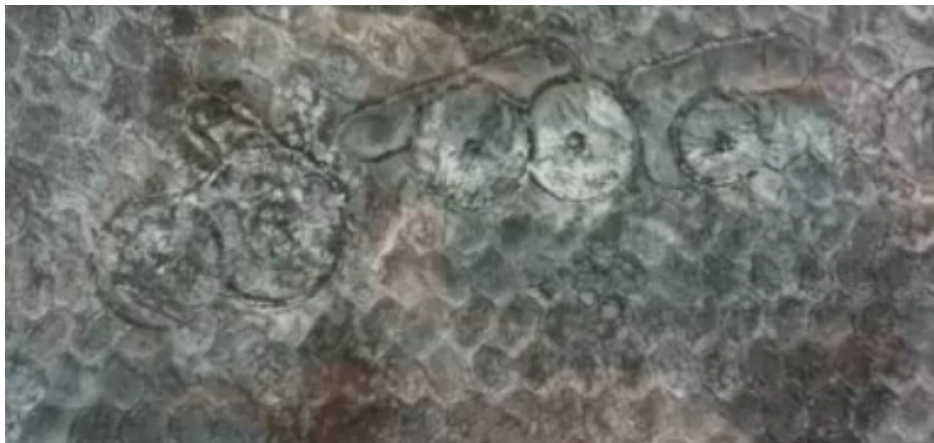
Figure 14. Apollo plug repair¹²

The Apollo Program developed and implemented a repair process because Avcoat cracking was a known issue at the time. Indeed, all Apollo Command Module spacecraft had these repairs, as shown in Figure 14.

The issues associated with Avcoat cracking on Orion were corrected in the field using a repair process derived from original Apollo processes. While the repair process was recertified for the MPCV implementation, much of the heritage Apollo process remained intact.
