# Lamb Wave Nondestructive Evaluation and Imaging on Plate-Like Structures

Ph.D. Comprehensive Exam Defense

08/05/2019

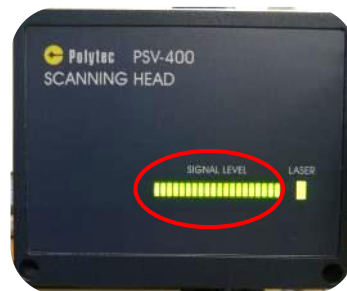
SLDV signal  
strength indicator

- Non-invasive PZT-SLDV system
  - Simply Balanced™ honey as couplant for PZT actuation
  - Albedo 100 wipe-off reflective spray as SLDV enhancement
