# Utilizing NASA Earth Observations to Assess Sea Level Rise and Develop Optimal Green Infrastructure Plans to Restore Mangrove Habitat and Enhance Coastal Resiliency

Maria Luisa Escobar Pardo\*, Christopher Cameron, Abhishek Kumar,  
Sonia Linton, David Rickless, Navid Hashemi Tonekabon, & Sam Weber

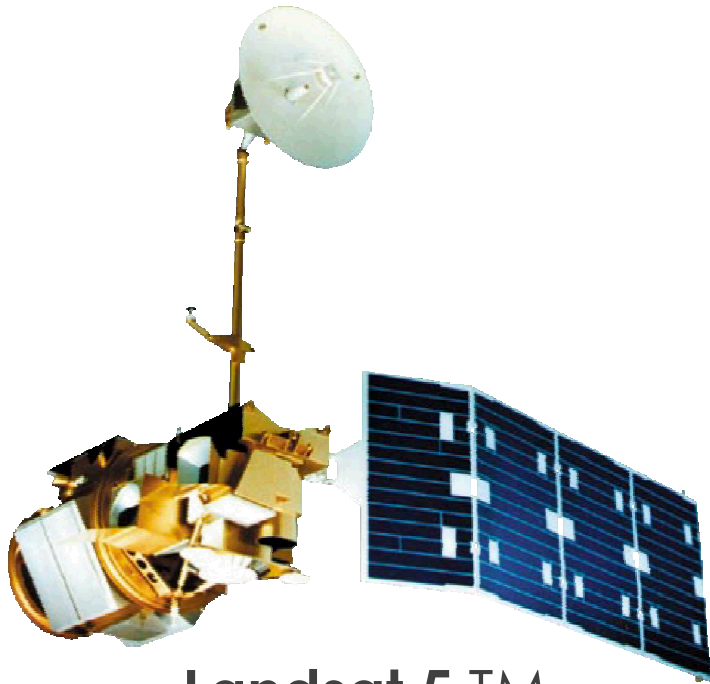
**Landsat 5** TM

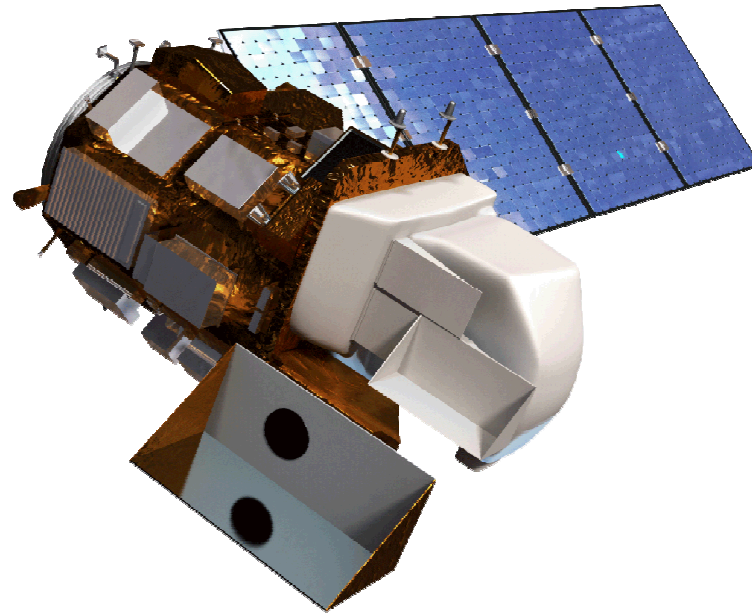
**Landsat 8** OLI

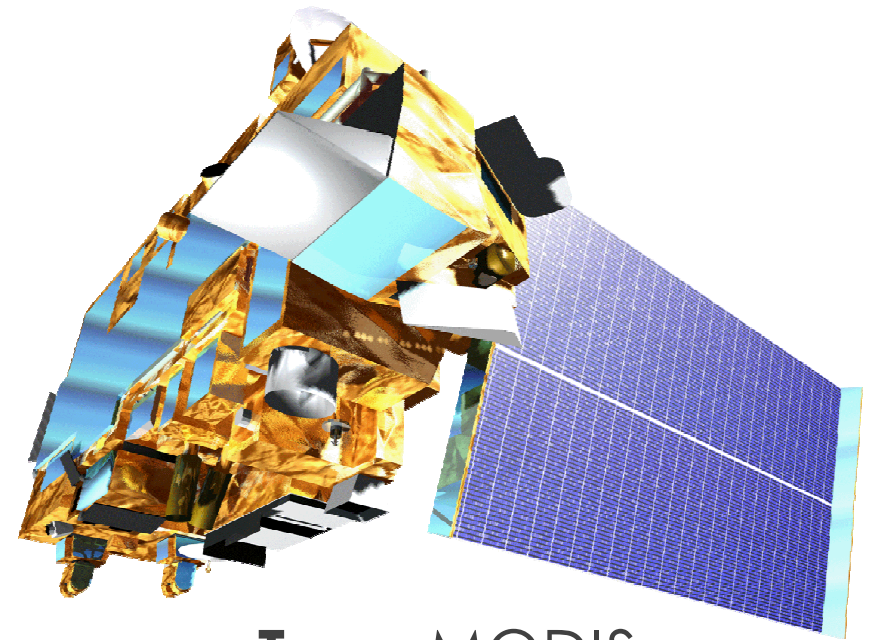
**Terra** MODIS

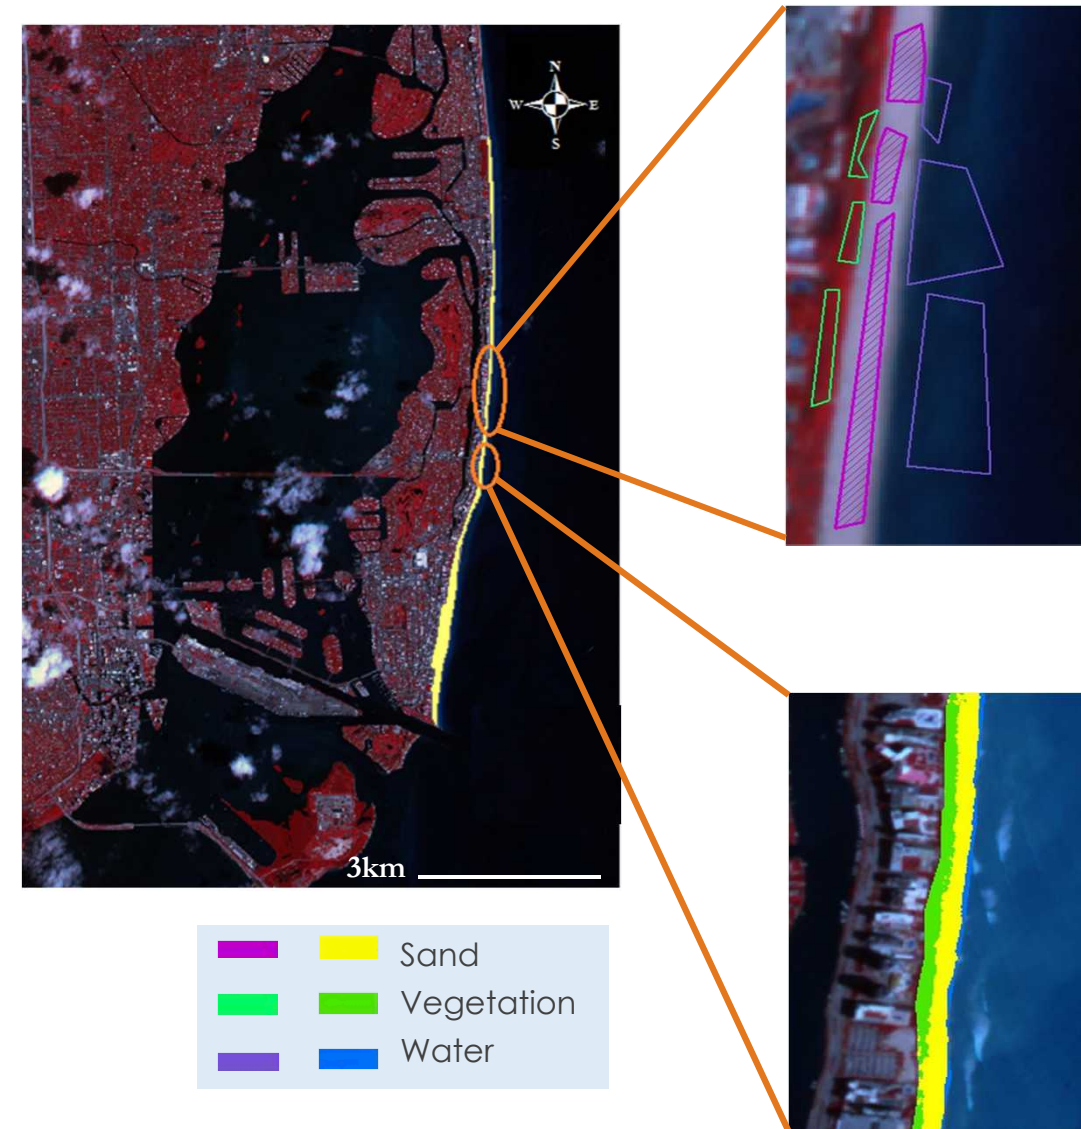
# Results – Coastal Damage

| Dates | Class | Area (km <sup>2</sup> ) |
| <b>09/07</b><br>(3 days before Irma) | Sand | 0.71 |
| | Vegetation | 0.48 |
| <b>09/12</b><br>(2 days after Irma) | Sand | 0.92 |
| | Vegetation | 0.26 |
| <b>10/30</b><br>(40 days after Irma) | Sand | 0.79 |
| | Vegetation | 0.39 |

- ▶ Approximately **45%** of coastal vegetation along Miami Beach **was lost or damaged**
- ▶ An estimated **26%** of this **vegetation recovered** within 40 days of the storm's passing

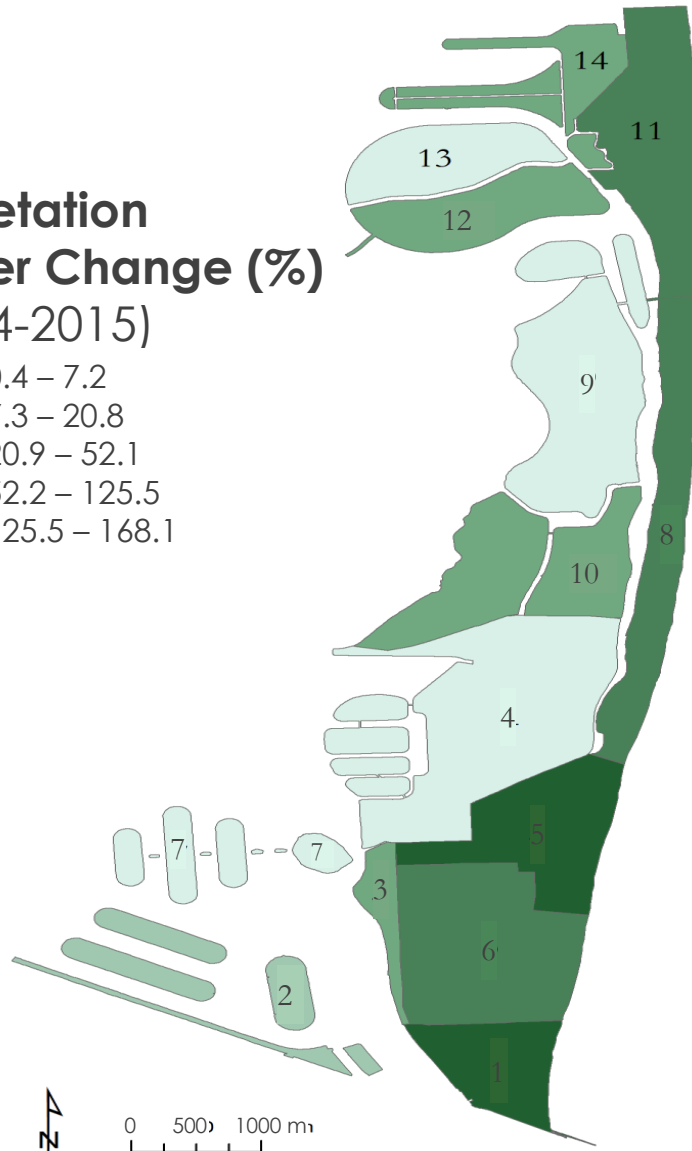
## Vegetation Cover Change (%) (1994-2015)

## Neighborhoods

1. South Pointe
2. Star/Palm/Hibiscus
3. West Avenue & Bay Road
4. Bayshore
5. City Center
6. Flamingo/Lummus
7. South & Venetian Islands
8. Oceanfront
9. La Gorce
10. Nautilus
11. North Shore
12. Normandy Isles
13. Normandy Shores
14. Biscayne Point

- ▶ The city of Miami Beach saw a **24% increase** in vegetation coverage between 1994 and 2015
- ▶ The city's plans to **implement and maintain green infrastructure** are having positive effects

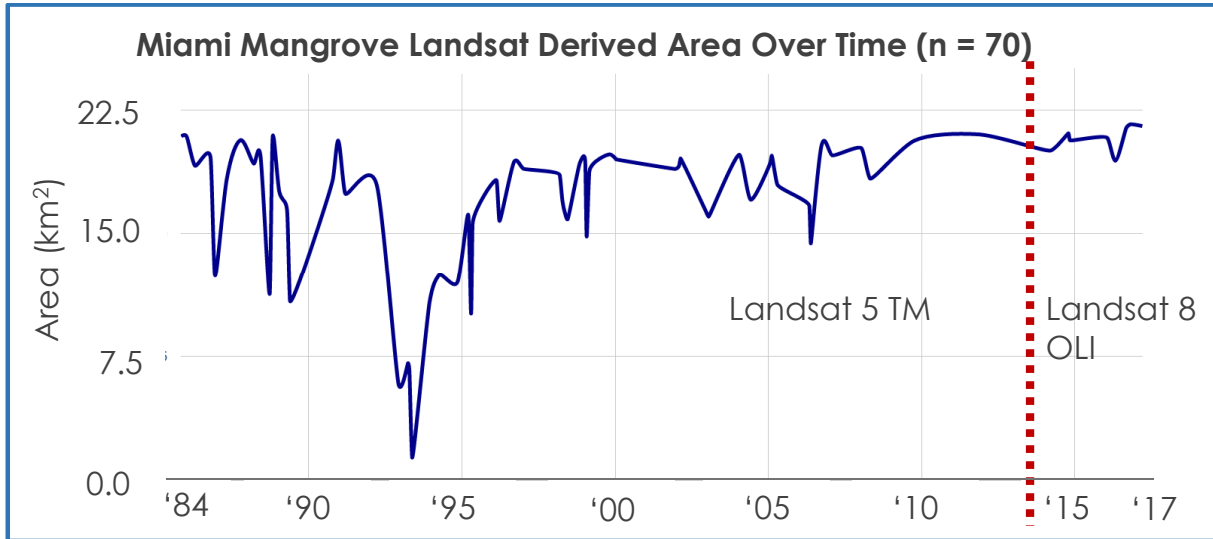
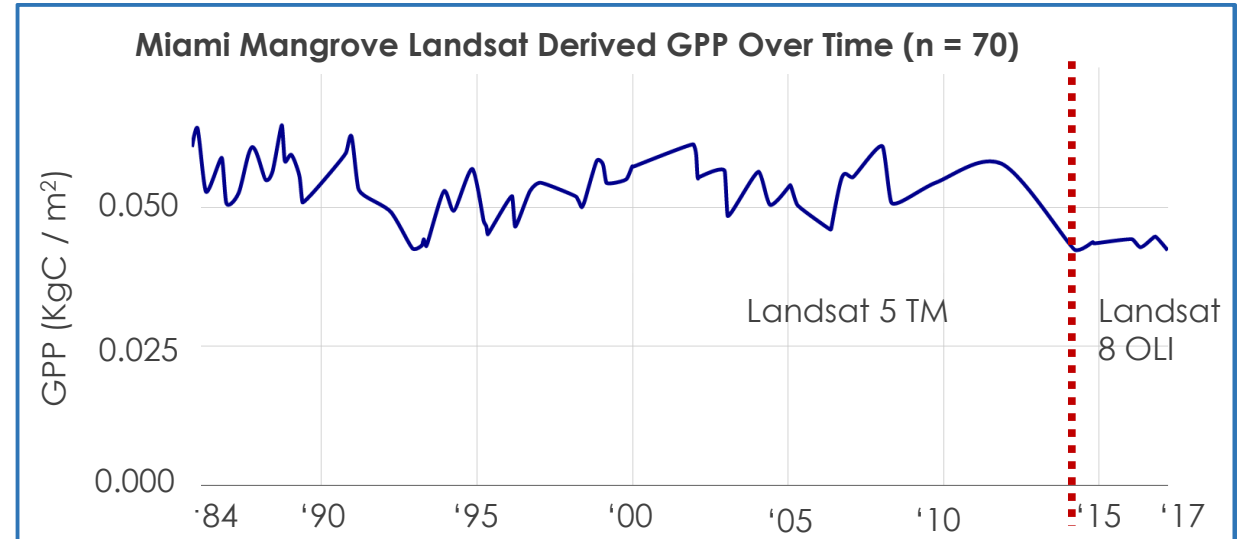
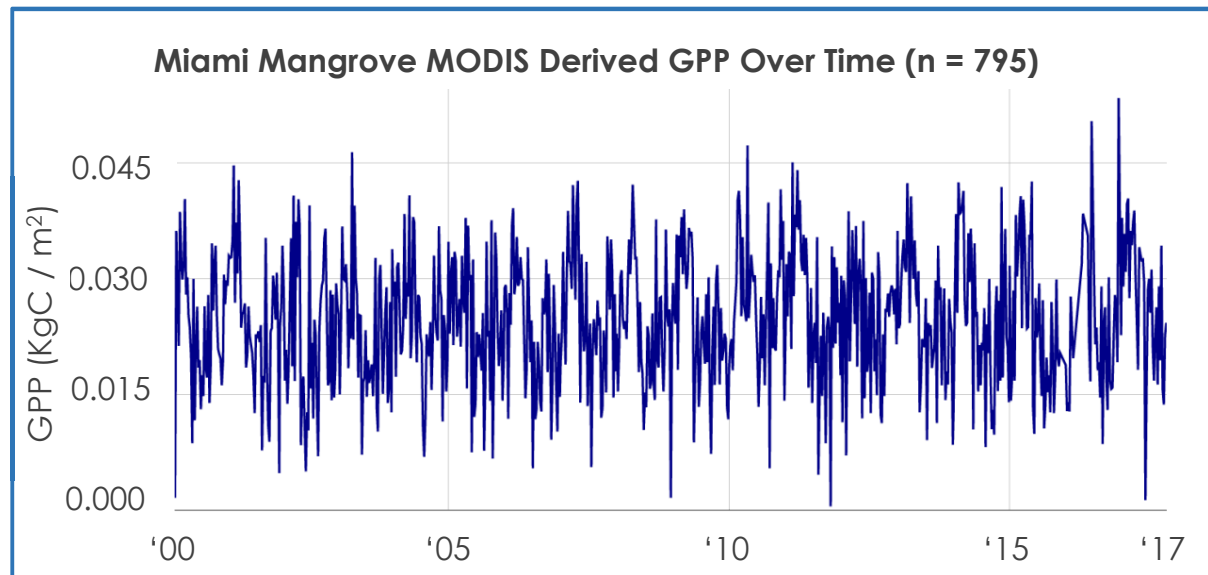
# Results – Mangrove Health

$$GPP = 0.096926 \cdot EVI + 0.0003819$$

Where,  $EVI = 2.5 \left[ \frac{(NIR - Red)}{(1 + NIR + 2.4 \cdot Red)} \right]$
